Inspection Photos  
Operator: BP America  
API#: 067-07843  
Date: 3/10/2020

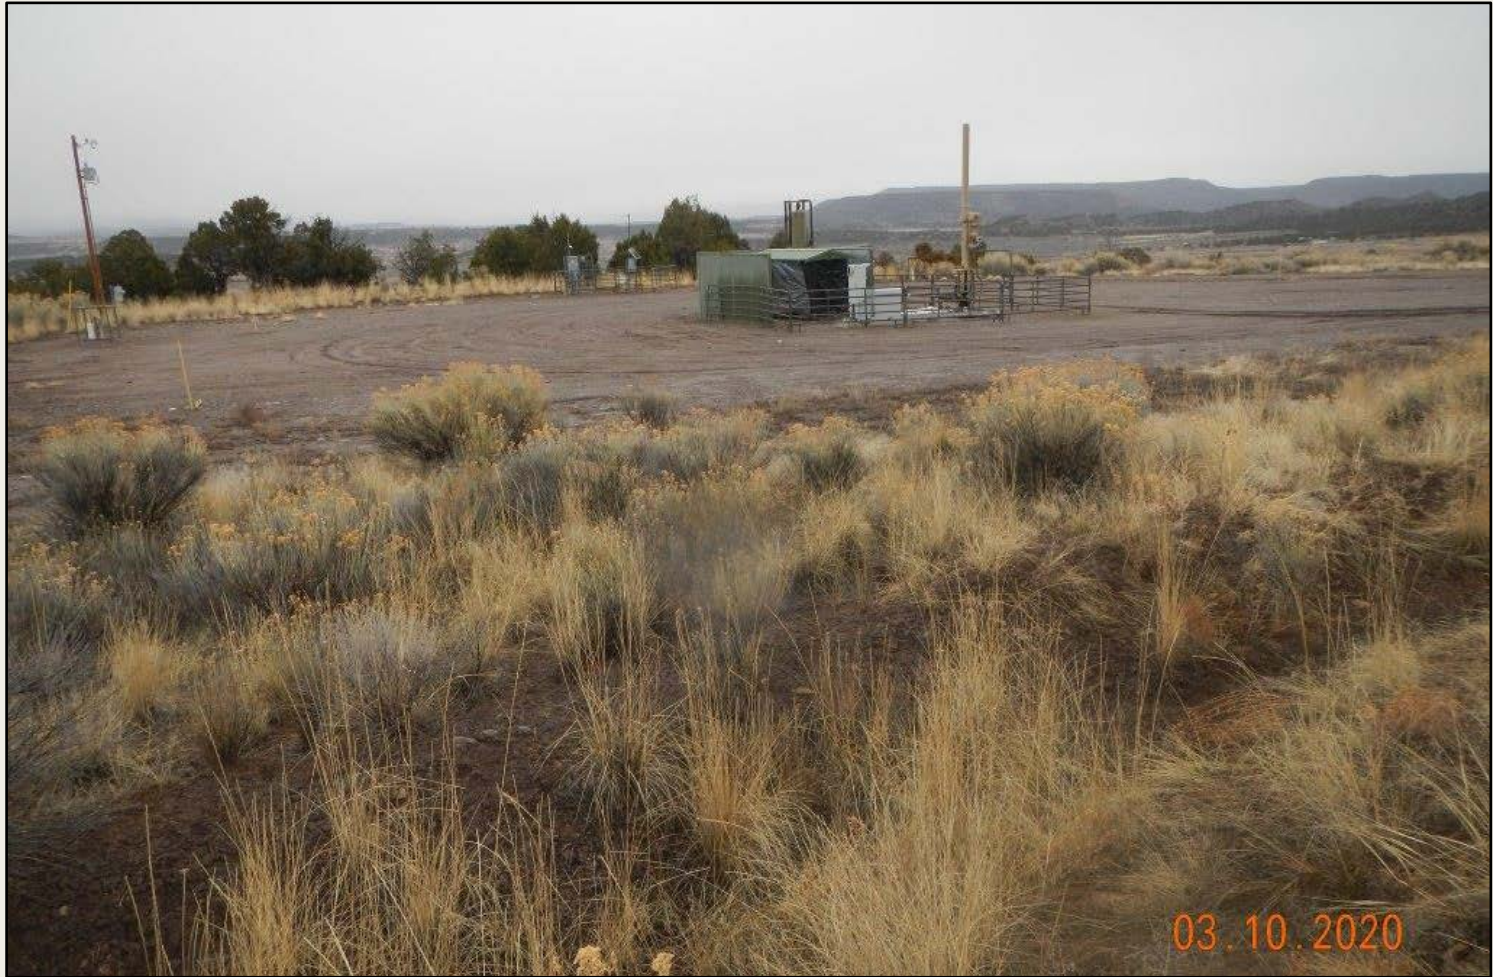
Photo 1. View of the project area from the northwestern corner facing center.

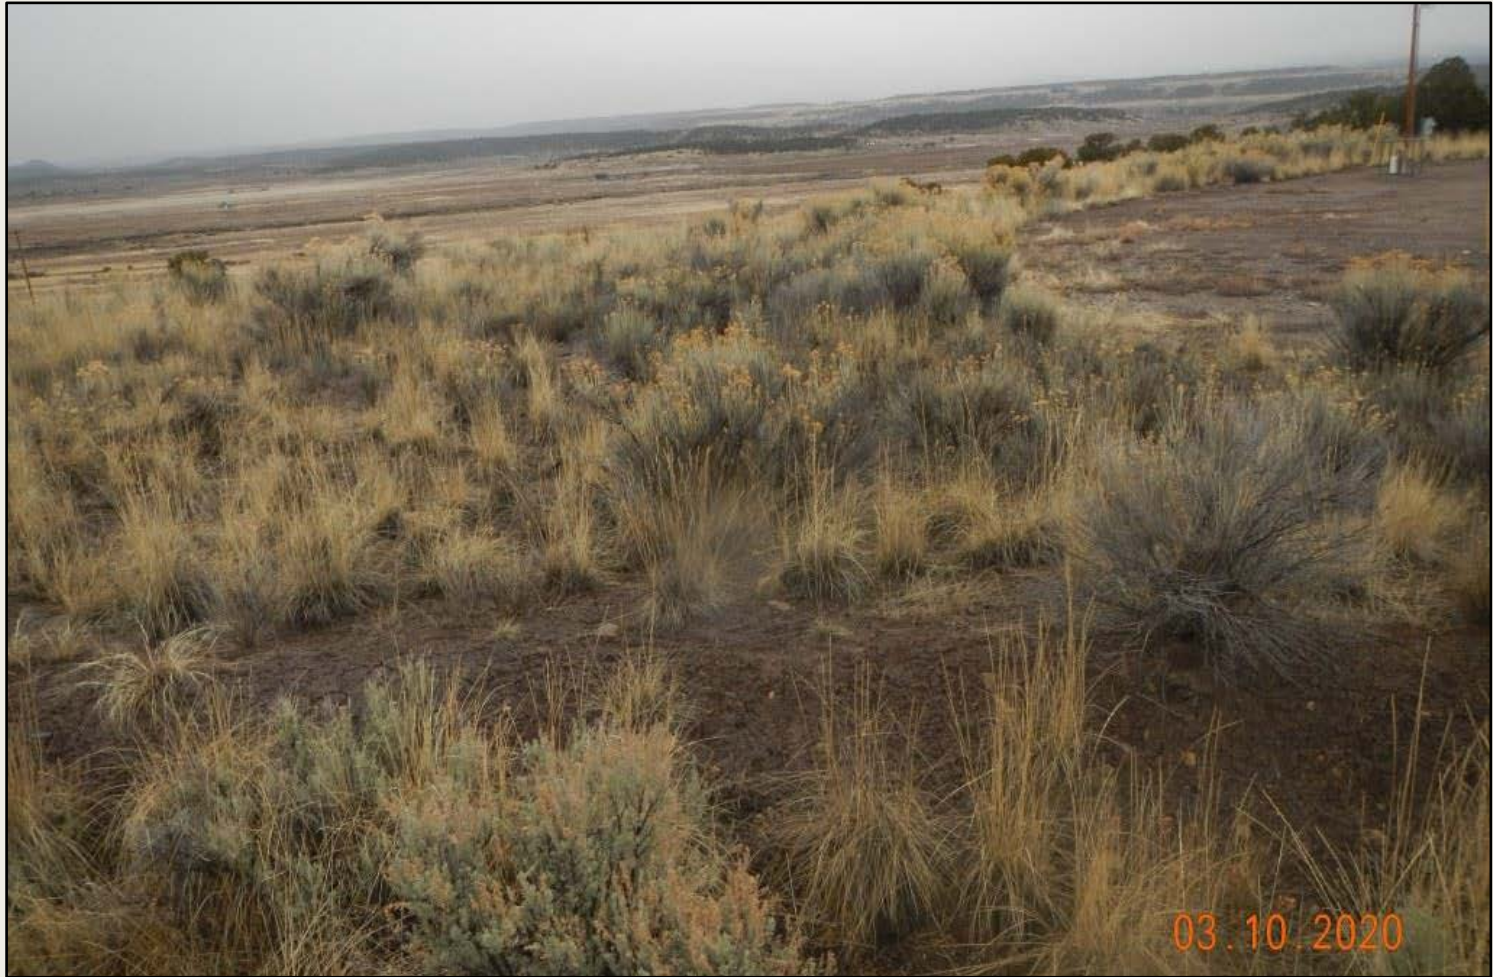
Photo 2. View of the northern fill slope from the northwestern corner facing eastward. Revegetation is progressing largely with western wheatgrass, crested wheatgrass, and rubber rabbitbrush.

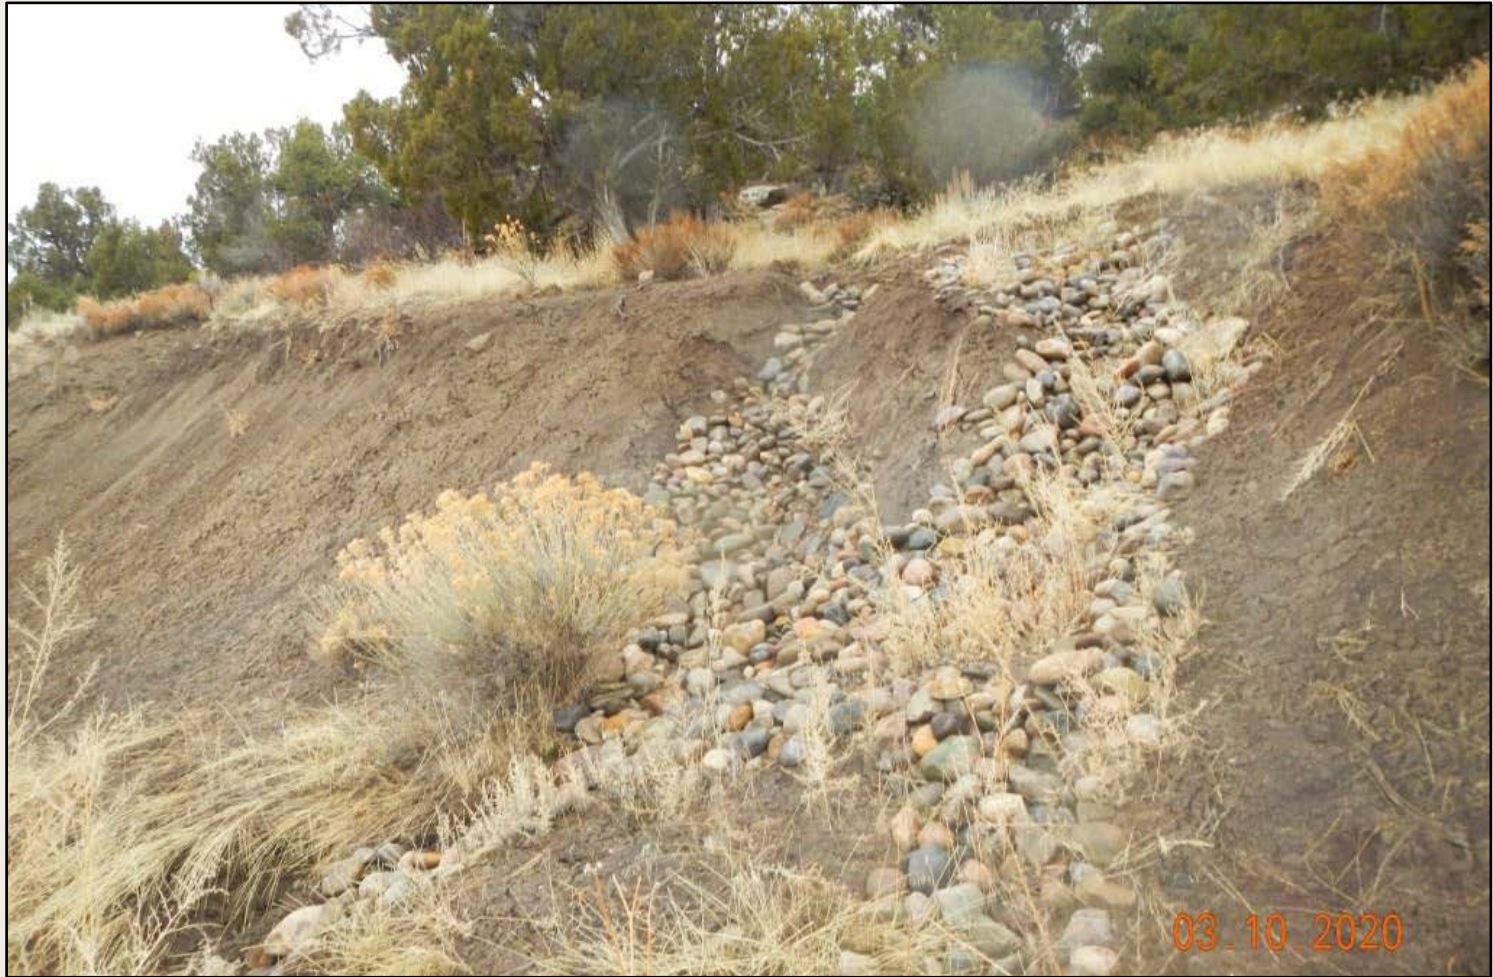
Photo 3. View of cobble placed on southwestern cut-slope, providing partial stabilization.

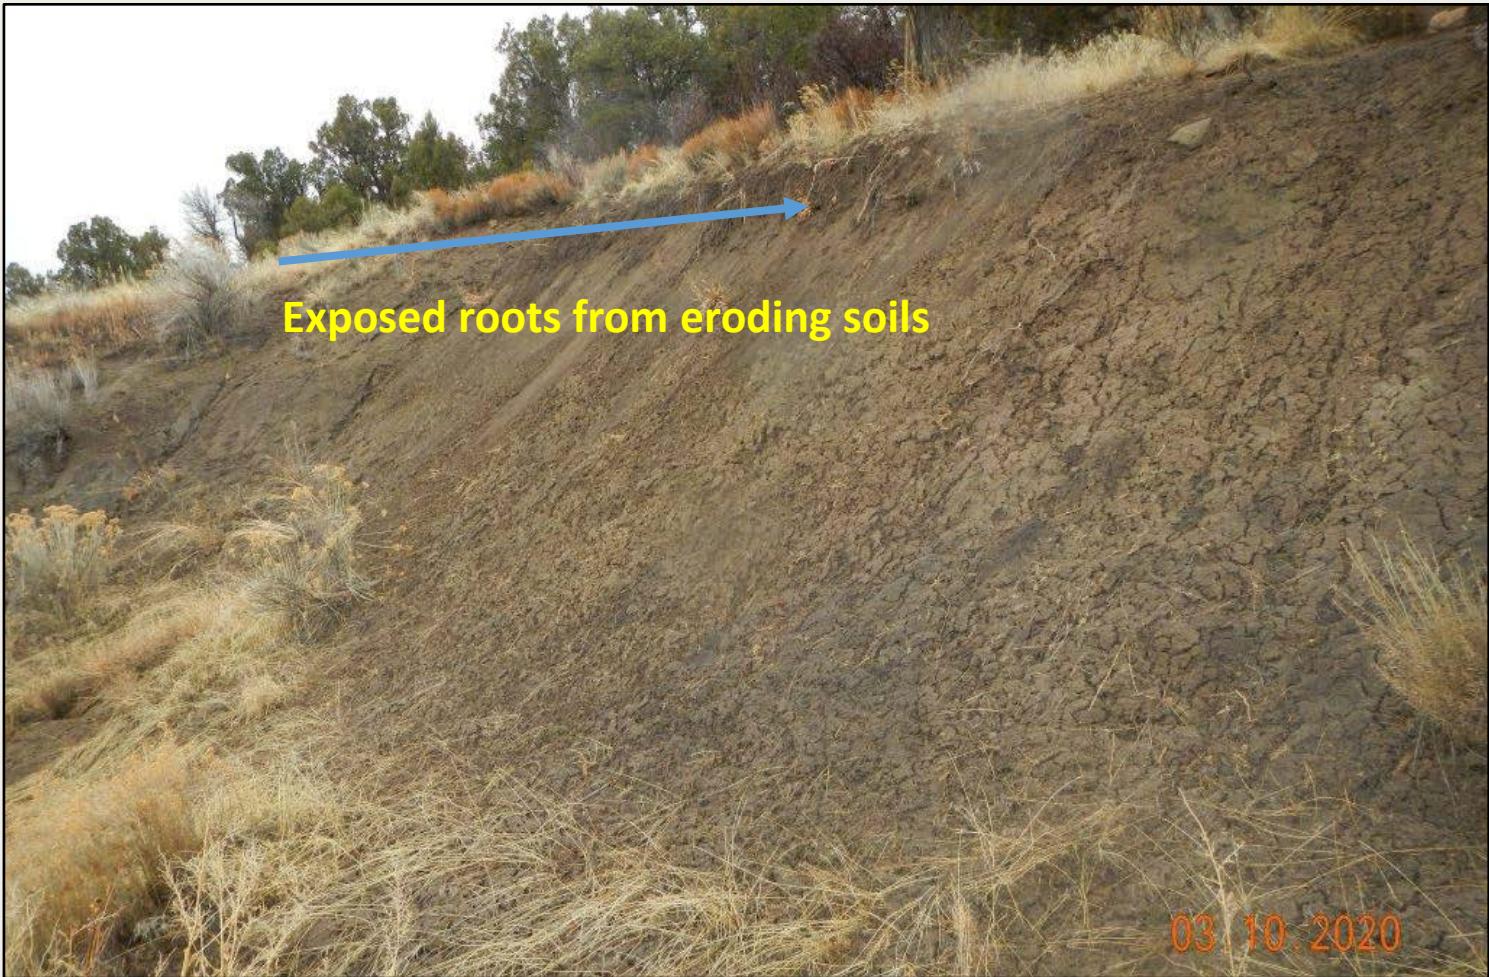
Photo 4. View of unprotected soils within the southwestern cut-slope still needing stabilization.

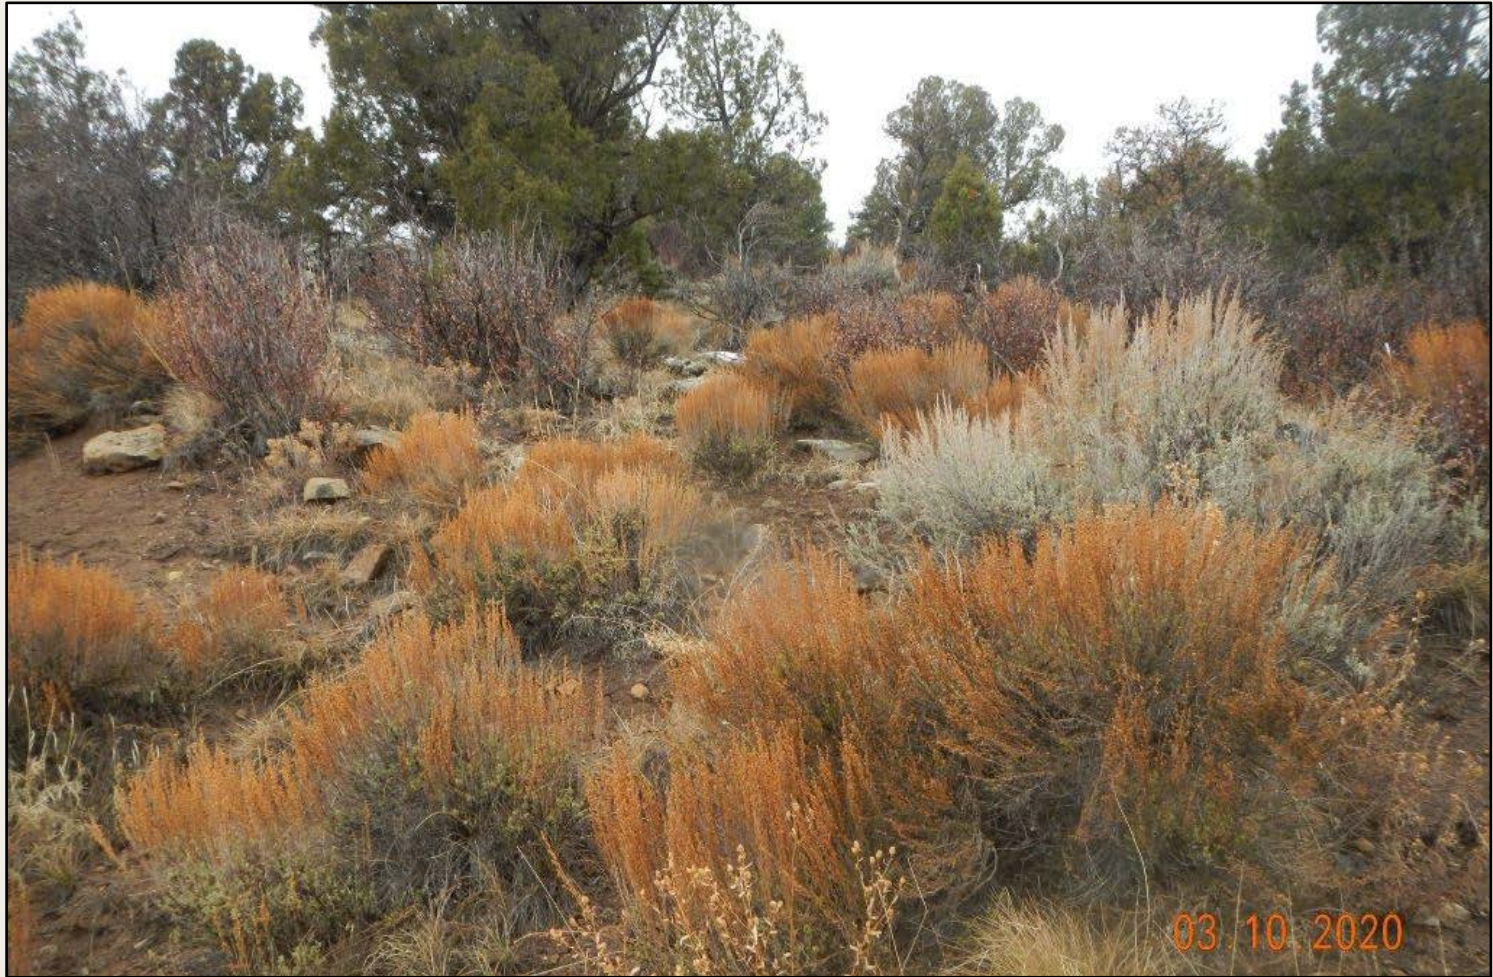
Photo 5. View of reference area vegetation comprised of pinyon juniper woodland, with shrubby understory dominated by black sagebrush and mountain mahogany.
