Spill/Incident Information

Spill Location: CASSLETT A3 Intersection: CR11+CR12

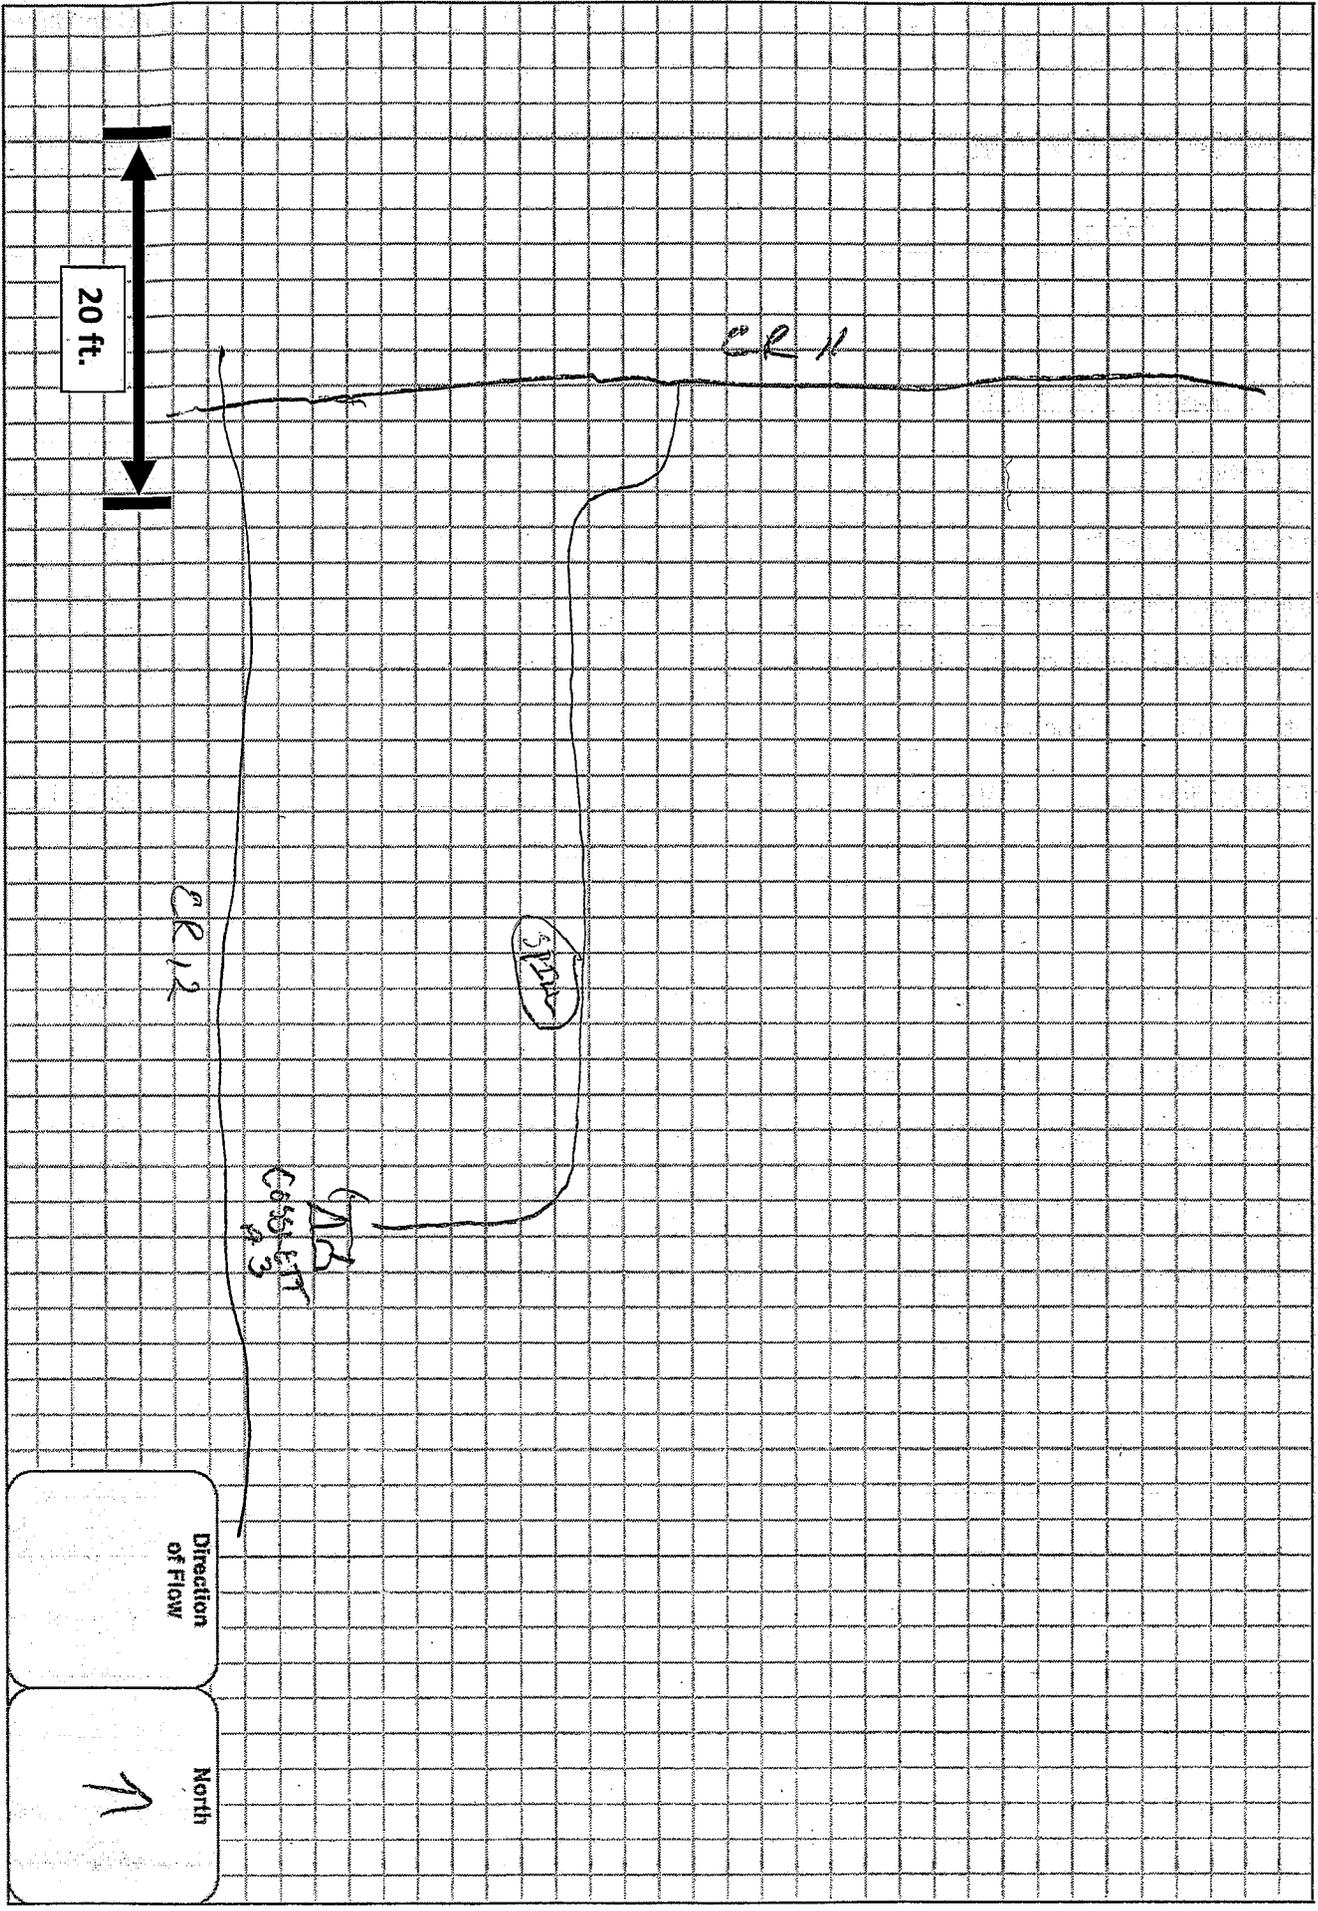
Quantity of Material Discharged: 7 bbl / gal Unknown

Describe Source & Cause of Incident: HOLE TOP FLOW LINE

Direction
of FLOW
