# Inspection Photos

API: 071-09122

Operator: EVERGREEN NATURAL RESOURCES

Inspection Date: 3/12/2020

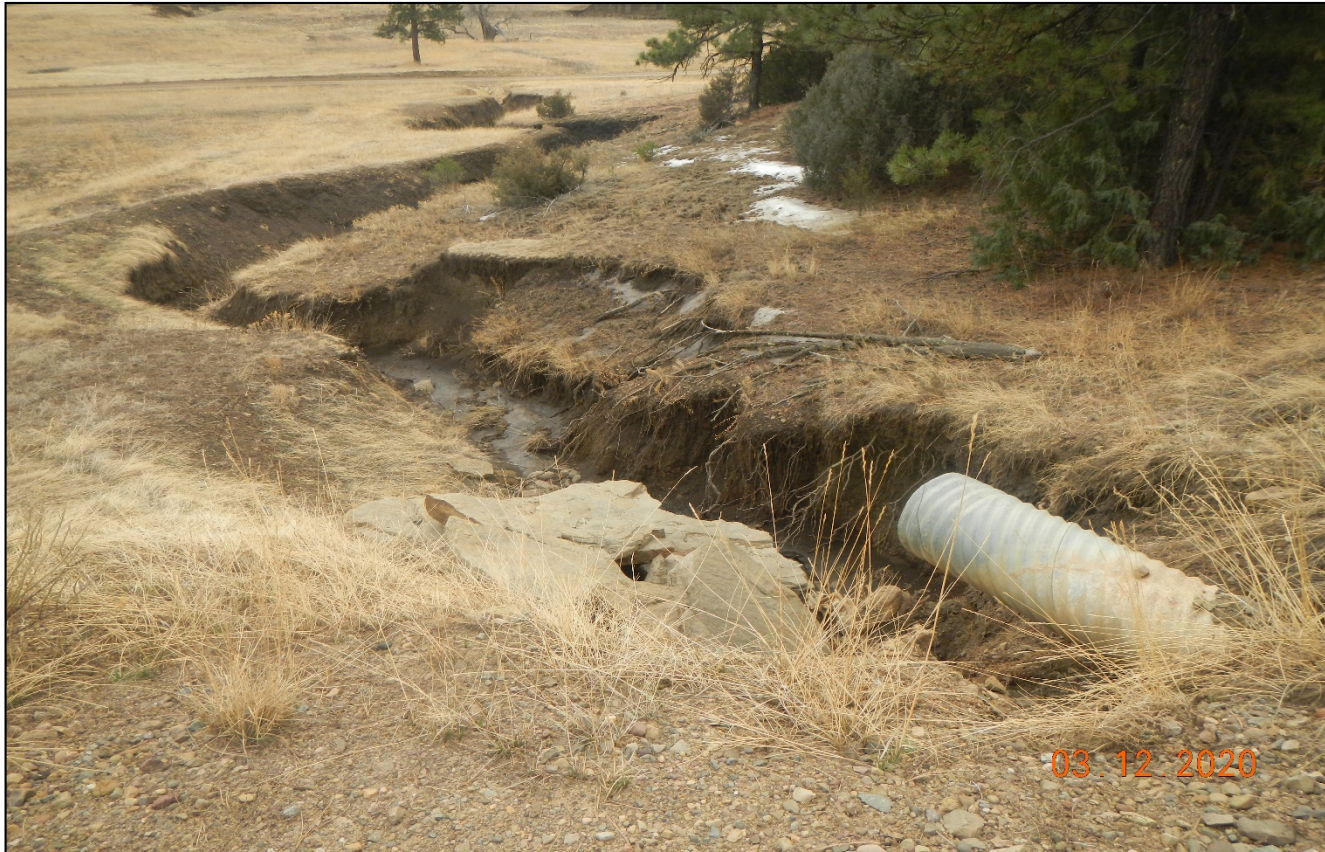
**Photo 1.** There is erosion occurring at this culvert outlet along the main road at Lat/Long:37.05979,-104.81561. No culvert outlet BMP to prevent erosion. Stormwater is being directed to this area from the road.

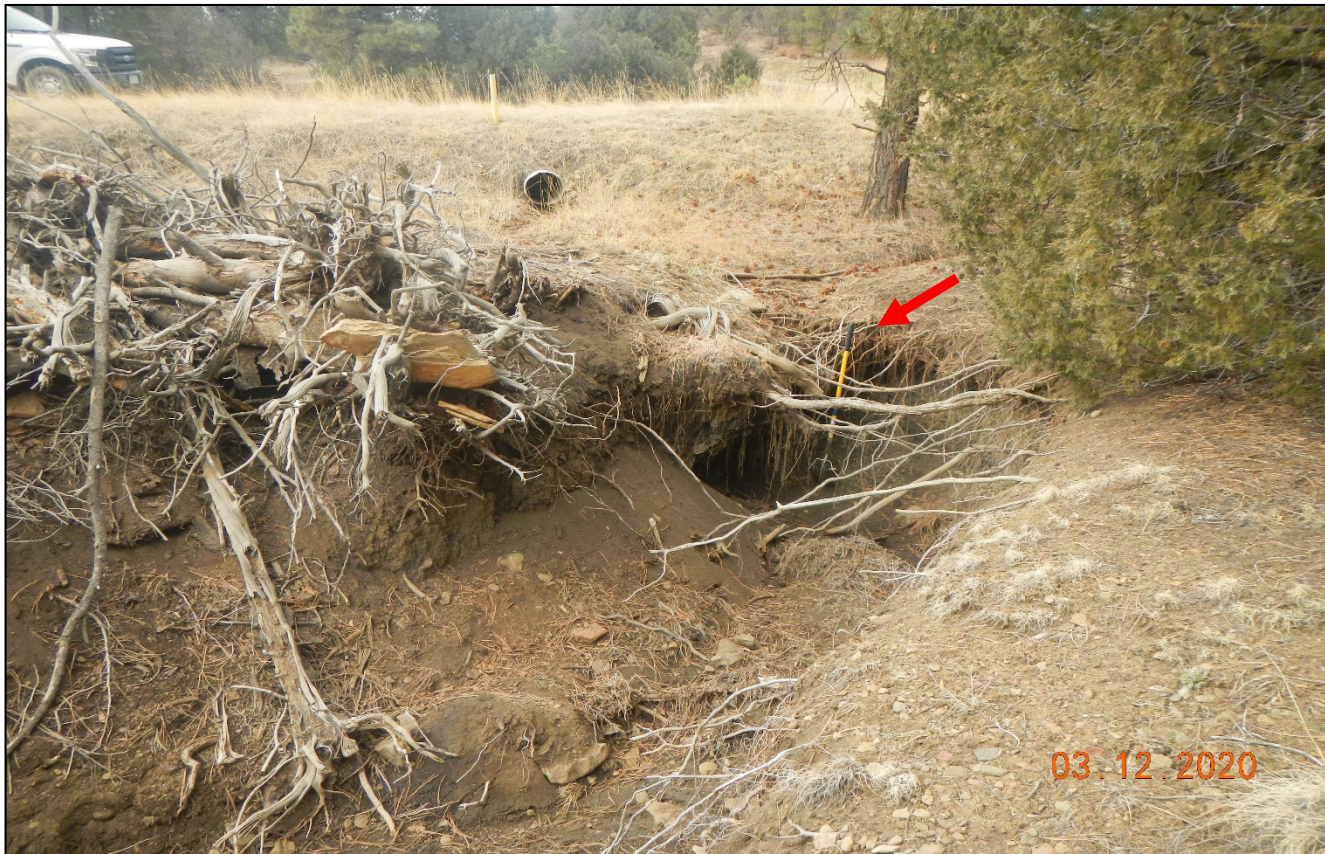
**Photo 2.** Further up the road there is erosion occurring from the culvert outlet along the main road at Lat/Long:37.05963,-104.81659. No culvert outlet BMP to prevent erosion. Red arrow points to 4.5 foot shovel placed in erosion gully.

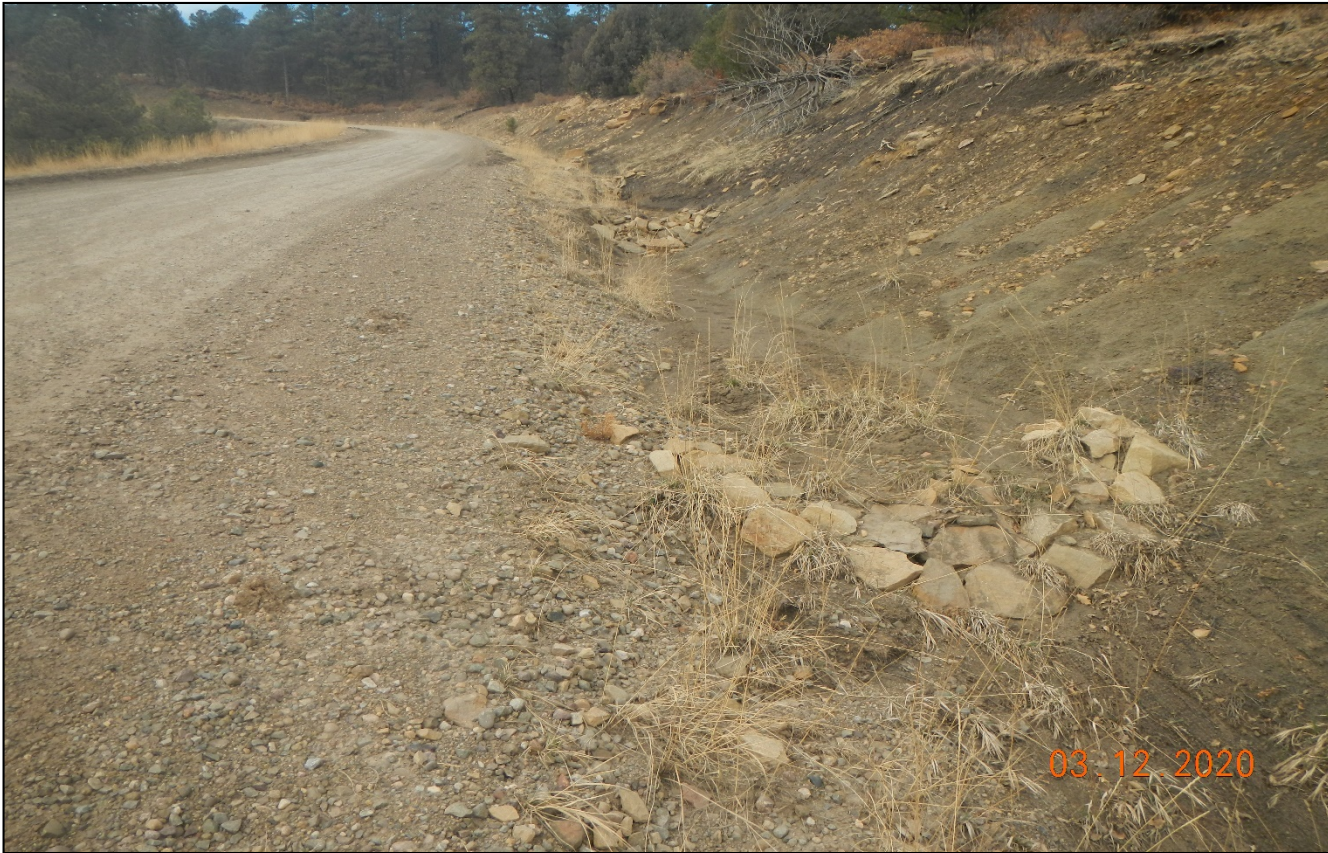
**Photo 3.** Erosion is occurring on the side of the road and rock check damns have filled up with sediment at Lat/Long:37.0586,-104.81750.

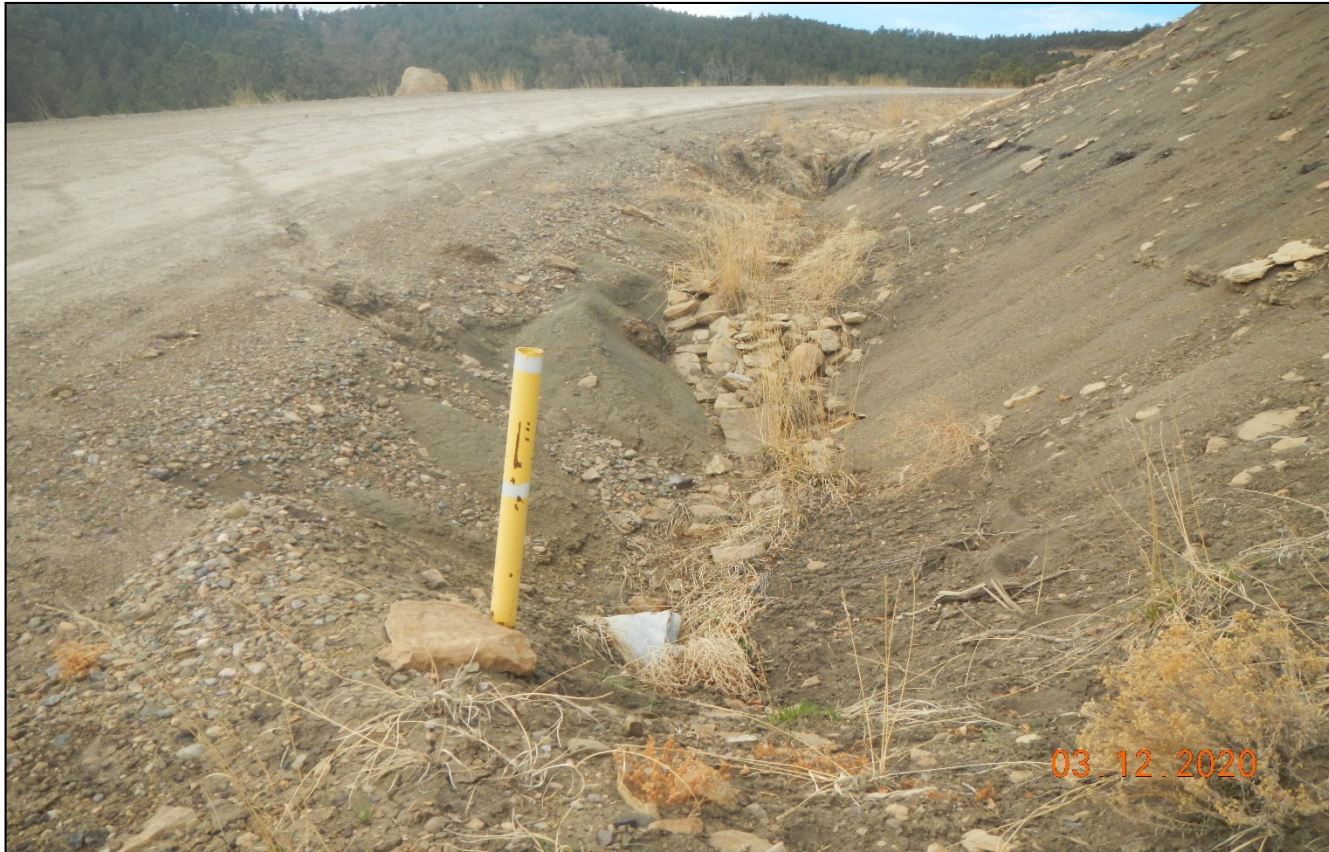
**Photo 4.** Erosion is occurring on the side of the road and this culvert has filled in with sediment at Lat/Long:37.0586,-104.81750.

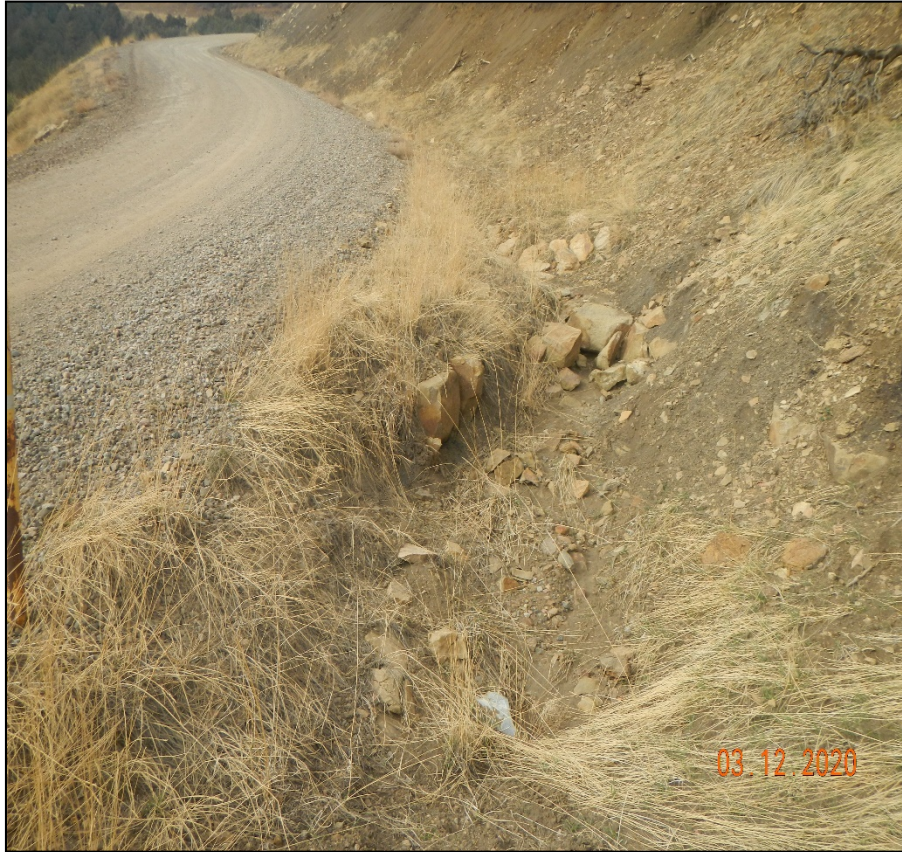
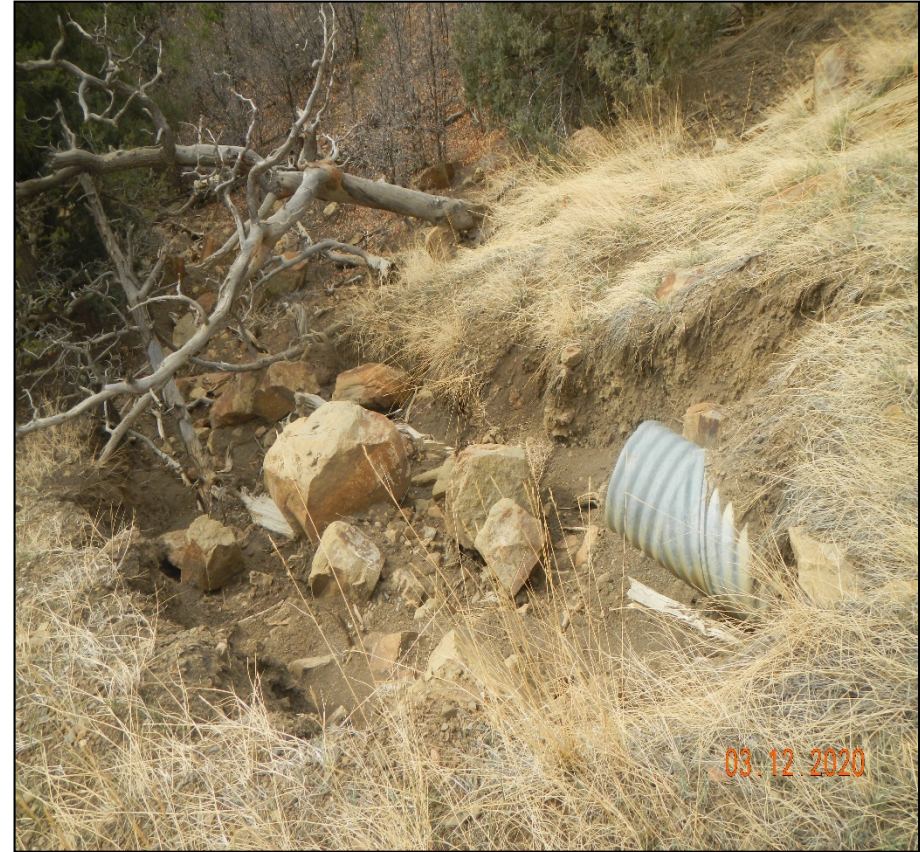
**Photo 6.** The above photos of the culvert inlet and outlet were taken at Lat/Long:37.05354,-104.82491. The inlet culvert has filled in with sediment and the outlet culvert is causing erosion.

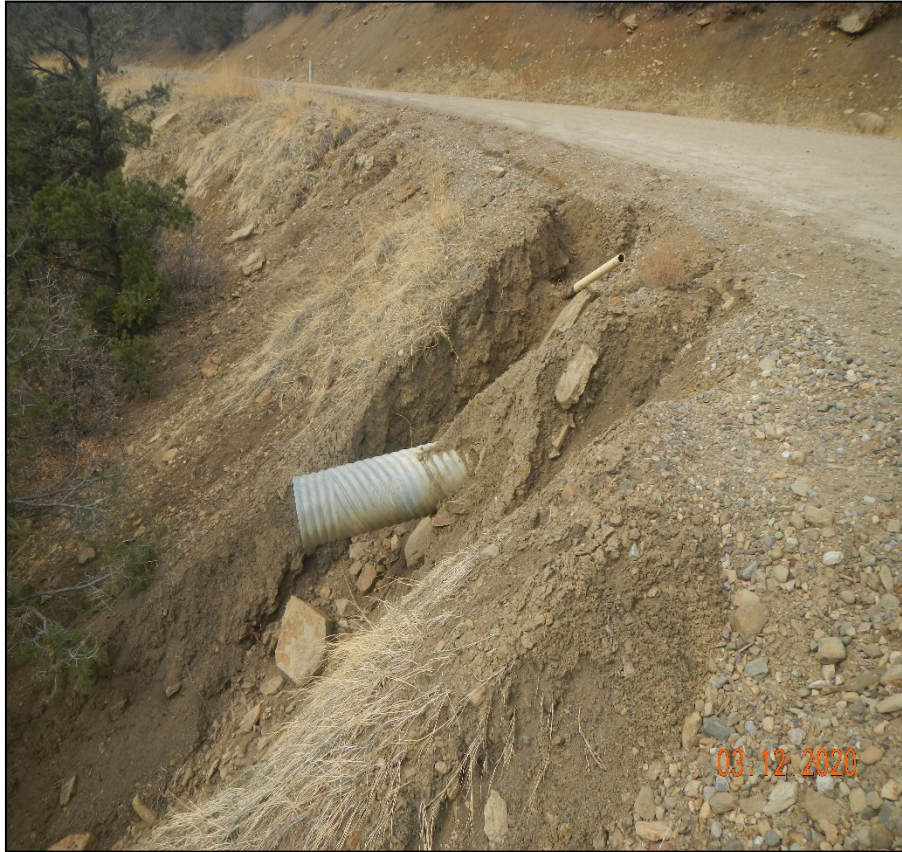
**Photo 7. Photo 5.** Stormwater runoff from the road is causing erosion near this culvert at Lat/Long:37.05297,-104.82619. There is no outlet protection installed at the culvert outlet.

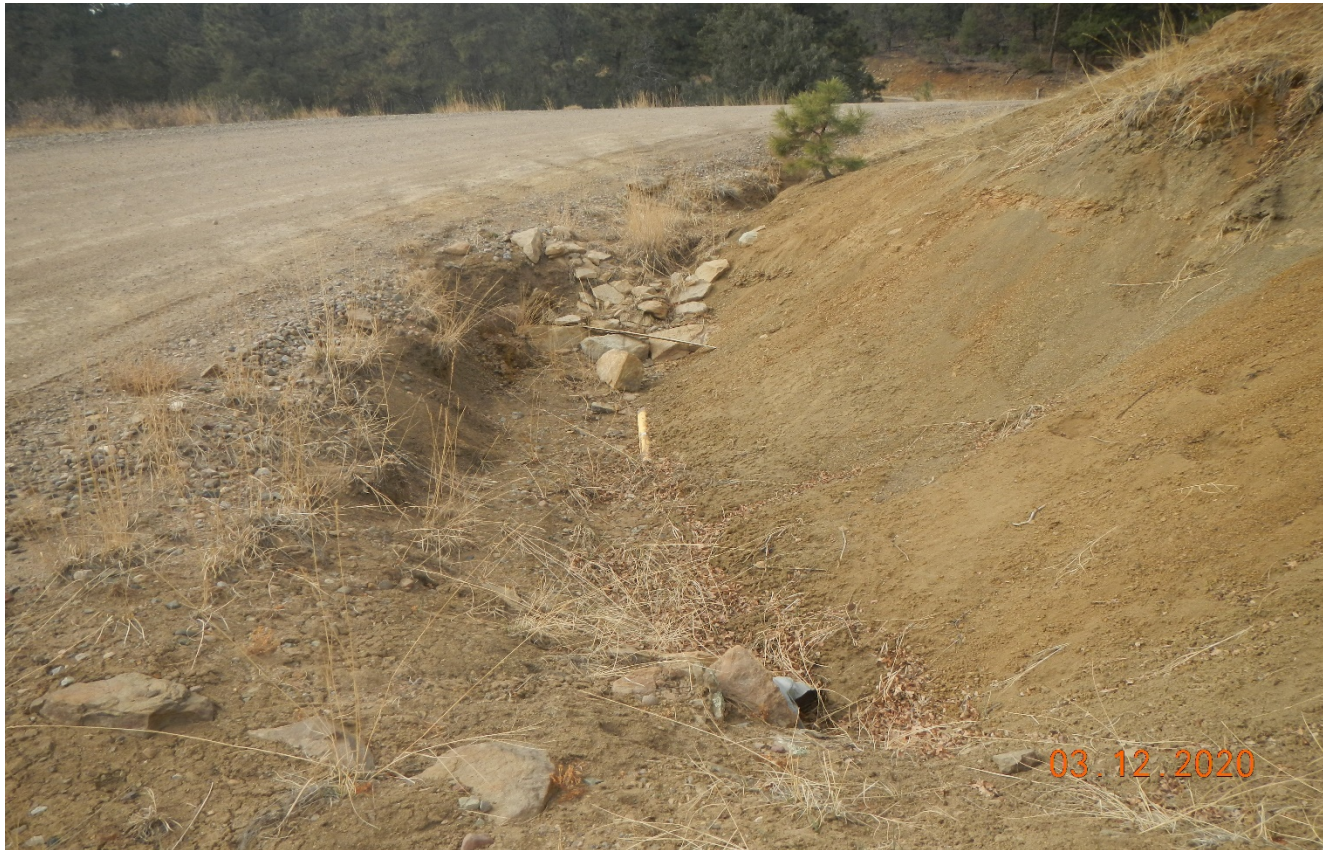
**Photo 8.** This culvert along the main road has filled in with sediment.

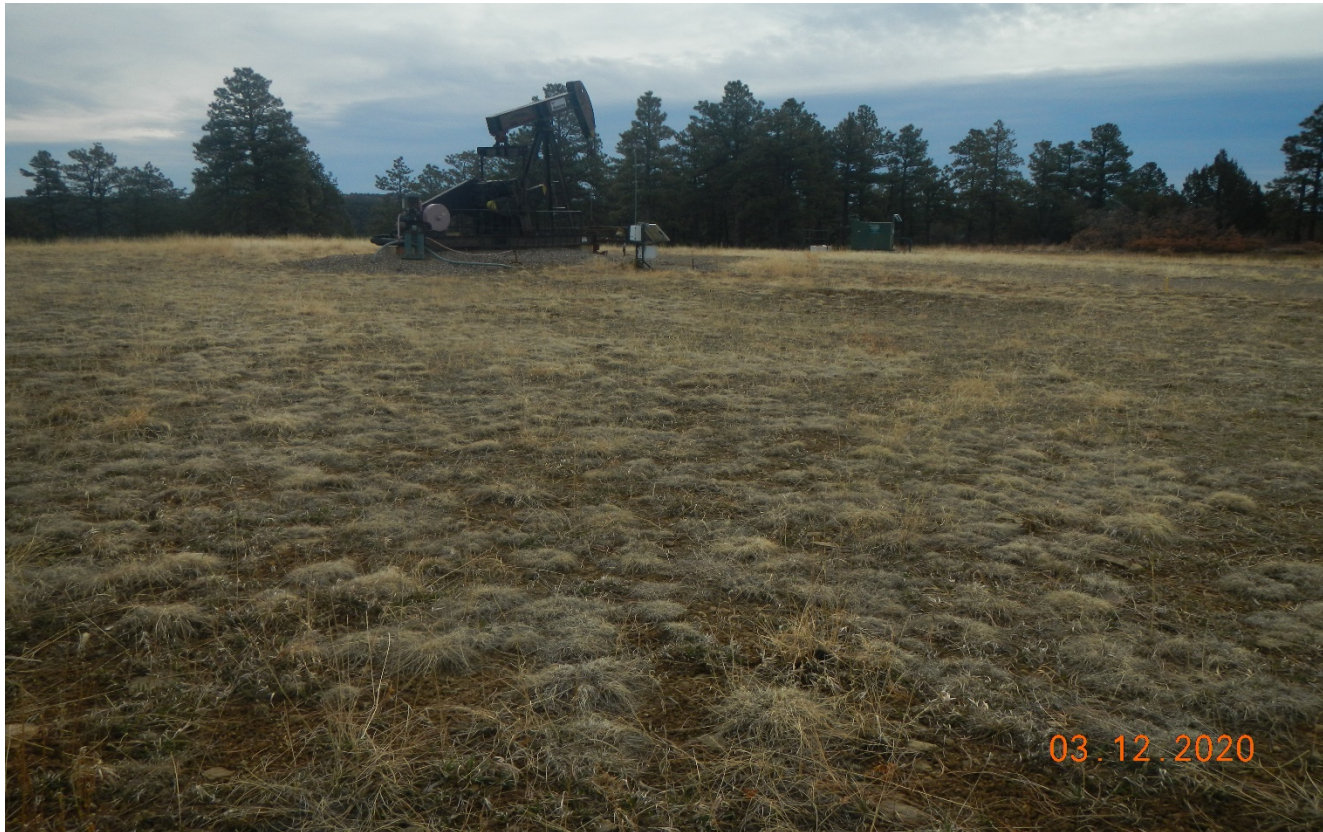
**Photo 9.** Facing southeast toward the location. Vegetation is well established in the interim area.
