Inspection Photos
Operator: BP America
API#: 067-07859
Date: 3/16/2020

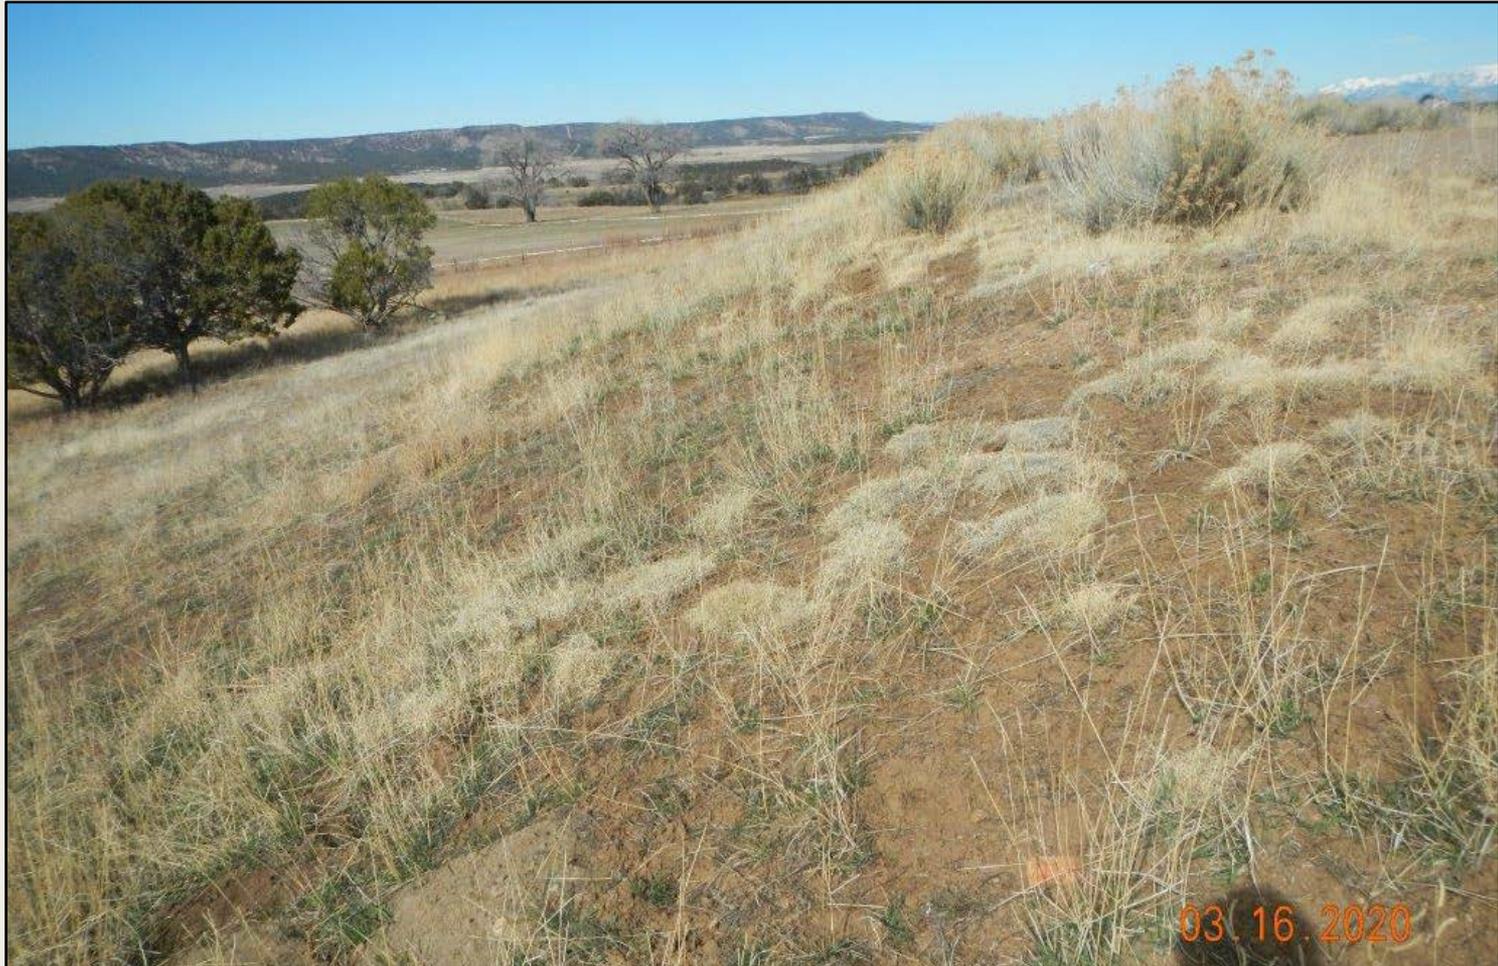
Photo 1. View of the southern project area from the southeastern corner facing westward. Revegetation is progressing with grasses such as blue grama, crested wheatgrass, and western wheatgrass, largely in a grazed condition.

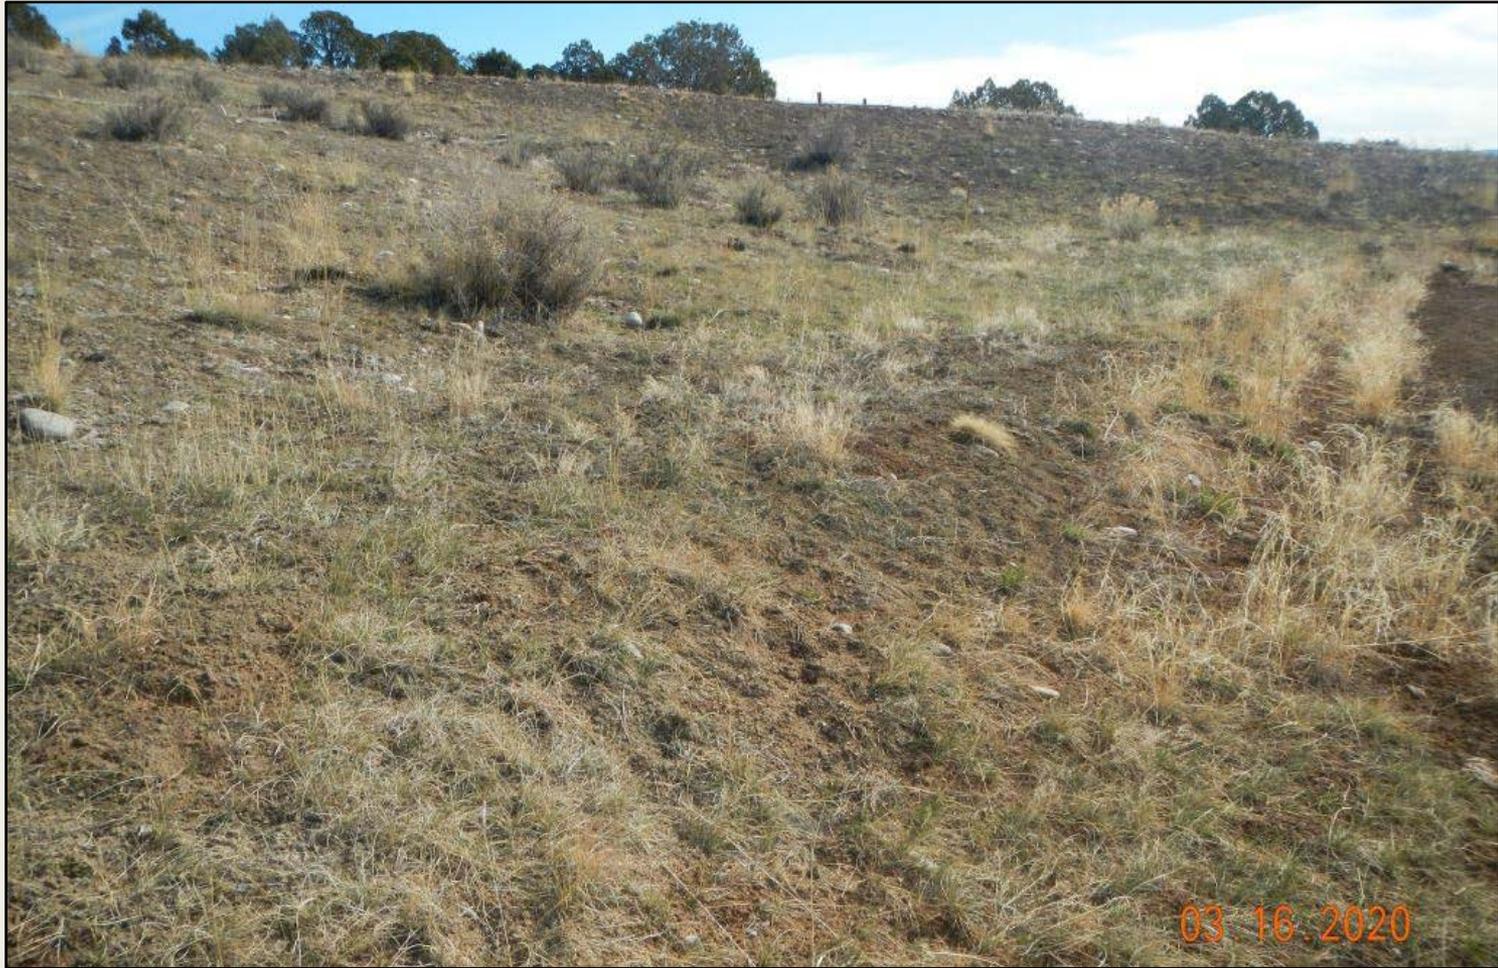
Photo 2. View of the northern project area from the southeastern corner facing northward. Revegetation is progressing with grasses and shrubs such as smooth brome and rubber rabbitbrush.

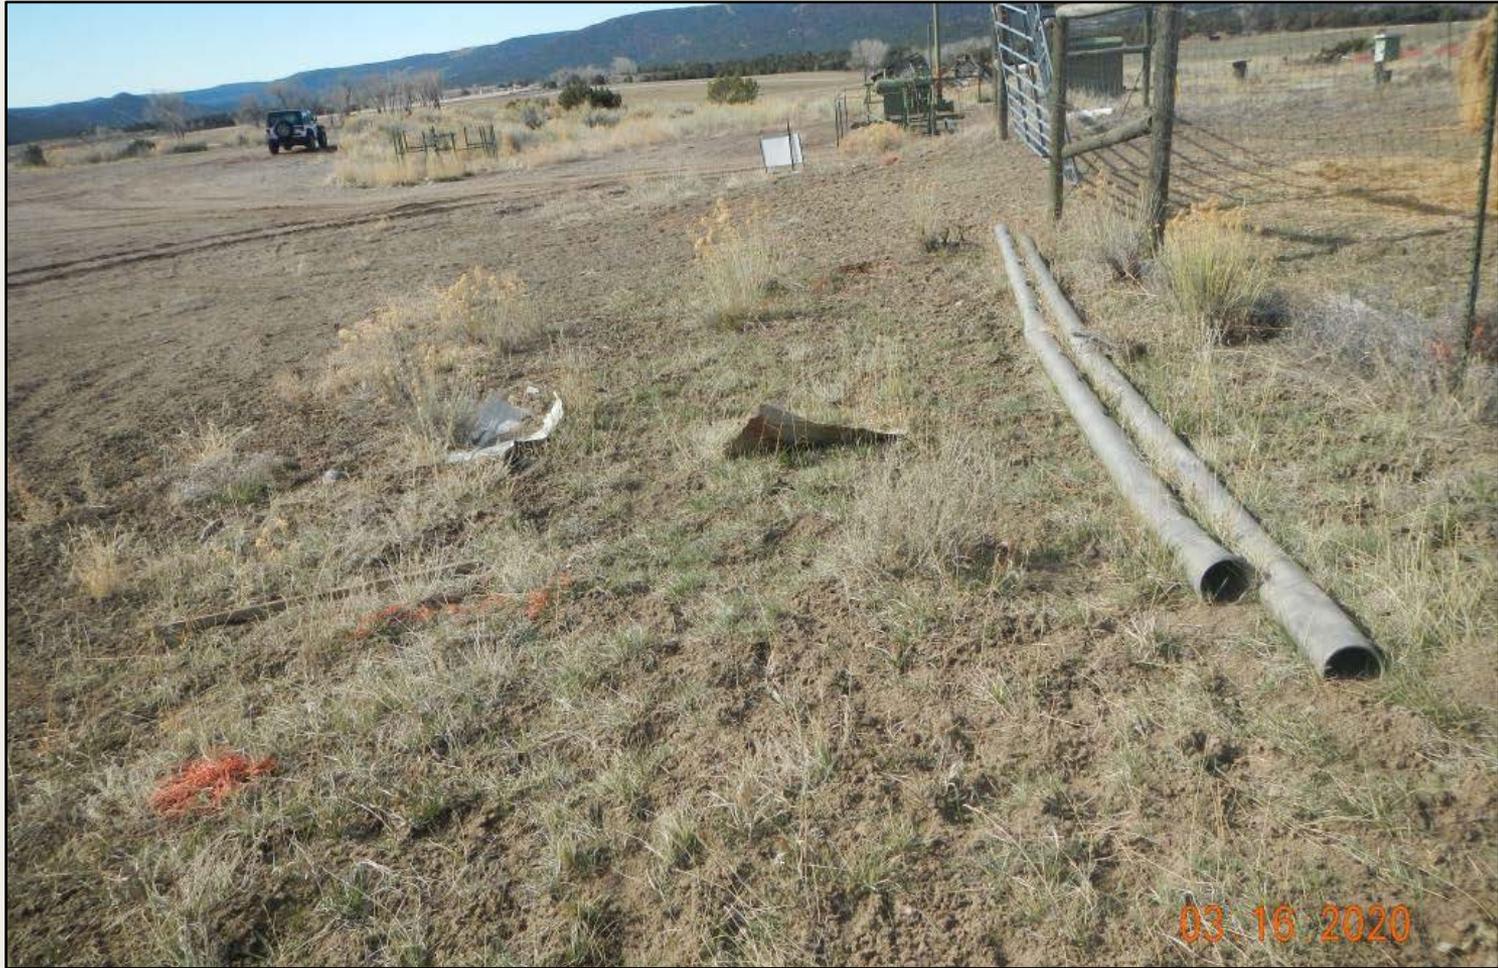
Photo 3. View of junk and debris within the northwestern project area.

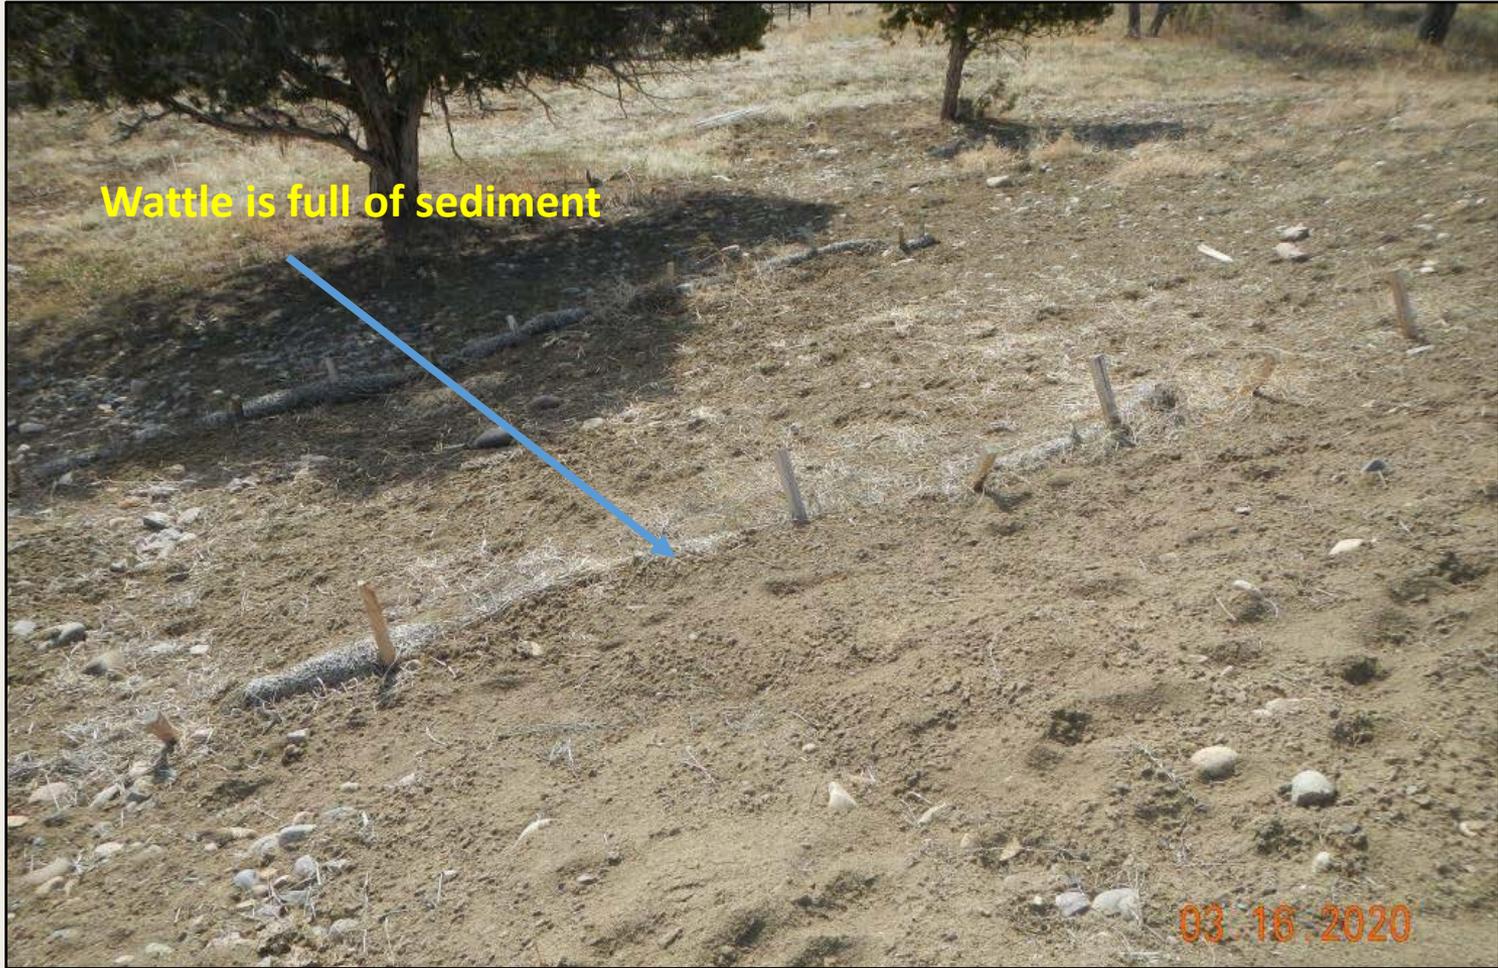
Photo 4. View of wattles full of sediment and bare soils needing additional stabilization, within the southeastern project area.

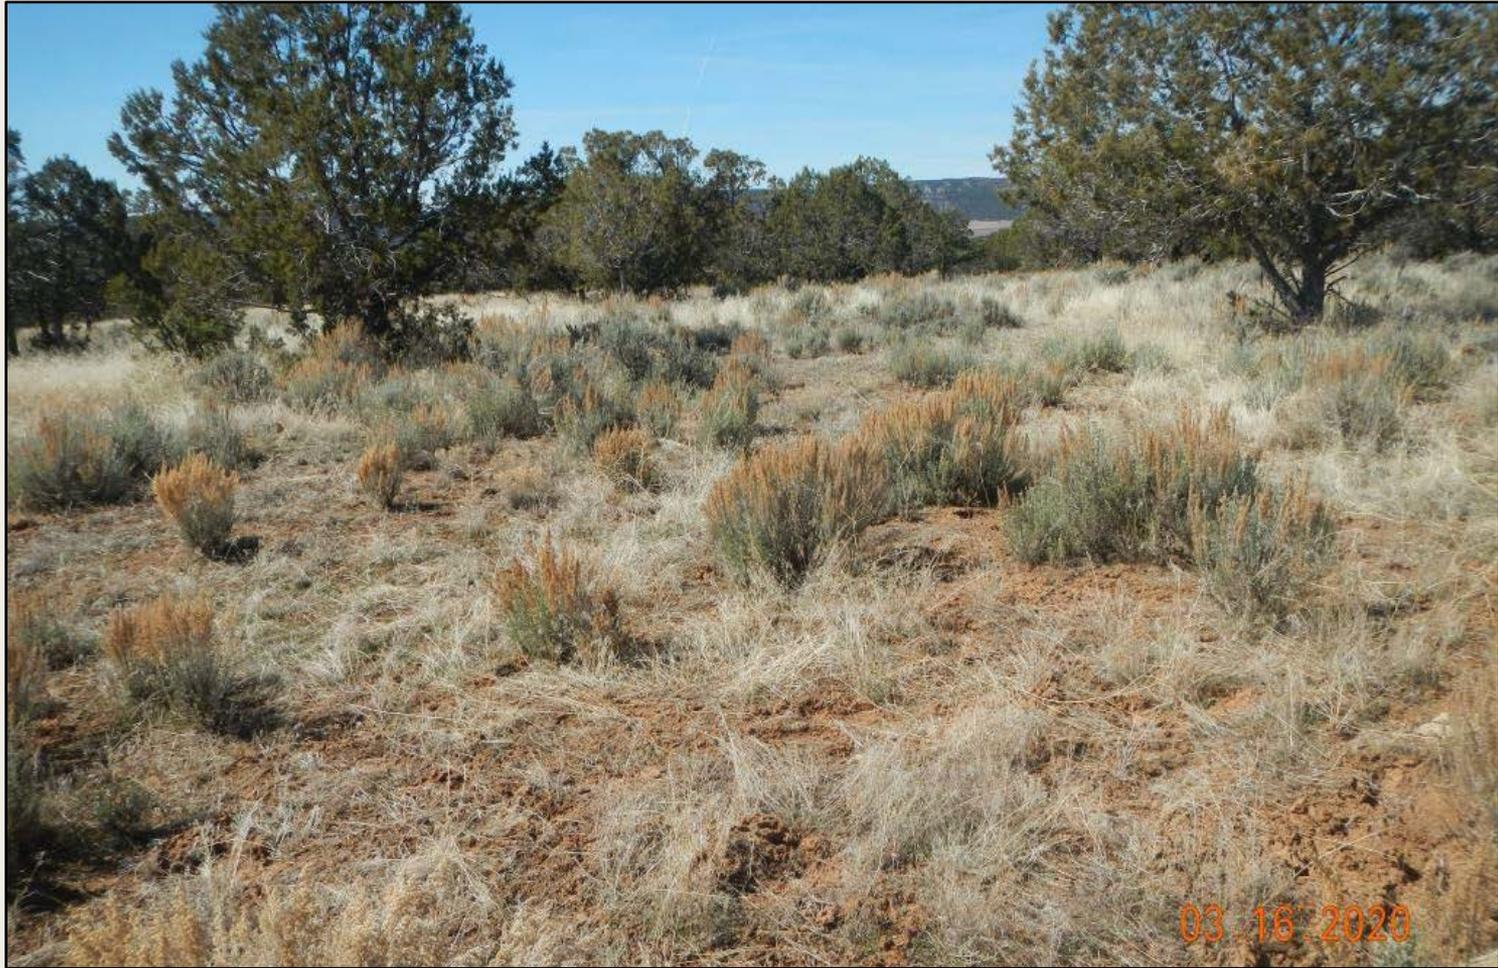
Photo 5. View of reference area vegetation, comprised of open pinyon-juniper woodland, with sagebrush and herbaceous understory.
