Inspection Photos
Operator: BP America
API#: 067-07037
Date: 3/16/2020

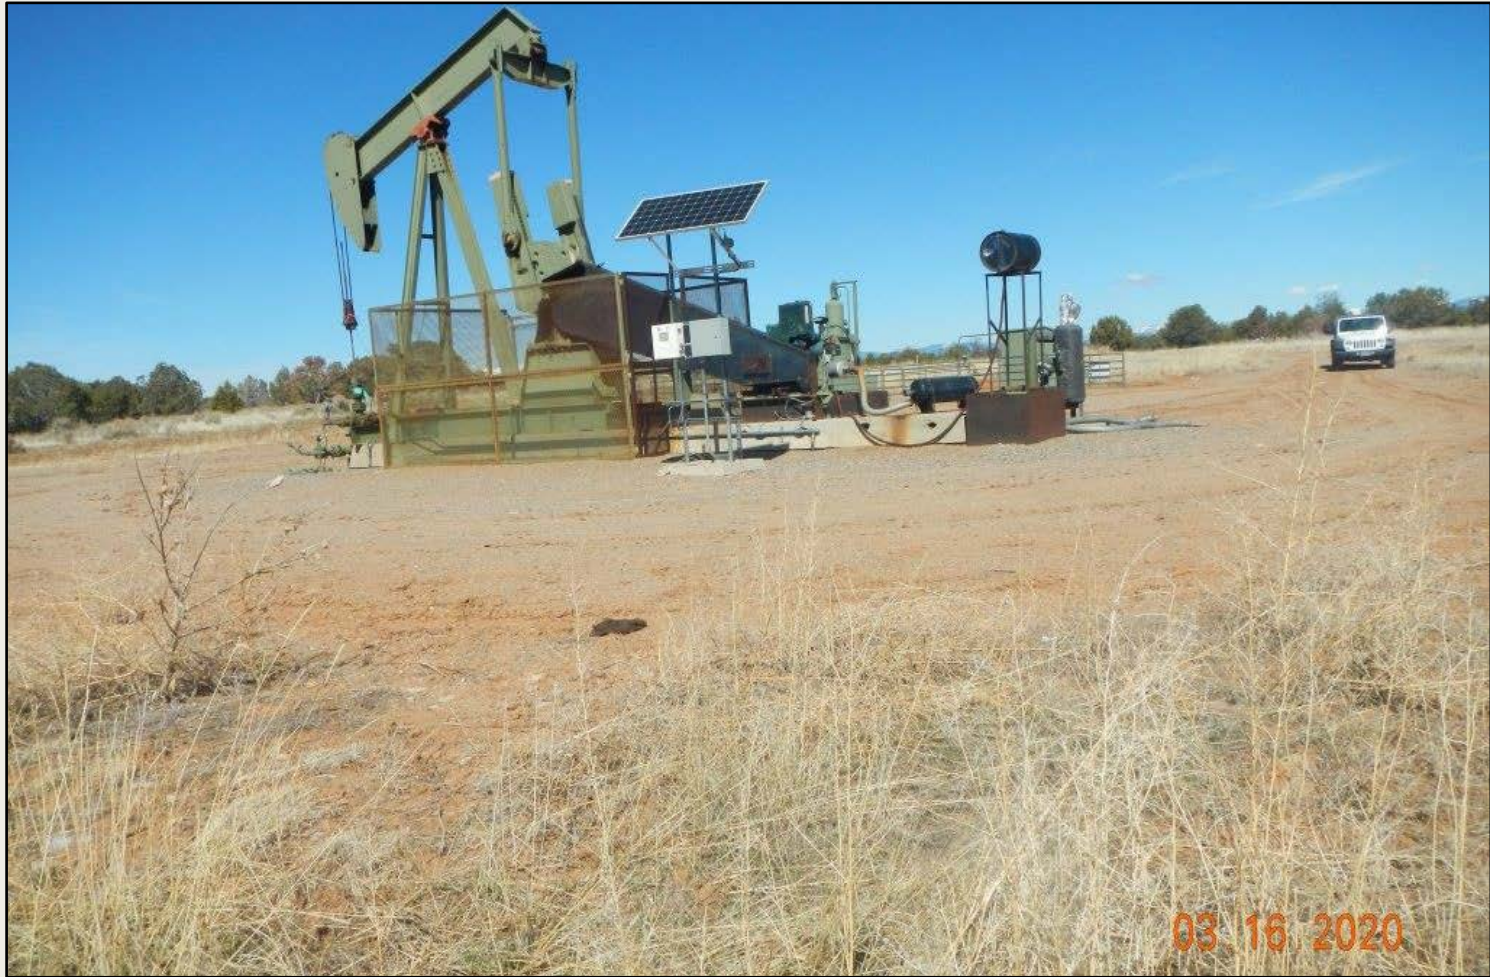
Photo 1. View of the project area from the southeastern corner facing center.

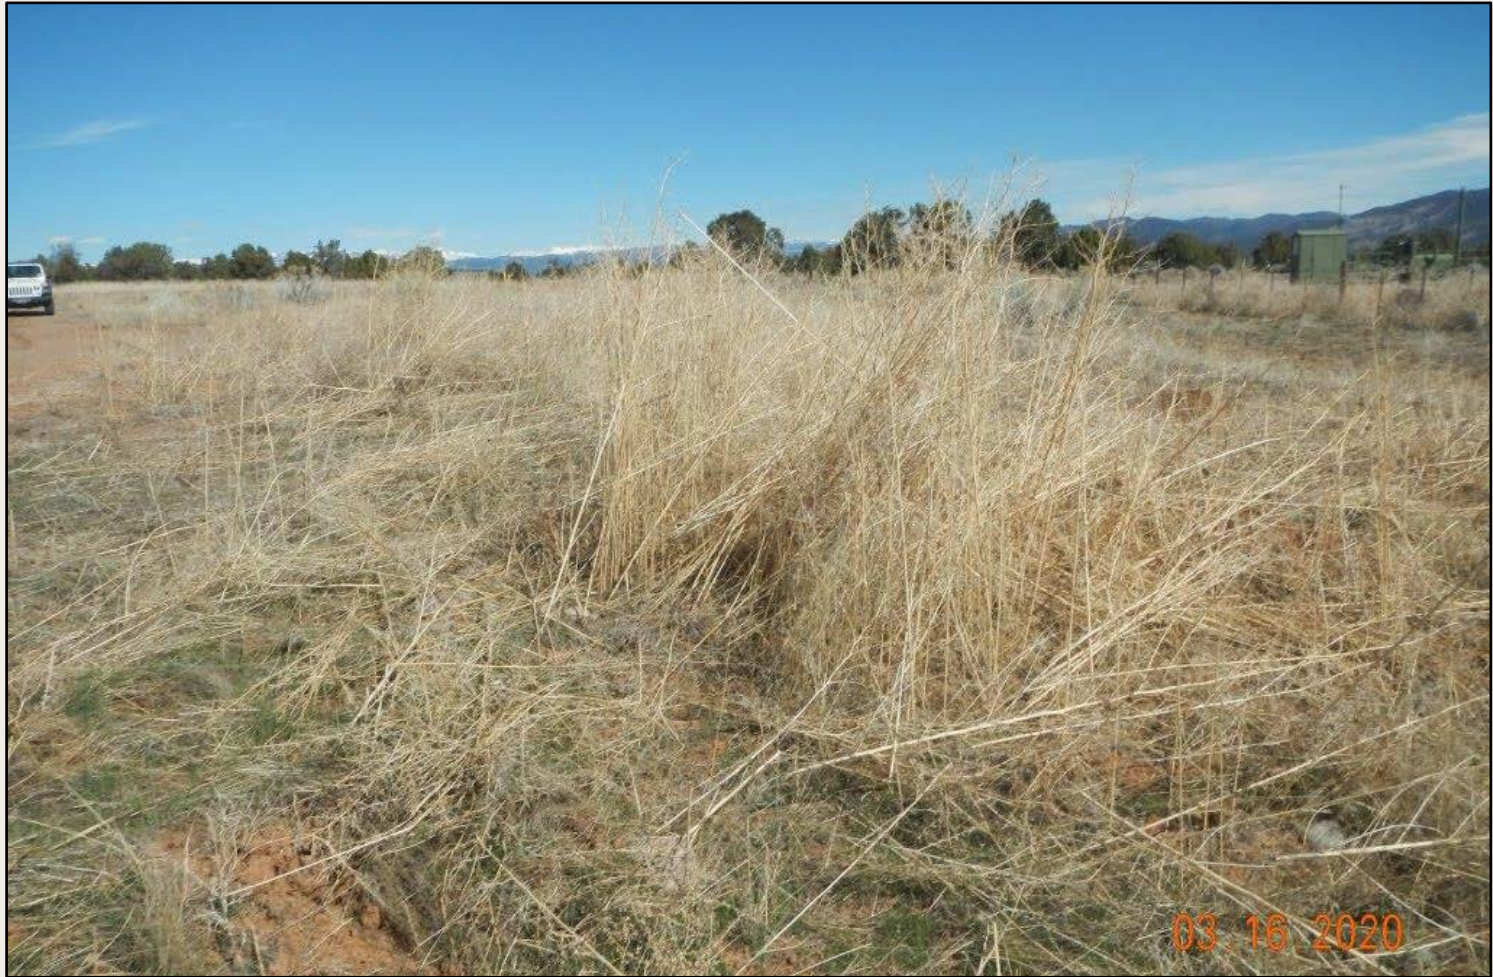
Photo 2. View of the eastern project area. Vegetation is weedy. Weed debris needs to be removed and managed.

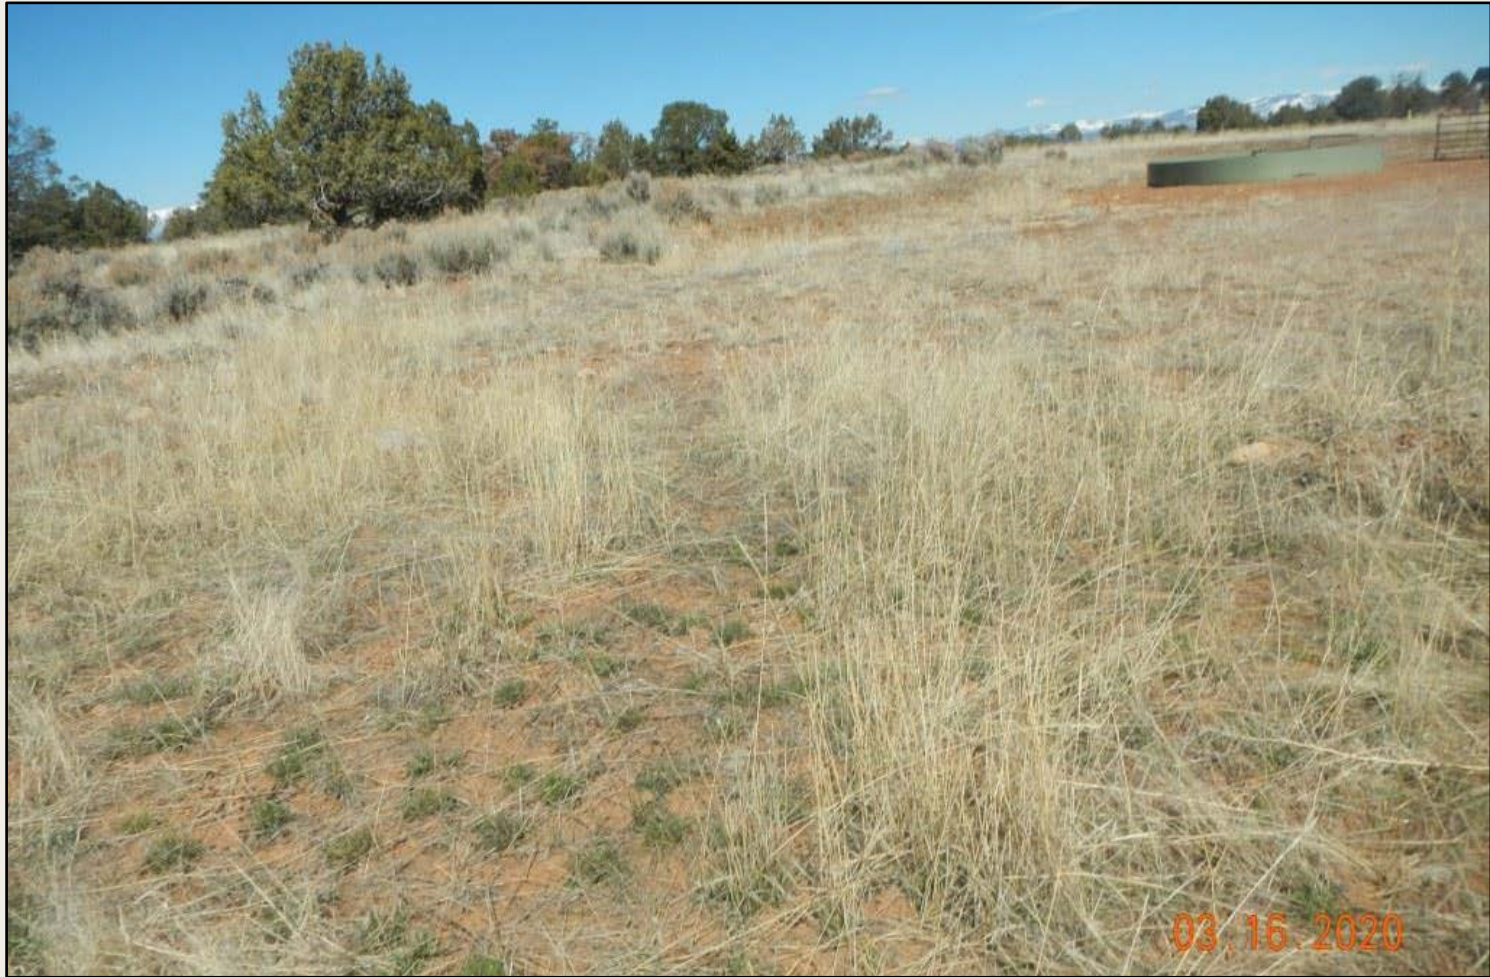
Photo 3. View of the western project area from the southwestern corner facing northward. Revegetation is progressing here with western wheatgrass, smooth brome, and sand dropseed.

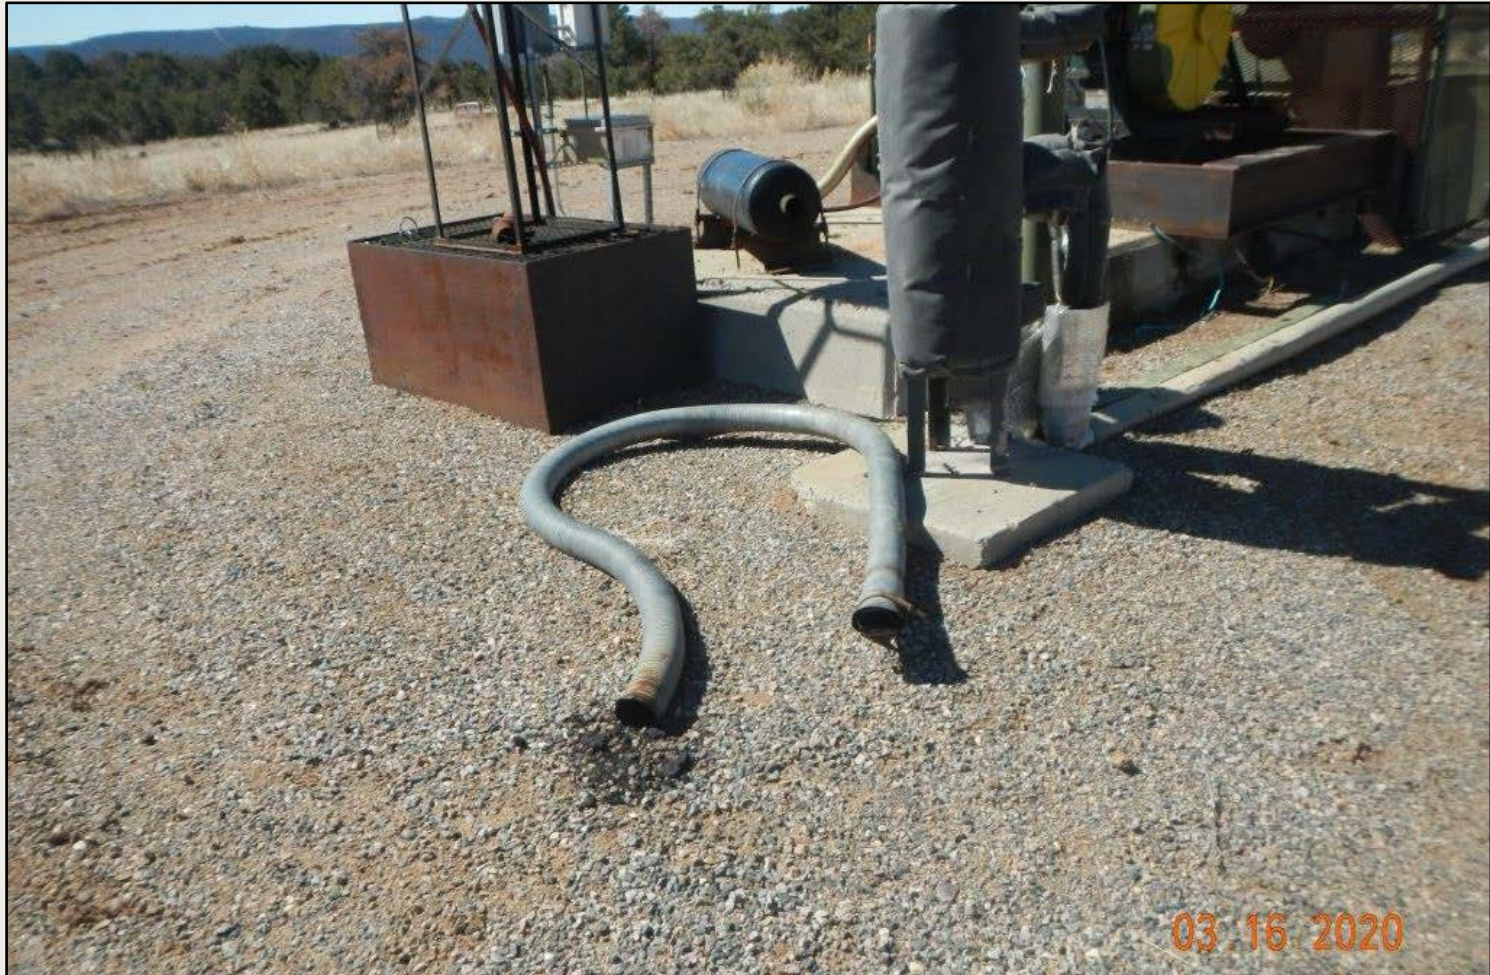
Photo 4. View of pipe debris and stained soils at the wellhead.

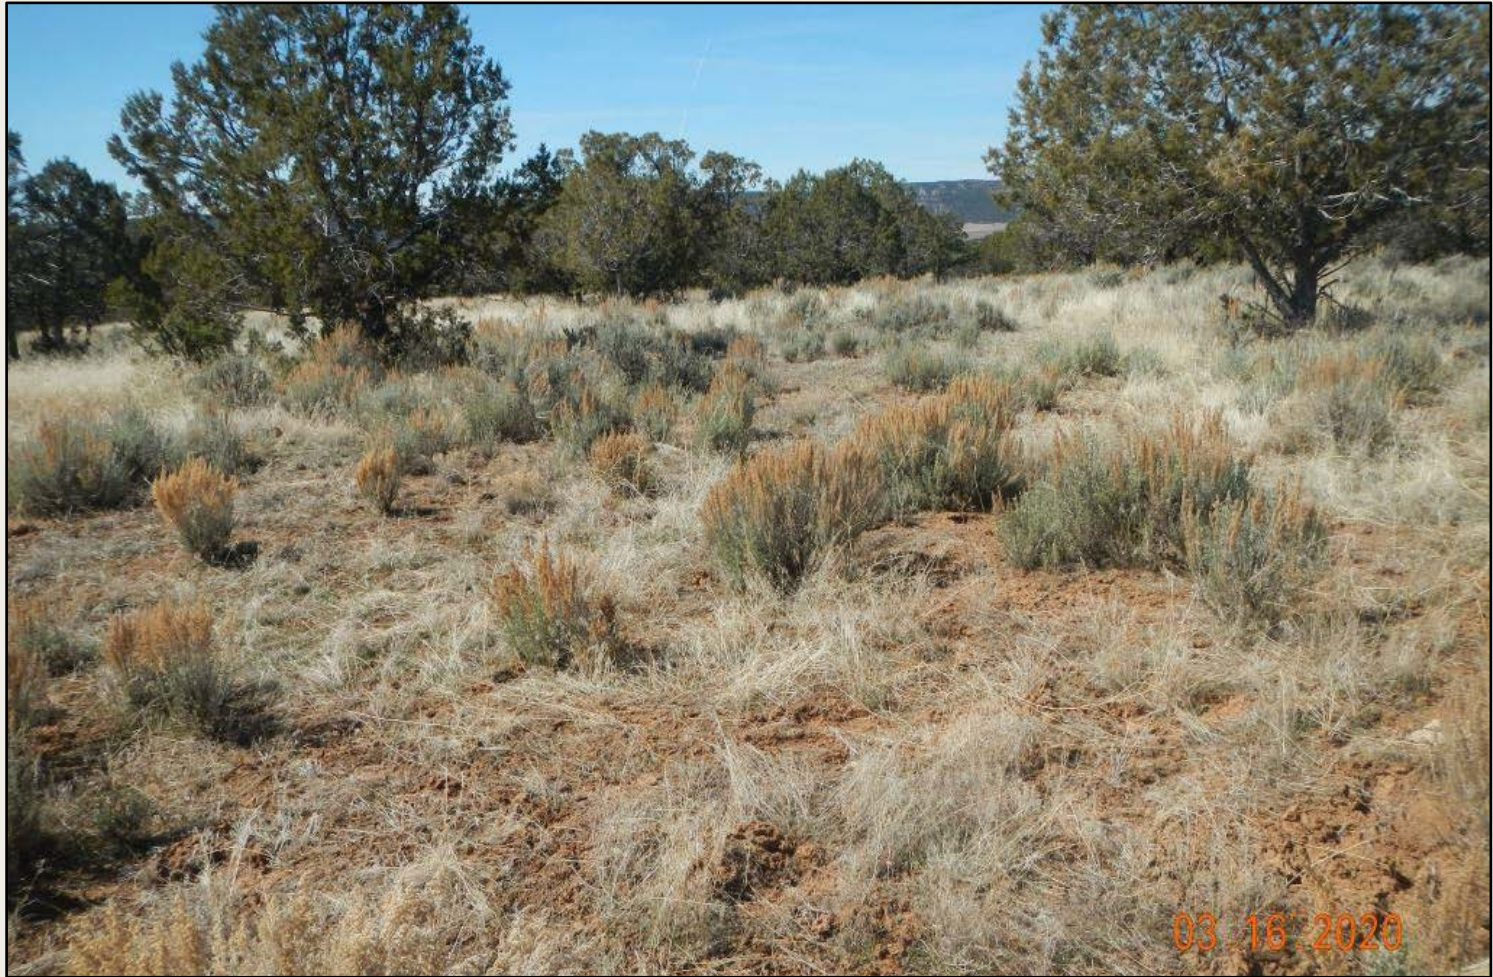
Photo 5. View of the reference area, comprised of open pinyon-juniper woodland with sagebrush and herbaceous understory.
