# Inspection Photos

API: 071-08351

Operator: TIMBER CREEK OPERATING

Inspection Date: 3/19/2020

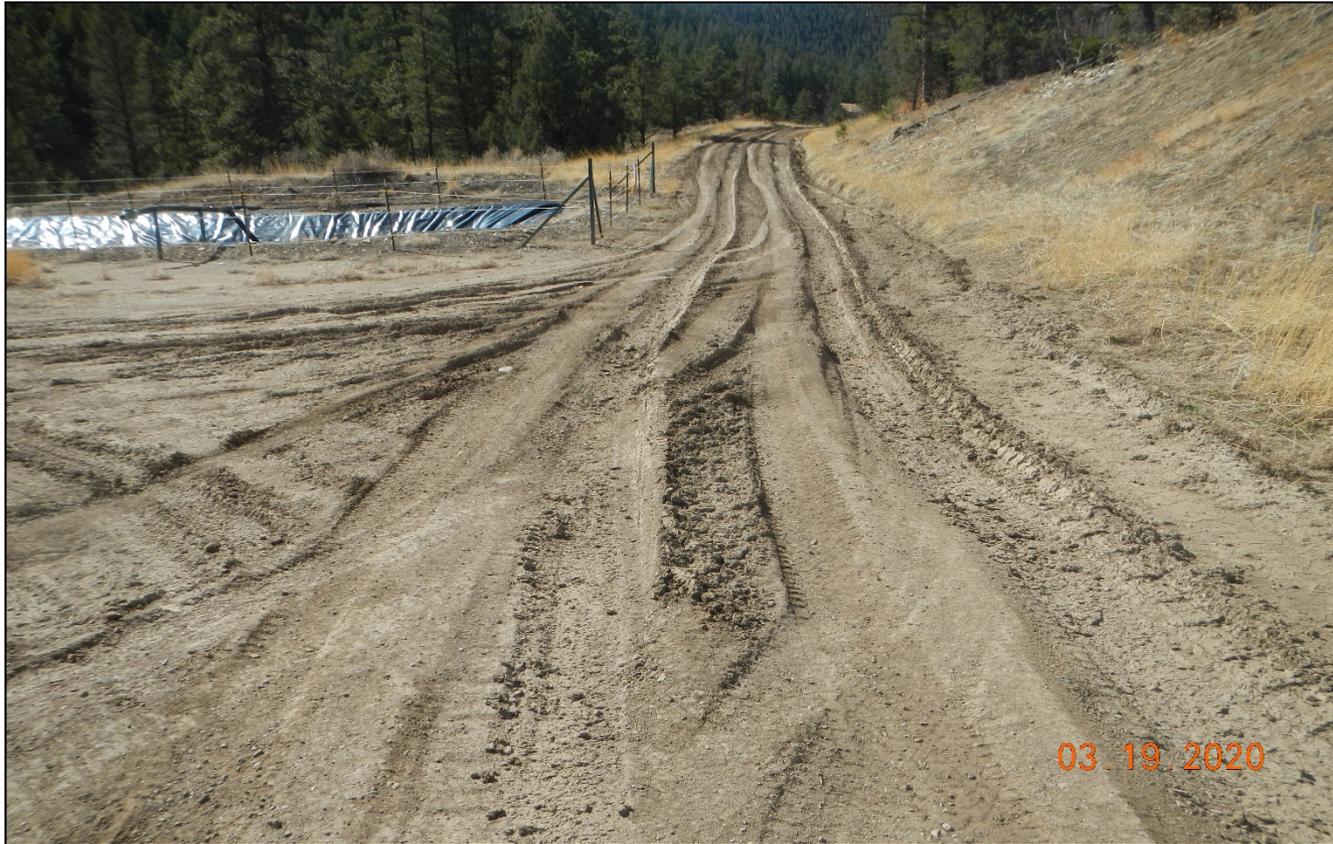
**Photo 1.** Facing southwest along the access road near the GE 31-04 site. There are vehicle ruts along the road. The road needs to be graded and maintained.

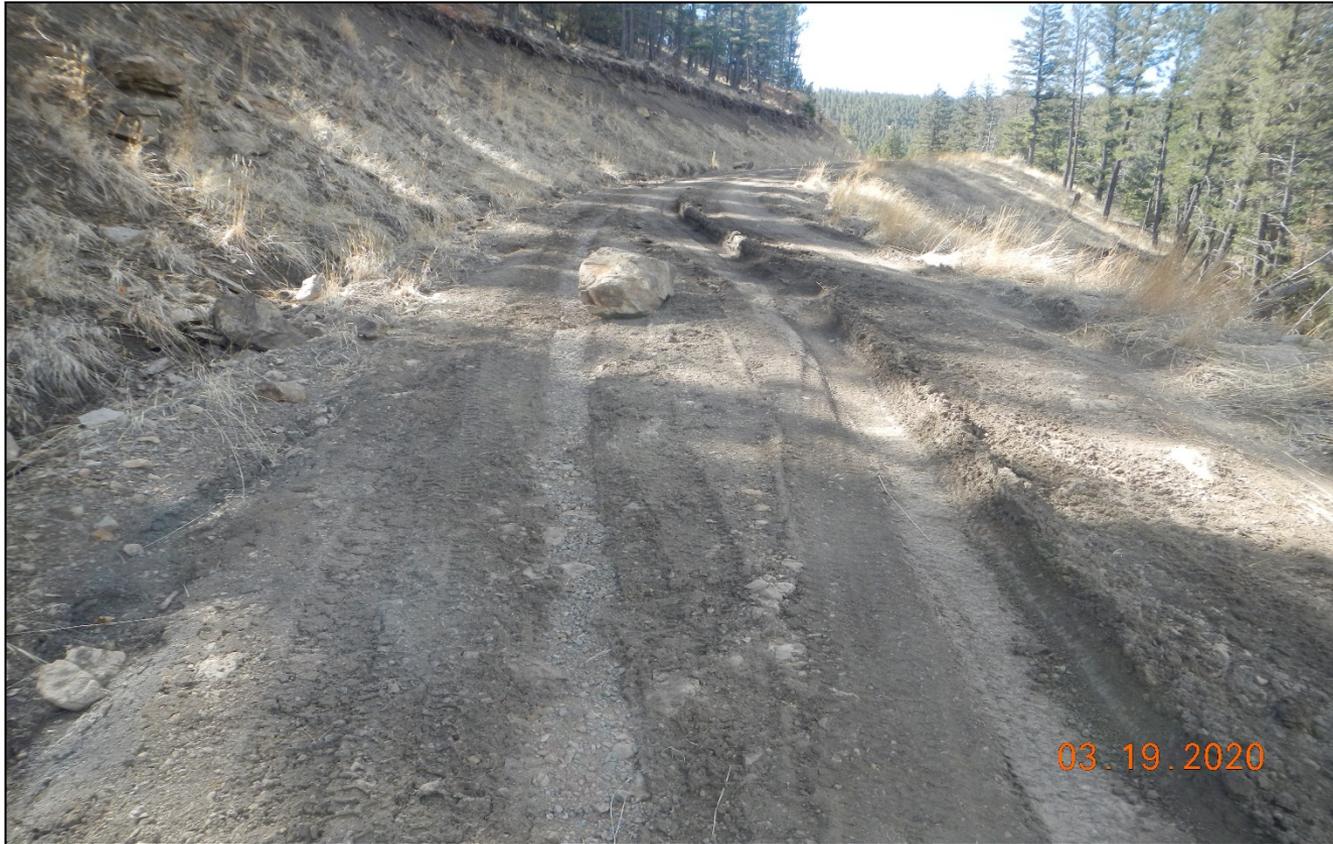
**Photo 2.** Facing west along the access road. There is a large rock in the road and deep vehicle ruts along the road.

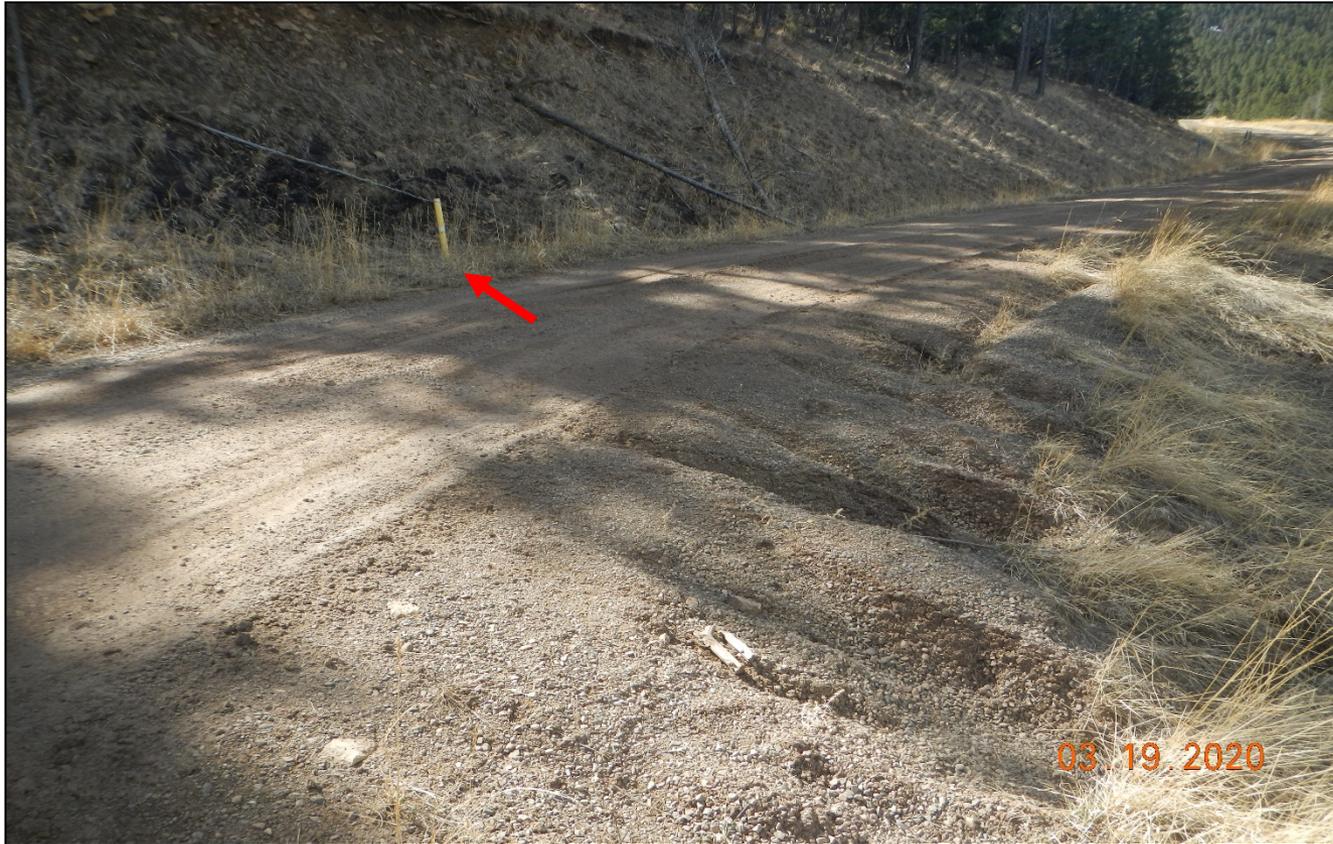
**Photo 3.** The culvert inlet shown at red arrow is filled in with sediment causing stormwater to flow across the road causing erosion.

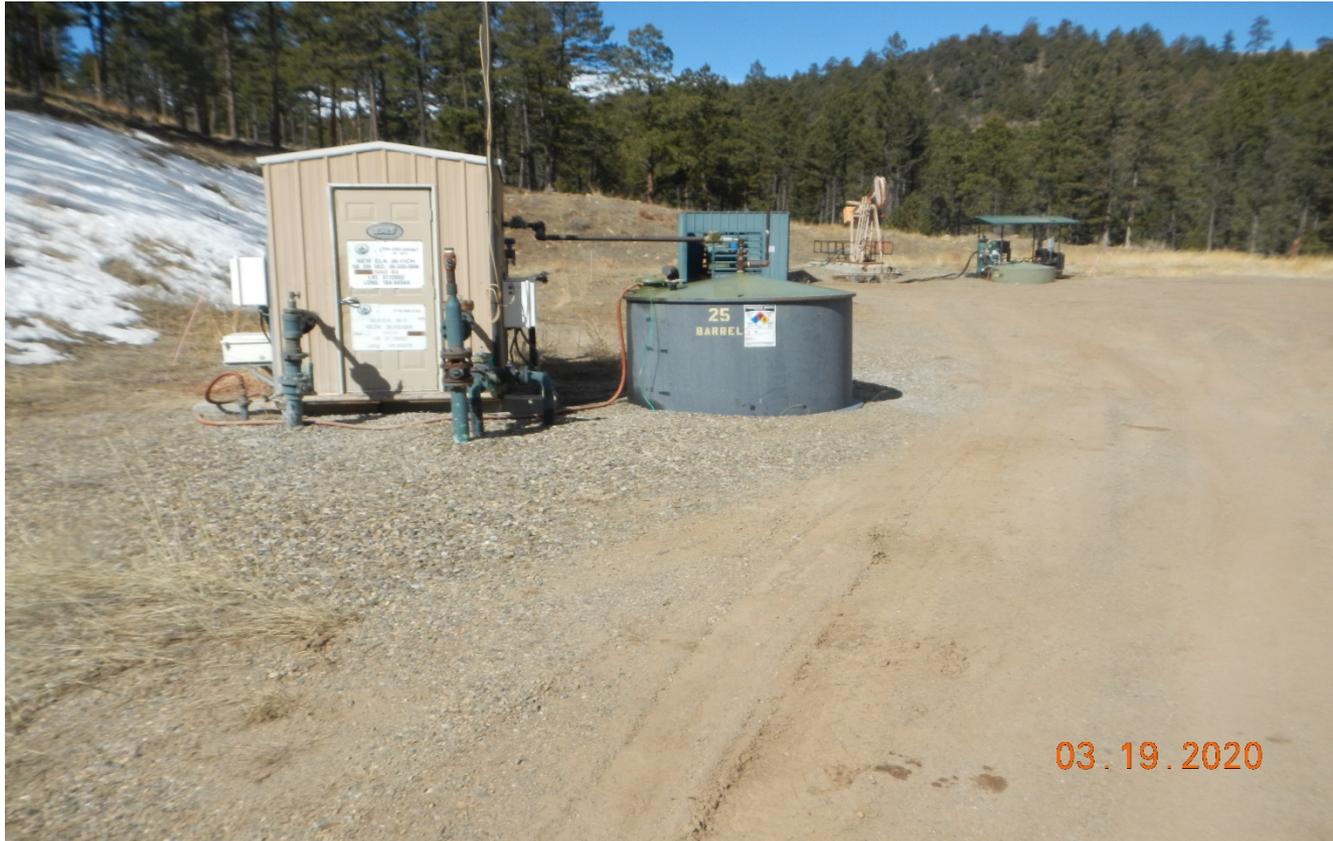
**Photo 4.** Facing toward the location.

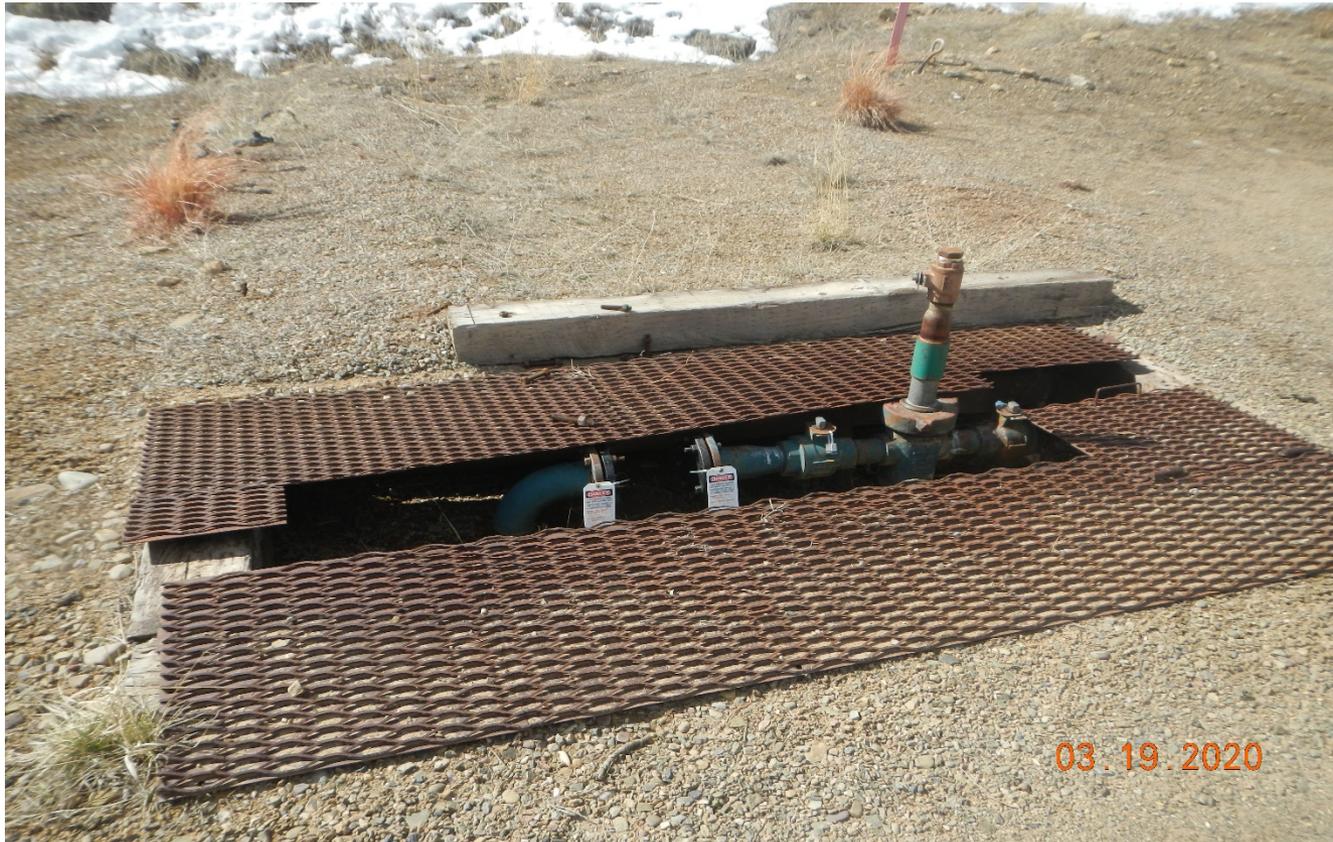
**Photo 5.** The pipe risers have been LO/TO.

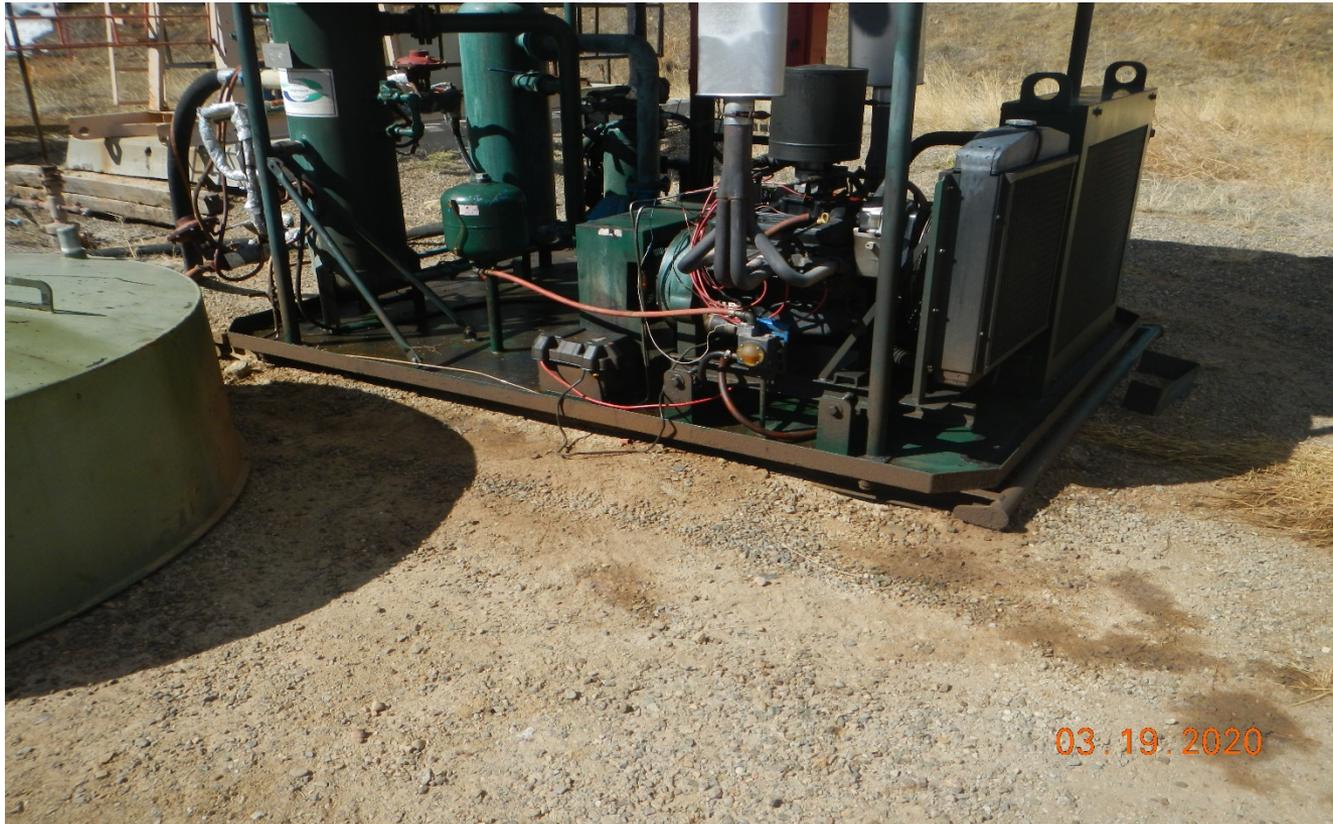
**Photo 6.** The oil in the engine skid has been cleaned up. There is still some spotting stained soil around engine skid.
