Inspection Photos

API: 071-09238

Operator: TIMBER CREEK OPERATING

Inspection Date: 3/19/2020

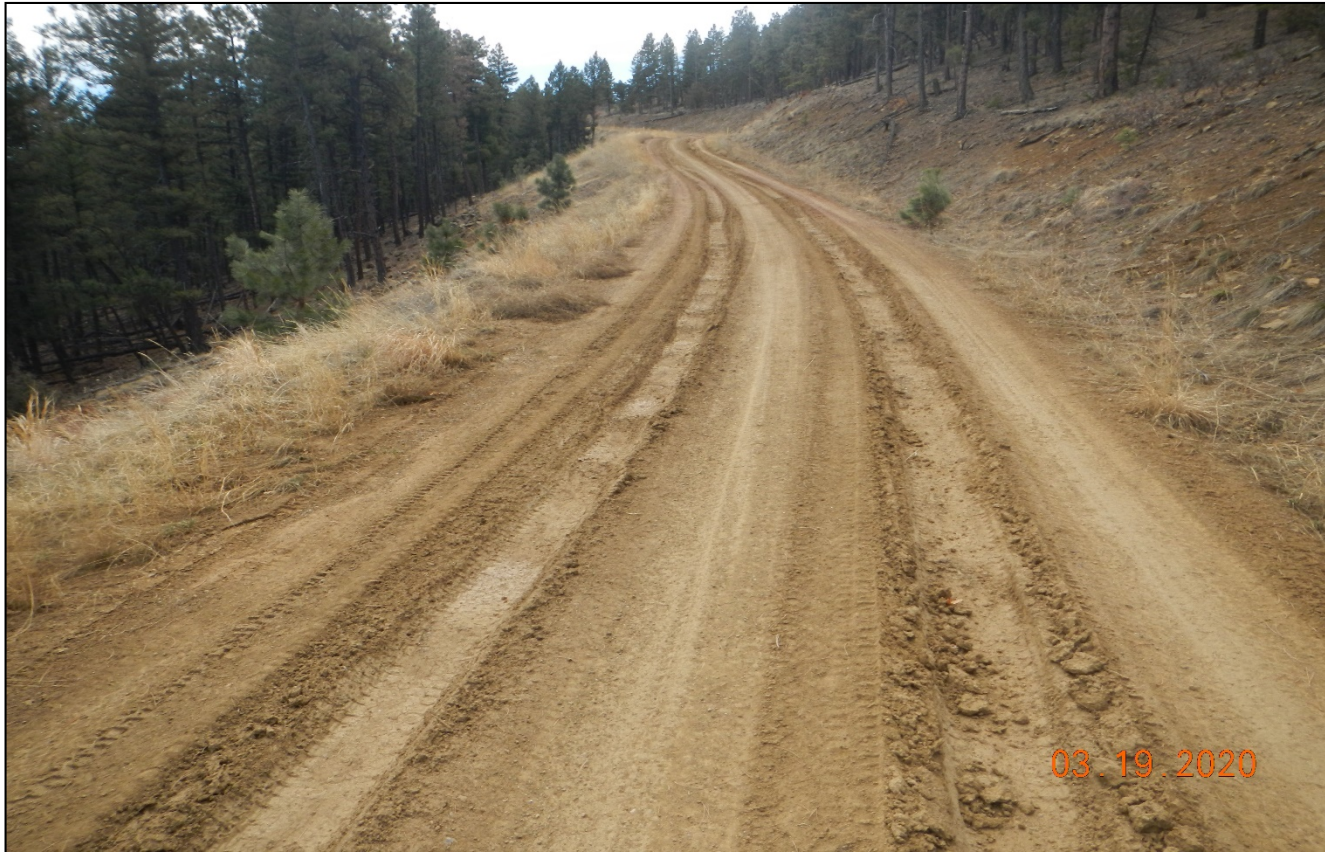
Photo 1. Facing southeast along the main lease road ascending the hill. There are vehicle ruts along the road. The road needs to be graded and maintained.

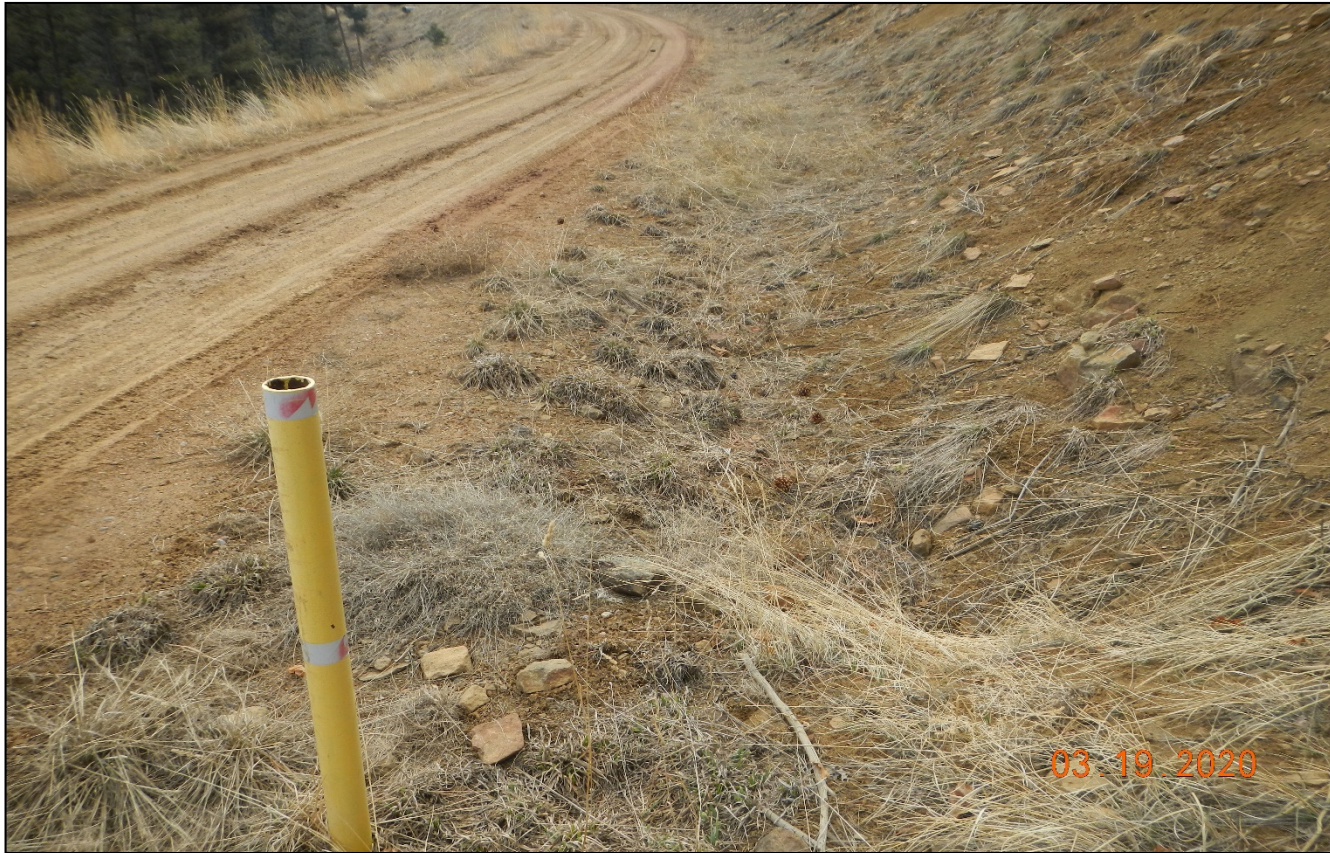
Photo 2. The culvert along the main lease road is filled in with sediment.

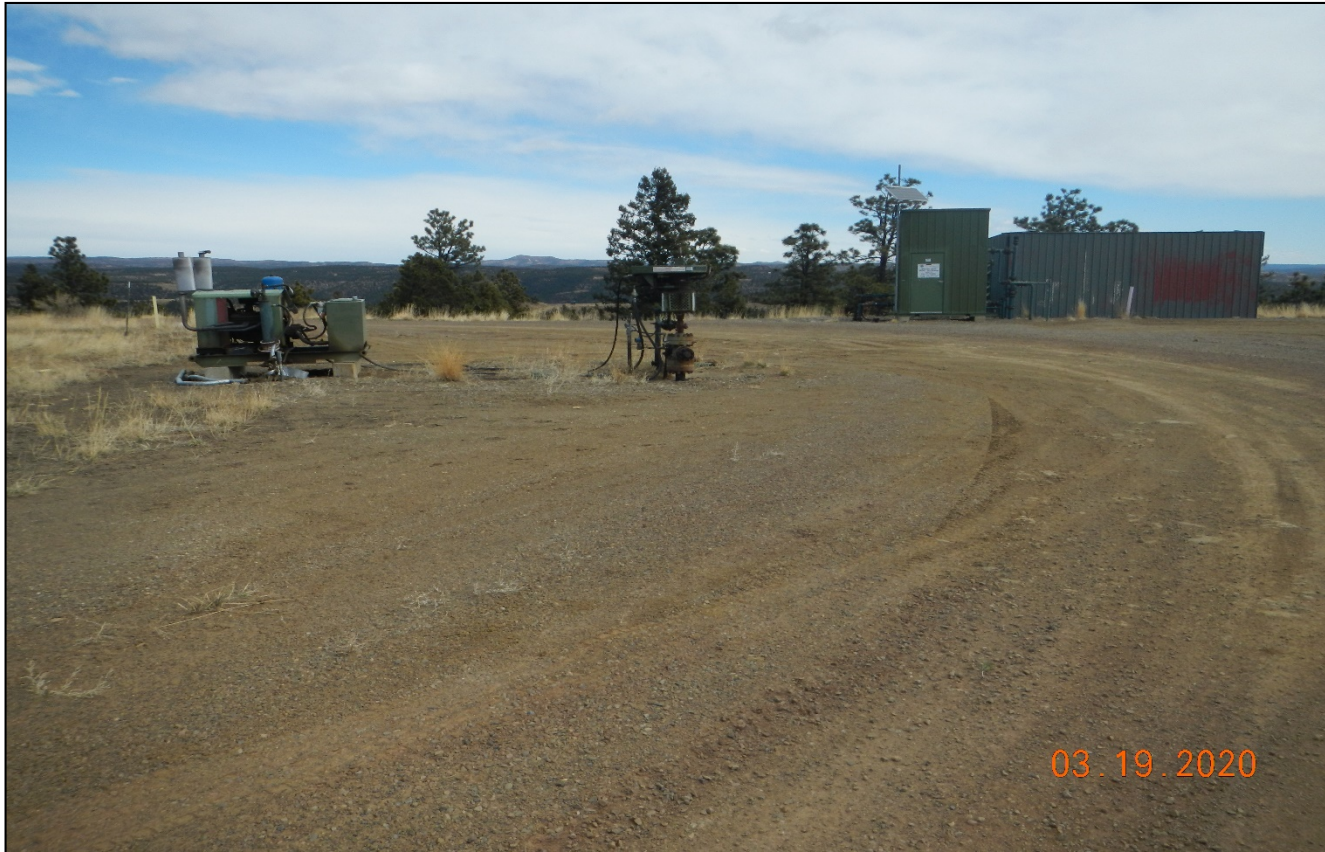
Photo 3. Facing northeast toward the location.

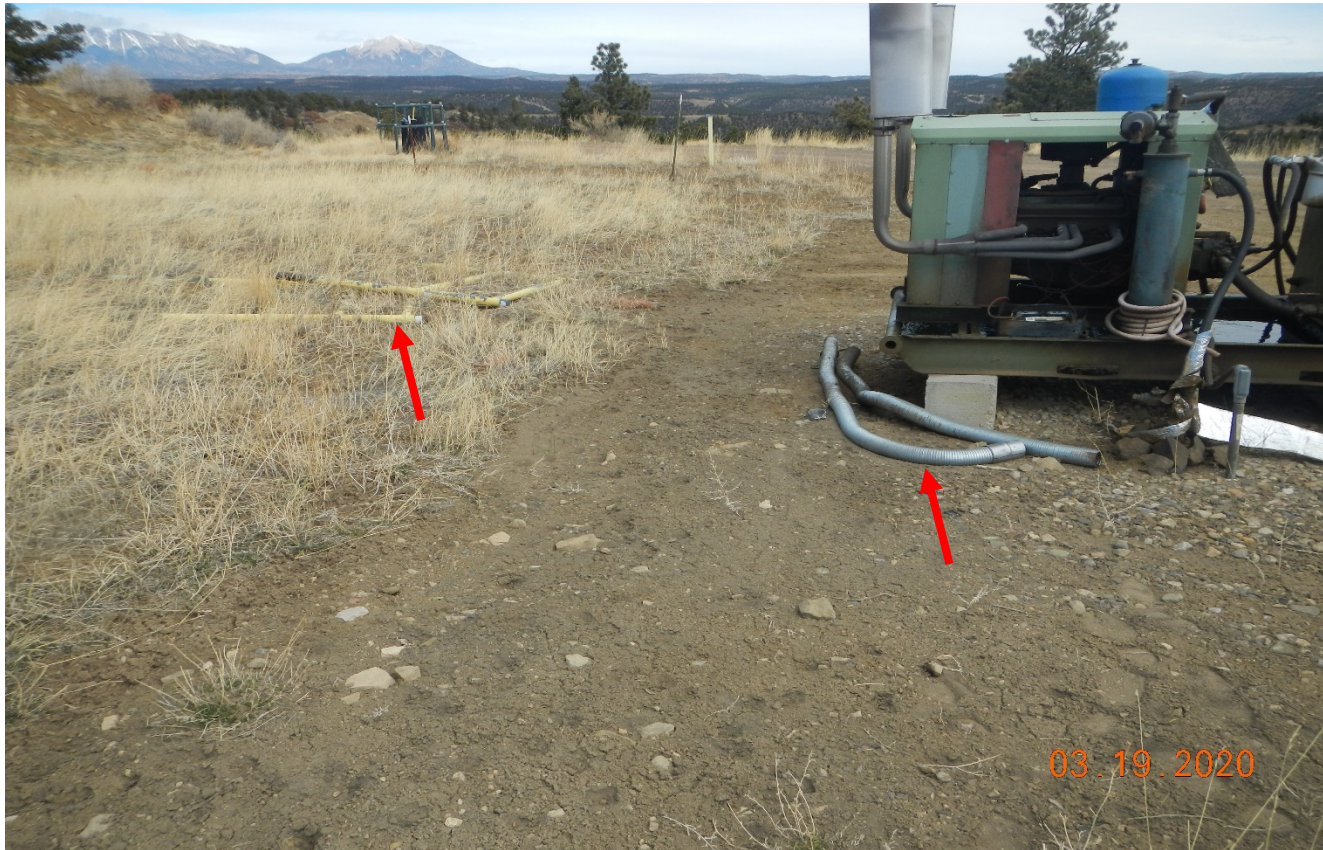
Photo 4. The exhaust pipe is laying on the ground and pipe h braces guards are laying in the grass. Unused equipment needs to be used or removed.

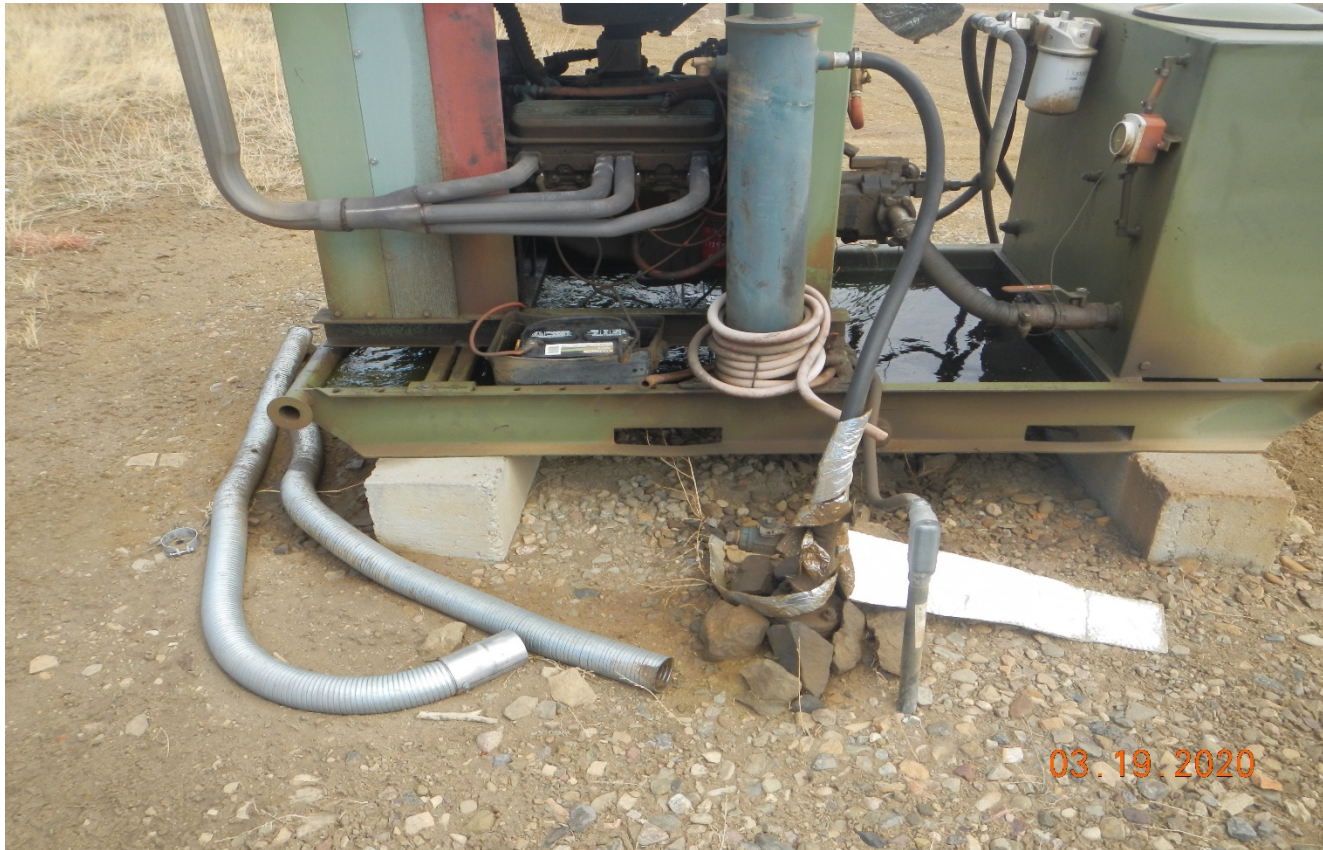
Photo 5. The is oily water in the engine skid.

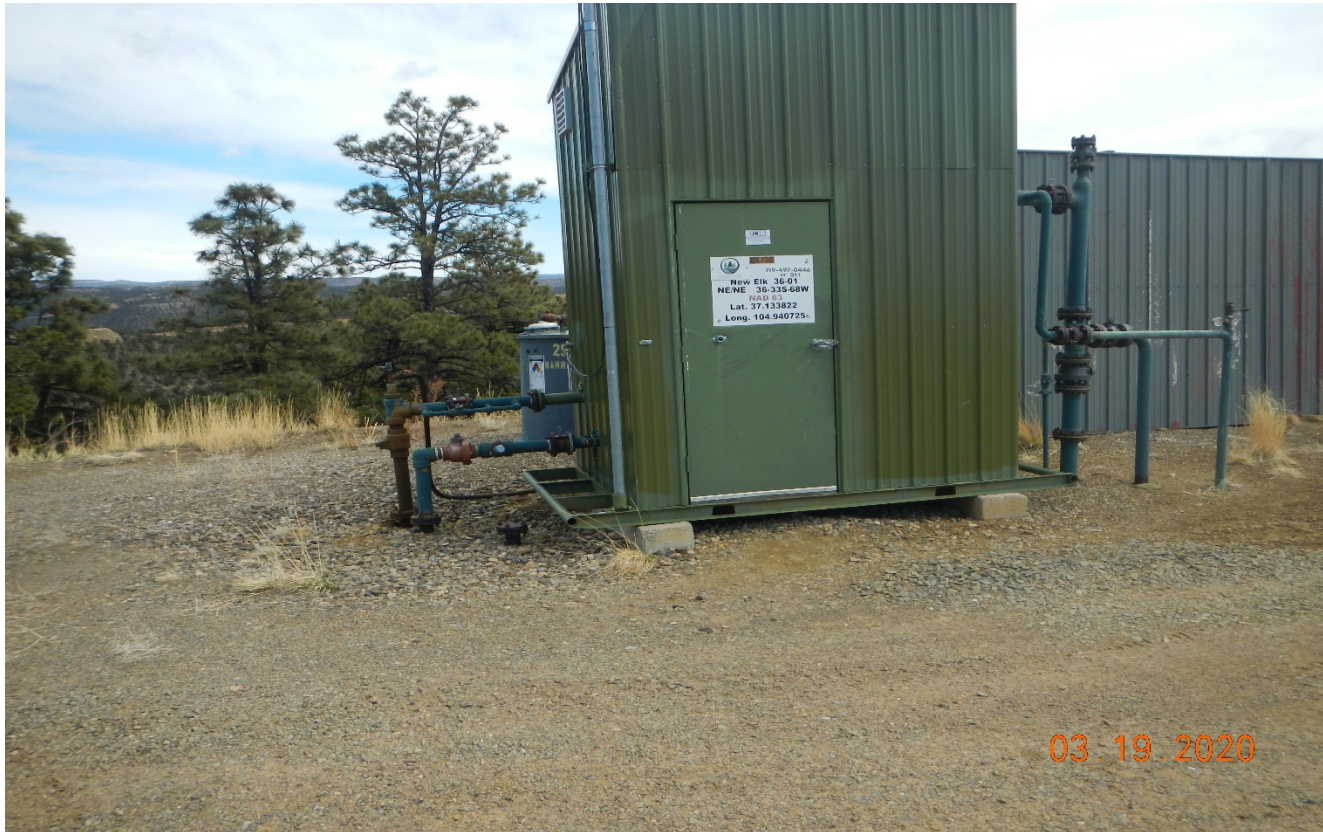
Photo 6. Well sign is posted at the meter shed.

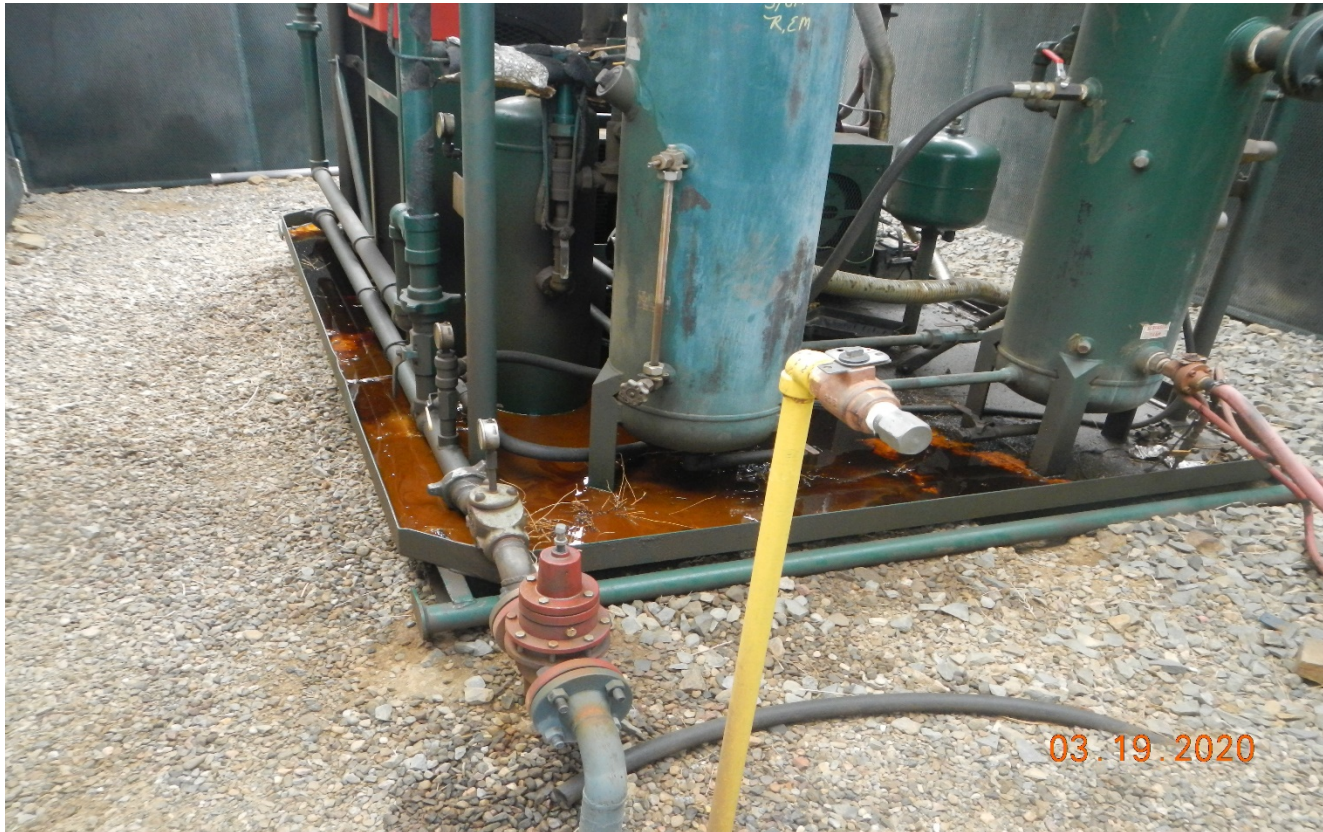
Photo 7. There is oily waste in the engine skid at compressor.
