Inspection Photos

Operator: Hilcorp Energy
API#: 067-08158
Date: 3/18/2020

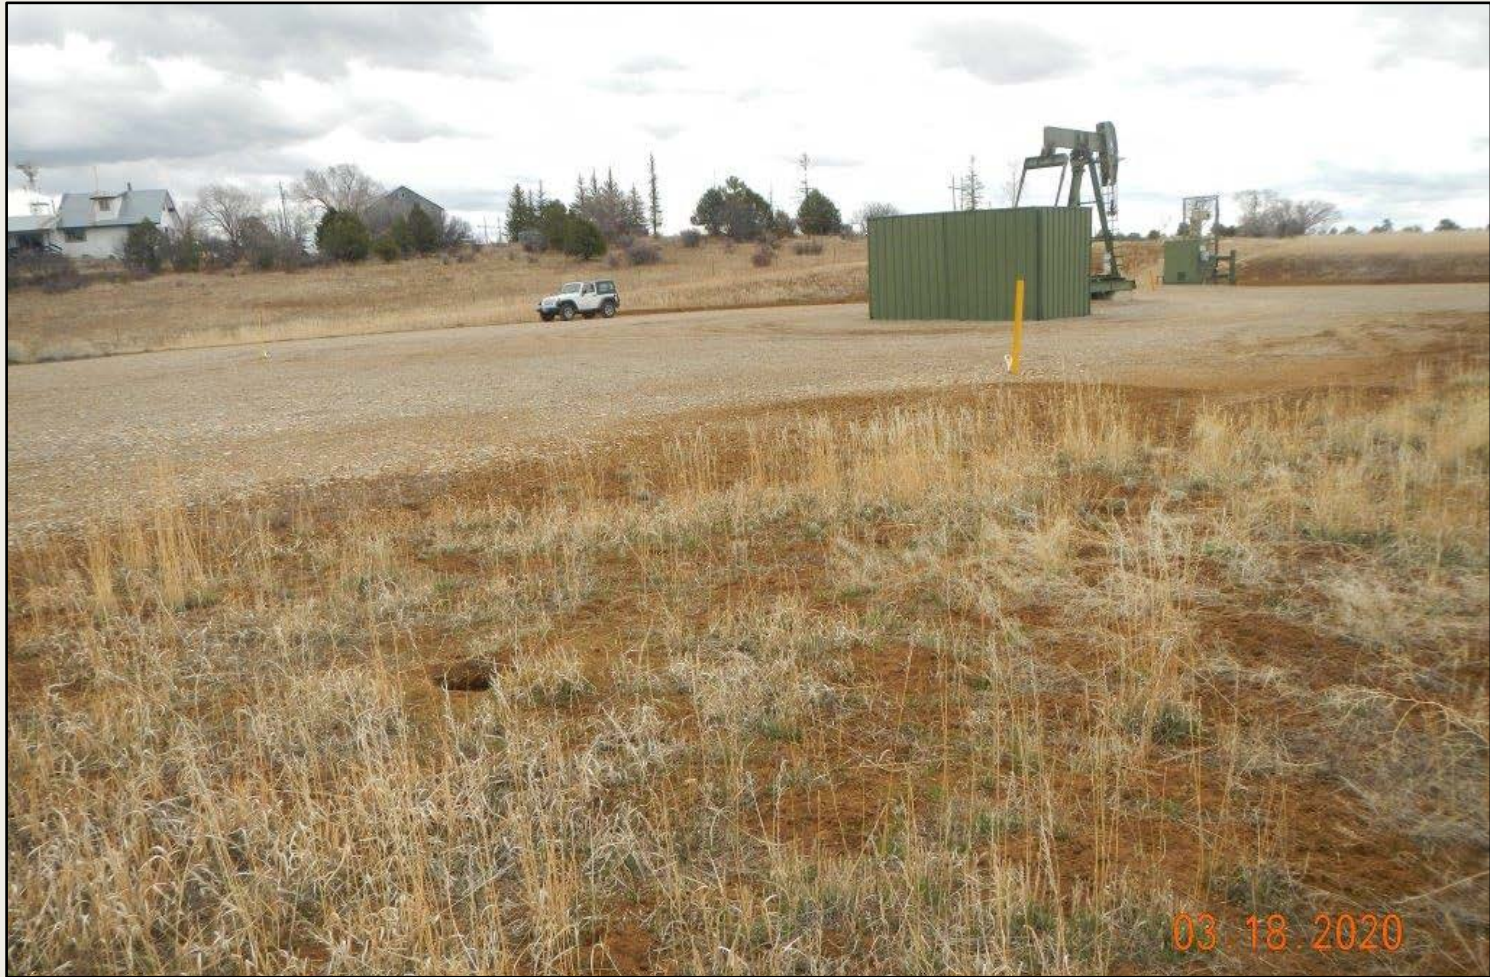
Photo 1. View of the project area from the northwestern corner entrance facing center.

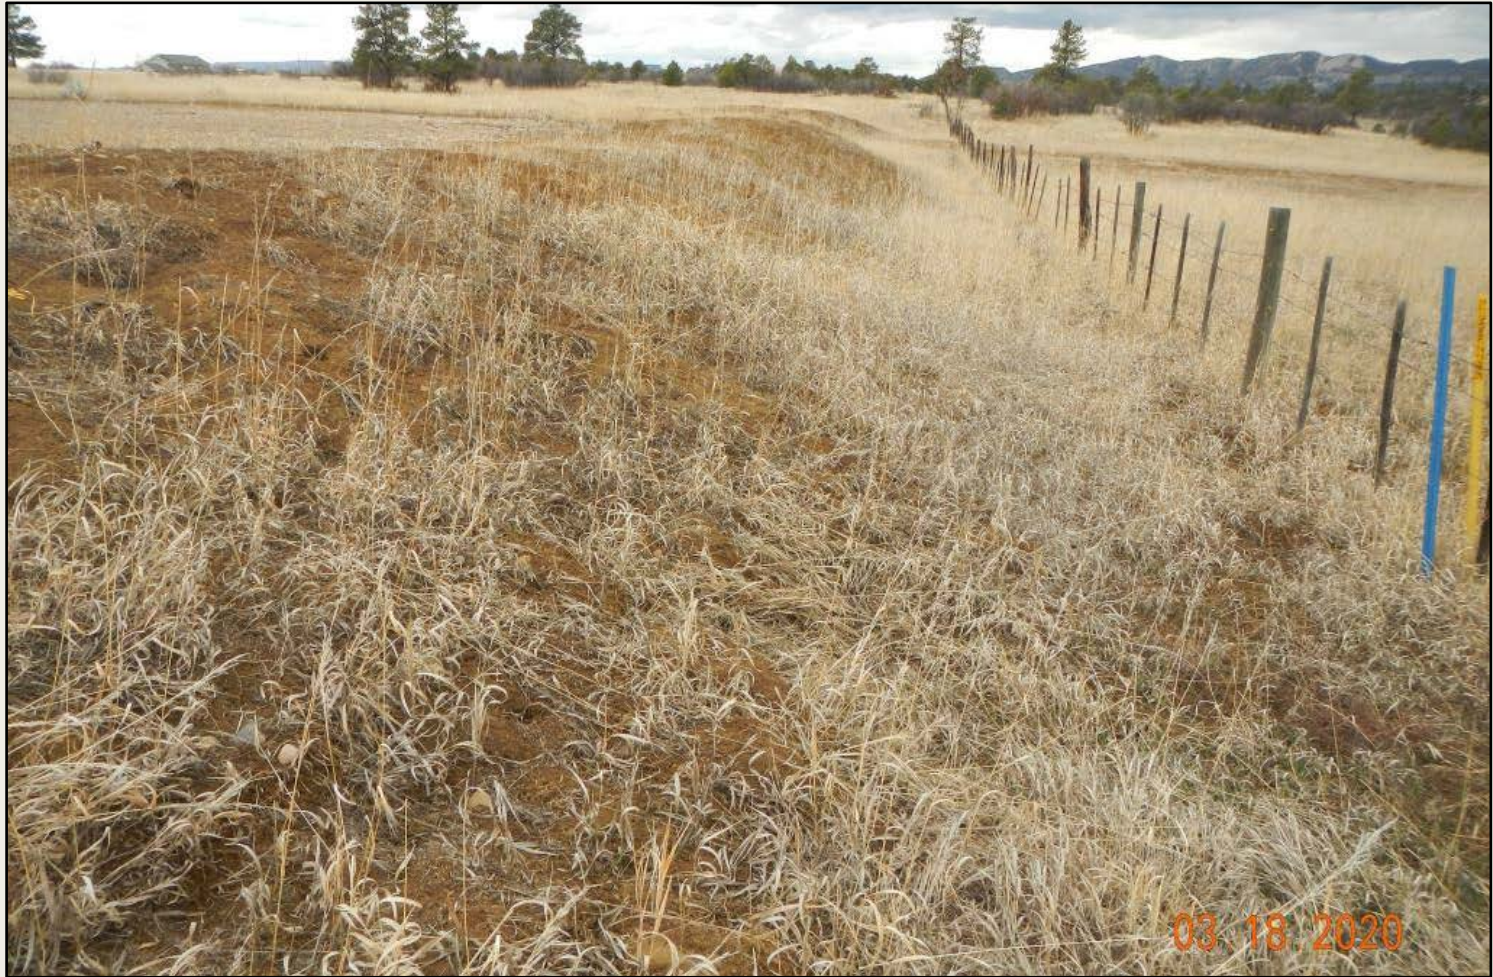
Photo 2. View of the northern project area from the northeastern corner facing westward. Revegetation is progressing here, largely with smooth brome.

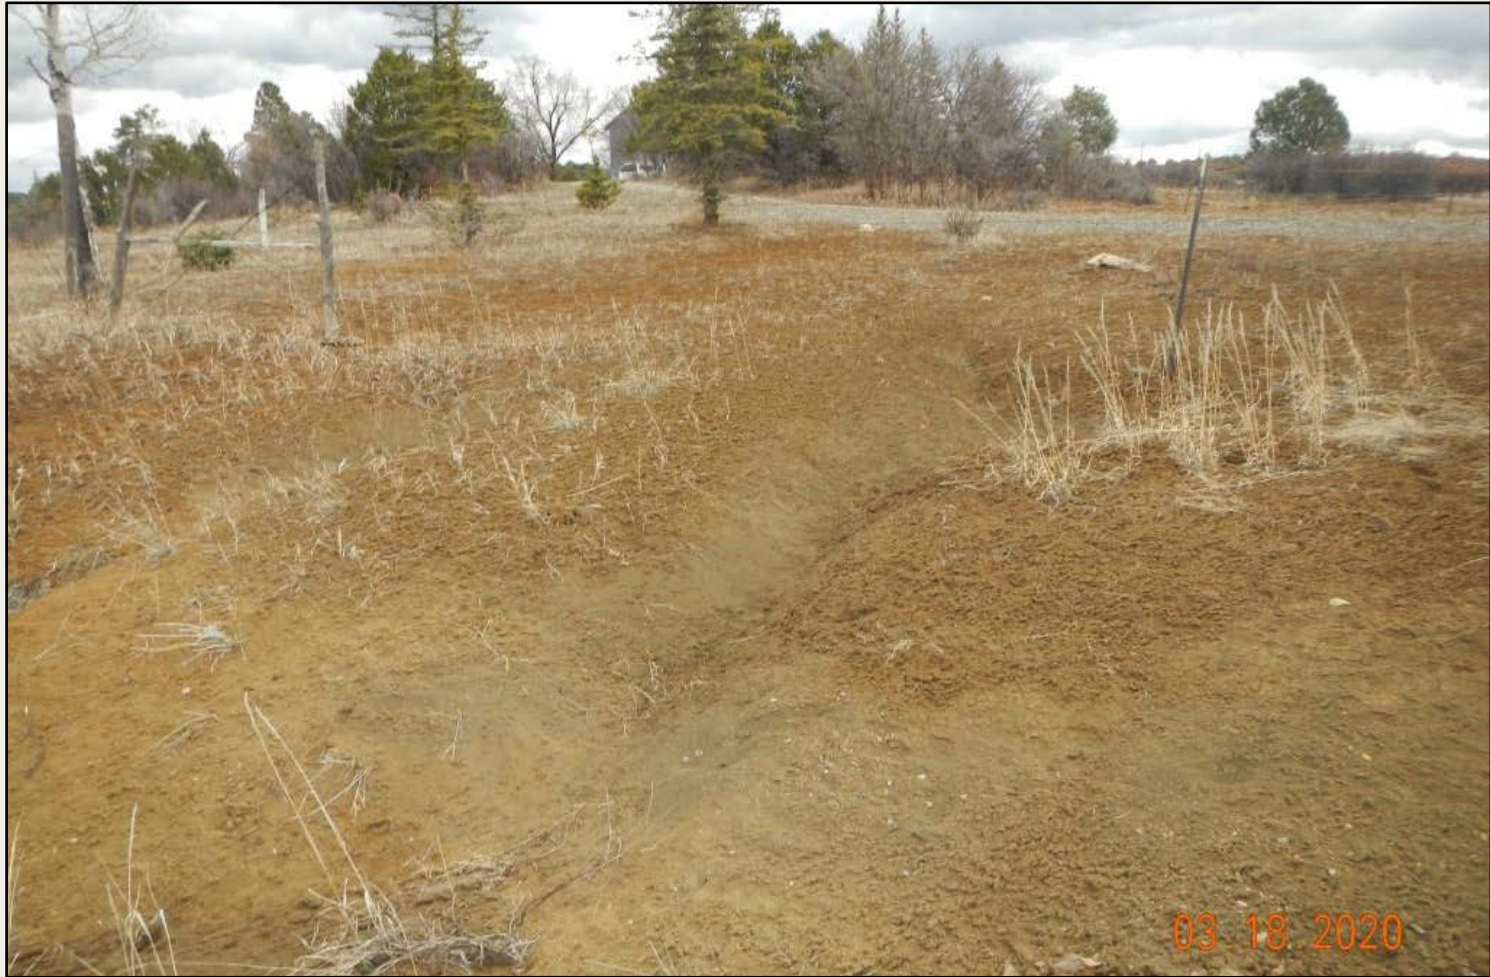
Photo 3. View of area near well pad entrance where stormwater run-on is eroding down-slope toward the access road. Stabilization measures are needed here.

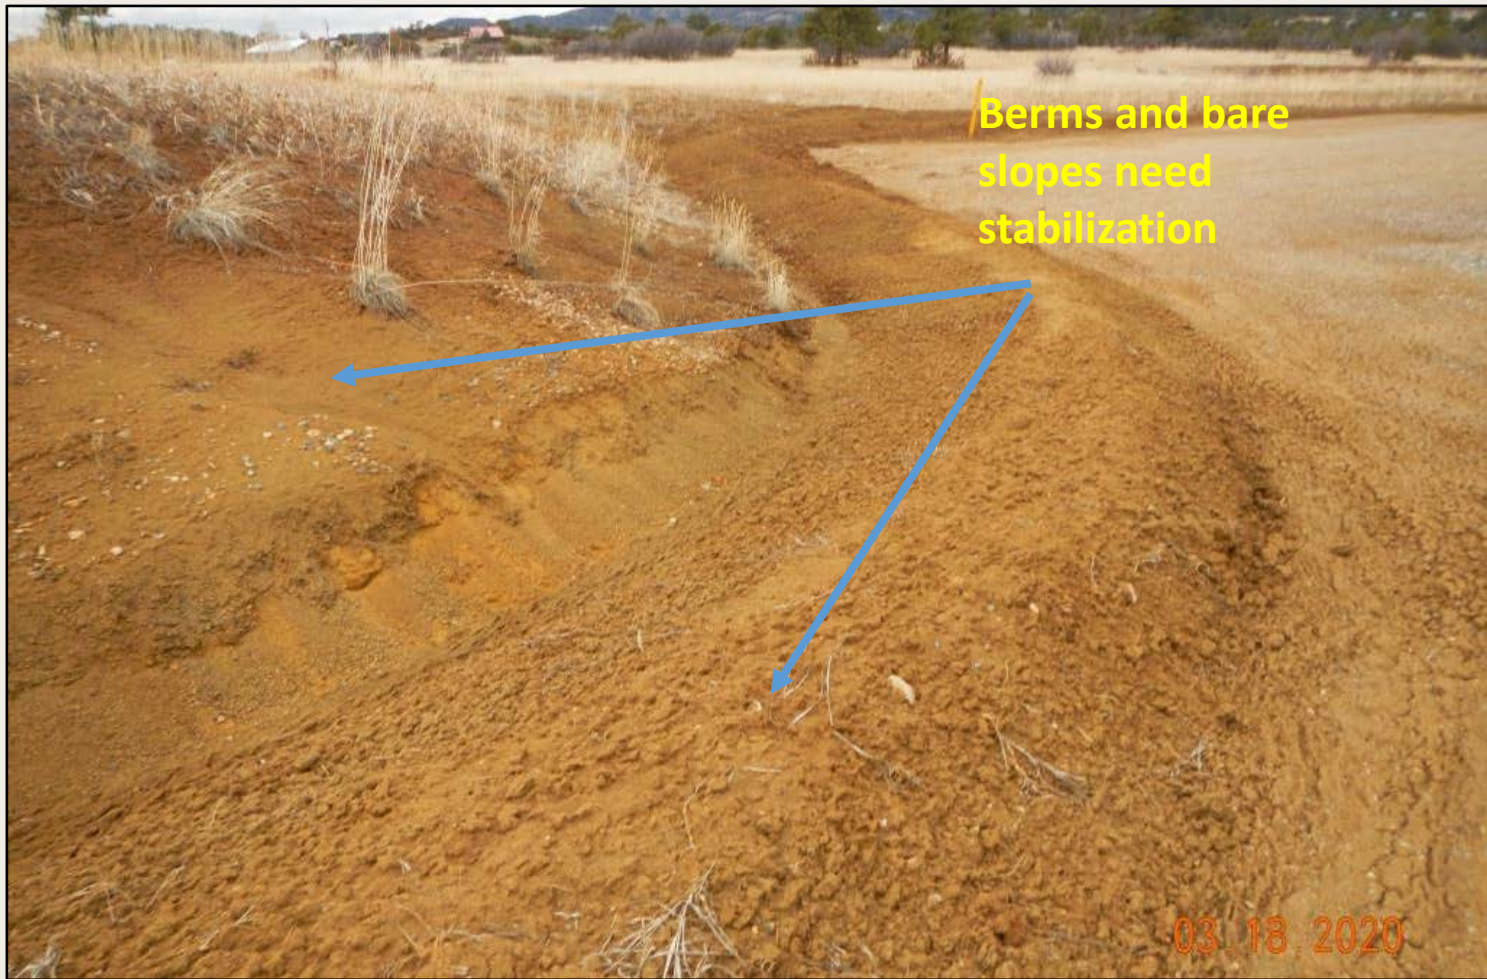
Photo 4. View of the southwestern edge of the well pad working area facing westward from the well pad entrance. Berms and eroding slopes need stabilization.

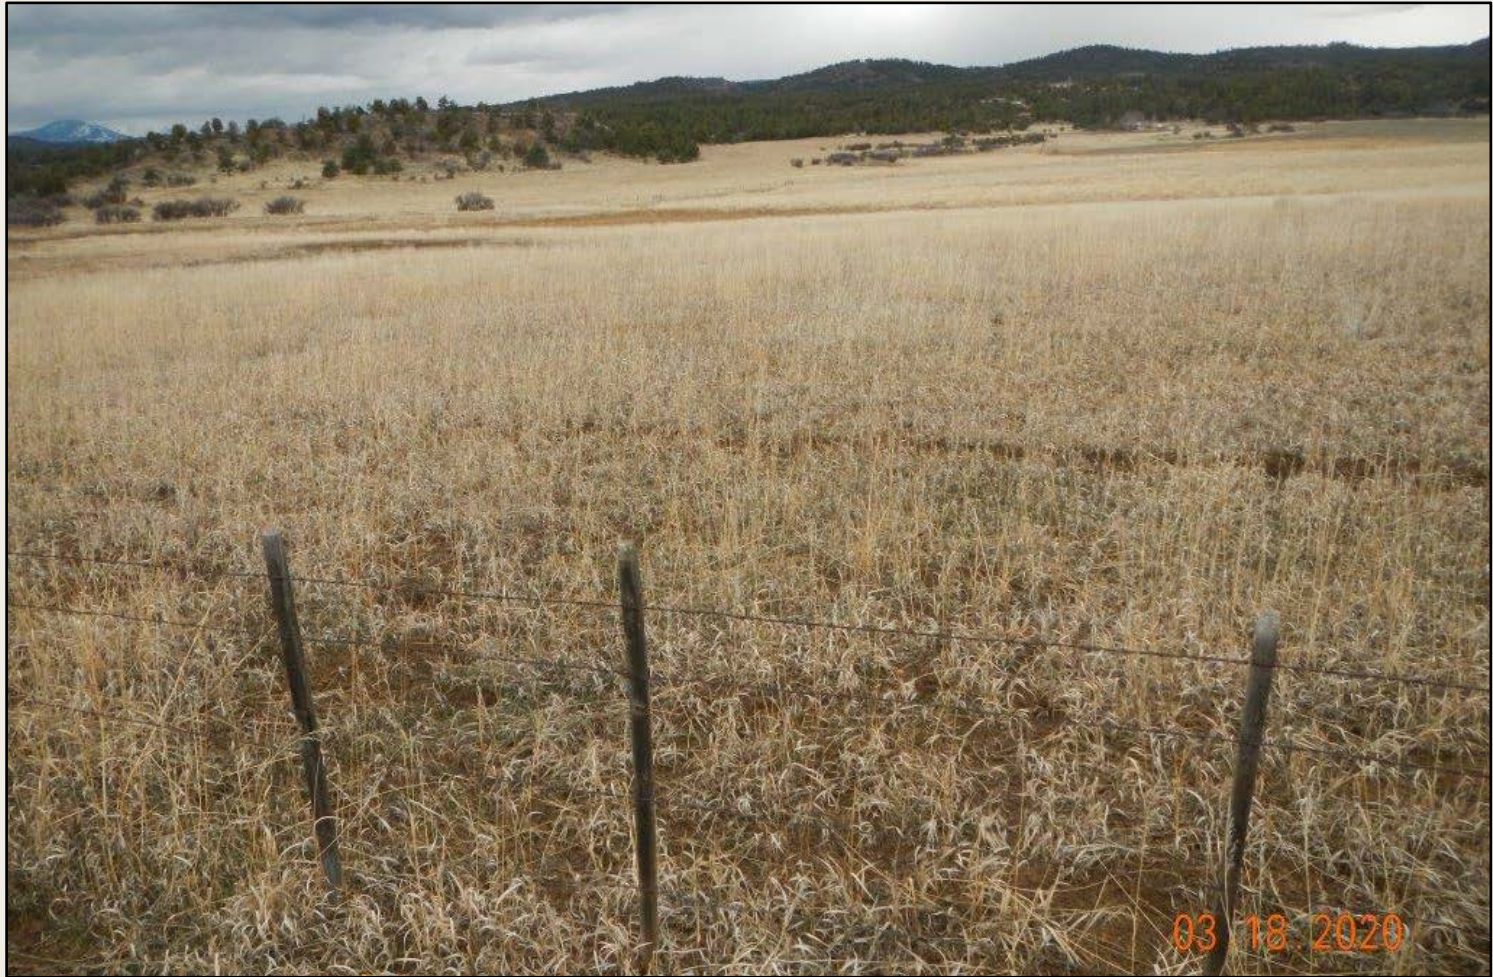
Photo 5. View of the surrounding reference area comprised of smooth brome dominated grass field.
