Inspection Photos

Location Name: MARALEX RESOURCES INC FEDERAL-68S97W /30SWSW

Location ID: 312470

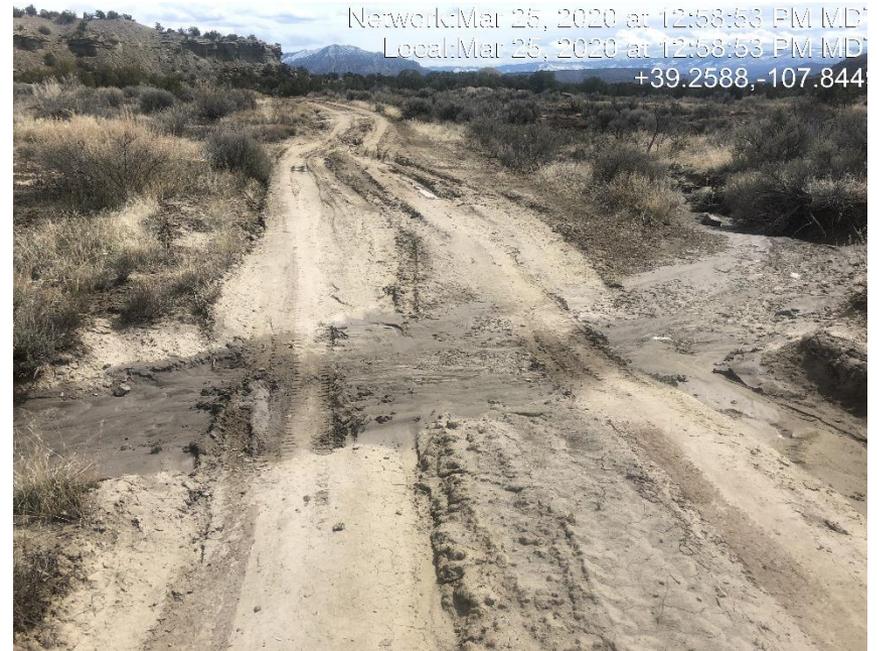
Photo #0825 Access road has not been maintained.

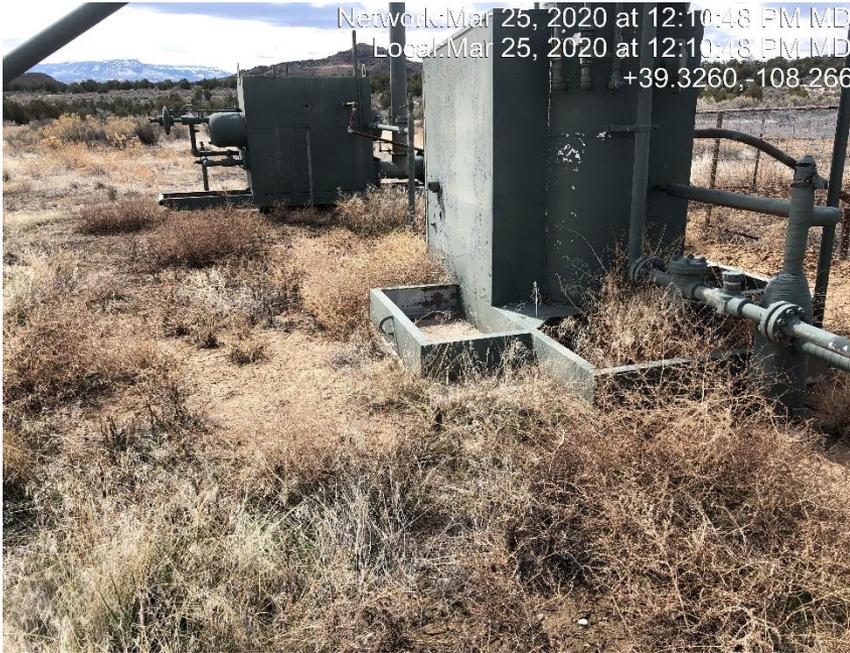
Photo #0818 Debris around equipment.

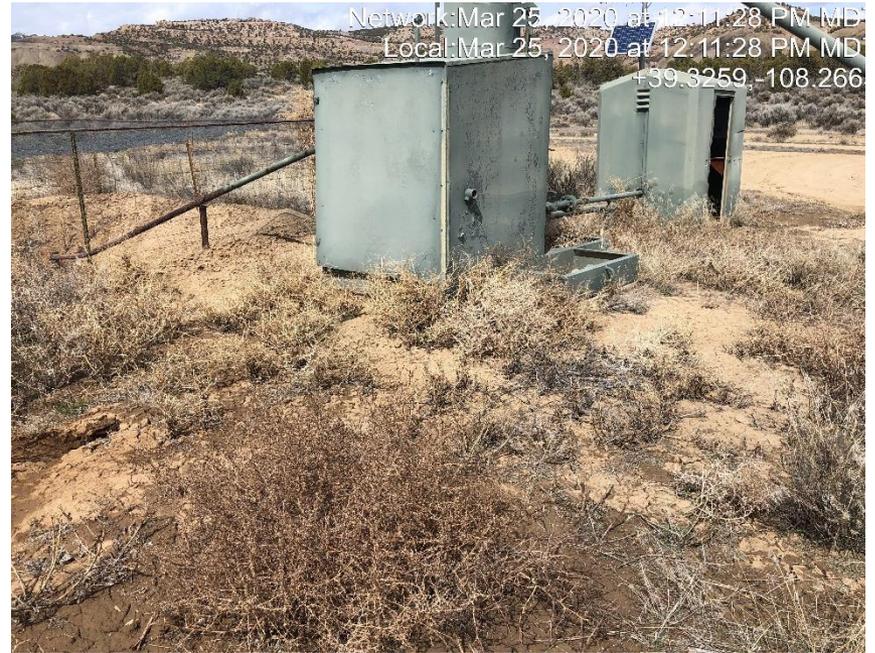
Photo #0819 Debris around equipment.

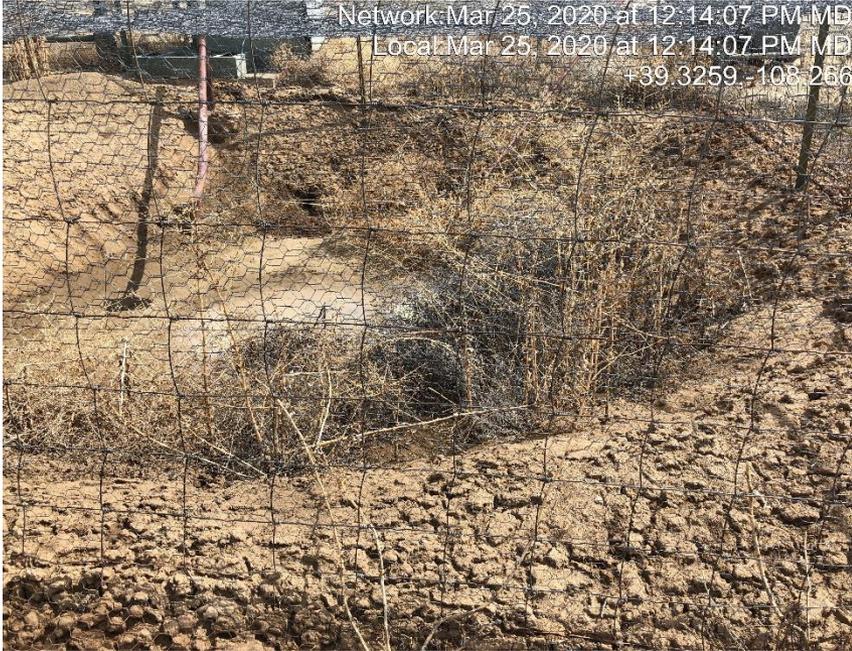
Photo #0823 Debris inside pit.

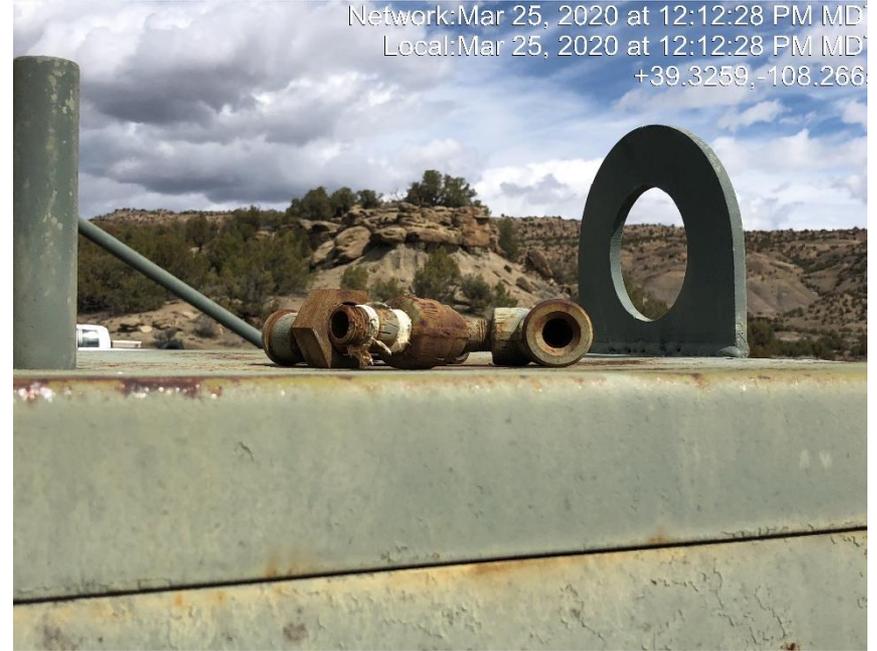
Photo #0821 Multiple places with unused equipment on location.

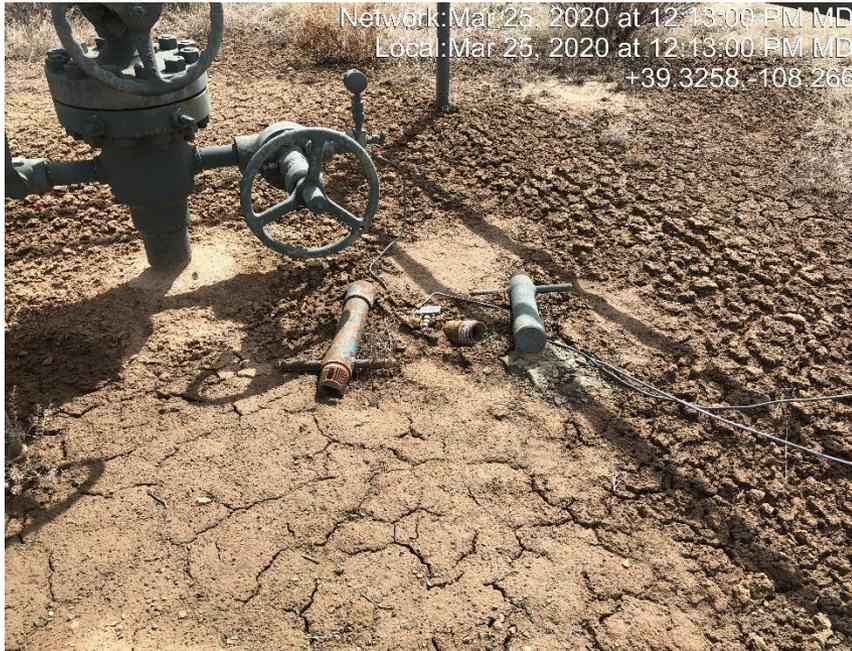
Photo #0822 Multiple places with unused equipment on location.

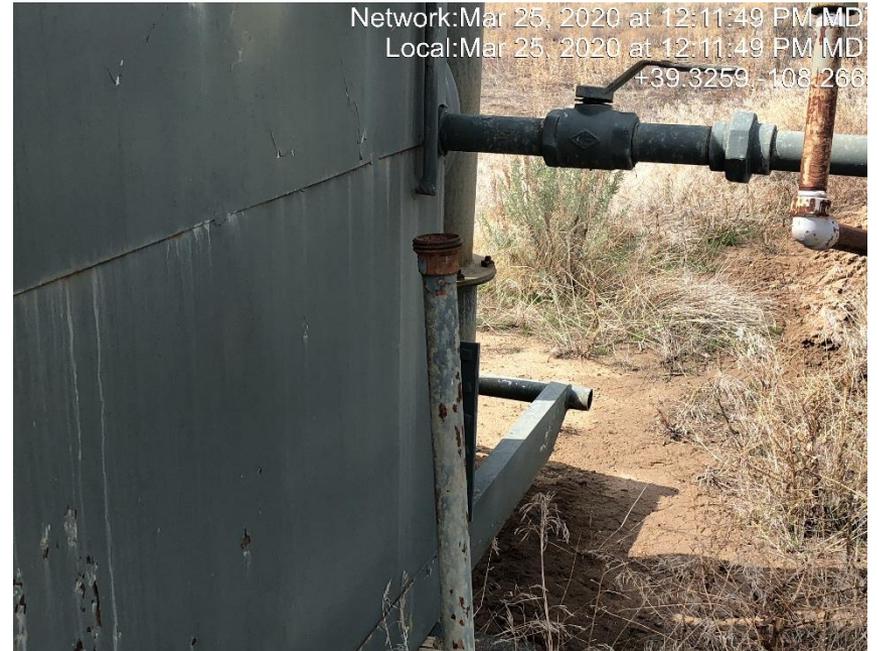
Photo #0820 Flow line risers not LO/TO.
