Inspection Photos

Location Name: MARALEX RESOURCES INC FEDERAL-68S98W /25NWSE

Location ID: 312513

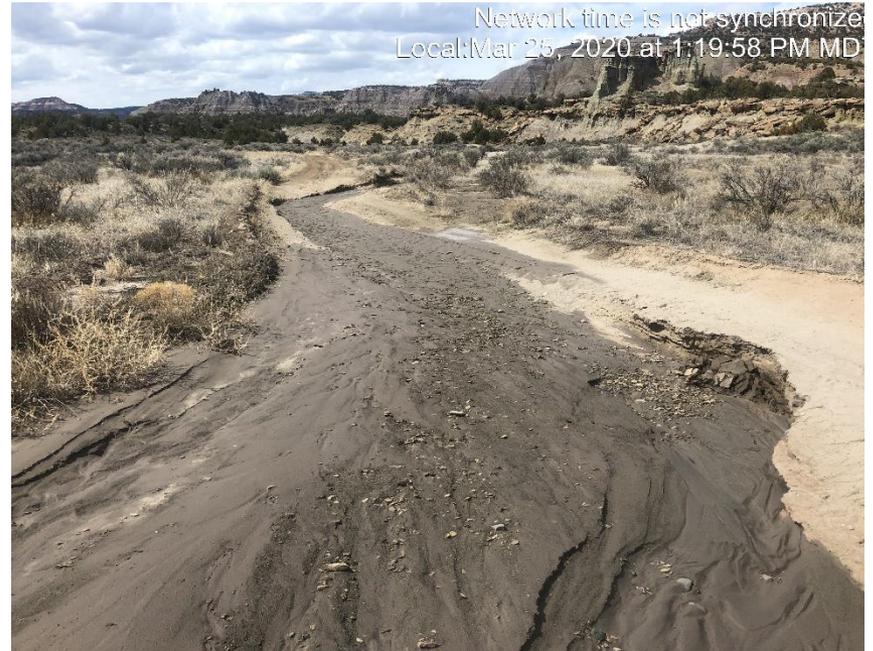
Photo #0826 Access road has not been maintained.

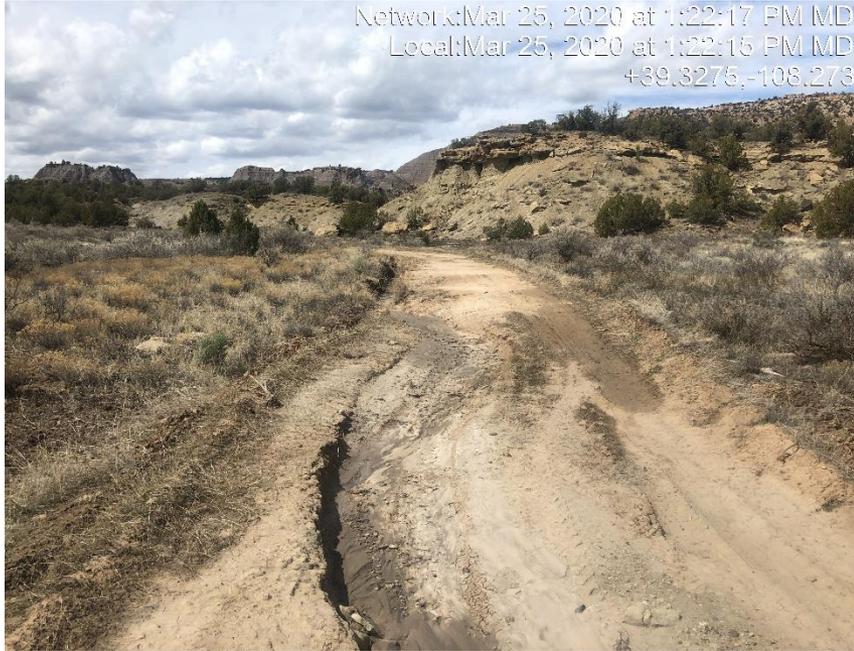
Photo #0827 Access road has not been maintained.

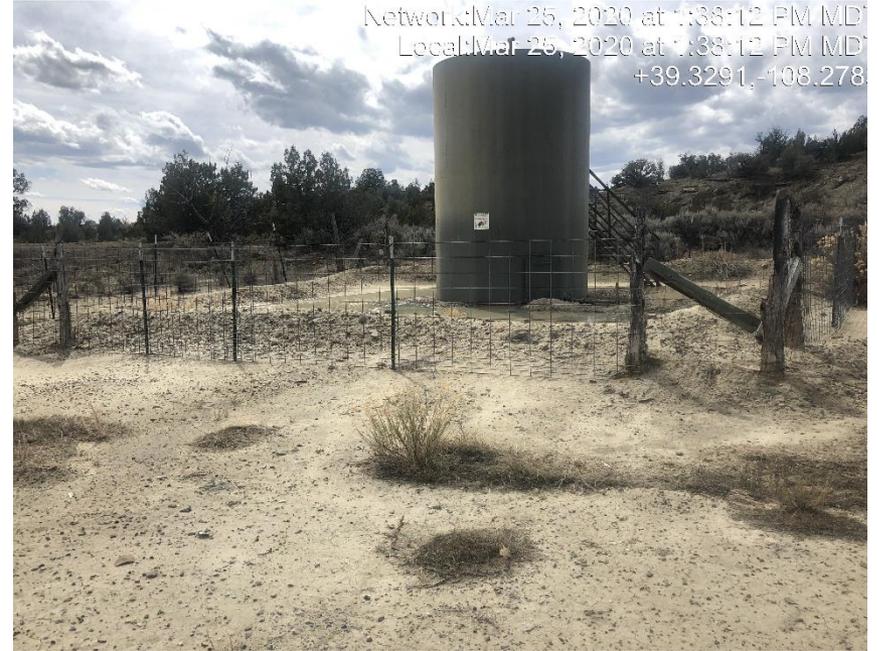
Photo #0833 Battery sign not posted.

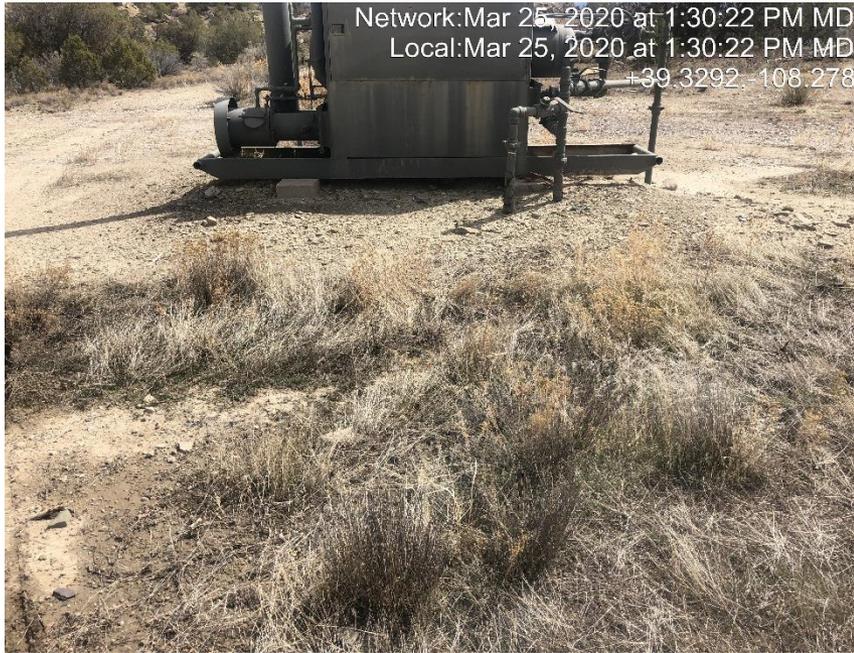
Photo #0831 Debris around equipment.

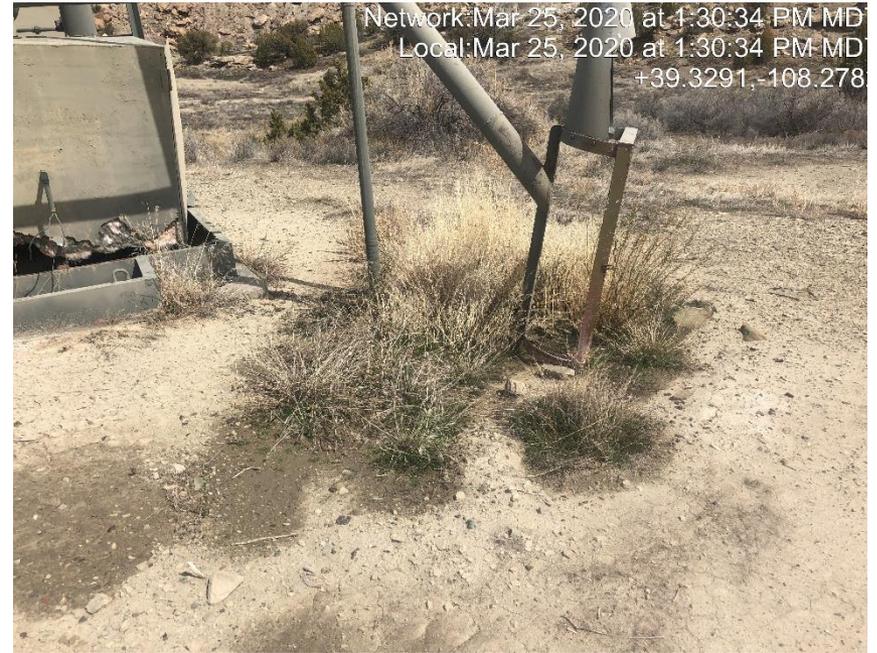
Photo #0832 Debris around equipment.

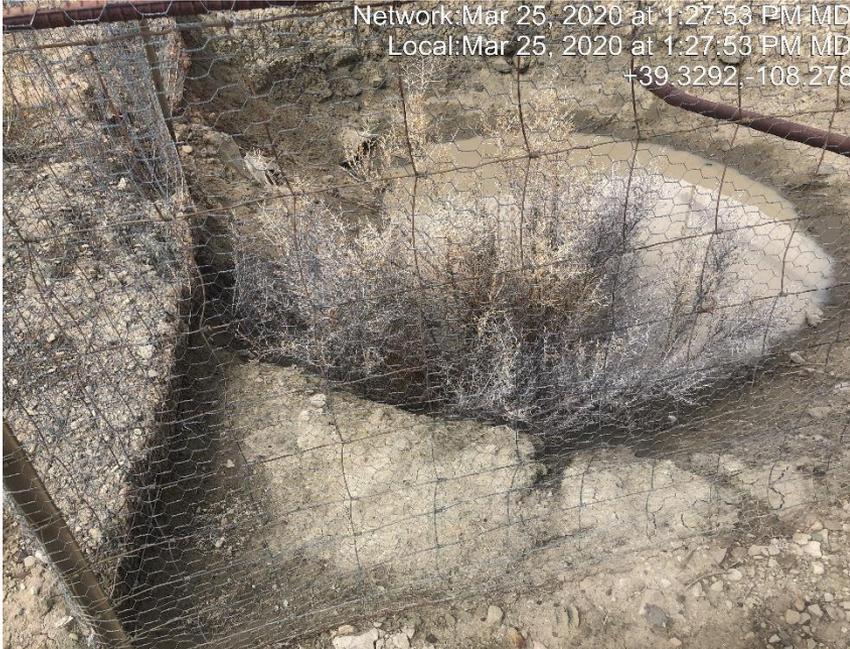
Photo #0829 Debris inside pit.

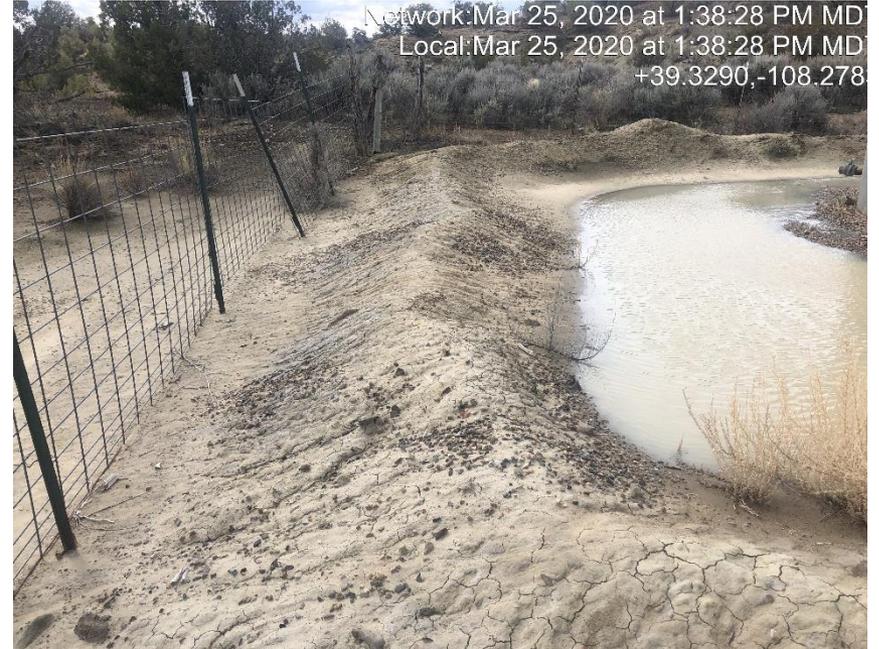
Photo #0834 Tank containment berm needs repaired.

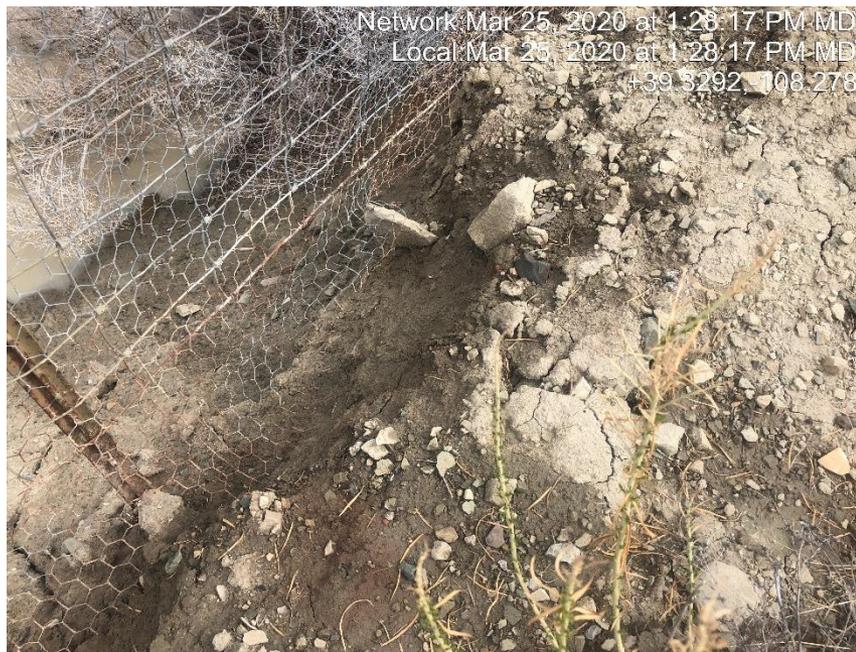
Photo #0830 Hole in wildlife protection device.
