Inspection Photos

Operator: Hilcorp Energy
API#: 067-09551
Date: 3/24/2020

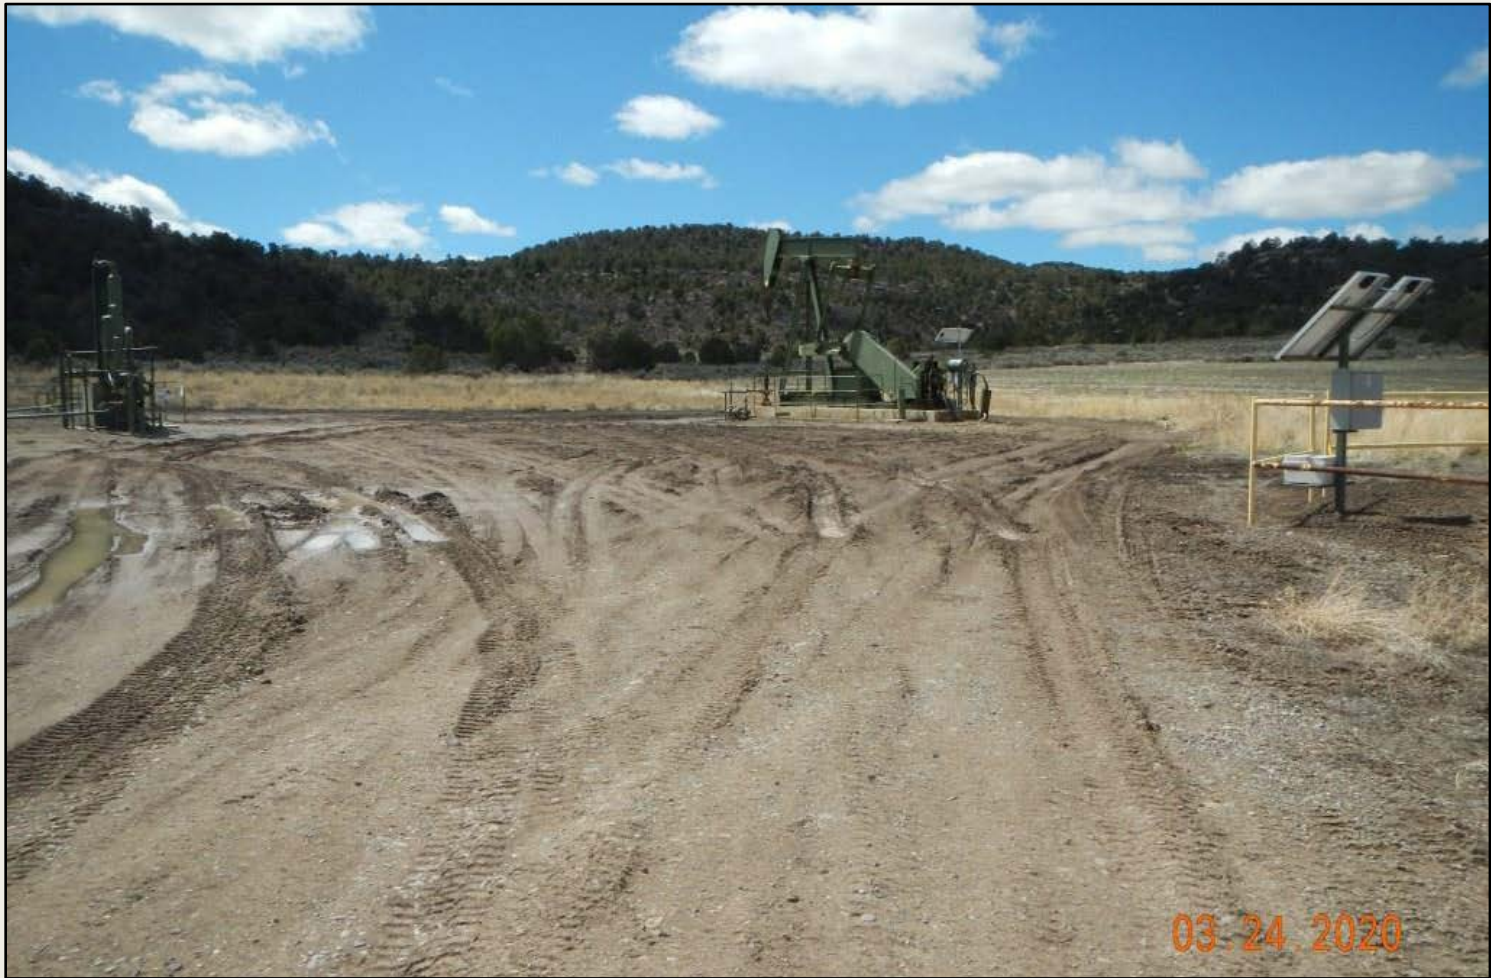
Photo 1. View of the project area from the well pad entrance facing center.

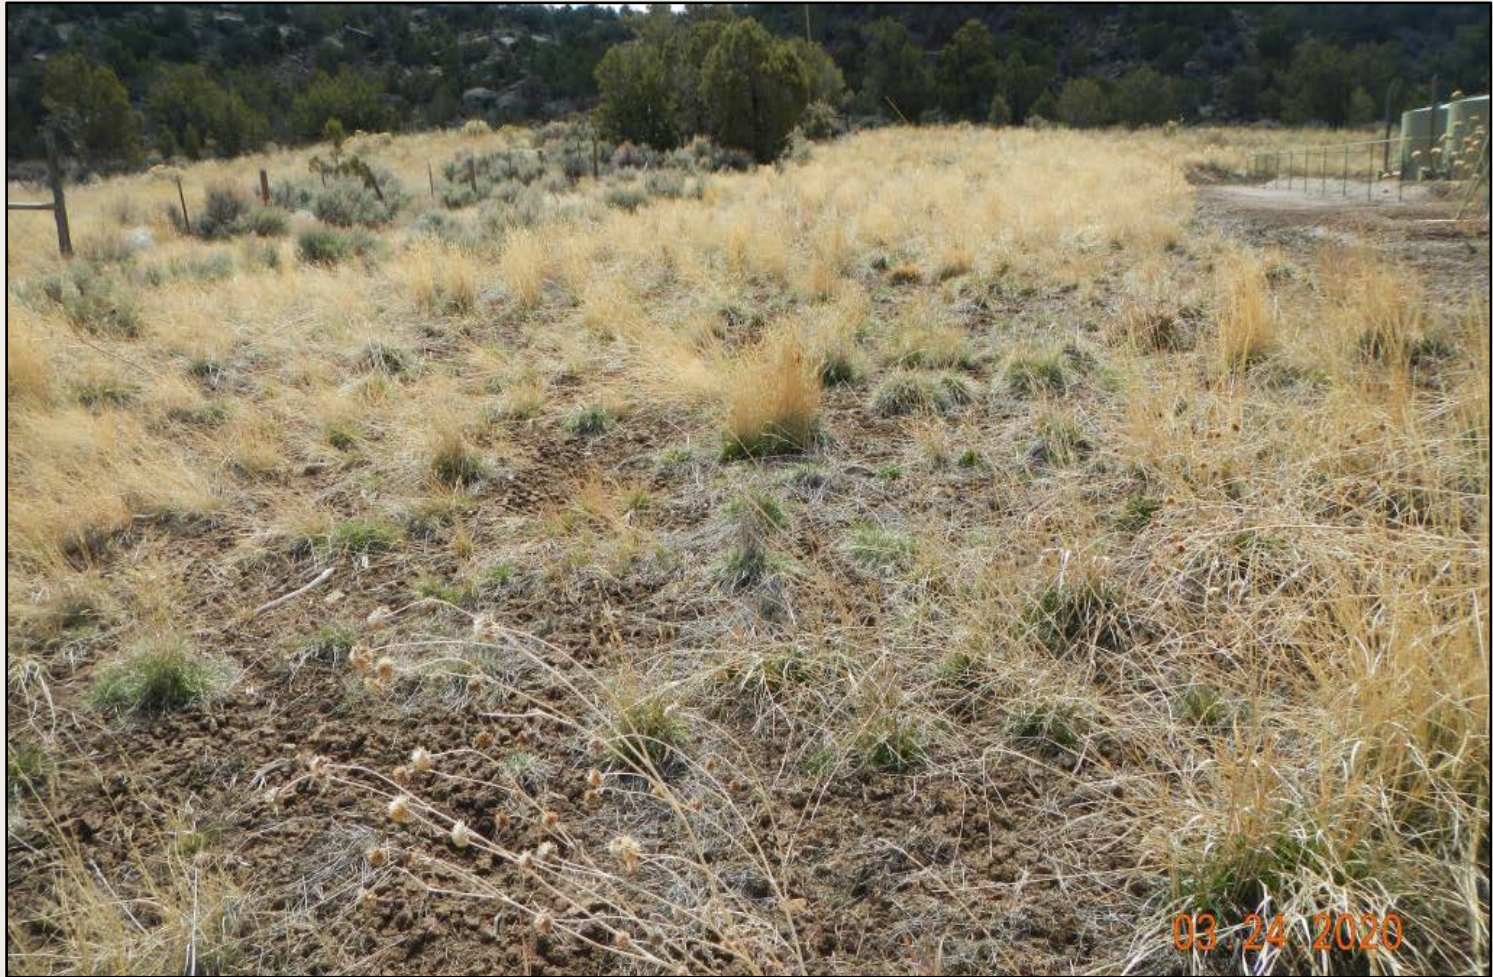
Photo 2. View of the eastern fill slope from the northeastern edge facing southward. Revegetation is progressing with mixed wheatgrasses.

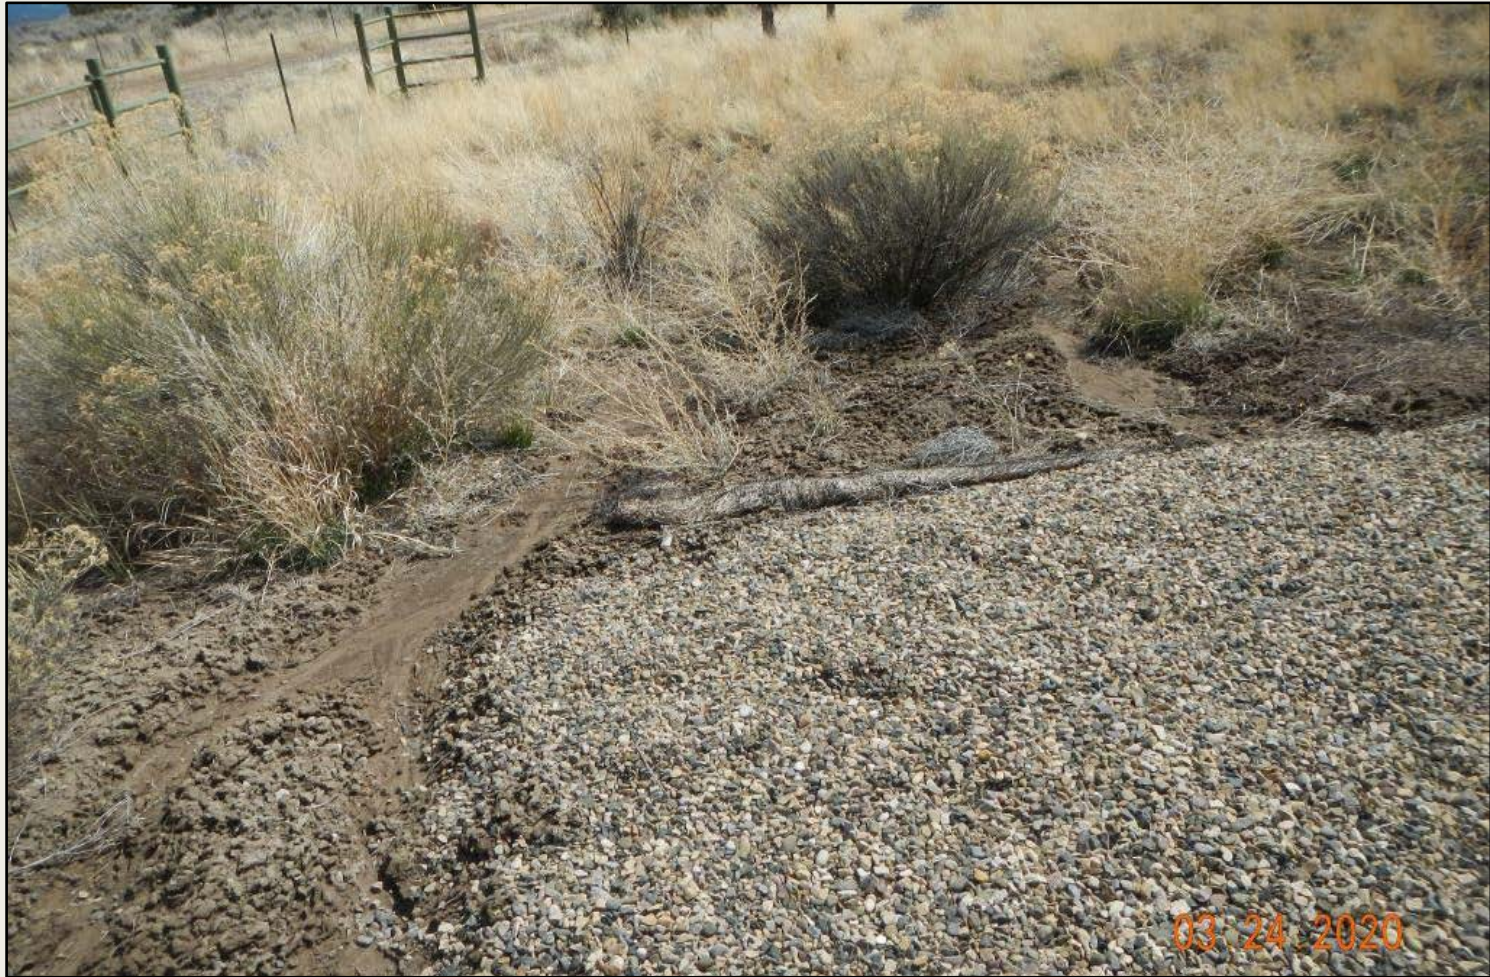
Photo 3. View of erosional channeling and failed wattle within the northeastern corner of the working area.

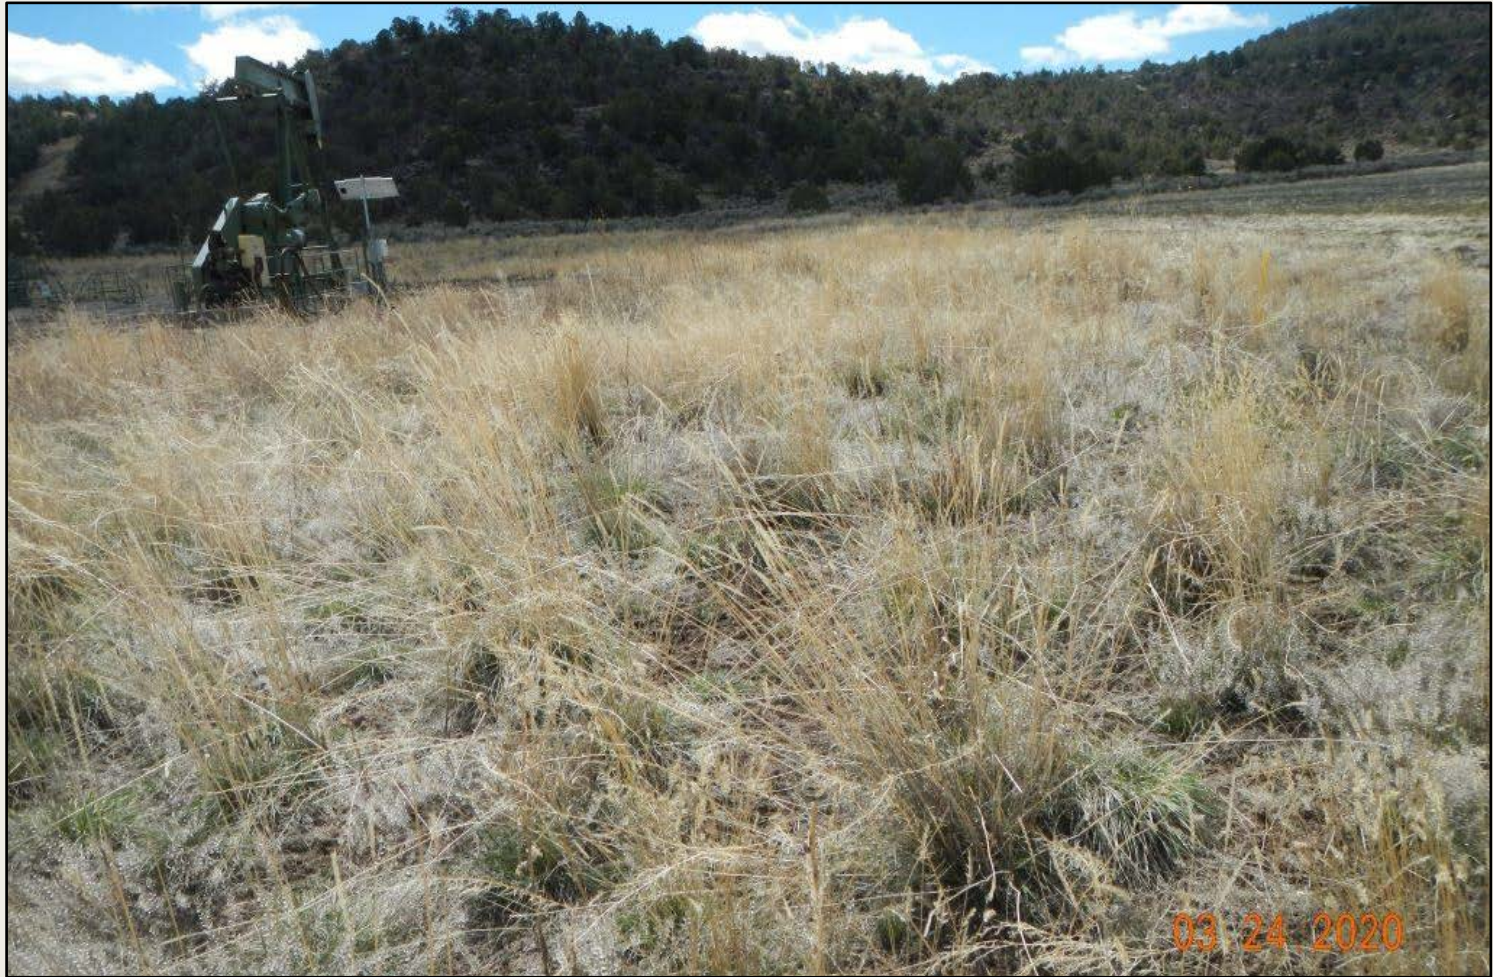
Photo 4. View of the western project area from the northeastern corner facing southward.

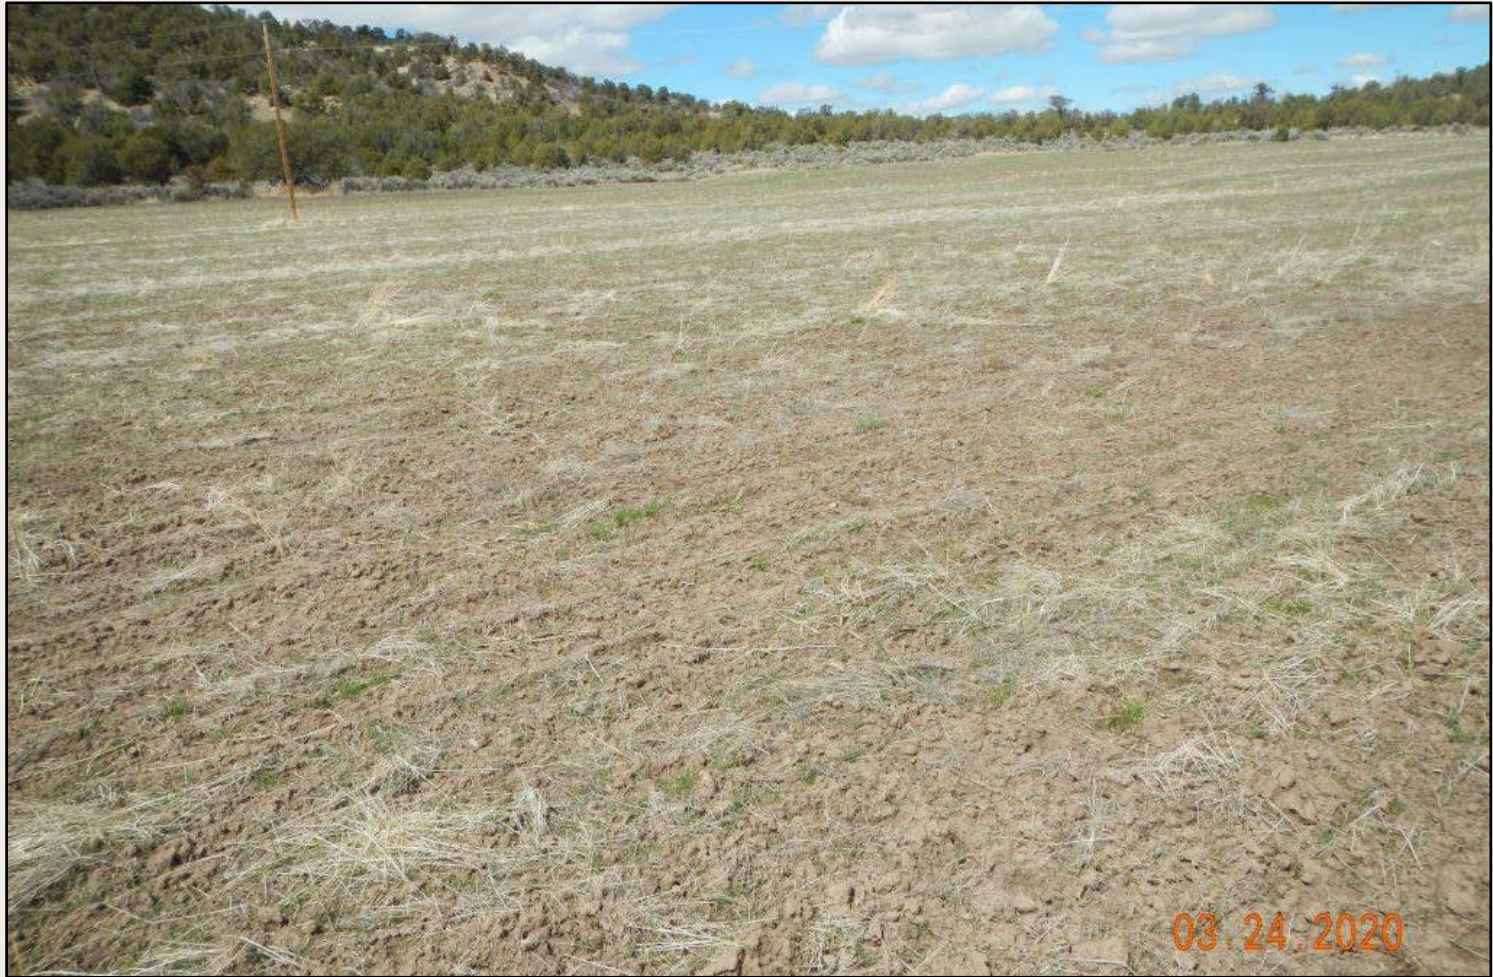
Photo 5. View of reference area, comprised of cultivated field in dormant/fallow condition at this time.
