NRM 808 Government 2-34
API: 05-103-07413
Inspection: 700400826

COLORADO
Oil & Gas Conservation
Commission
Department of Natural Resources

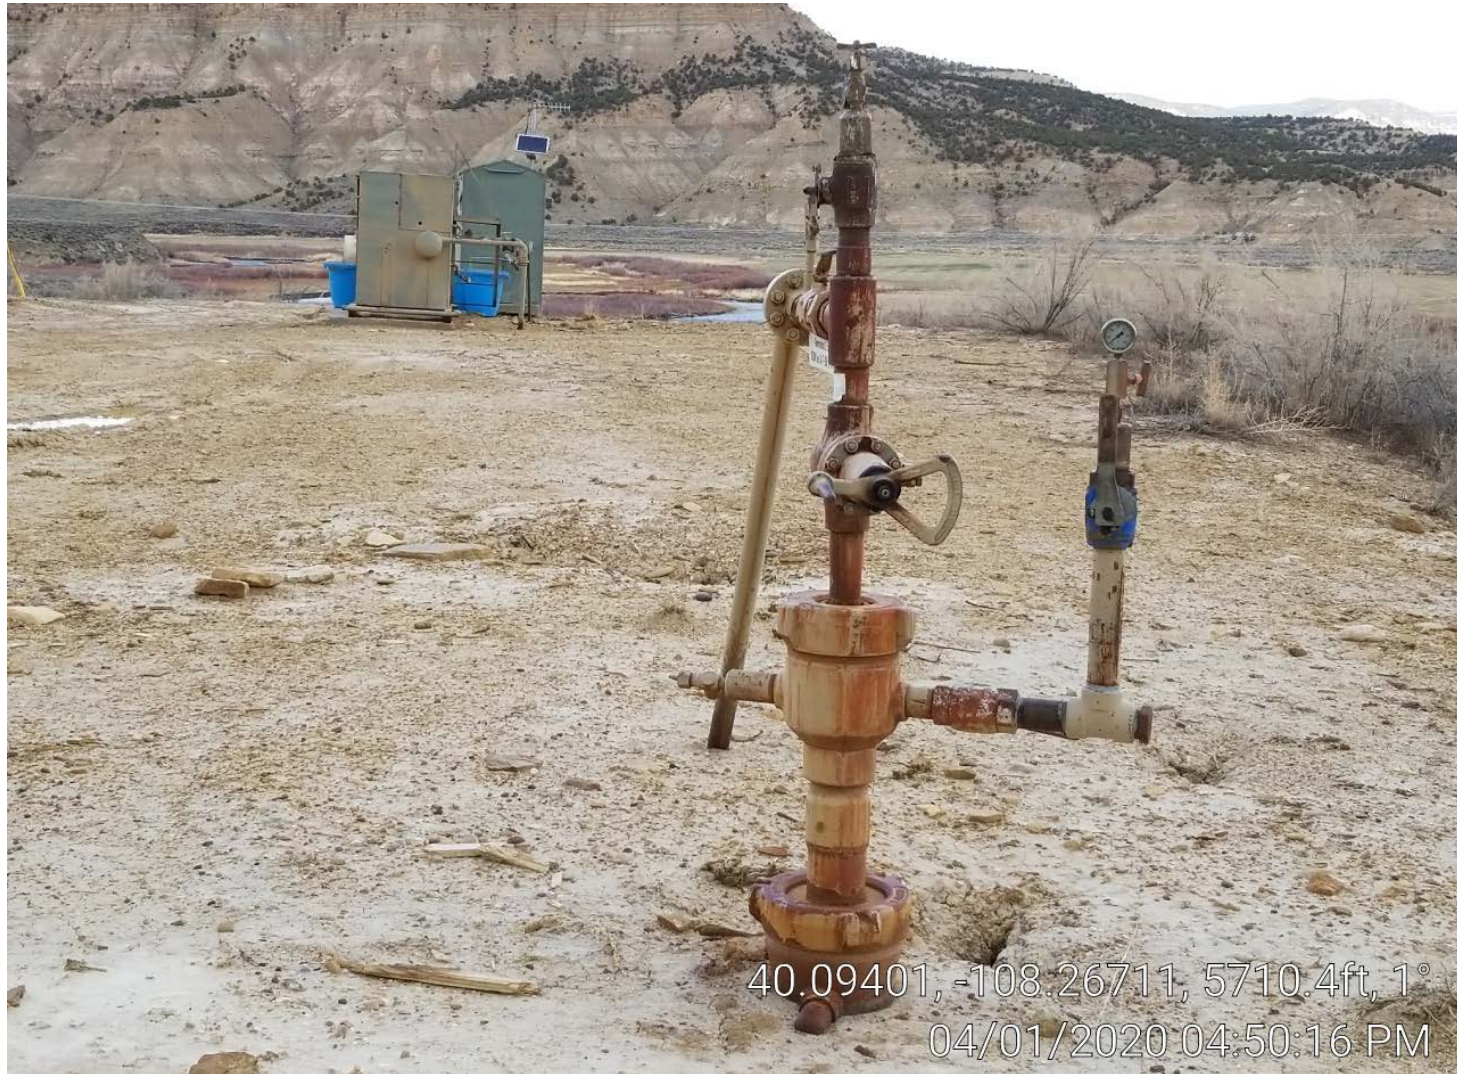
Photo 1. Location.

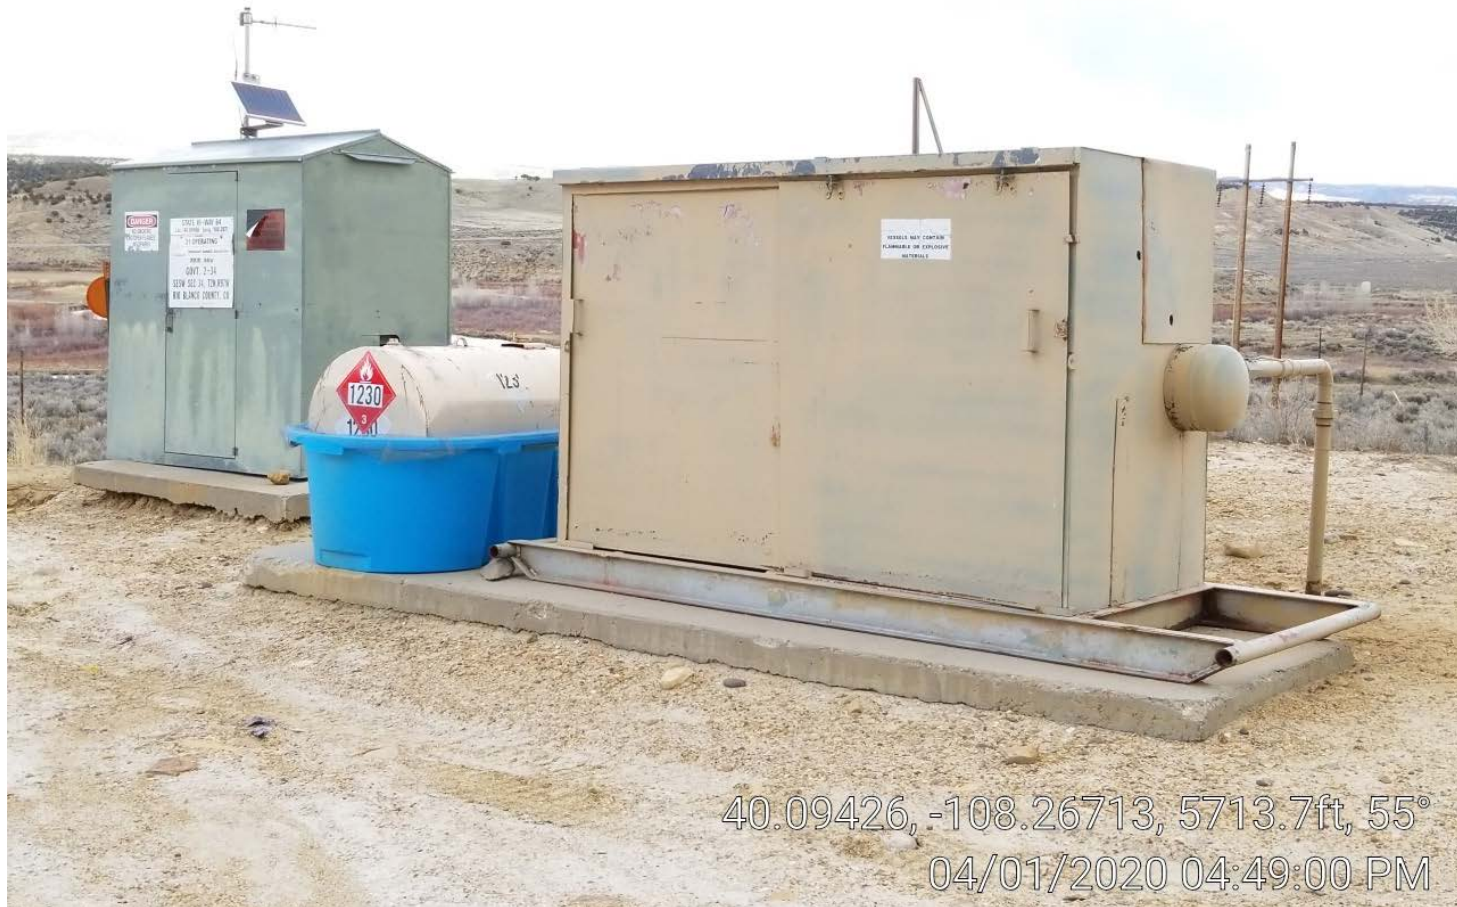
Photo 2. Meter building & separator.

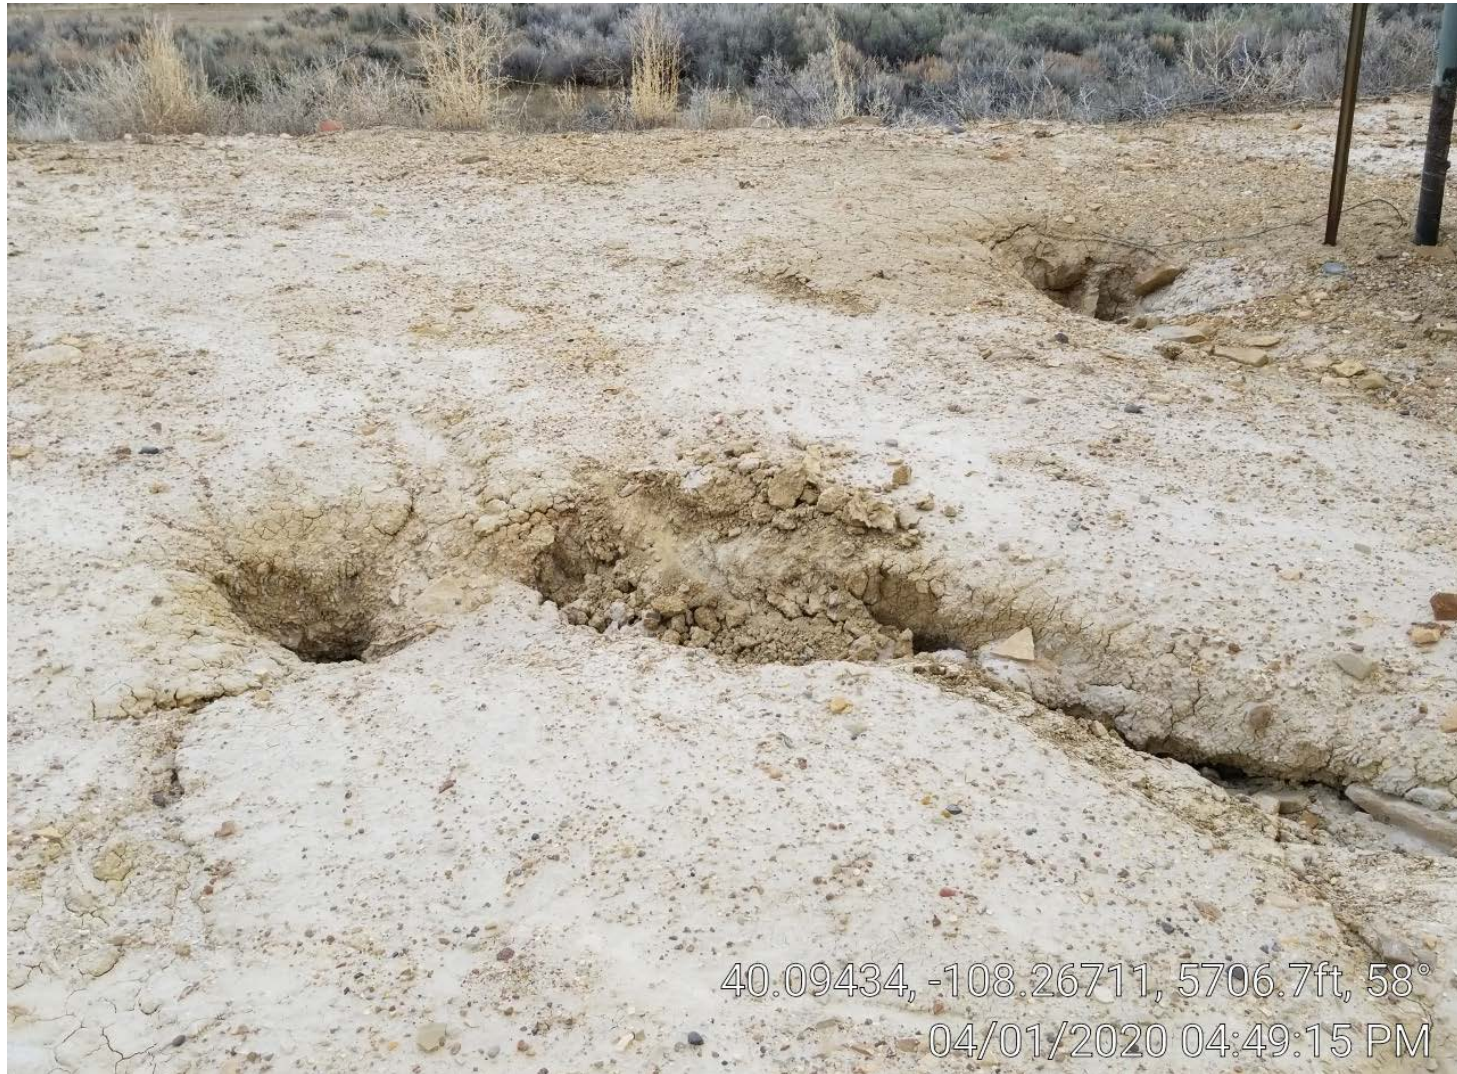
Photo 4. Storm water channel s & holes by meter building.

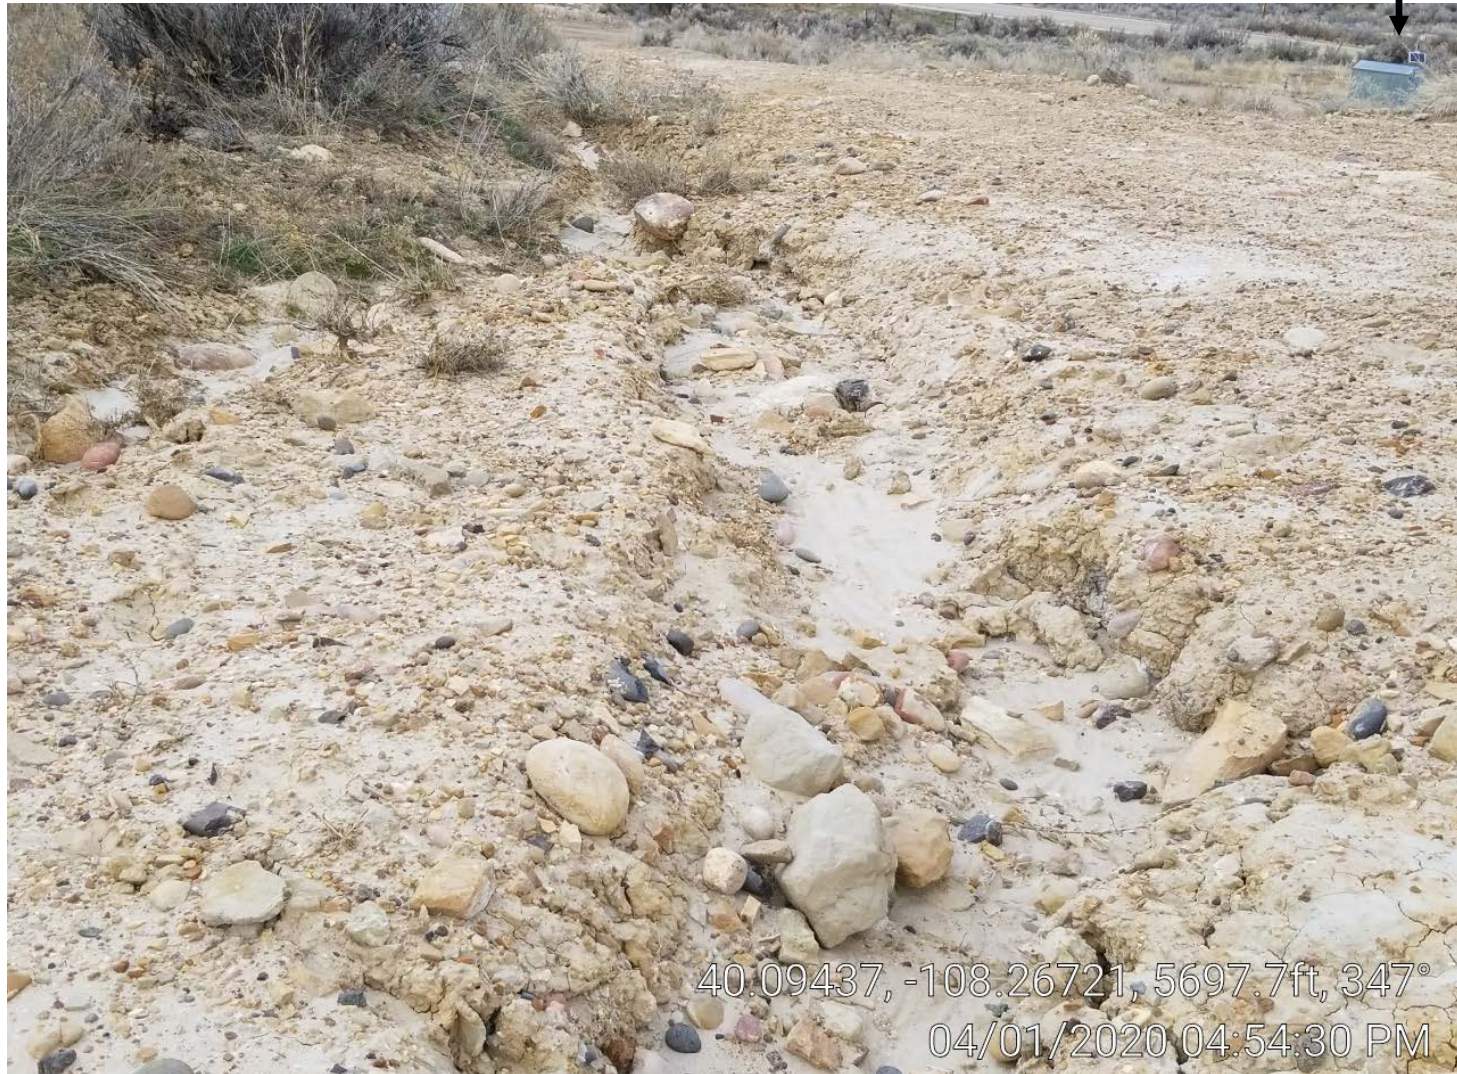
Photo 5. Storm water channel coming off location down access road.

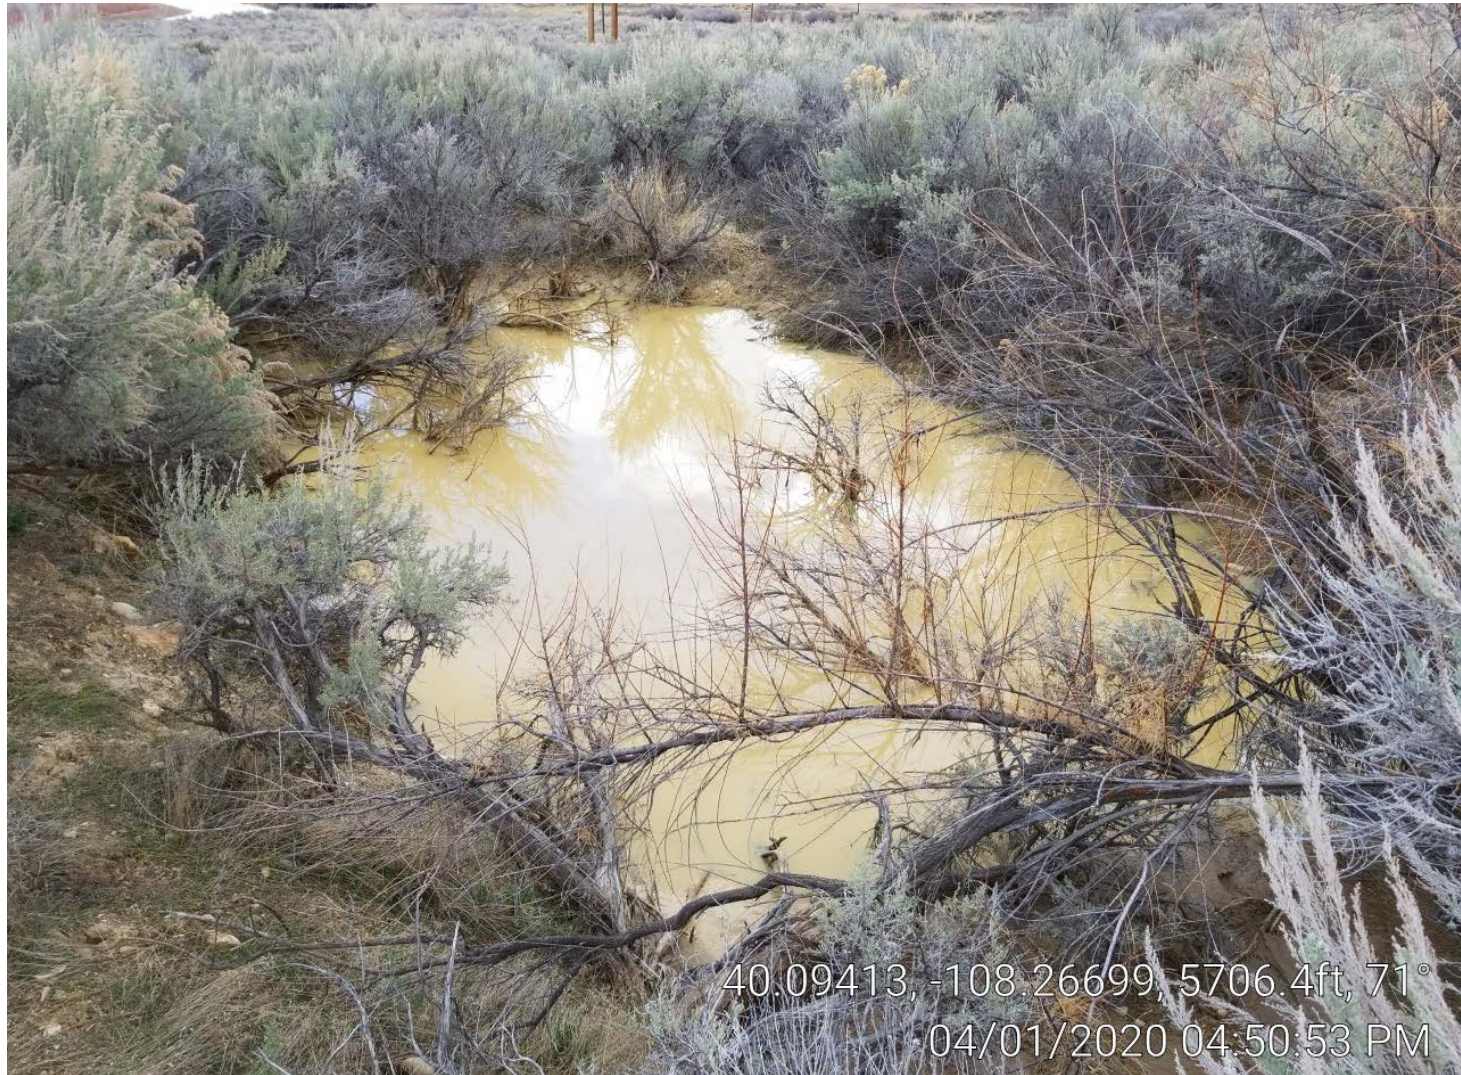
Photo 6. Pit on east side of location.

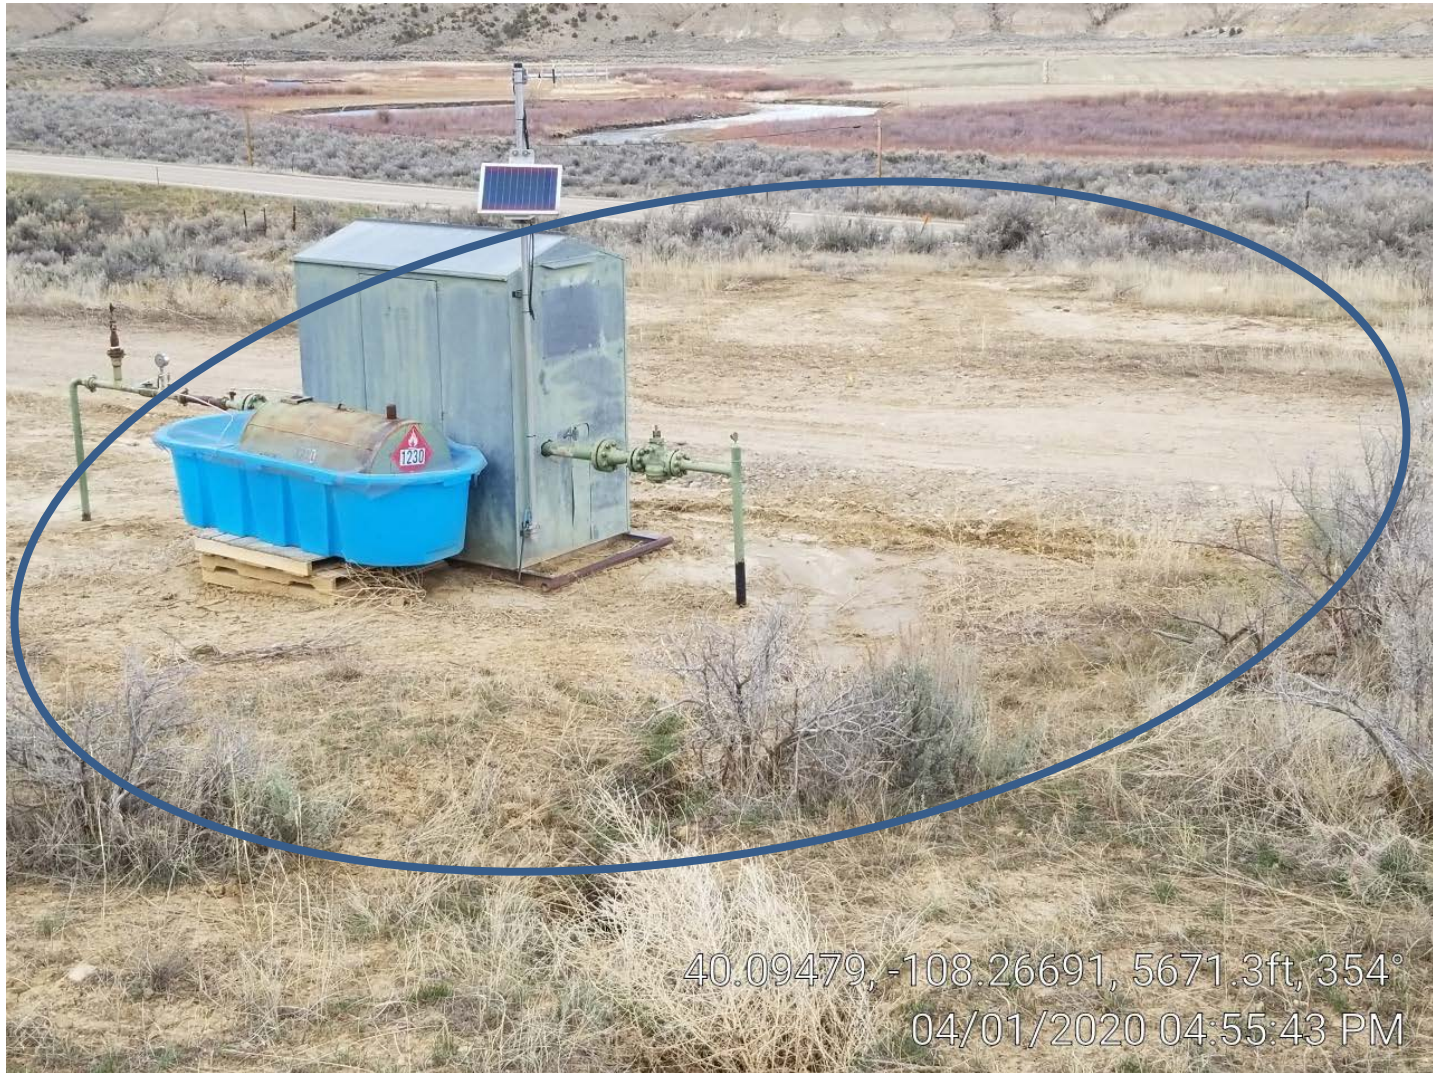
Photo 7. Storm water sediment coming from location located 300' away from location.
