**Inspection Photos**  
**Location Name: Mcelwain #13-17**  
**Location ID: 320470**

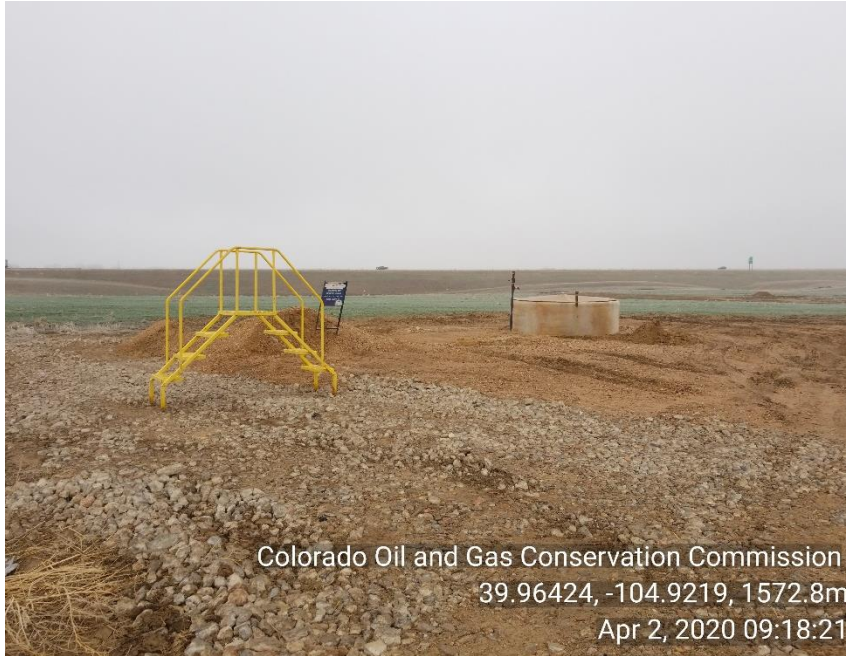
**Photo 1 TNK BTRY Stormwater: no BMP's in place during the removal of the facility**

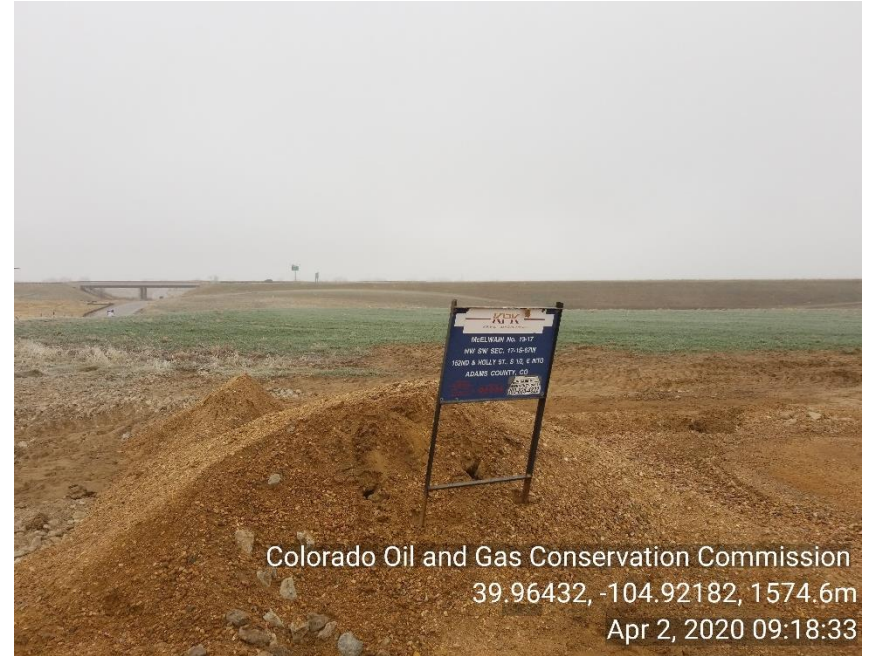
**Photo 2 TNK BTRY sign. Storm water no BMP's in place during the removal of the facility**

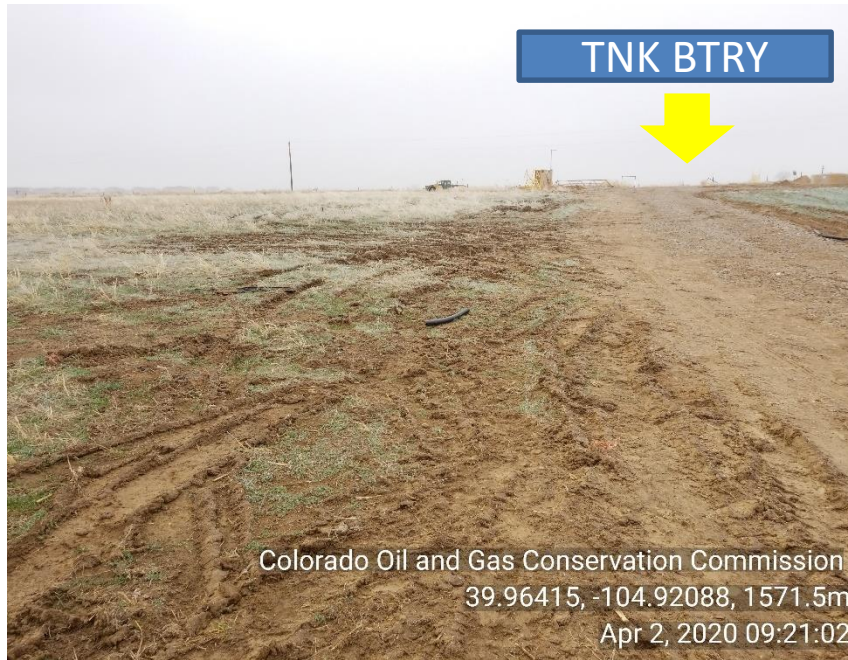
**Photo 5 Vehicle tracking off road rightaway Between TBK BTRY and Well head**

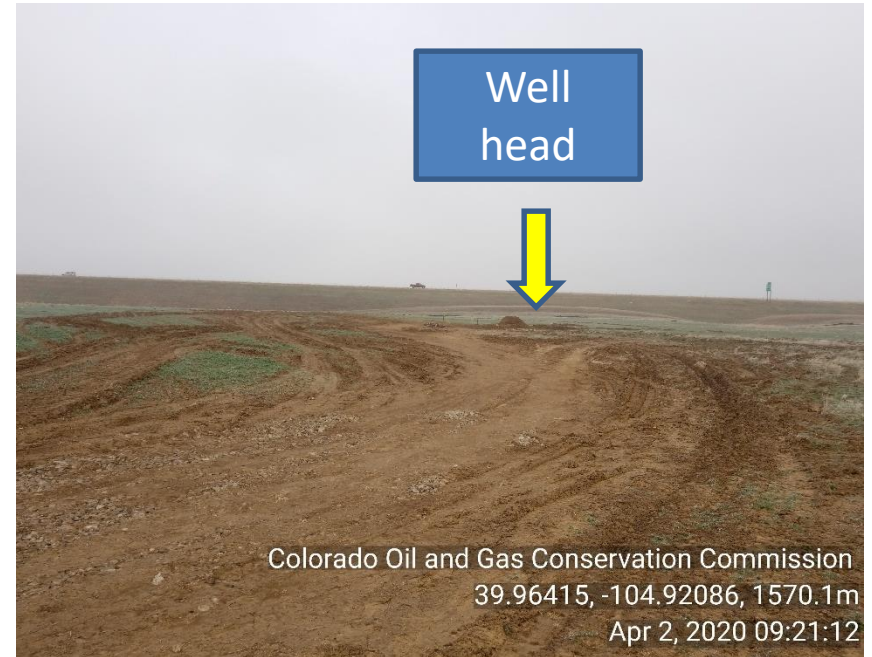
**Photo 6 Vehicle tracking out side of well pad in planted area.**

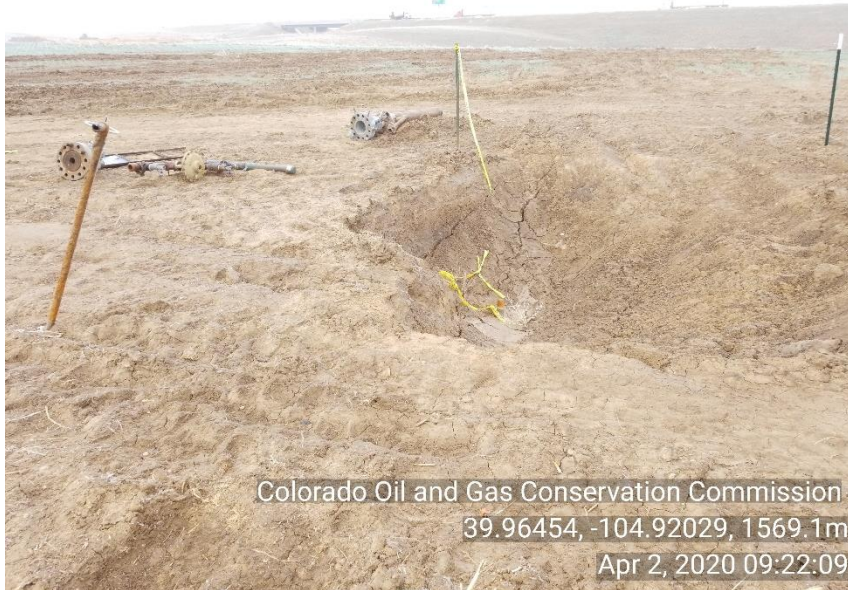
**Photo 7 Open excavation around well head no safety fence of storm water BMP's in place.**

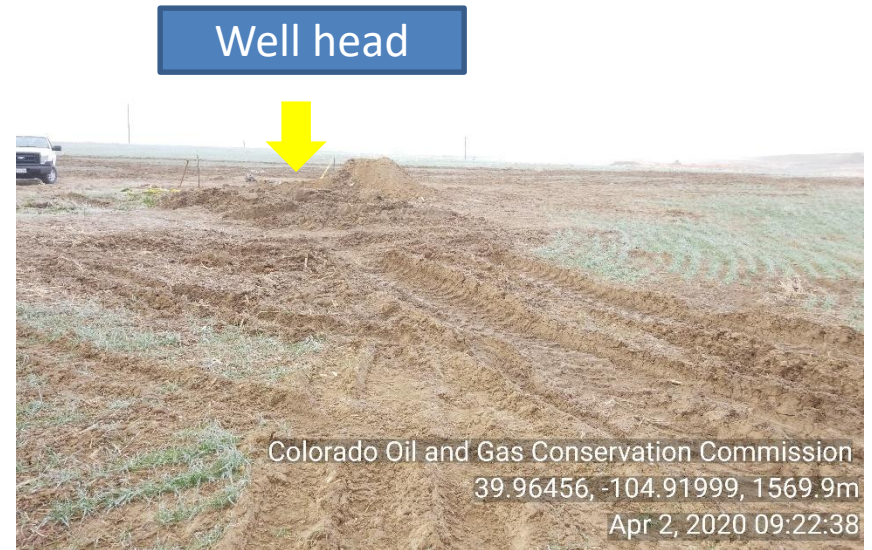
**Photo 8 Vehicle tracking off well site in planted area**

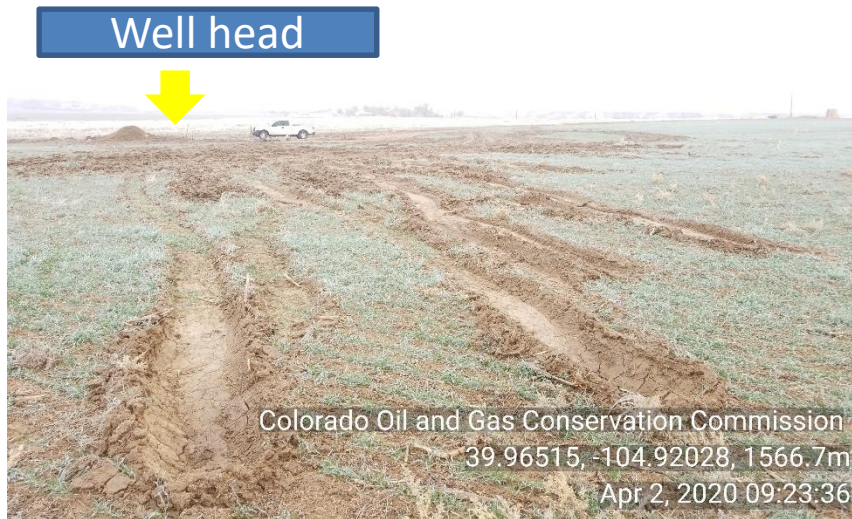
**Photo 9 Vehicle tracking off well site in planted area well out side of permitted area.**

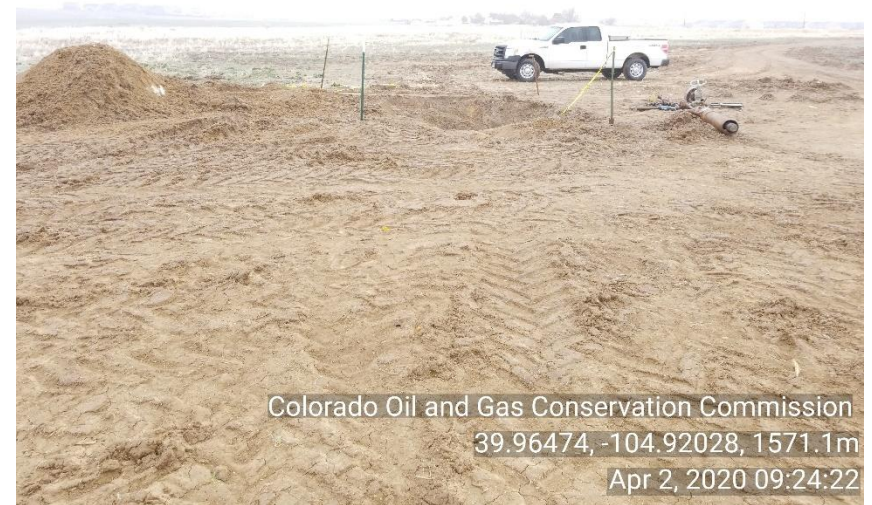
**Photo 10 Storm water: no BMP's in place in removal of well head.**
