Inspection Photos
Operator: Hilcorp Energy
API#: 067-08716
Date: 4/3/2020

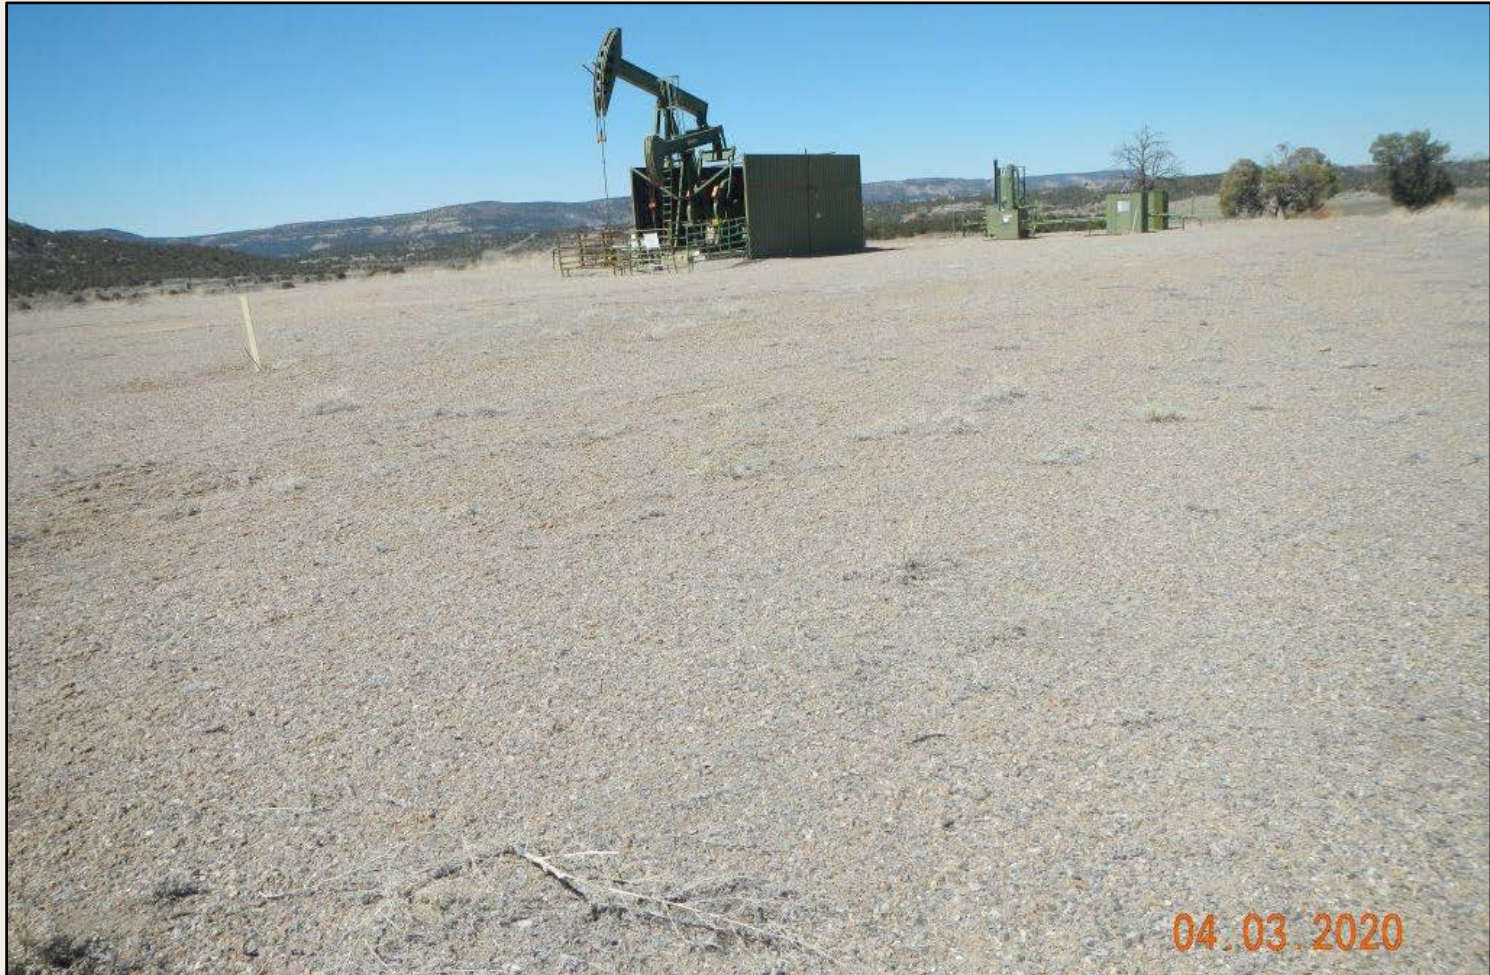
Photo 1. View of the project area from the southeastern corner facing center.

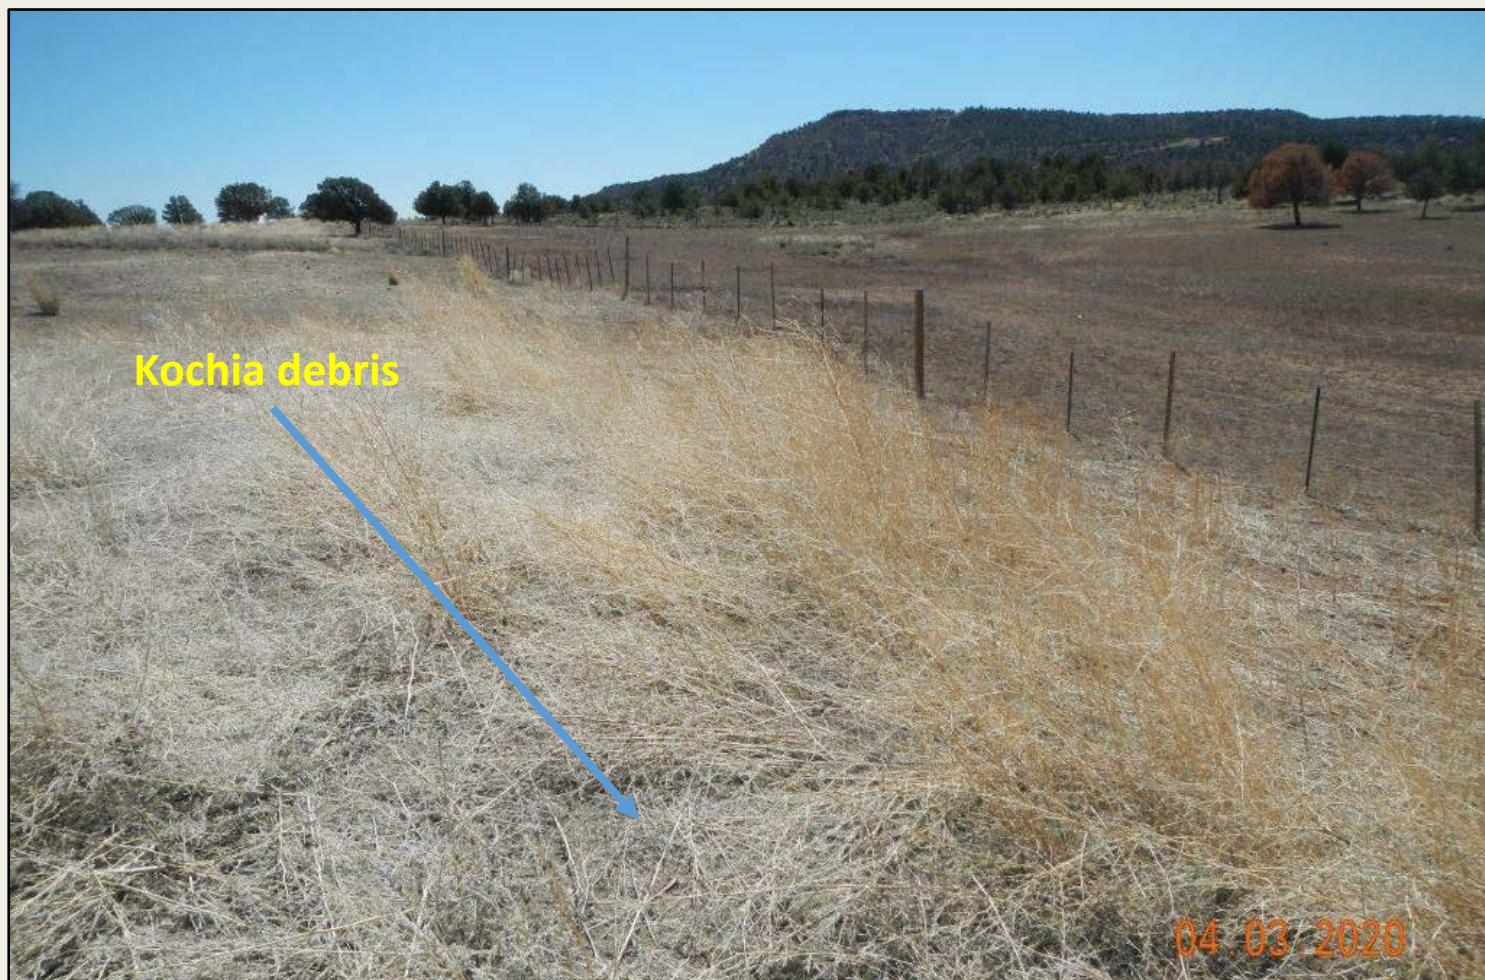
Photo 2. View of the western fill slope from the northwestern corner facing southward. Vegetation is largely comprised of dense kochia debris and cheatgrass.

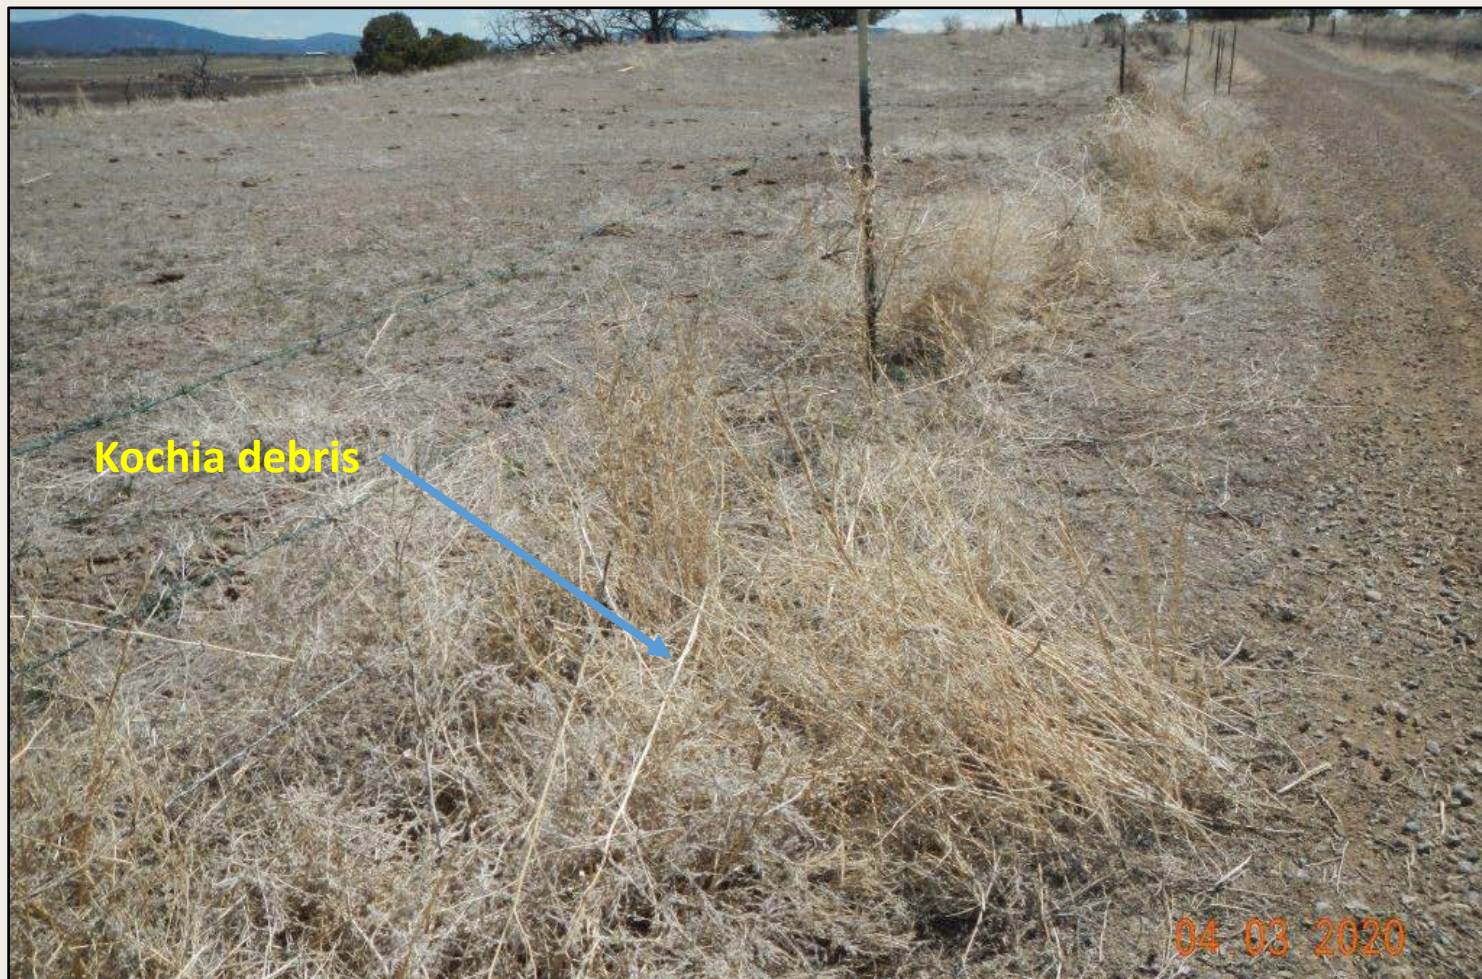
Photo 3. View of dense kochia weed debris along the access road.

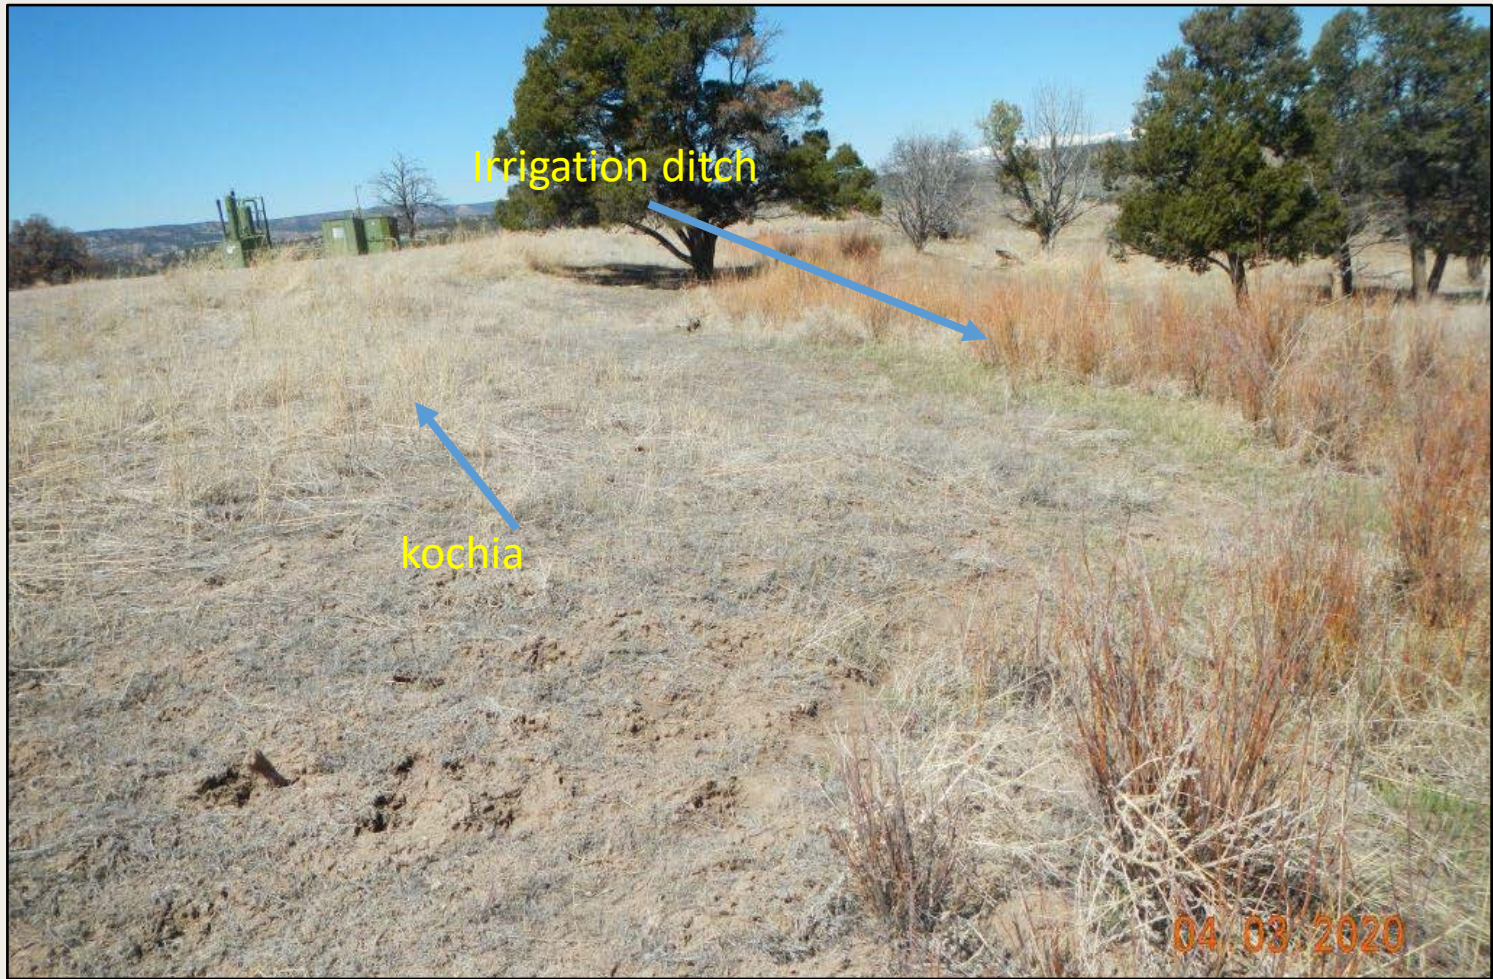
Photo 4. View of the eastern project area facing northward from the southeastern corner. An irrigation ditch runs adjacent to the eastern edge and is vegetated with willows. Vegetation above the ditch is largely kochia and other weeds.

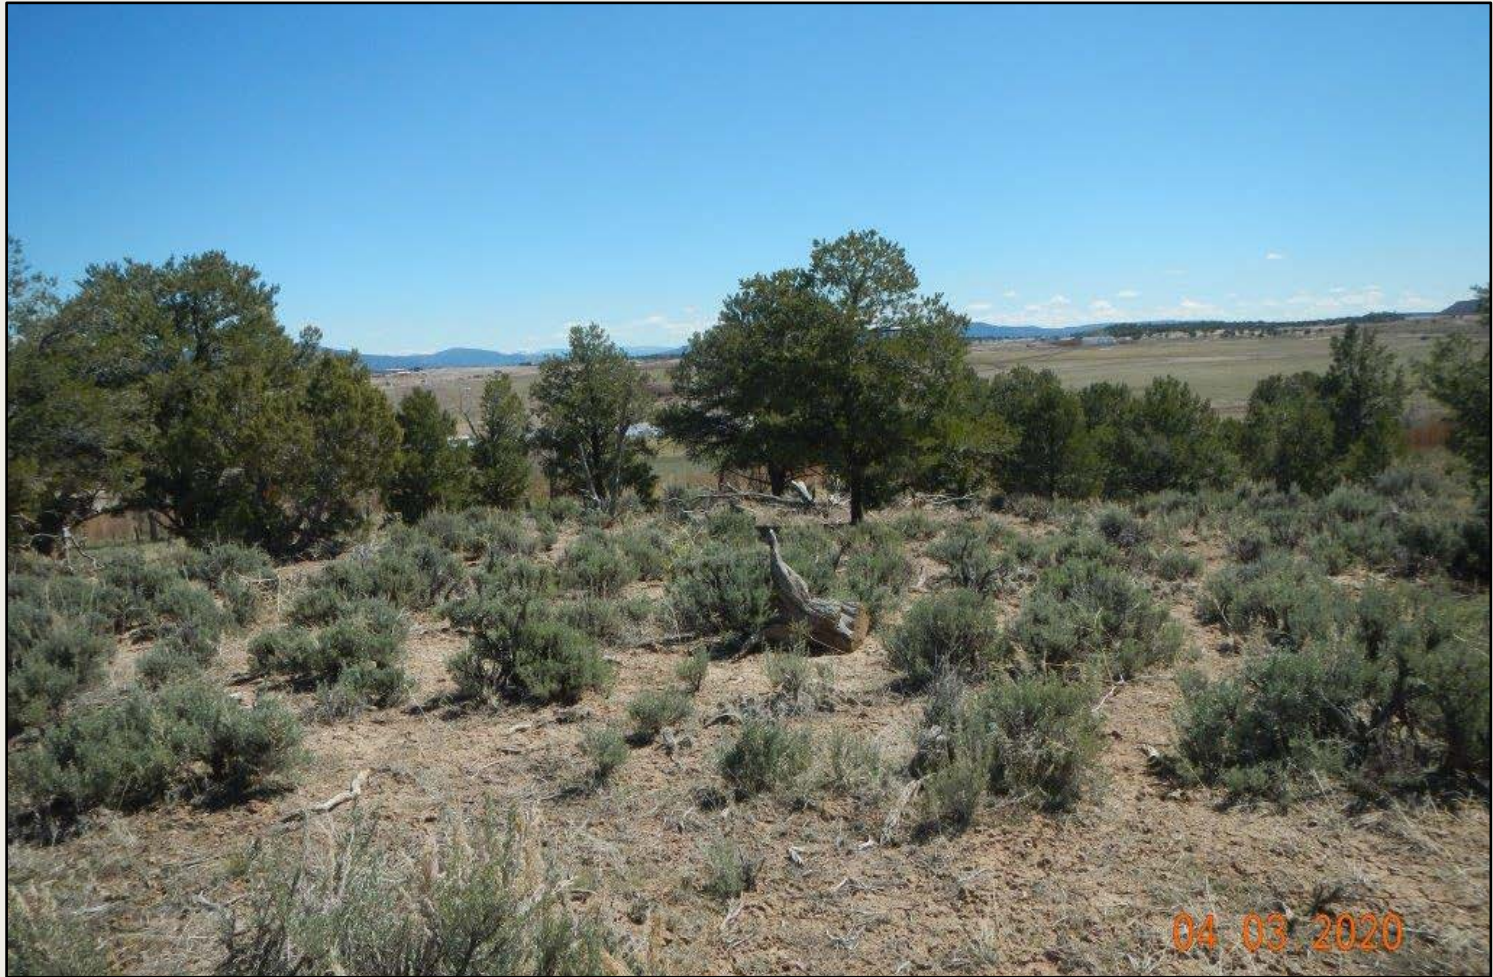
Photo 5. View of reference area vegetation comprised of sagebrush shrubland and pinyon juniper woodland.
