# Inspection Photos

Location Name: APADACA 33-29 CA DATE 5-6-20

API#: 05-071-06480

INSP. #: 695102

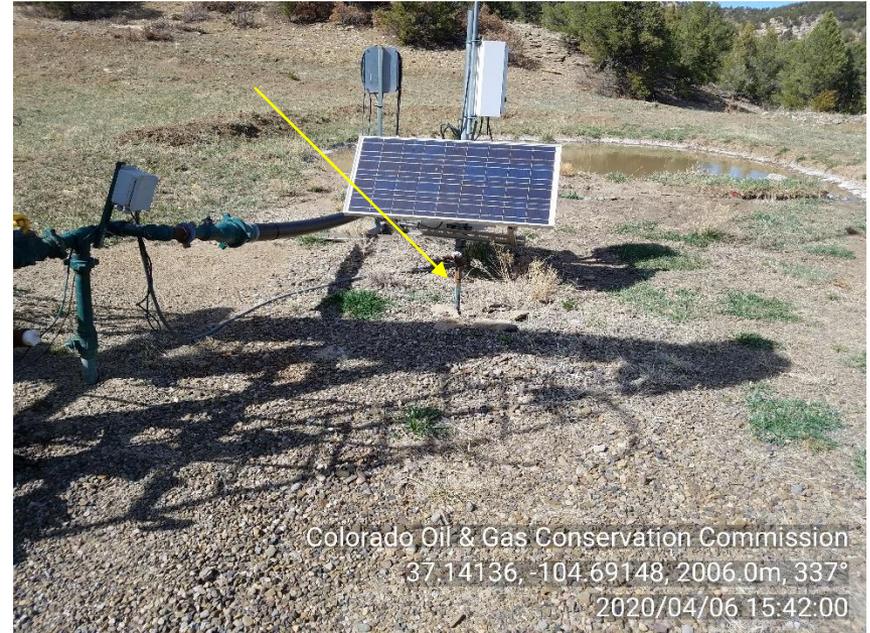
**PHOTO 4: UNUSED 1" RISER NOT LO/TO. 24 HOURS TO LO/TO 30 DAYS TO REMOVE RISER PER RULE 603.f. CA DATE 4-7-20.**

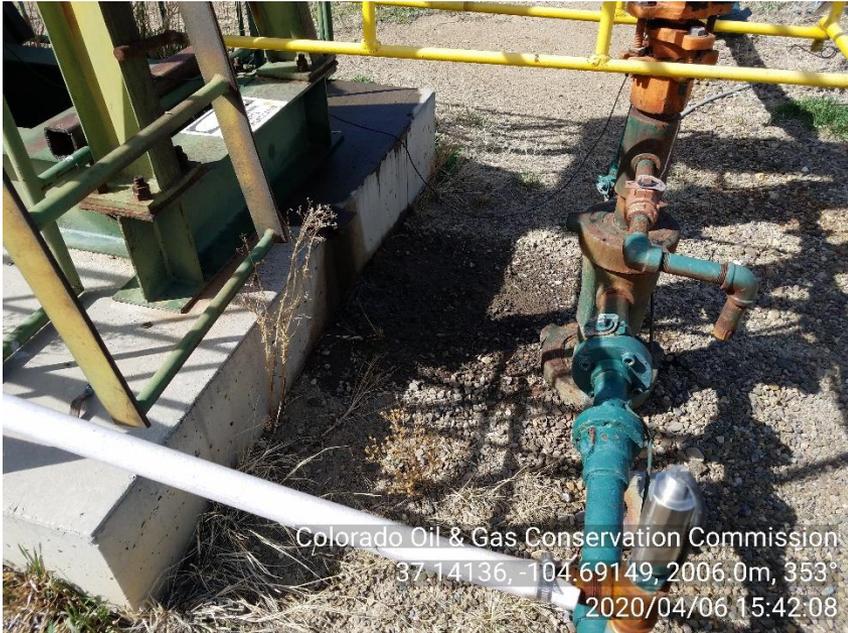
**PHOTO 5: AREA OF IMPACTED SOIL NEAR WELLHEAD APPEARS TO BE COMING FROM OIL RUNNING OFF PUMPJACK BASE. Conduct maintenance on equipment, cleanup stained material and review self inspection processes. PER RULE 1002.f.(2).D CA DATE 5-6-20.**

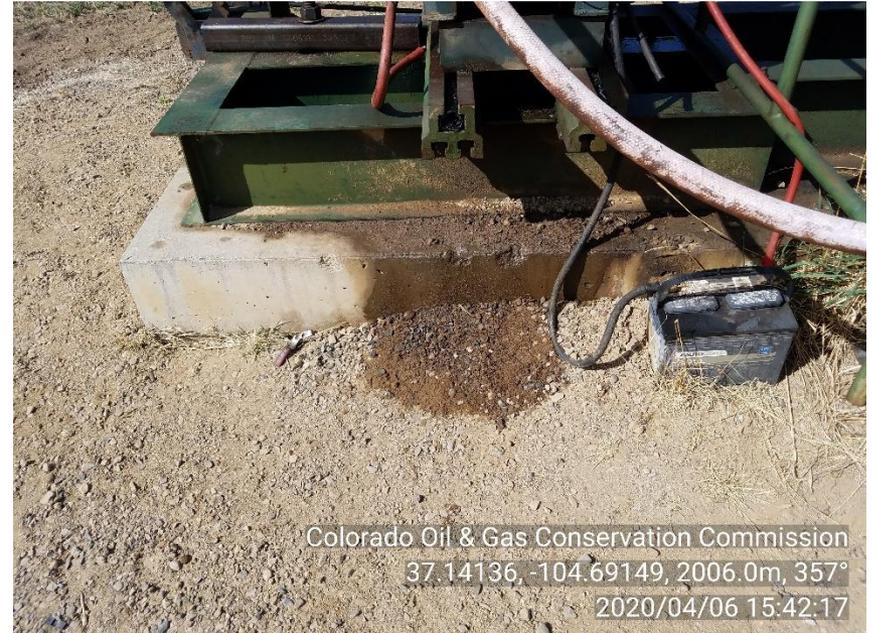
**PHOTO 6: AREA OF IMPACTED SOIL NEAR PUMPJACK PRIME MOVER APPEARS TO BE COMING FROM OIL PUMPJACK PRIME MOVER LEAKS. Conduct maintenance on equipment, cleanup stained material and review self inspection processes. PER RULE 1002.f.(2).D CA DATE 5-6-20.**

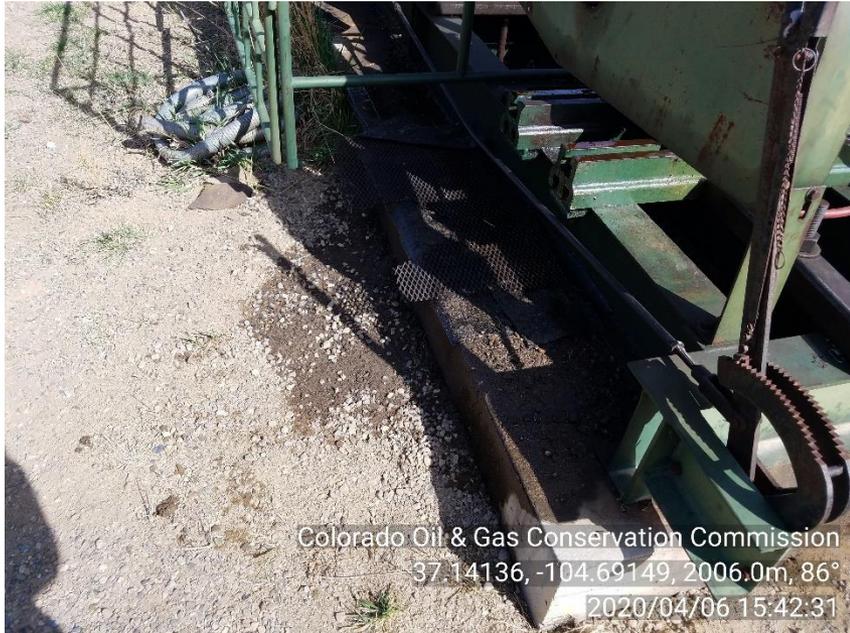
**PHOTO 7: AREA OF IMPACTED SOIL NEAR PUMPJACK PRIME MOVER ON THE OPPOSITE SIDE FROM PREVIOUS PHOTOS APPEARS TO BE COMING FROM OIL PUMPJACK PRIME MOVER LEAKS. Conduct maintenance on equipment, cleanup stained material and review self inspection processes. PER RULE 1002.f.(2).D CA DATE 5-6-20.**

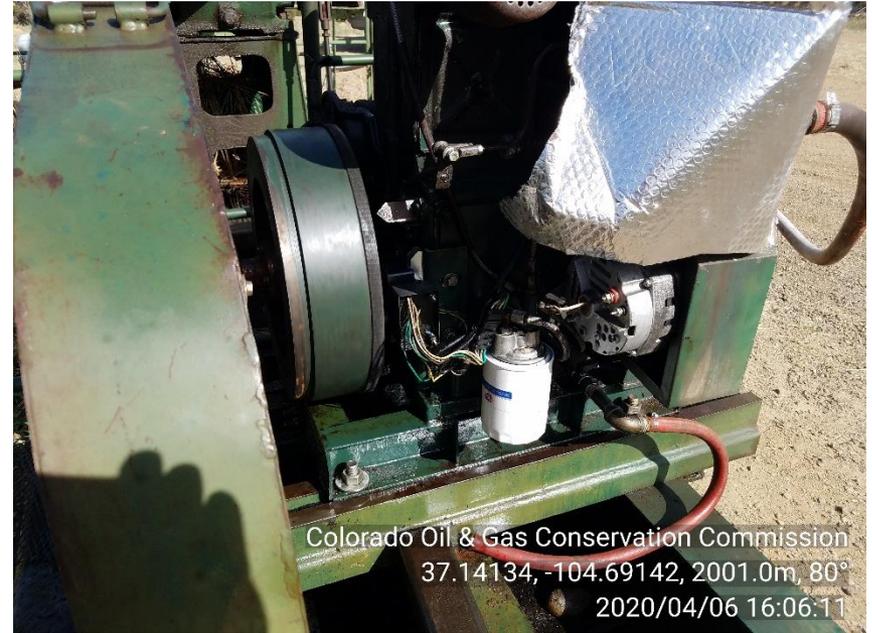
**PHOTO 8: PUMPJACK PRIME MOVER IS SATURATED WITH WHAT APPEARS TO BE OIL. Securely fasten all valves, pipes, and fittings to ensure good mechanical condition, inspect at regular intervals and maintain in good mechanical condition per Rule 605.d. CA DATE 5-6-20**
