**Inspection Photos**  
**Location Name: Dacono 1,2,3**  
**Location ID: 311311**

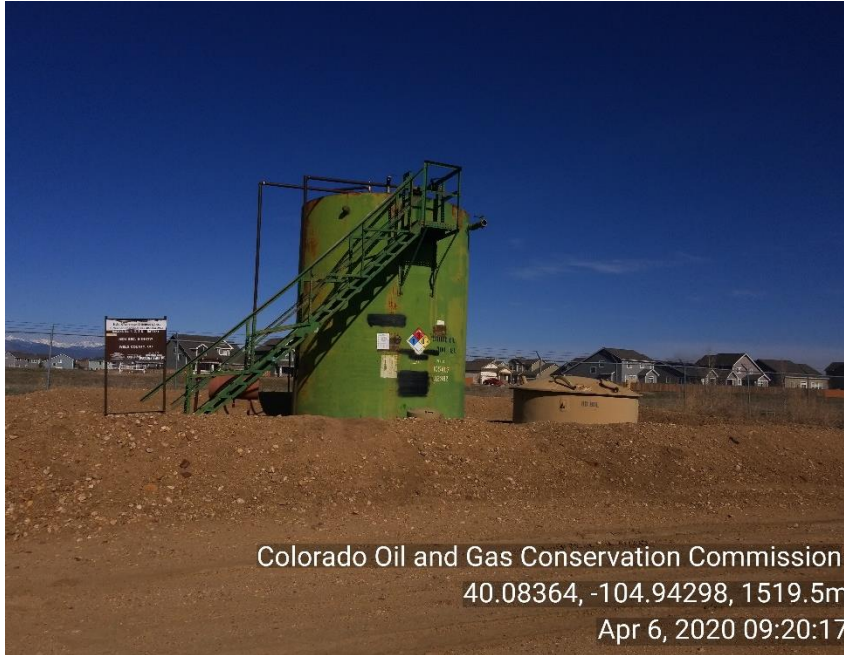
**Photo 5 Crude oil production tank Multiple areas of rust and not painted.**

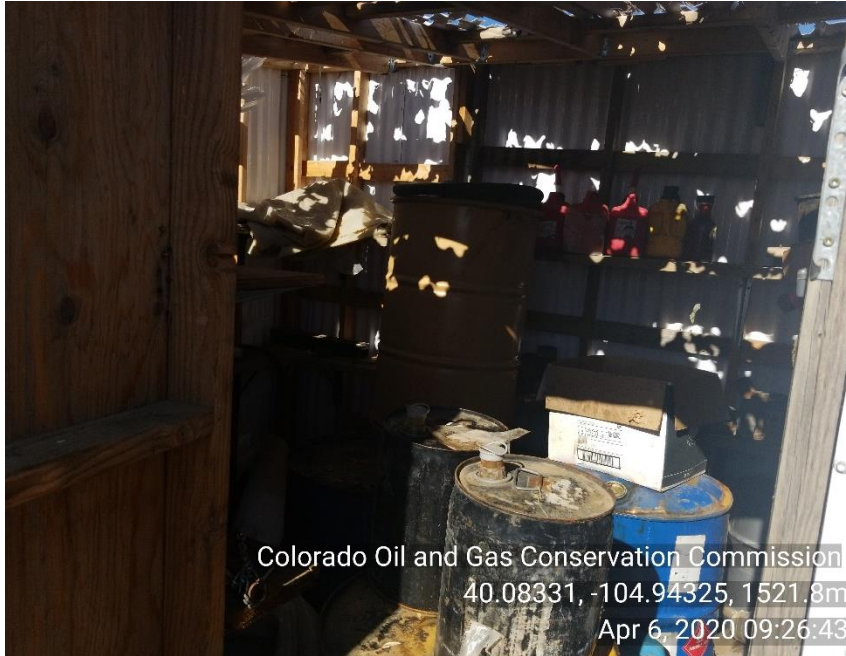
**Photo 7 Improper storage of chemicals in storage building no secondary containment.**

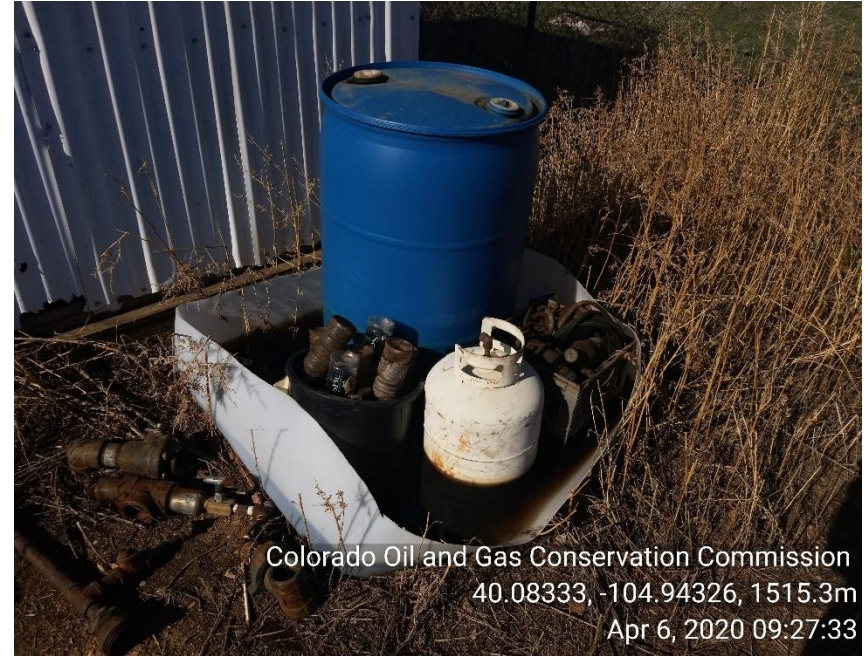
**Photo 8 Improper storage of chemicals fluid in container almost ready to overflow.**

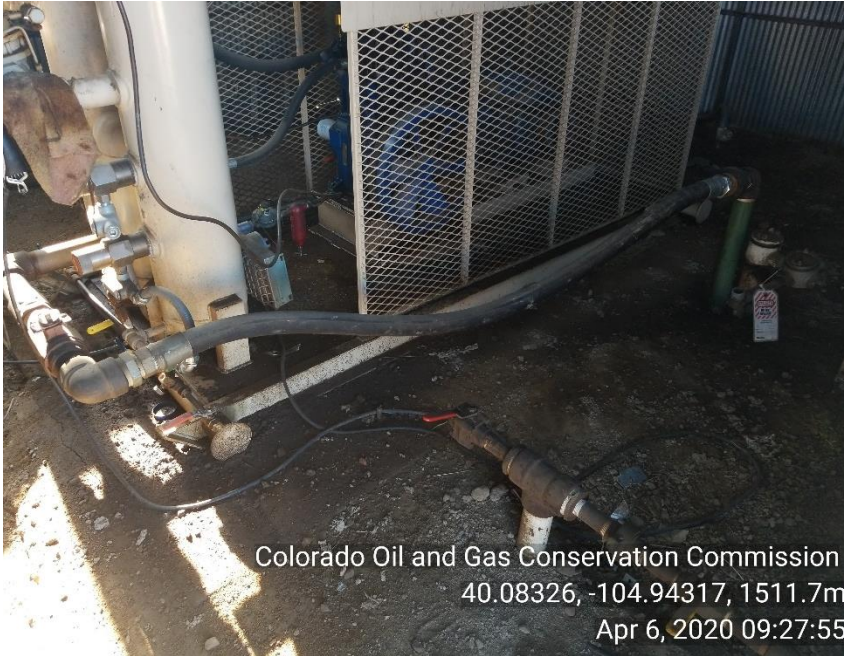
**Photo 9 Stained soil around compressor in compressor building.**

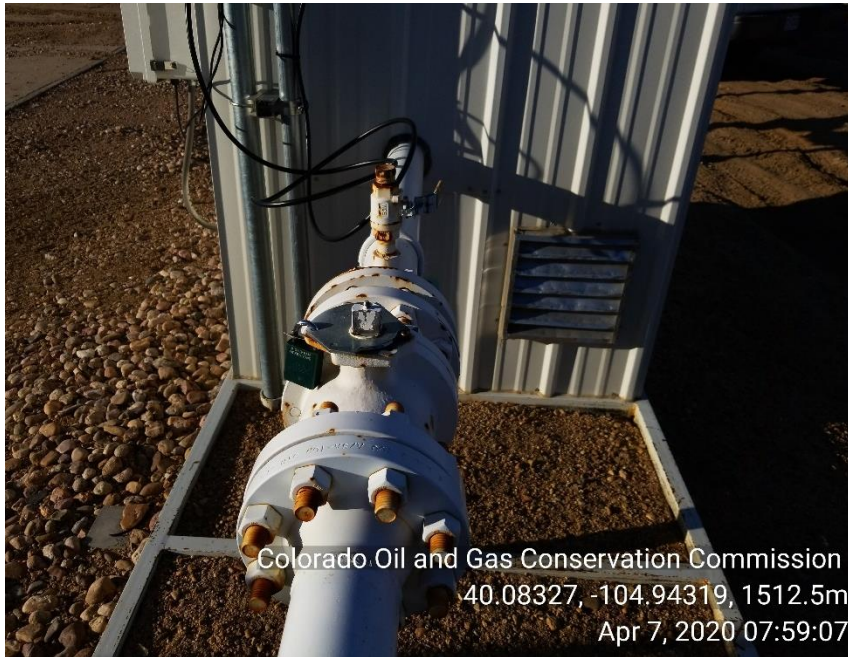
**Photo 11 inlet to meter house LOTO**

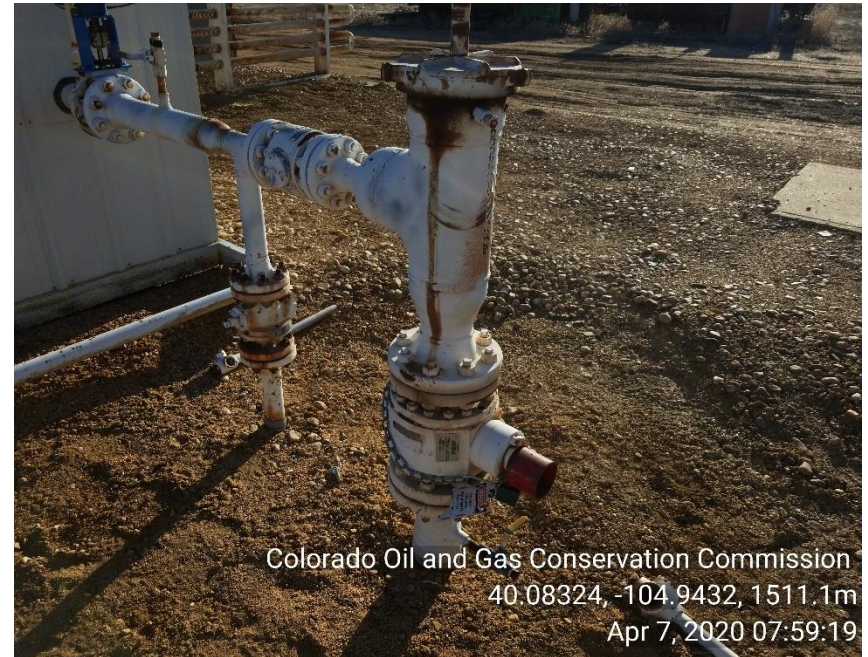
**Photo 12 Outlet from meter house LOTO**
