Inspection Photos
Operator: Hilcorp Energy
API#: 067-09084
Date: 4/3/2020

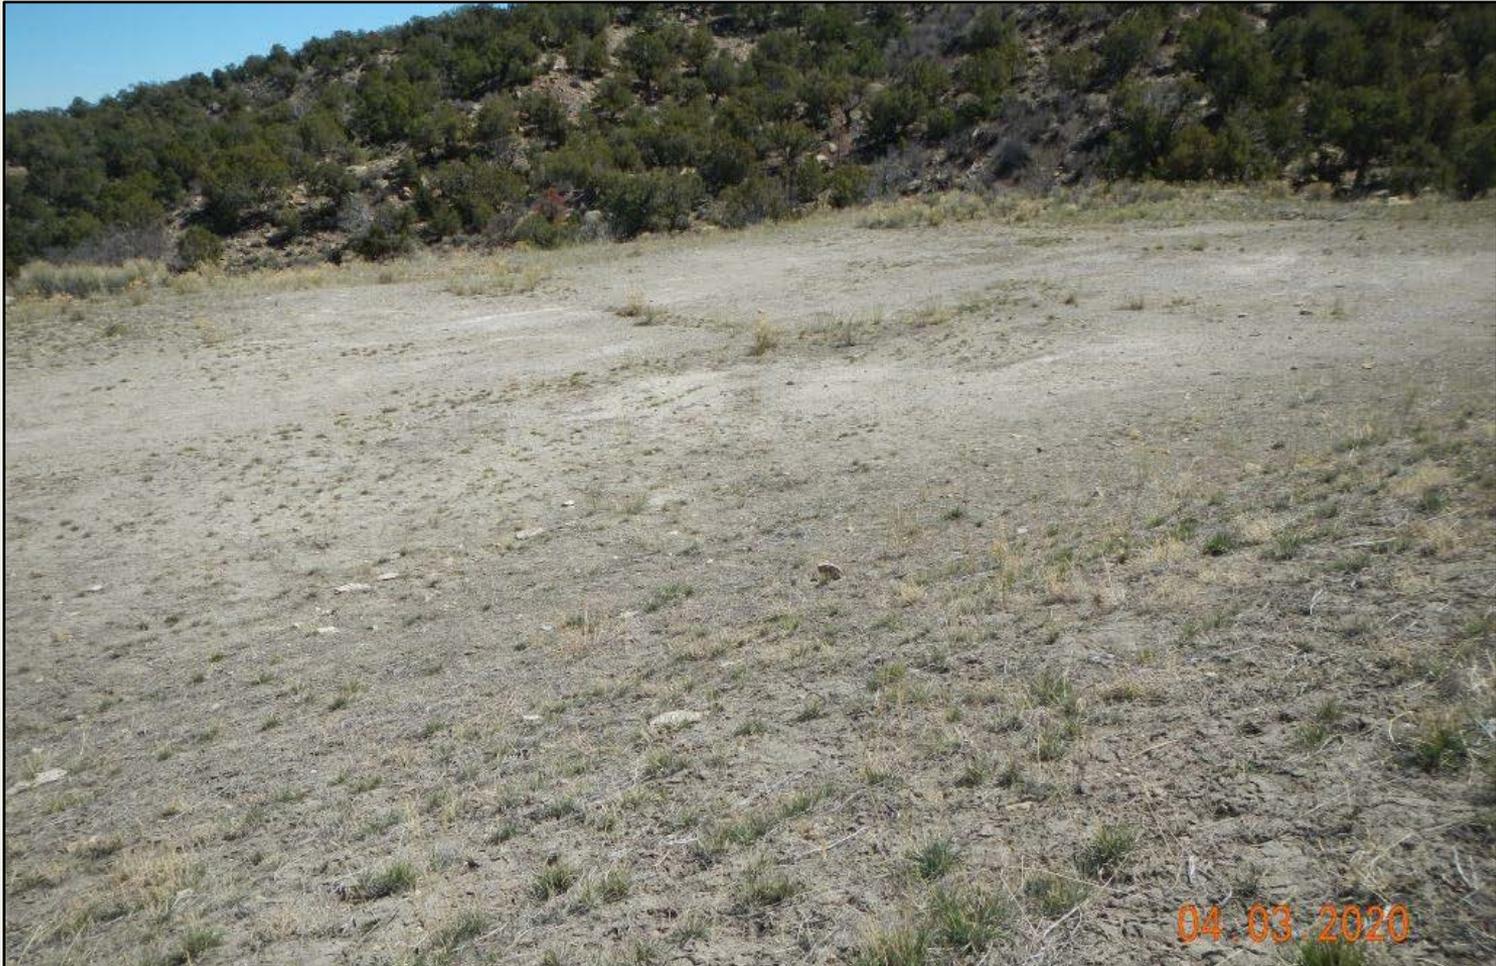
Photo 1. View of the project area from the southwestern corner facing center. Well pad is not reclaimed.

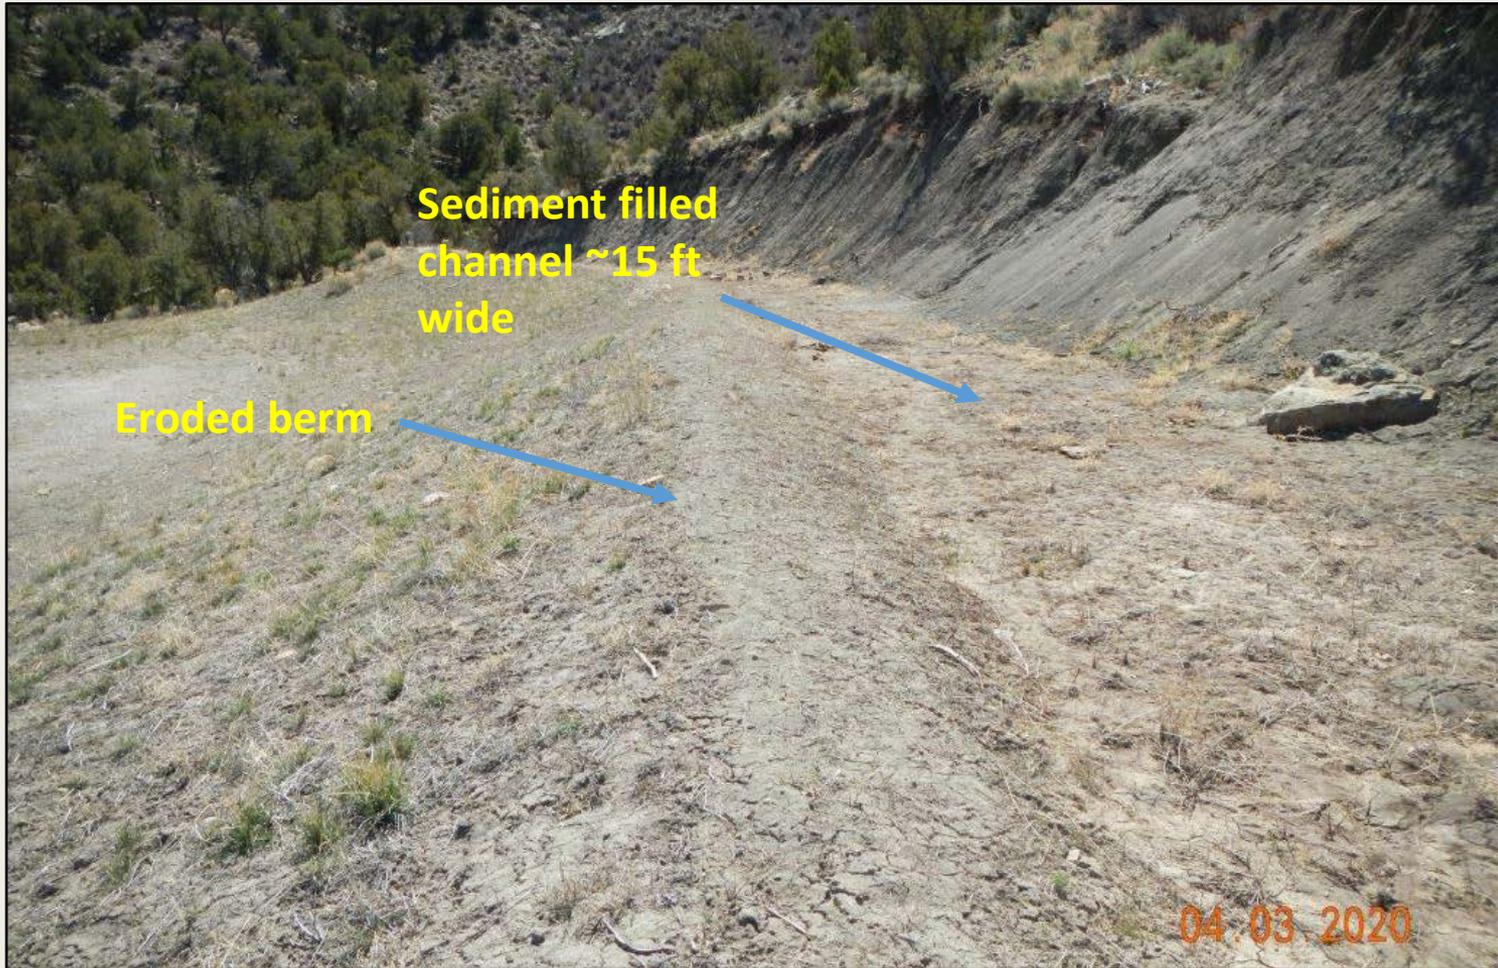
Photo 2. View of the western cut-slope and diversion channel. Slope and berm eroding and channel is full of sediment.

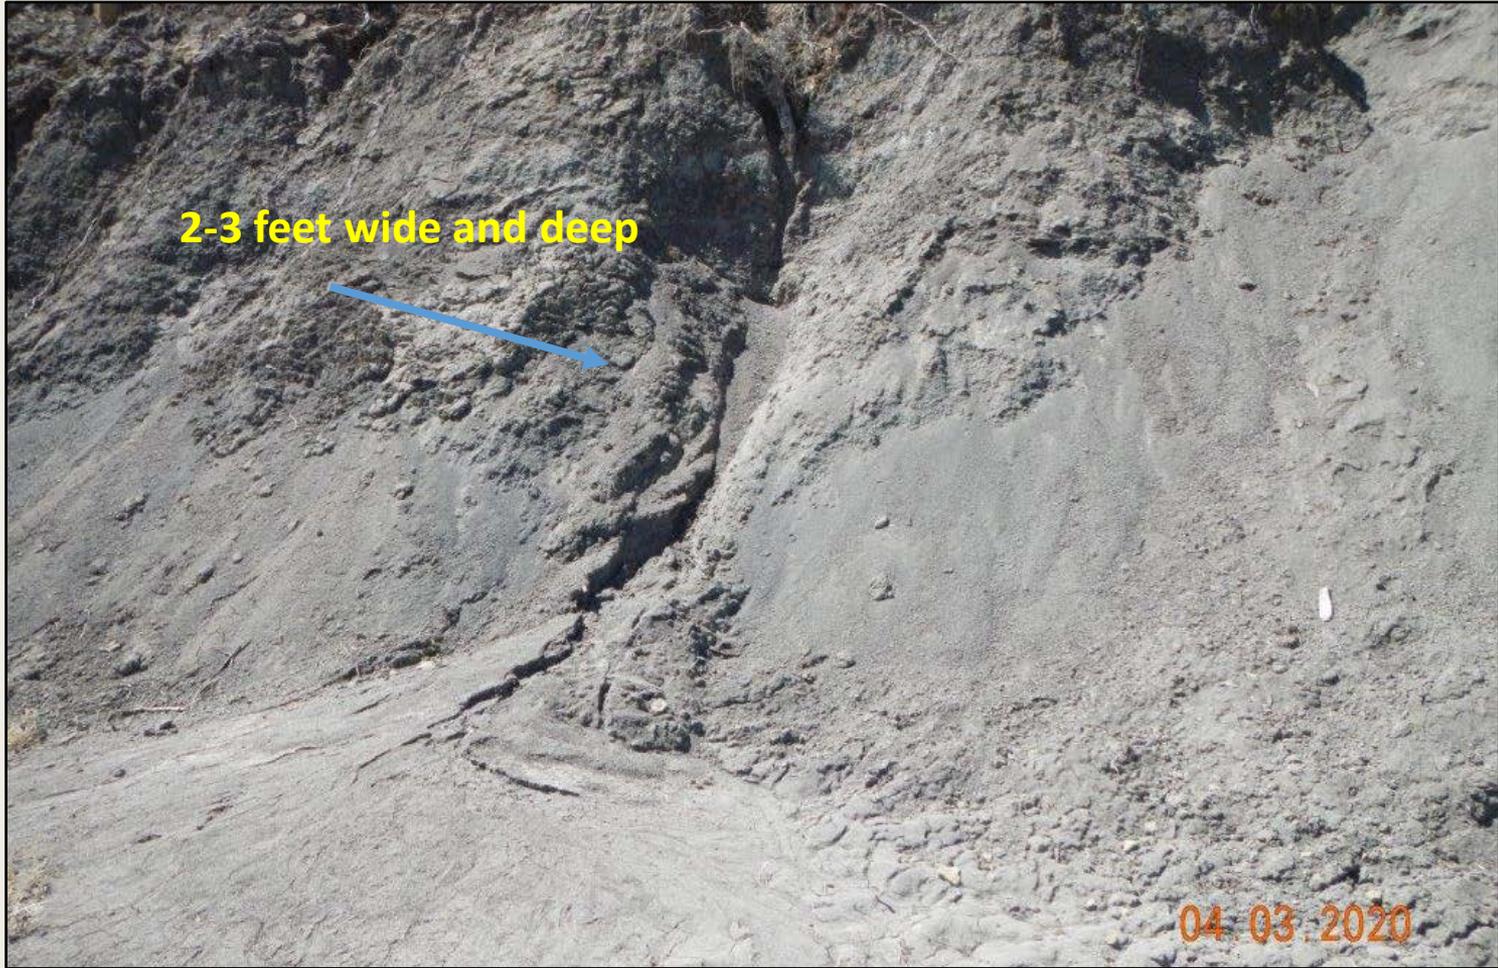
Photo 3. View of erosion and sediment deposition on western cut-slope.

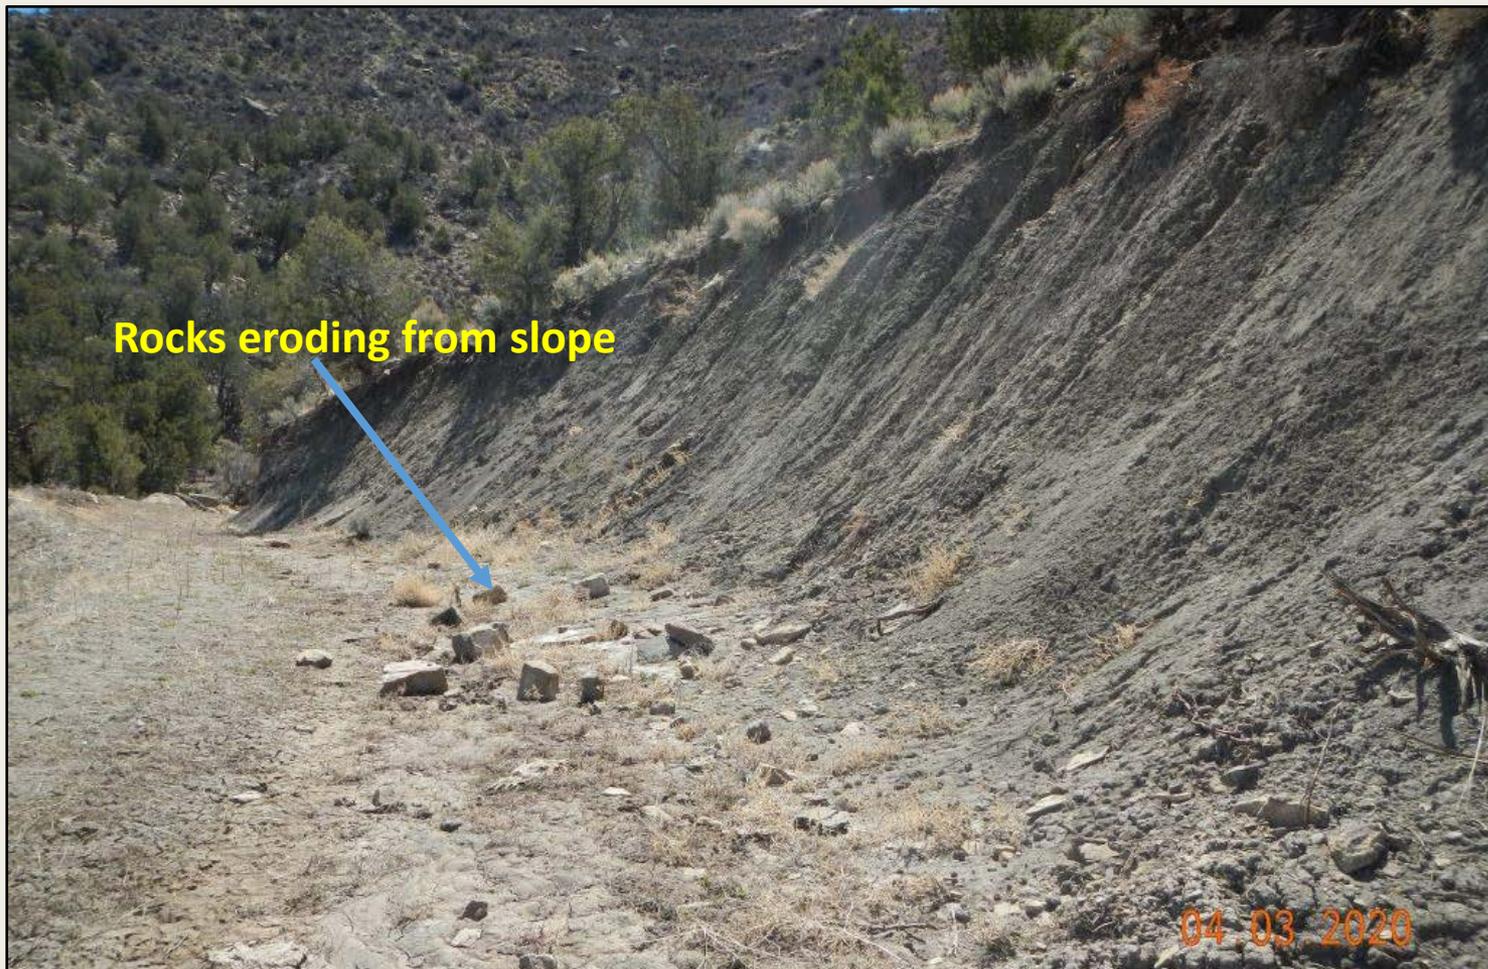
Photo 4. Another view of well pad cut-slope and sediment-filled diversion. Rocks at toe of slope appear to be eroding from slope above.

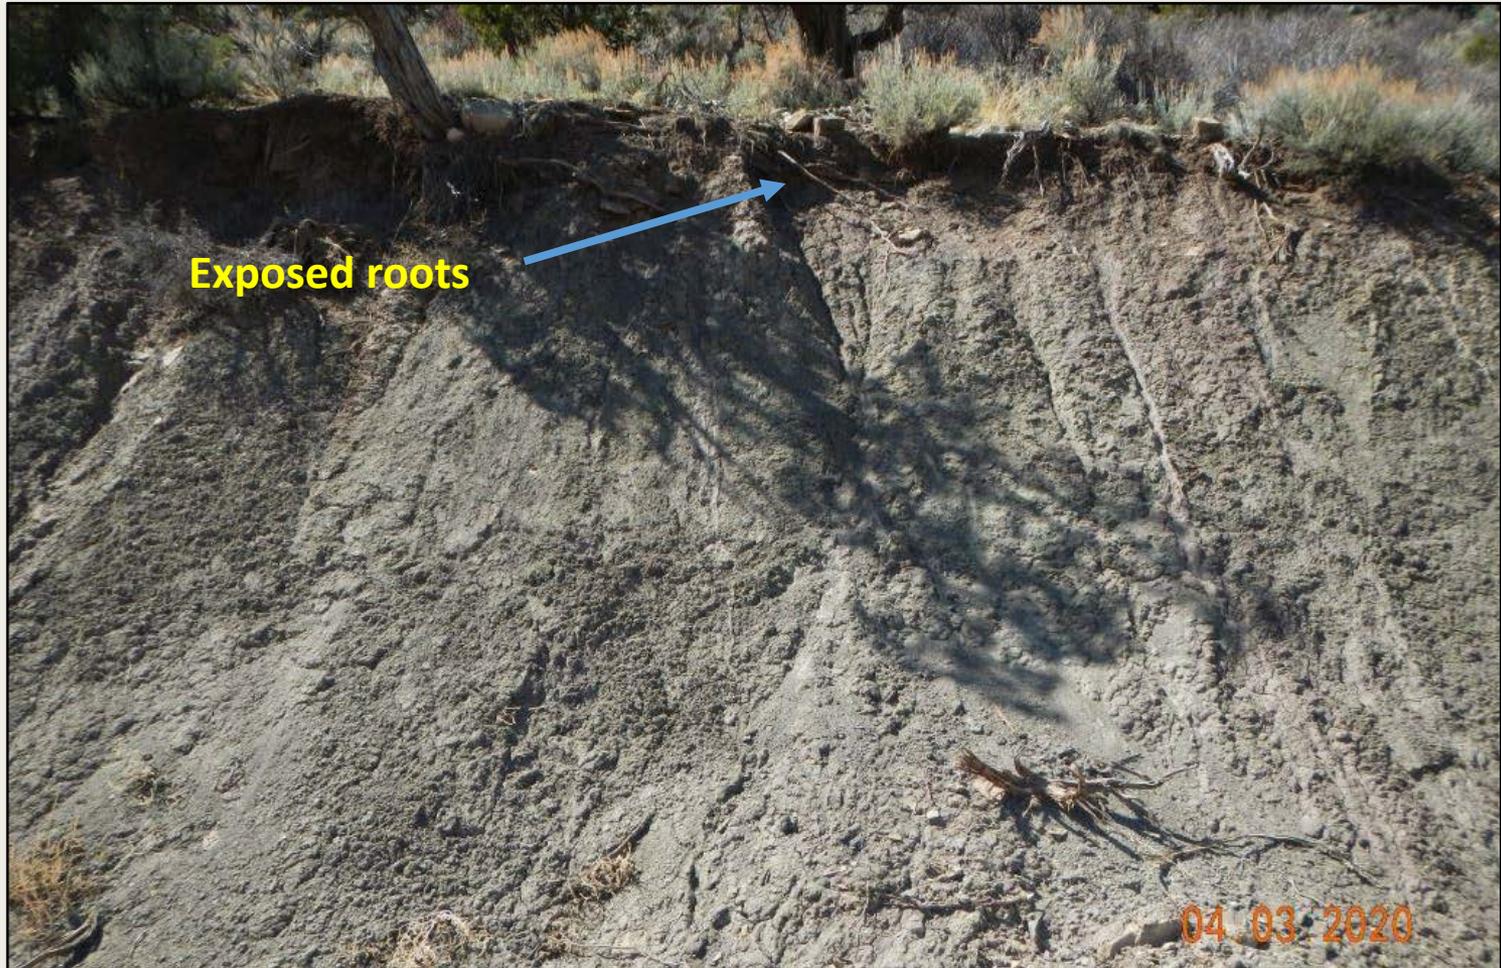
Photo 5. View of bare soils and exposed roots on cut-slope.

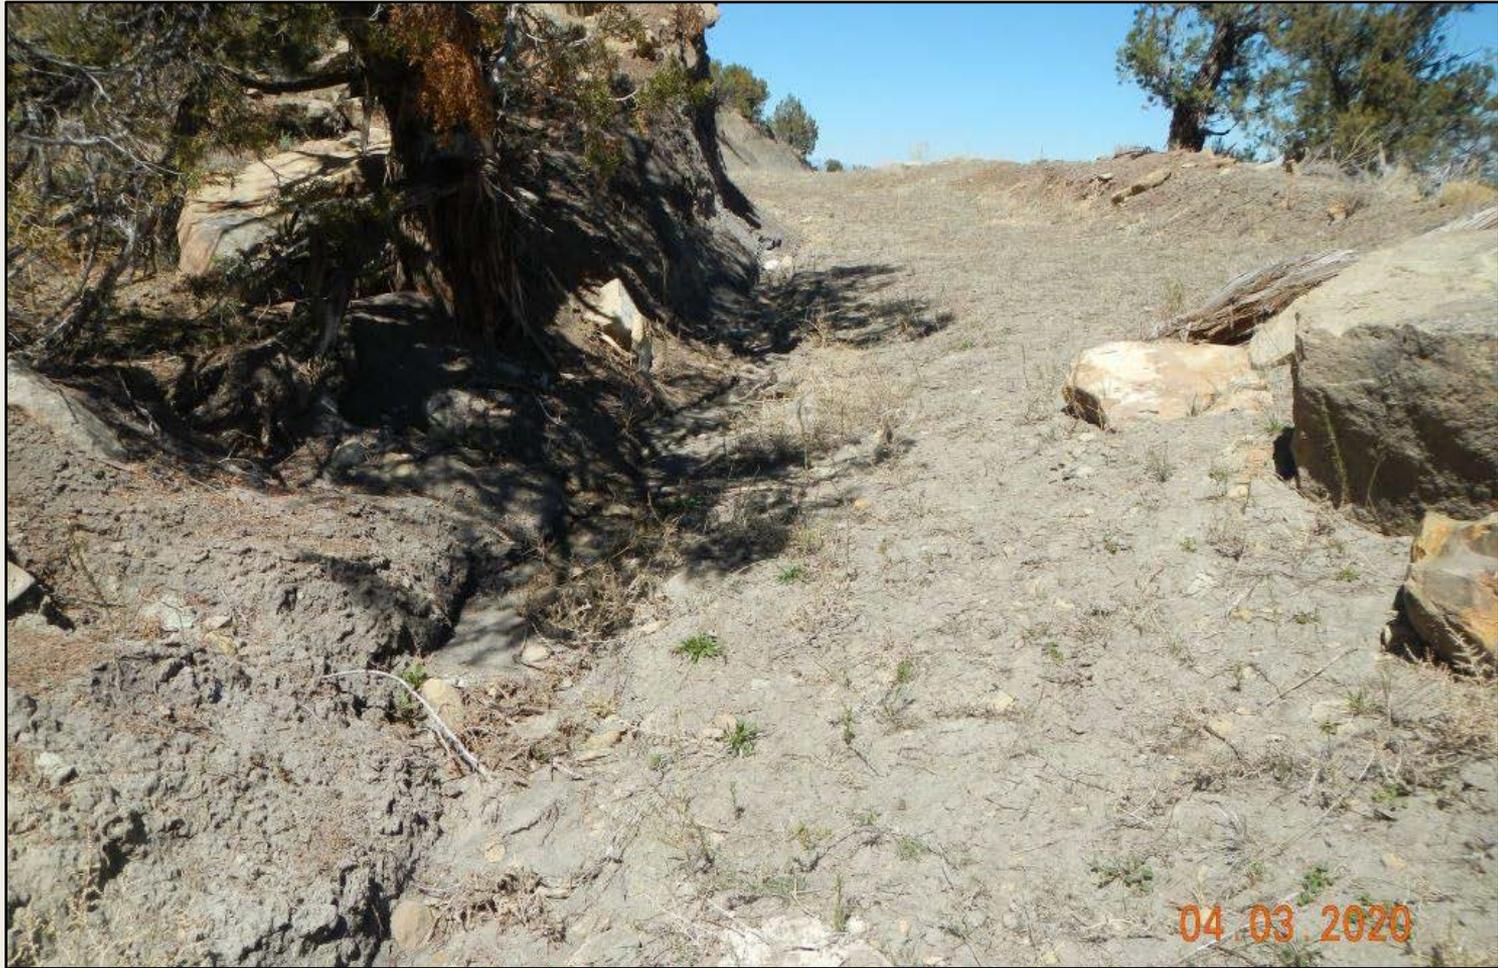
Photo 6. View of area where diversion slopes into drainage in southwestern project area.

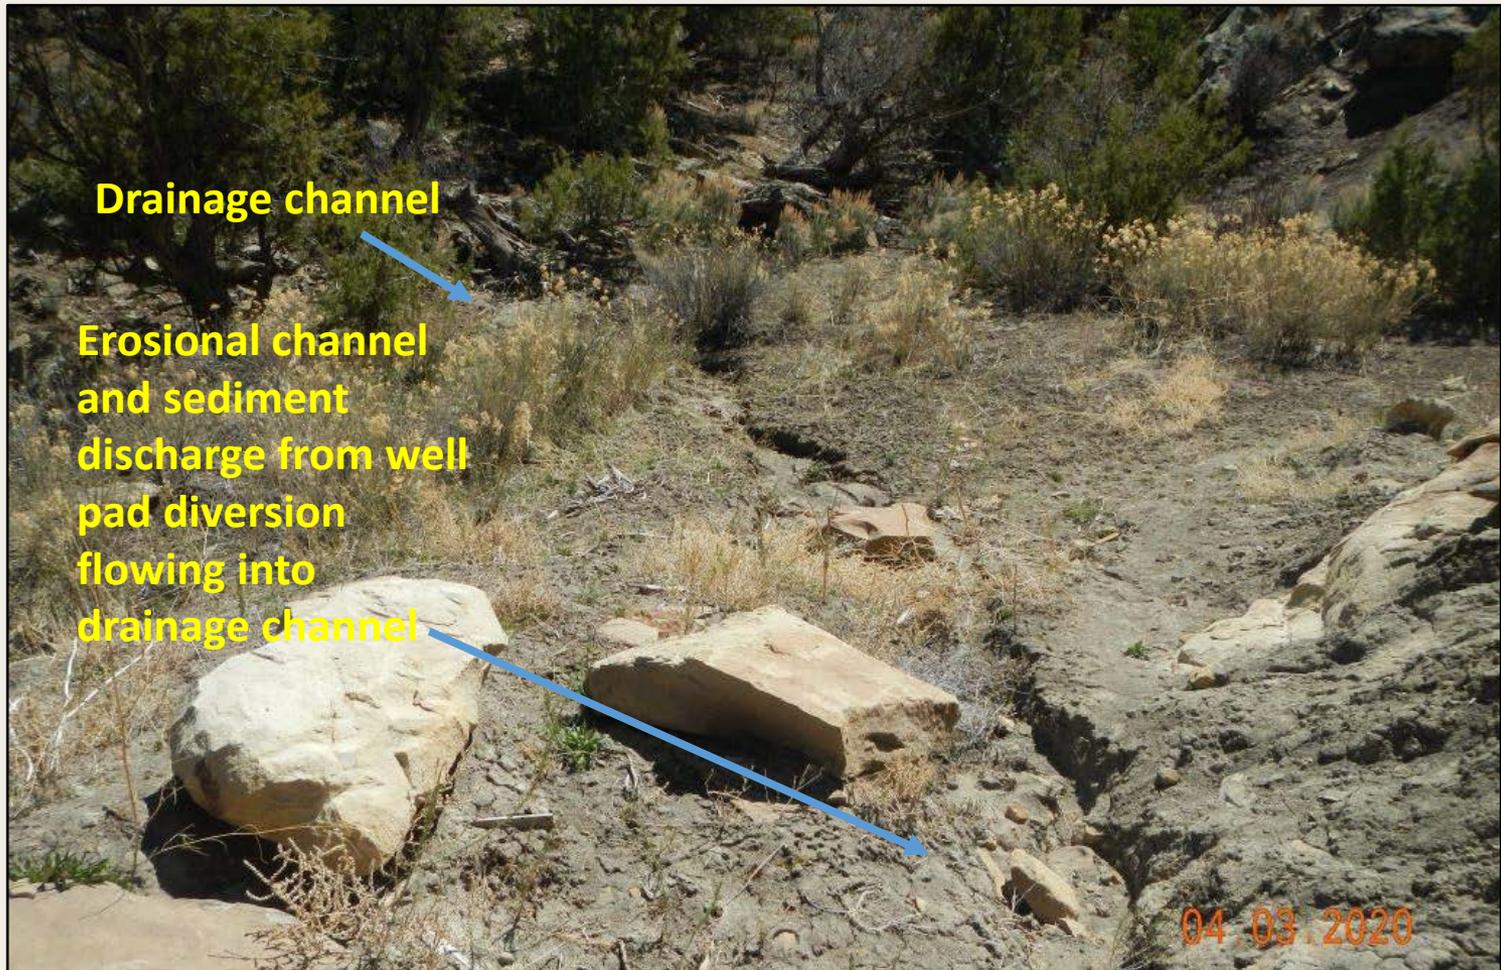
Photo 7. View of area where diversion slopes into drainage in the southwestern project area, facing down-slope toward drainage.

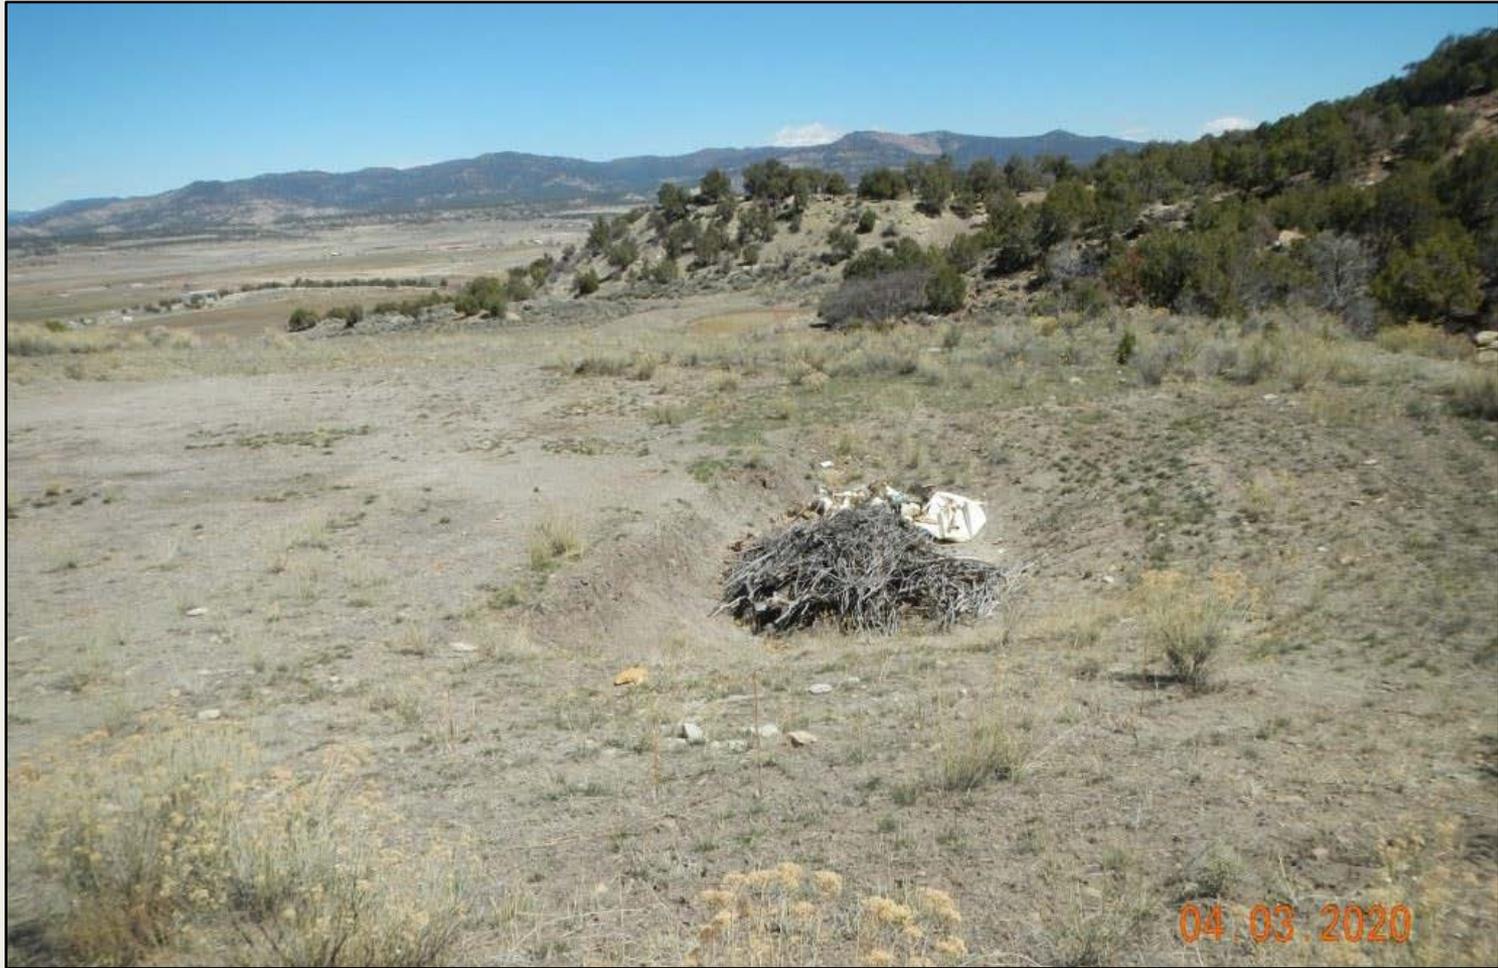
Photo 8. View of area in the southern project area with wood and debris stored in pit, facing eastward.

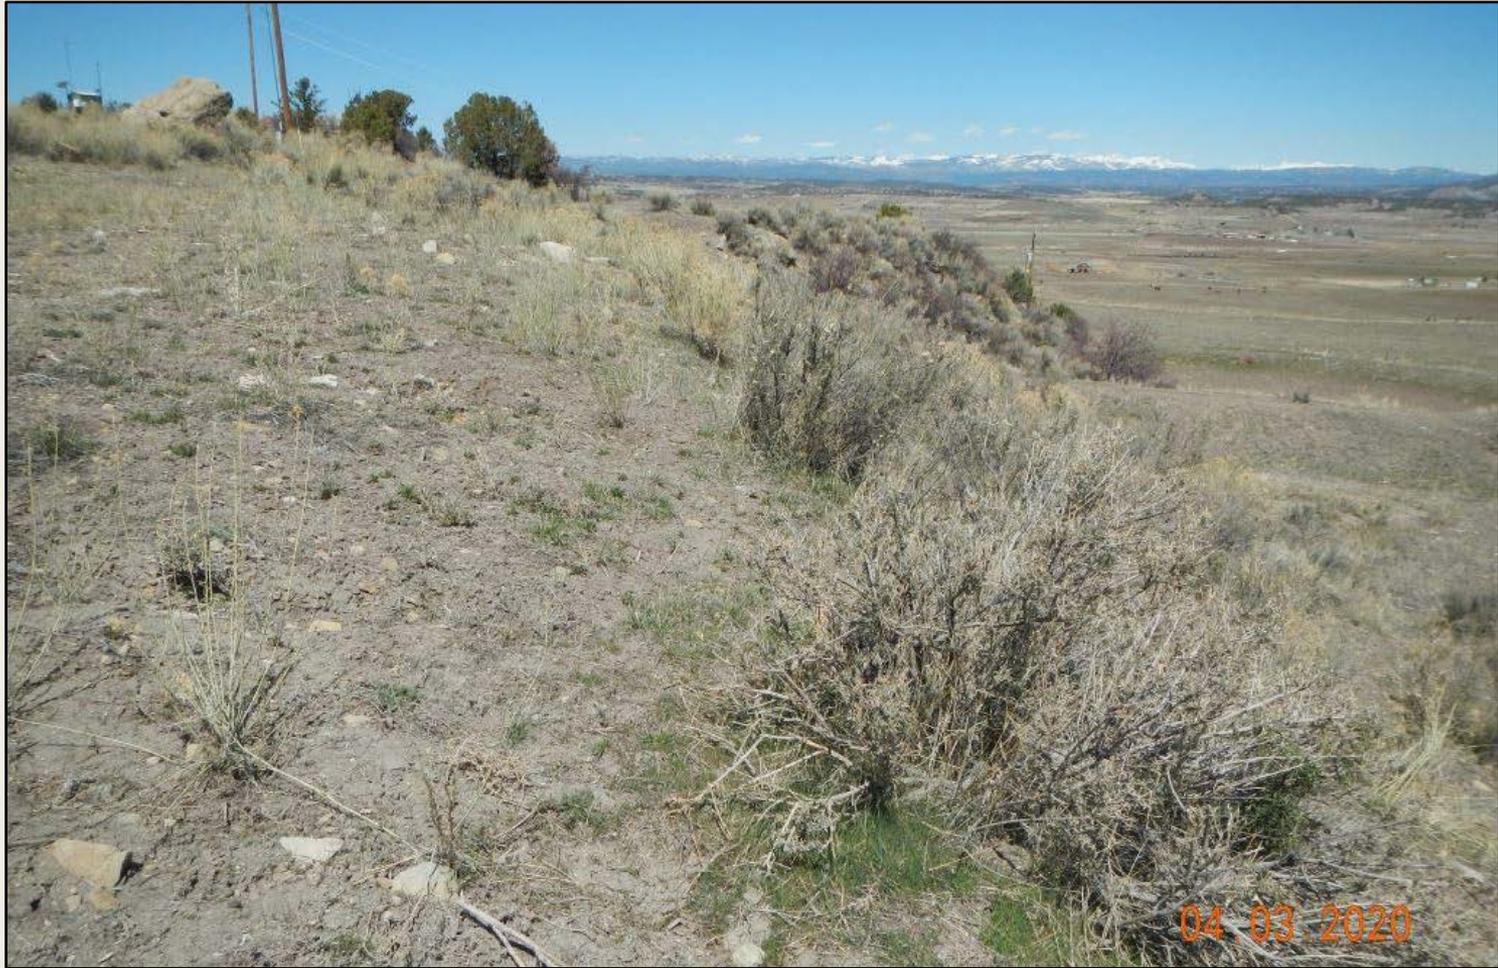
Photo 9. View of the eastern fill slope, facing northward. Revegetation is comprised of shrubs such as rubber rabbitbrush, as well as cheatgrass, and other perennial grasses such as crested wheatgrass.

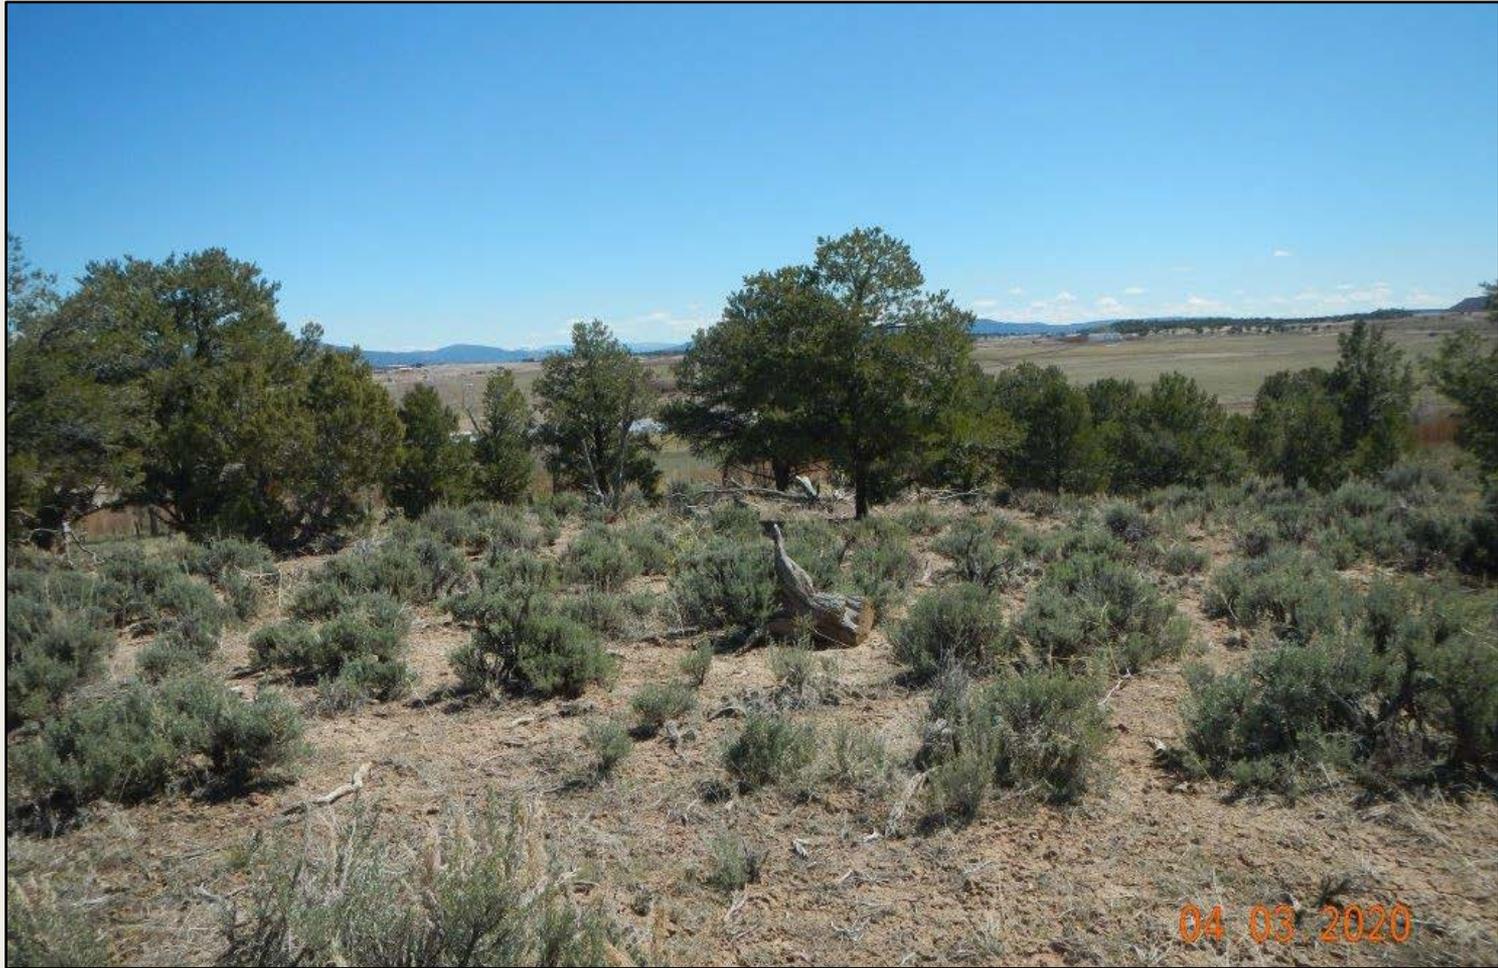
Photo 10. View of reference area vegetation comprised of pinyon juniper woodland with sagebrush in the understory.
