Inspection Photos

Location Name: Anschutz Equus Farms 3-62-33 NWNW

Location ID: 437854

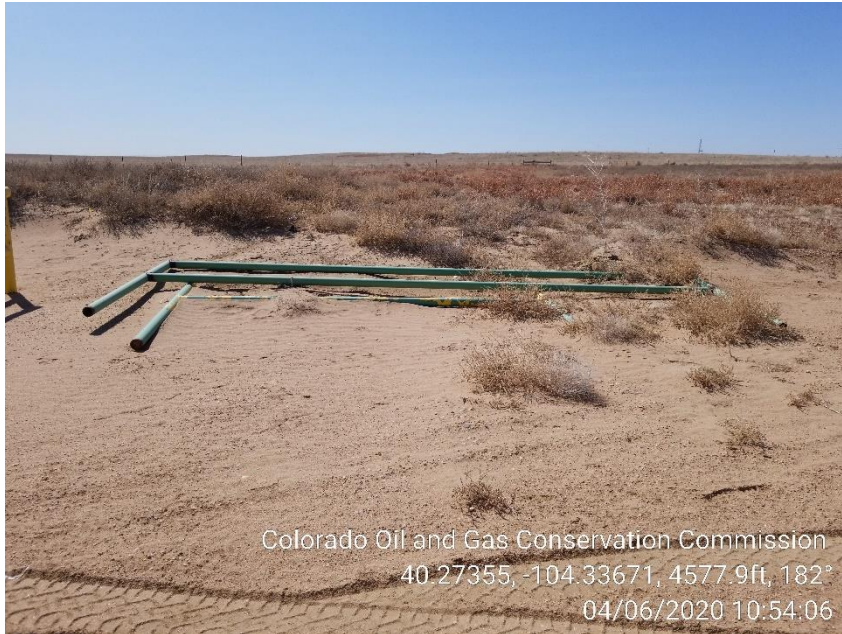
Photo 3 – Unused Pipe on Southside of Location

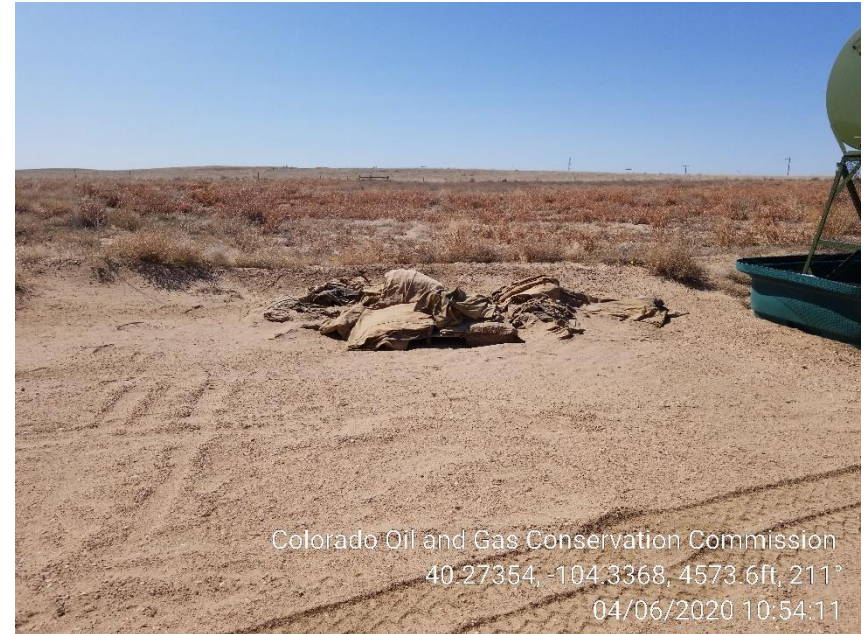
Photo 4 – Unused Tarps on Southside of Location

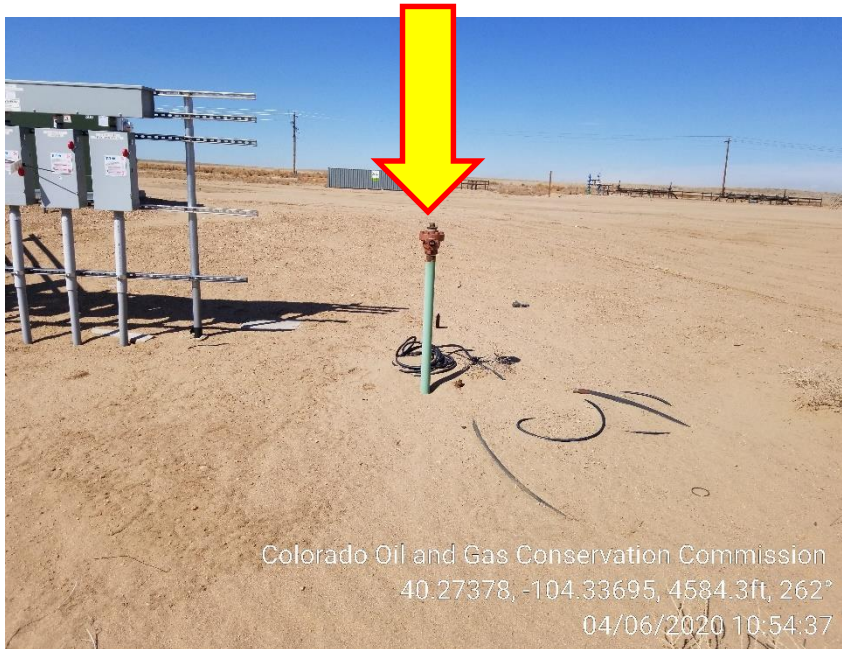
Photo 5 – Unmarked Riser

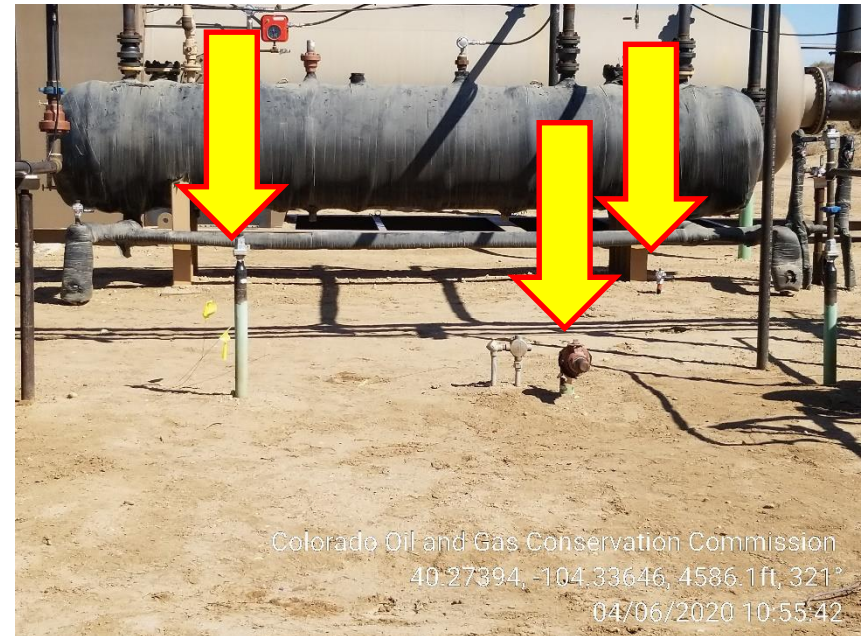
Photo 6 – Unmarked Risers

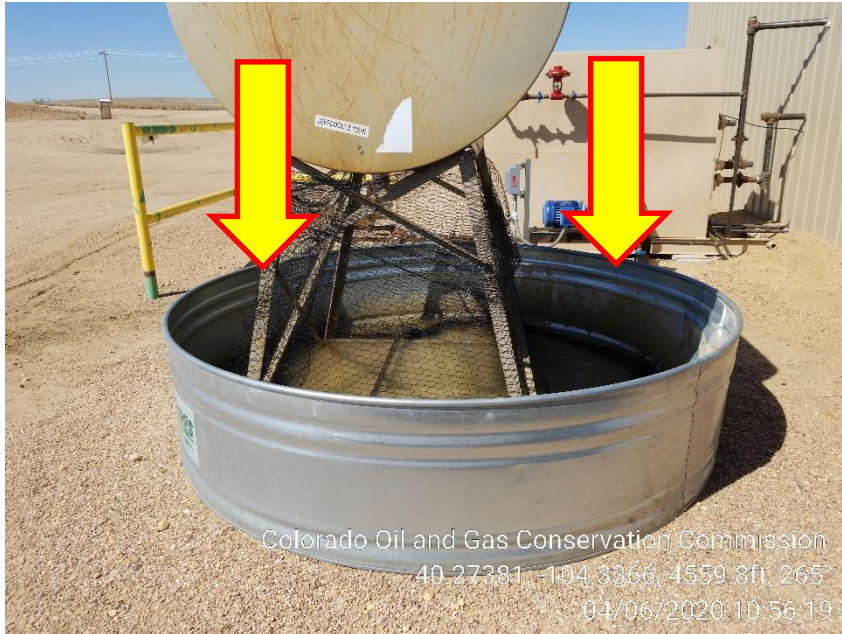
Photo 7 – Wildlife netting is in disrepair
