Inspection Photos

API: 071-07186

Operator: TIMBER CREEK OPERATING

Inspection Date: 4/6/2020

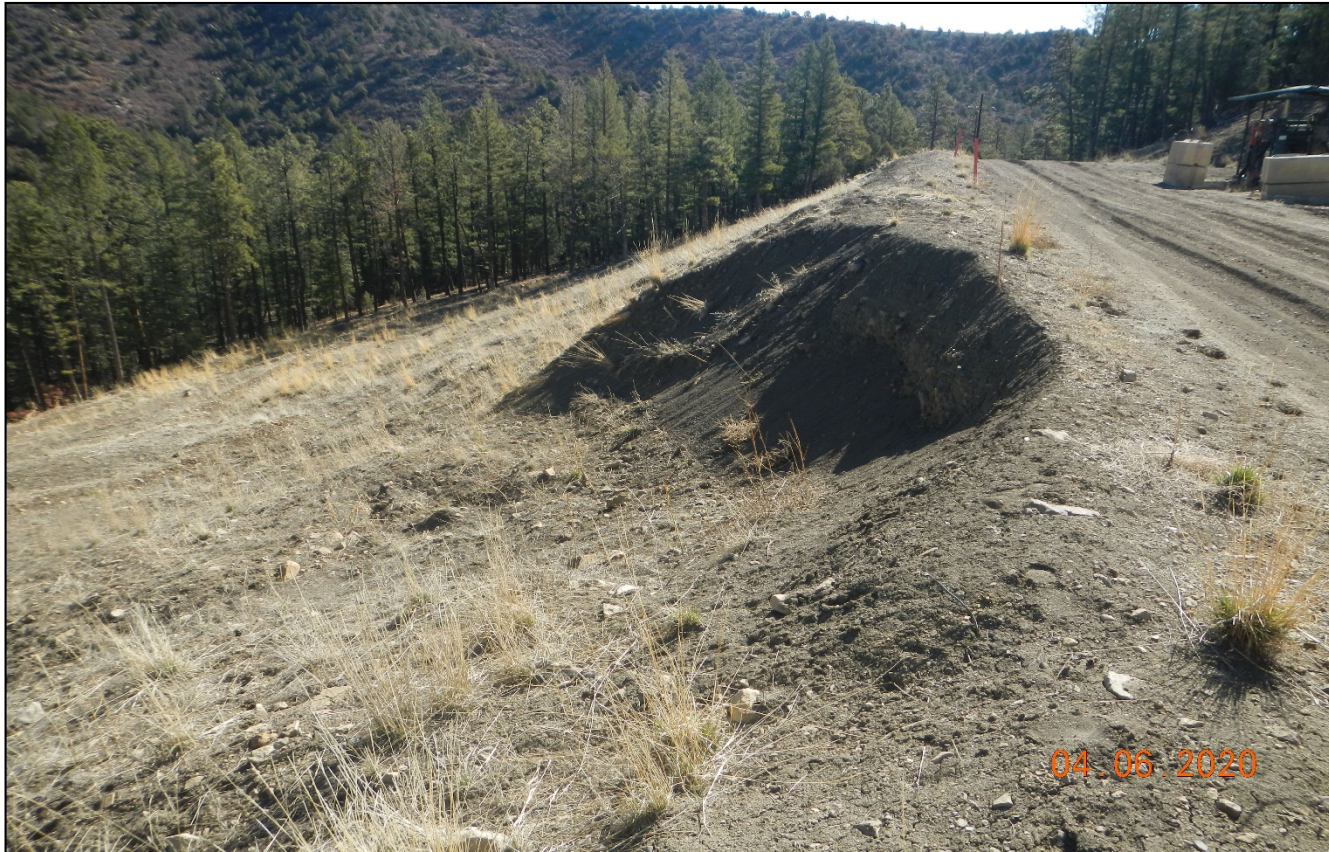
Photo 1. There is soil sloughing that occurred at the east side of the location. Corrective action of the previous inspection was not performed.

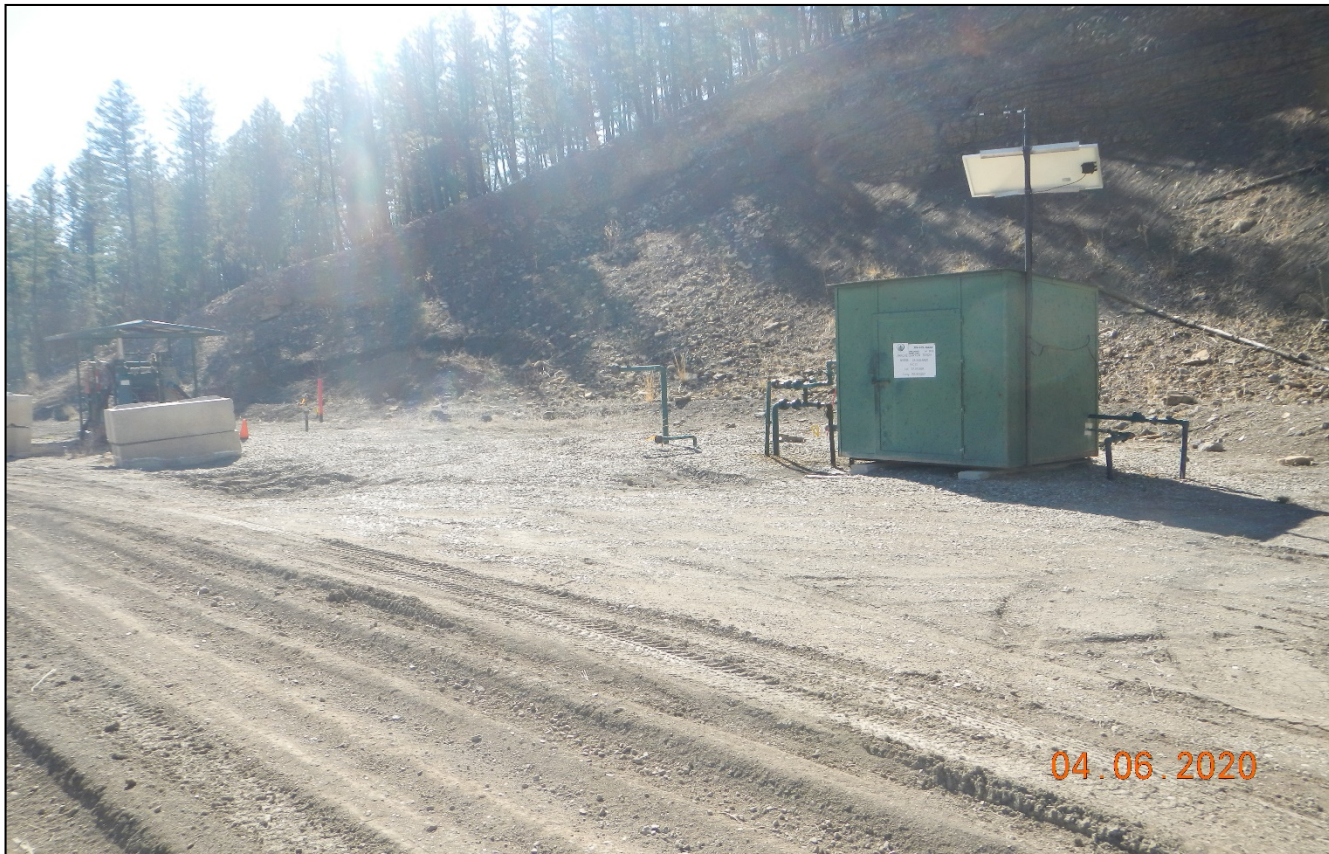
Photo 2. Facing toward location. Well sign is posted at meter shed.

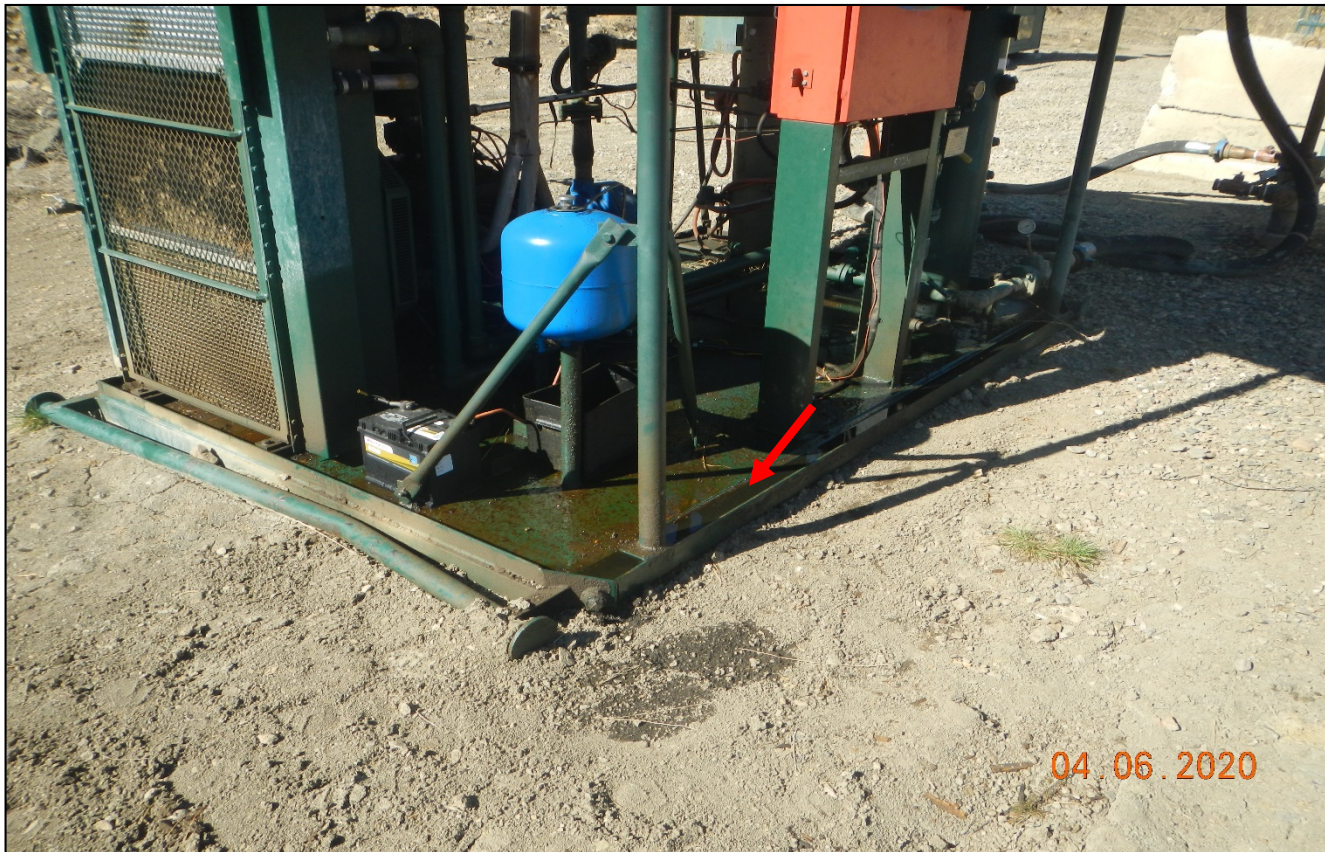
Photo 3. There is oil on the engine skid that will need to be cleaned up.

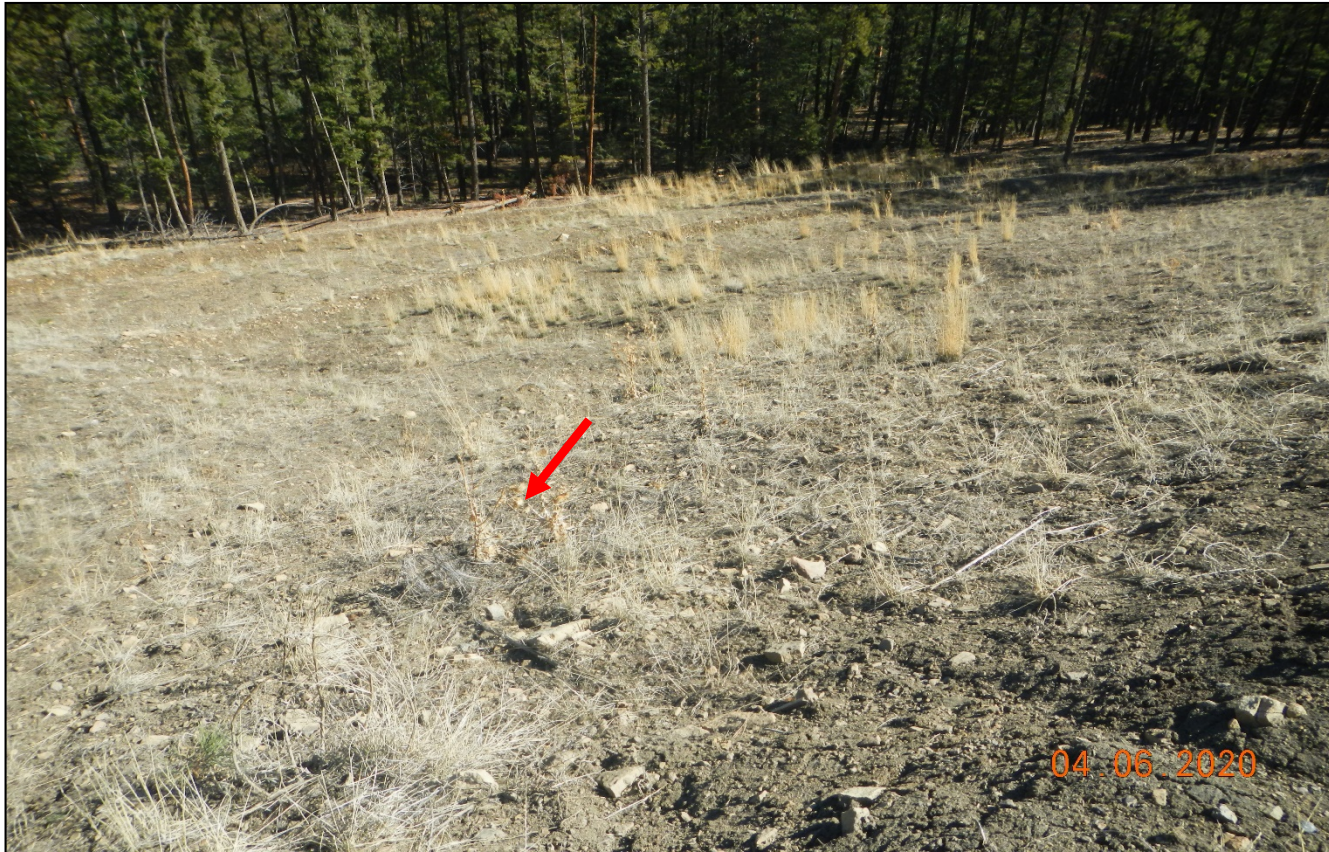
Photo 4. Facing down toward the fill slope. There were numerous noxious weeds observed along the fill slope during previous inspection which remain. (Canada thistle, Bull thistle. Noxious weed control will need to be performed in upcoming growing season.

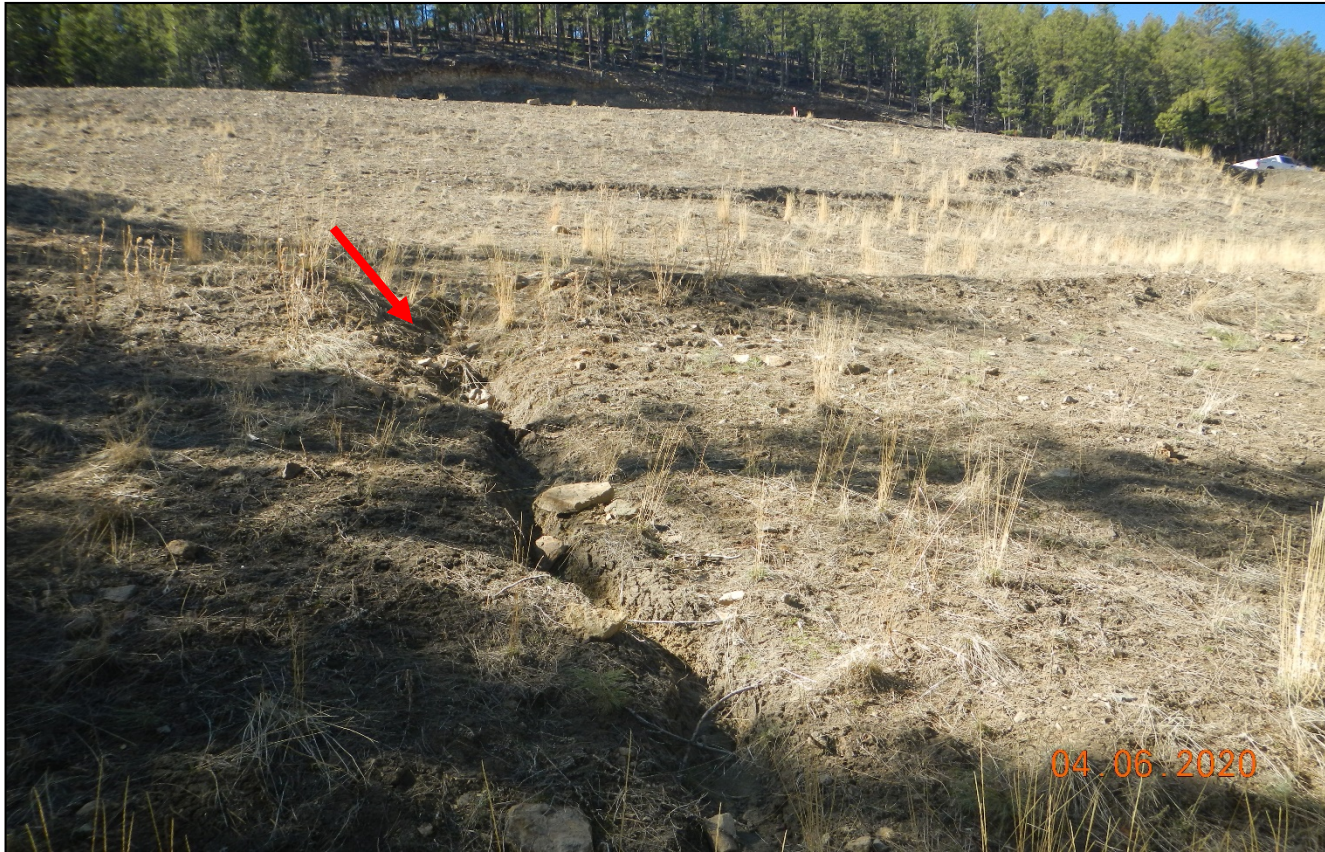
Photo 5. Facing southwest toward the fill slope. There is an erosion channel that has developed in this area.
