**Inspection Photos**  
**Location Name: UPRR 43 Pan AM 1 #16**  
**Location ID:318369**

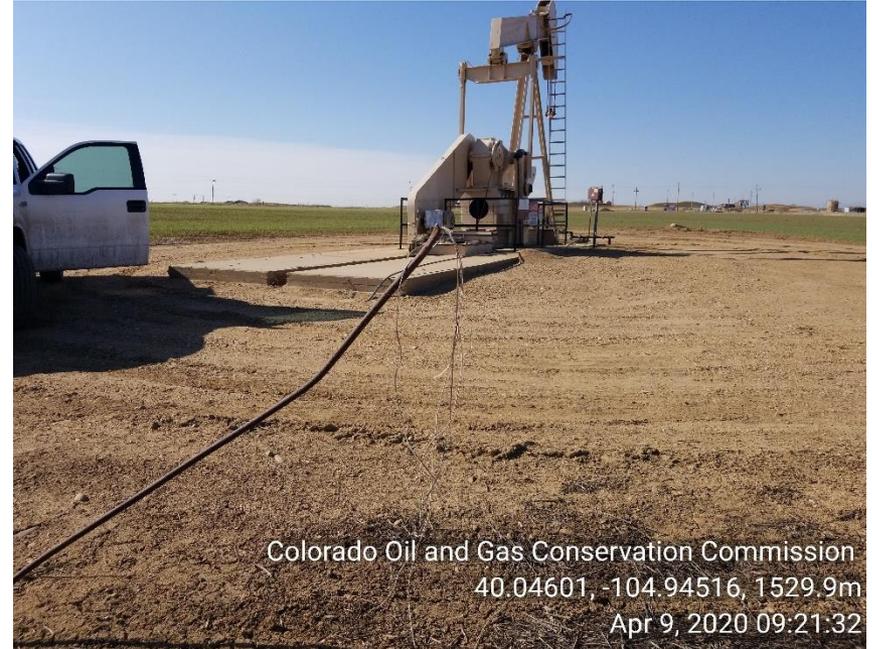
**Photo 2 Electric pipe with exposed wires not marked not LOTO.**

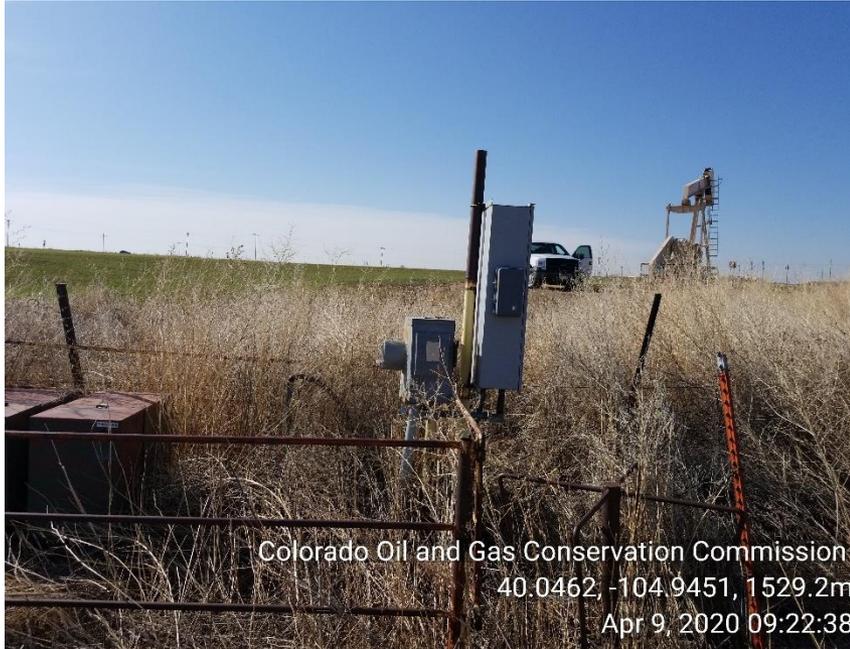
**Photo 3 Debris/trash: dead weeds around electric panel and on edge of location.**
