Inspection Photos
Operator: BP America
API#: 067-08812
Date: 4/8/2020

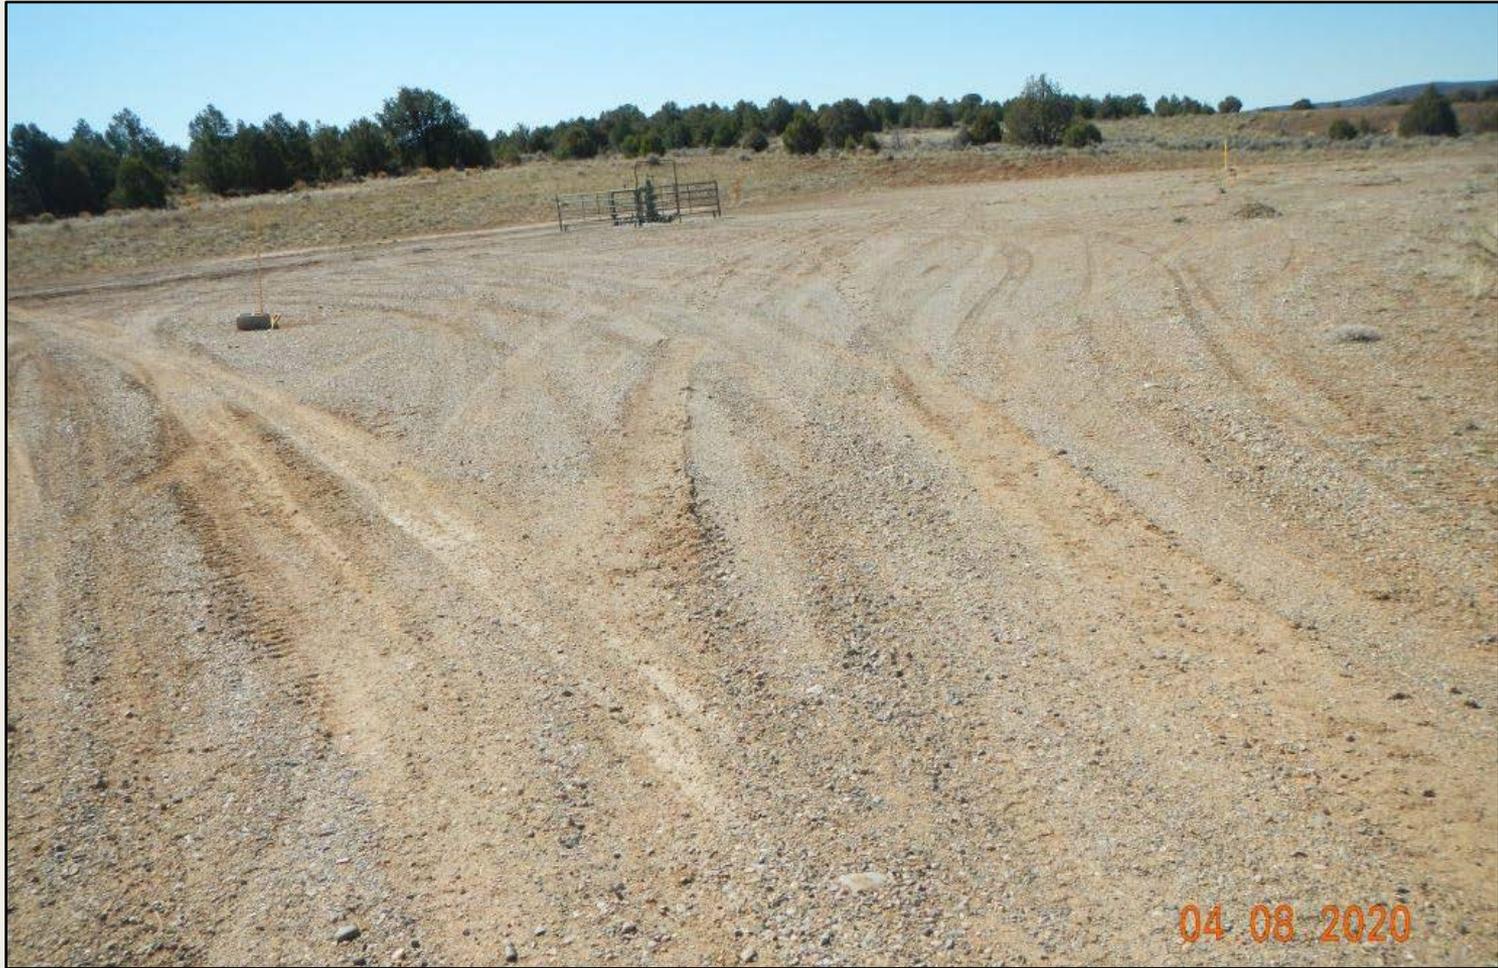
Photo 1. View of the project area from the well pad entrance facing center.

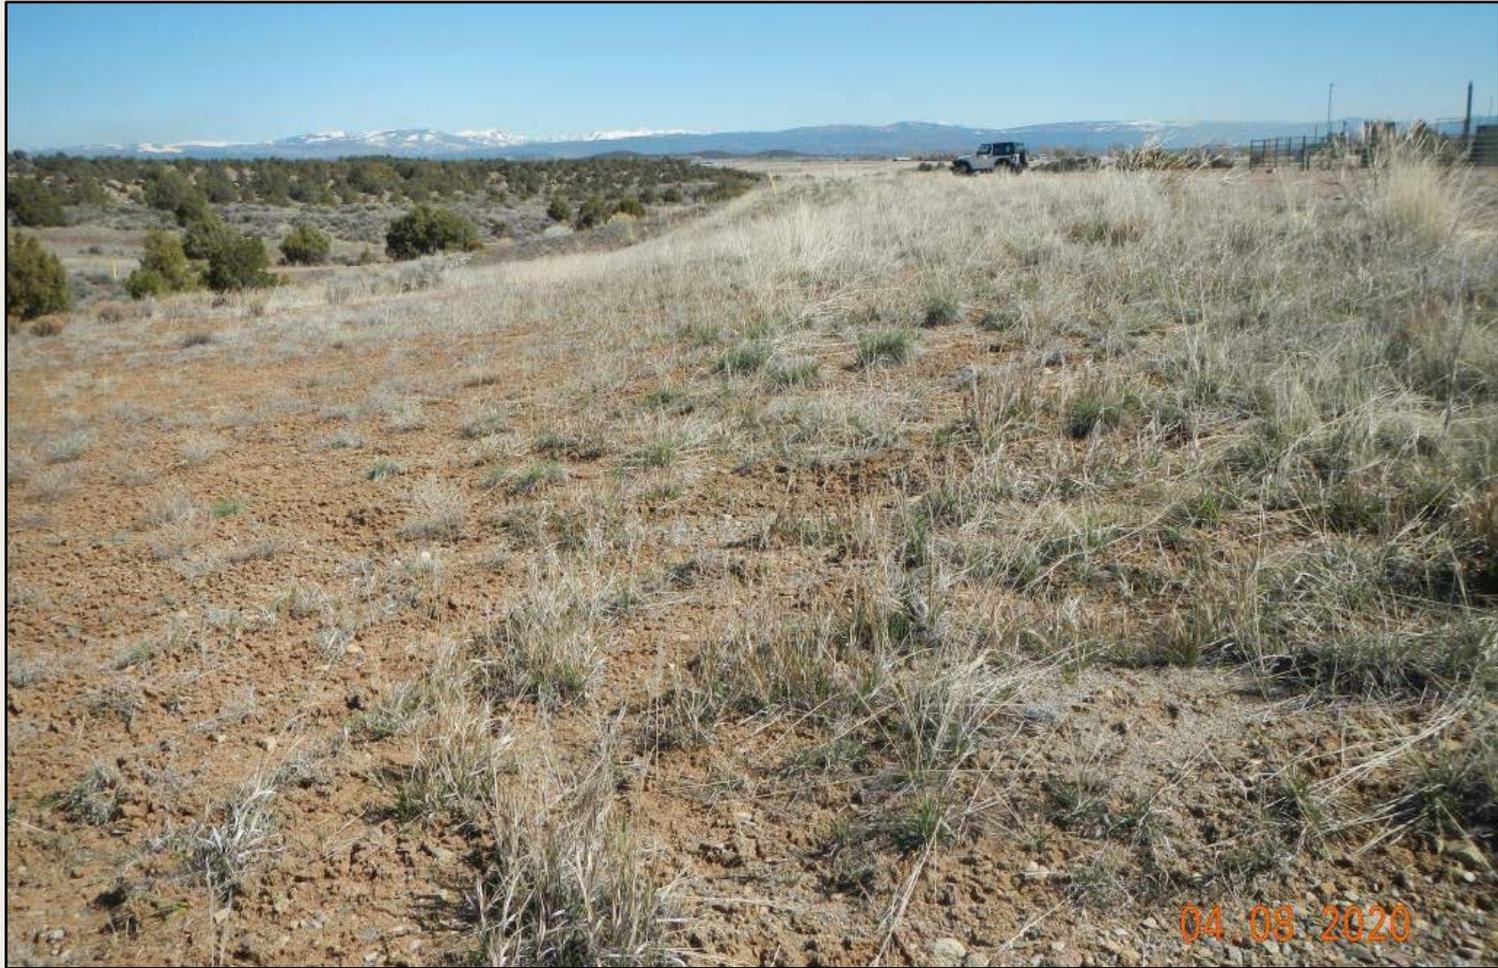
Photo 2. View of the western fill slope from the southwestern corner facing northward. Vegetation is progressing with a mixture of grasses such as western wheatgrass, squirreltail, and sand dropseed.

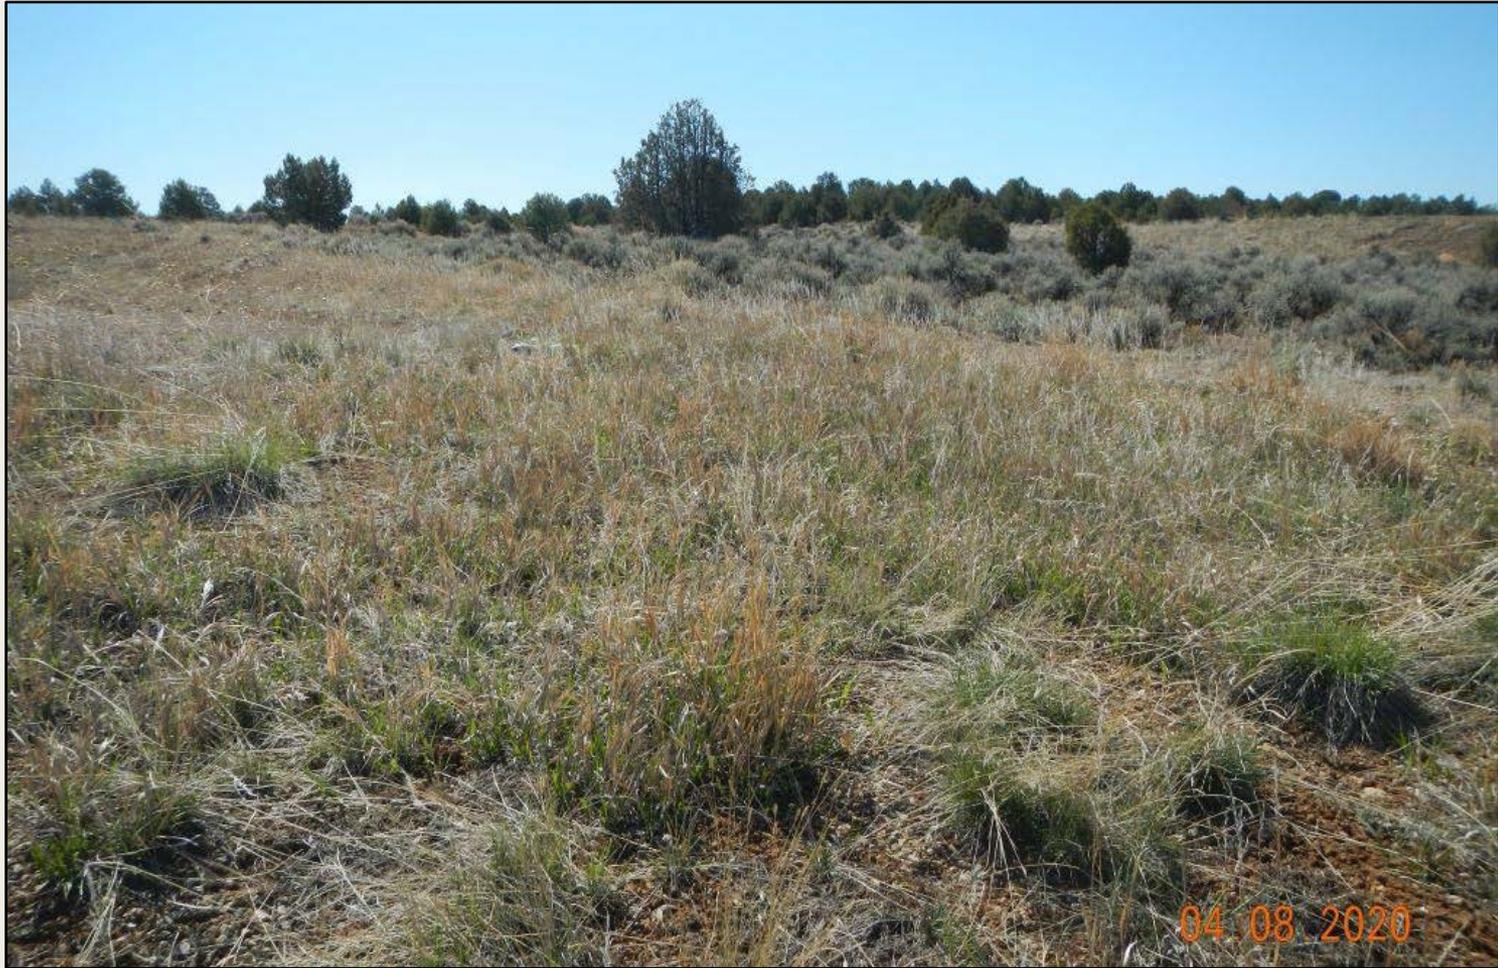
Photo 3. View of the southern project area from the southwestern corner facing eastward.

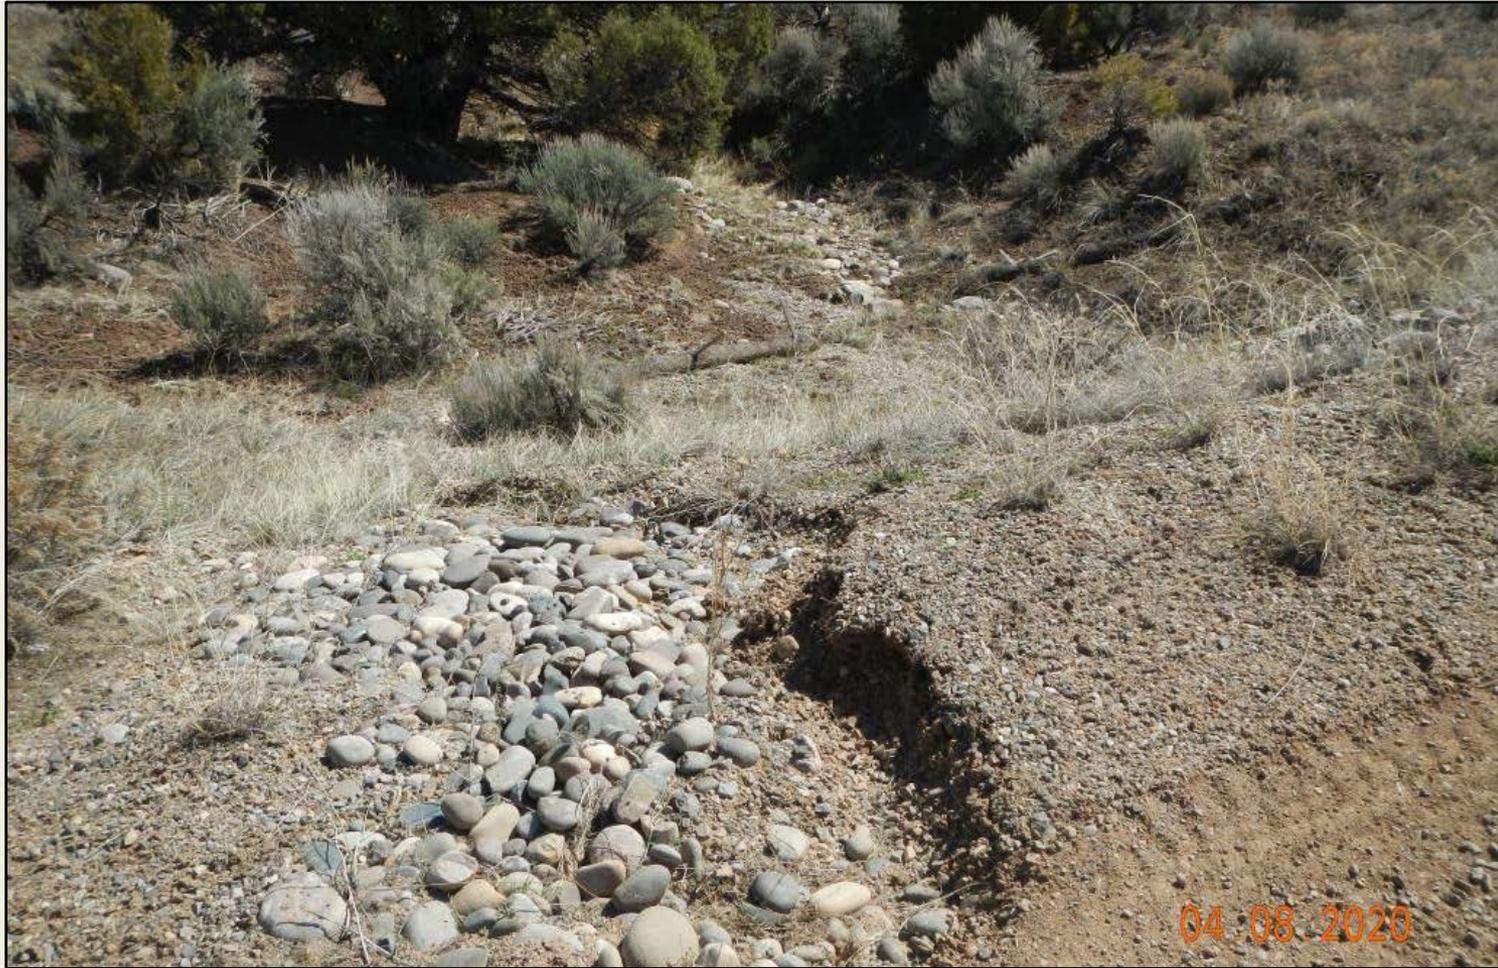
Photo 4. View of erosional channel (approx. 1 foot wide and deep) at culvert outlet (facing downslope), forming around cobble. Cobble is not an adequate BMP.

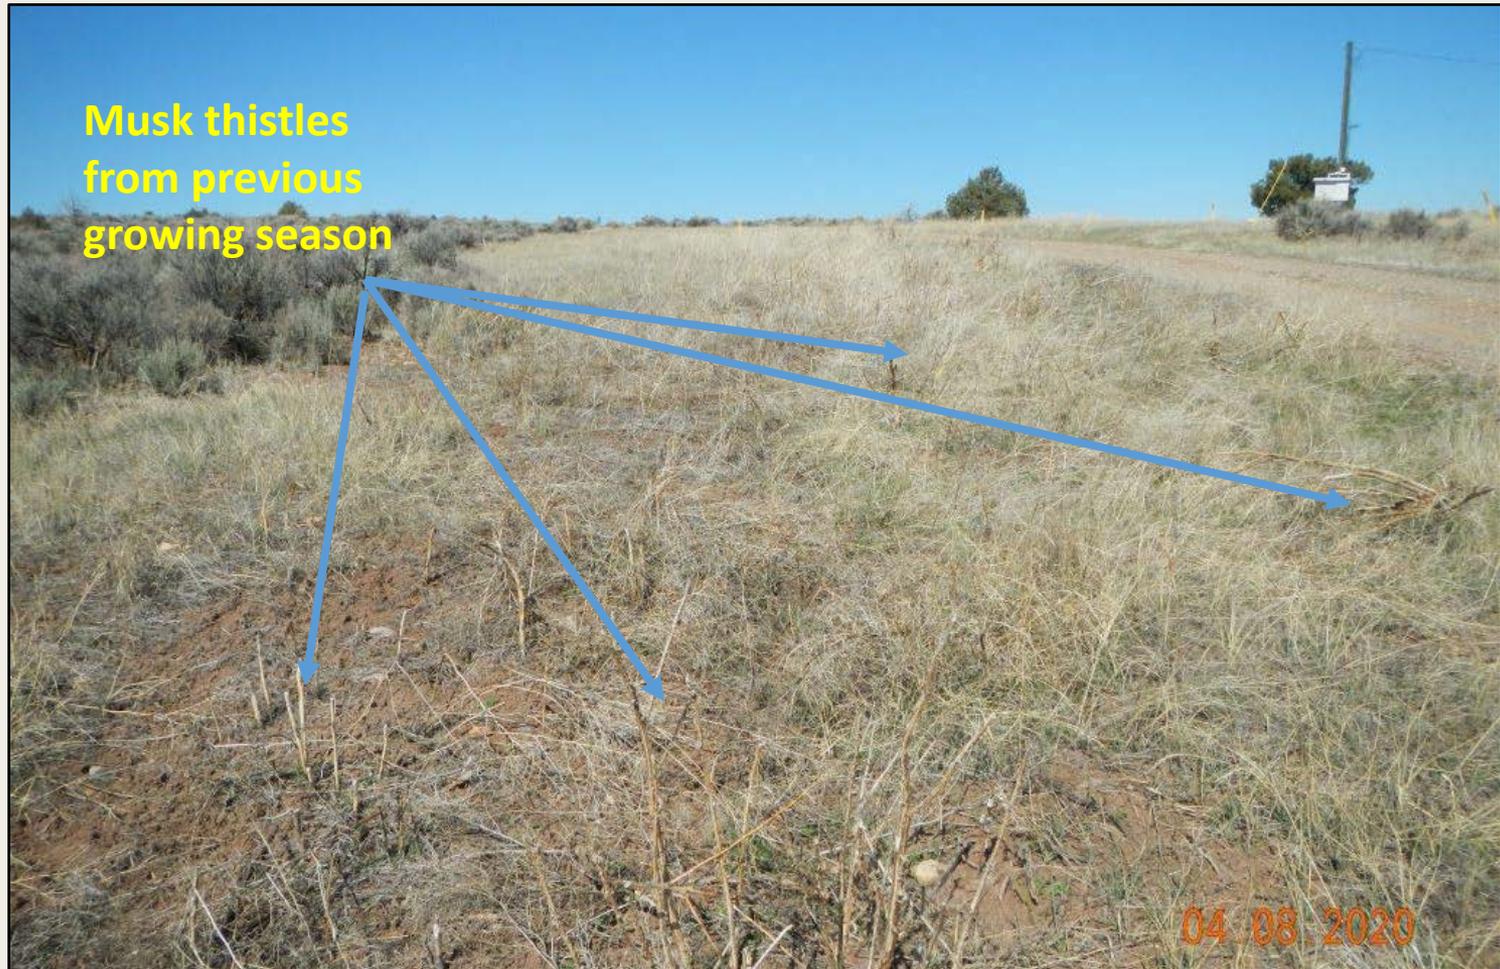
Musk thistles
from previous
growing season

Photo 5. View of the southern project area from the southeastern corner facing westward.

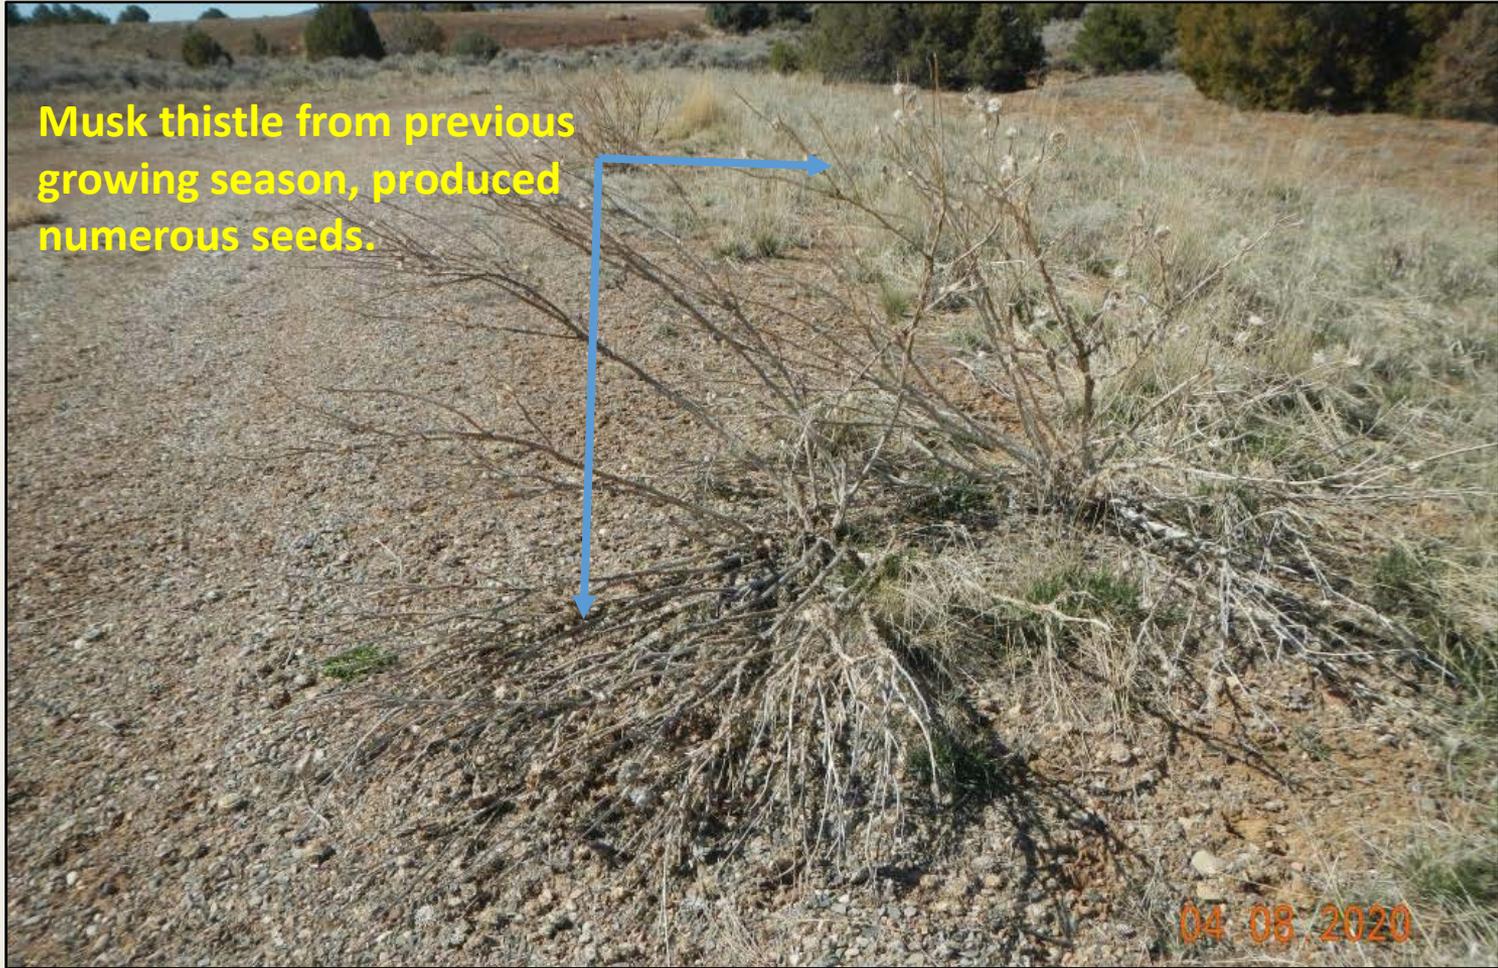
Musk thistle from previous growing season, produced numerous seeds.

Photo 6. View of the southern project area from the southeastern corner facing westward.

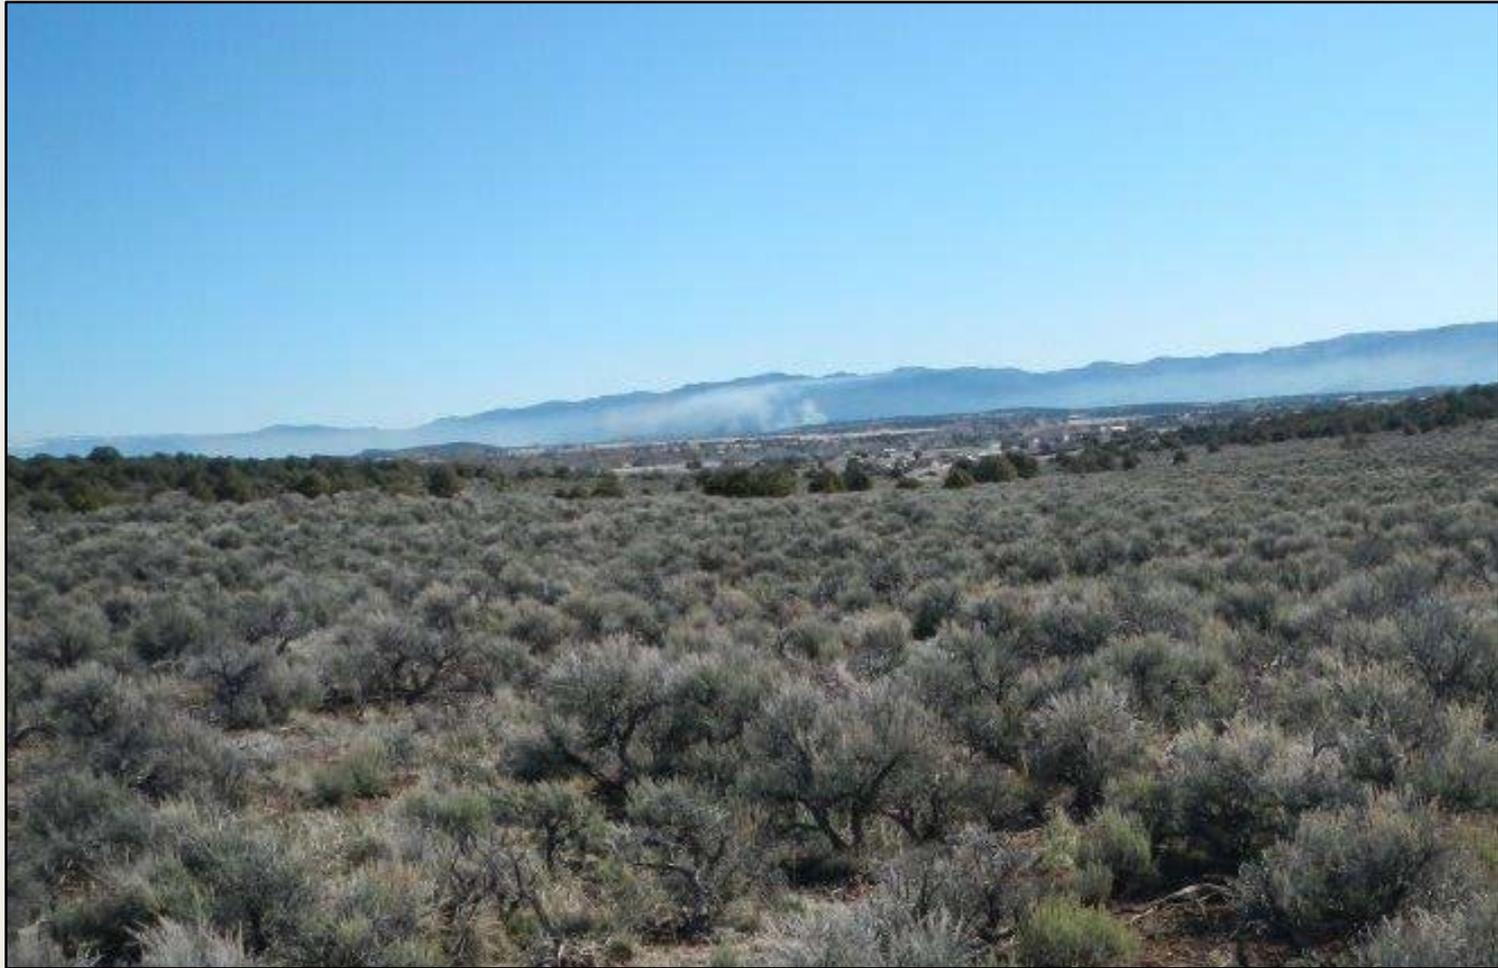
Photo 7. View of reference area vegetation, comprised of sagebrush shrubland, with scattered pinyon and juniper trees, and understory of grasses and forbs such as blue grama and sand dropseed.
