Inspection Photos  
Location Name: Cleveland 2  
Location ID: 332884

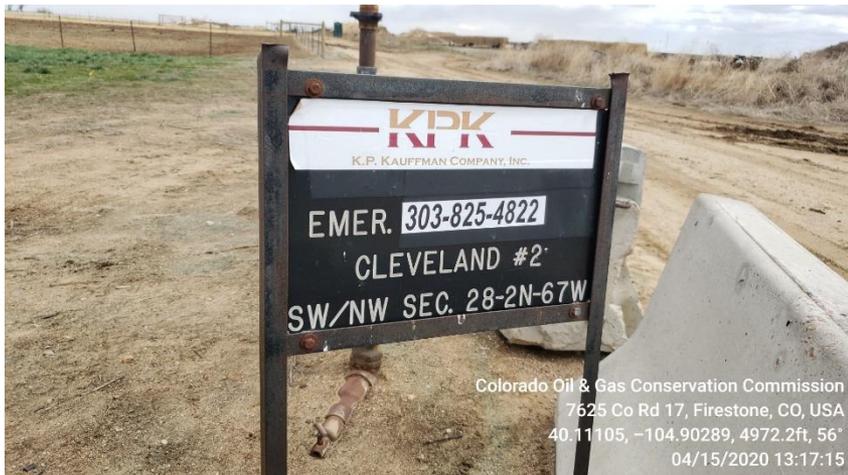
Photo 1 WH sign

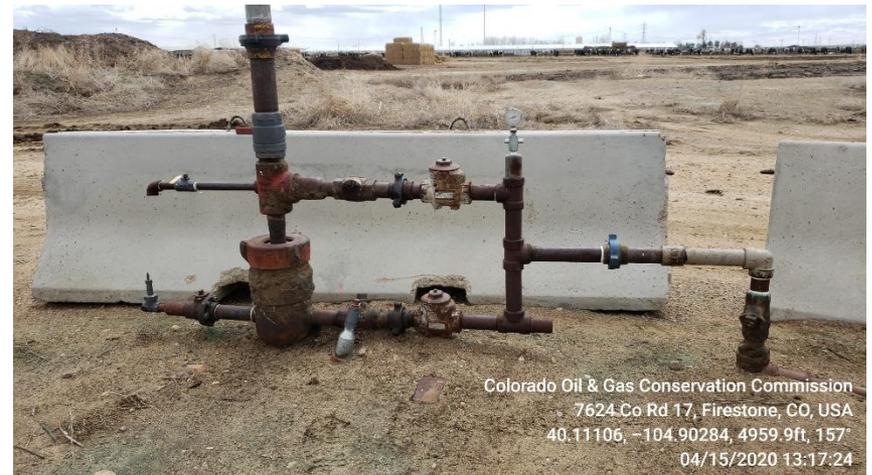
Photo 2 WH

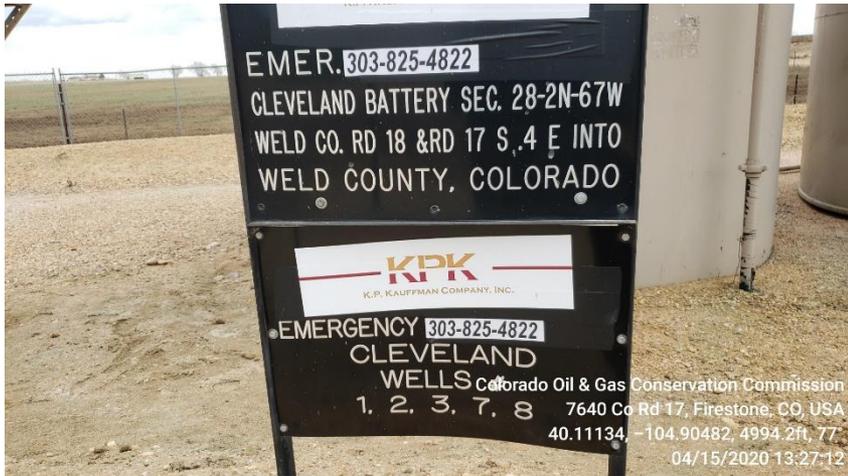
Photo 3 TB sign

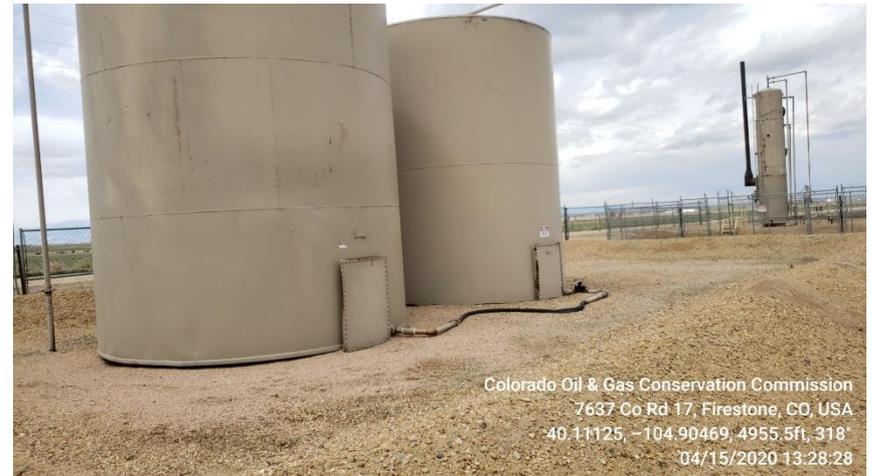
Photo 4 TB

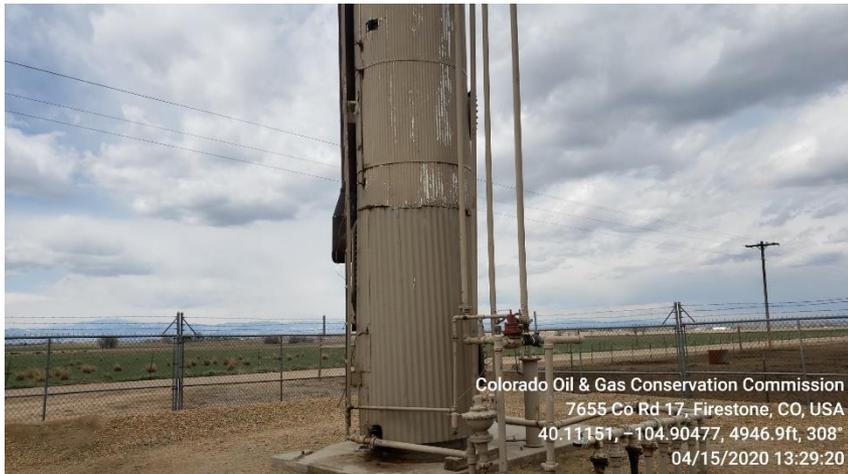
Photo 5 Vertical heated separator

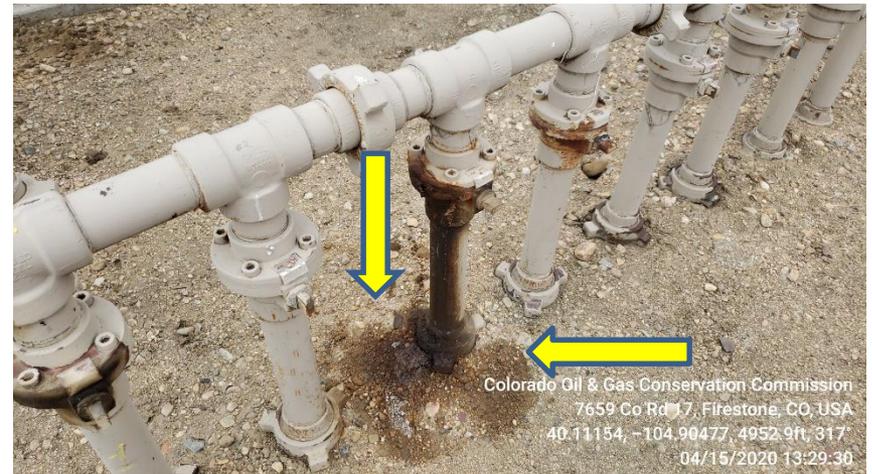
Photo 6 Stained soil around flow line, possible leak at hammer union.
