**Inspection Photos**  
**Operator: Enduring Resources**  
**API#: 067-07841**  
**Date: 4/14/2020**

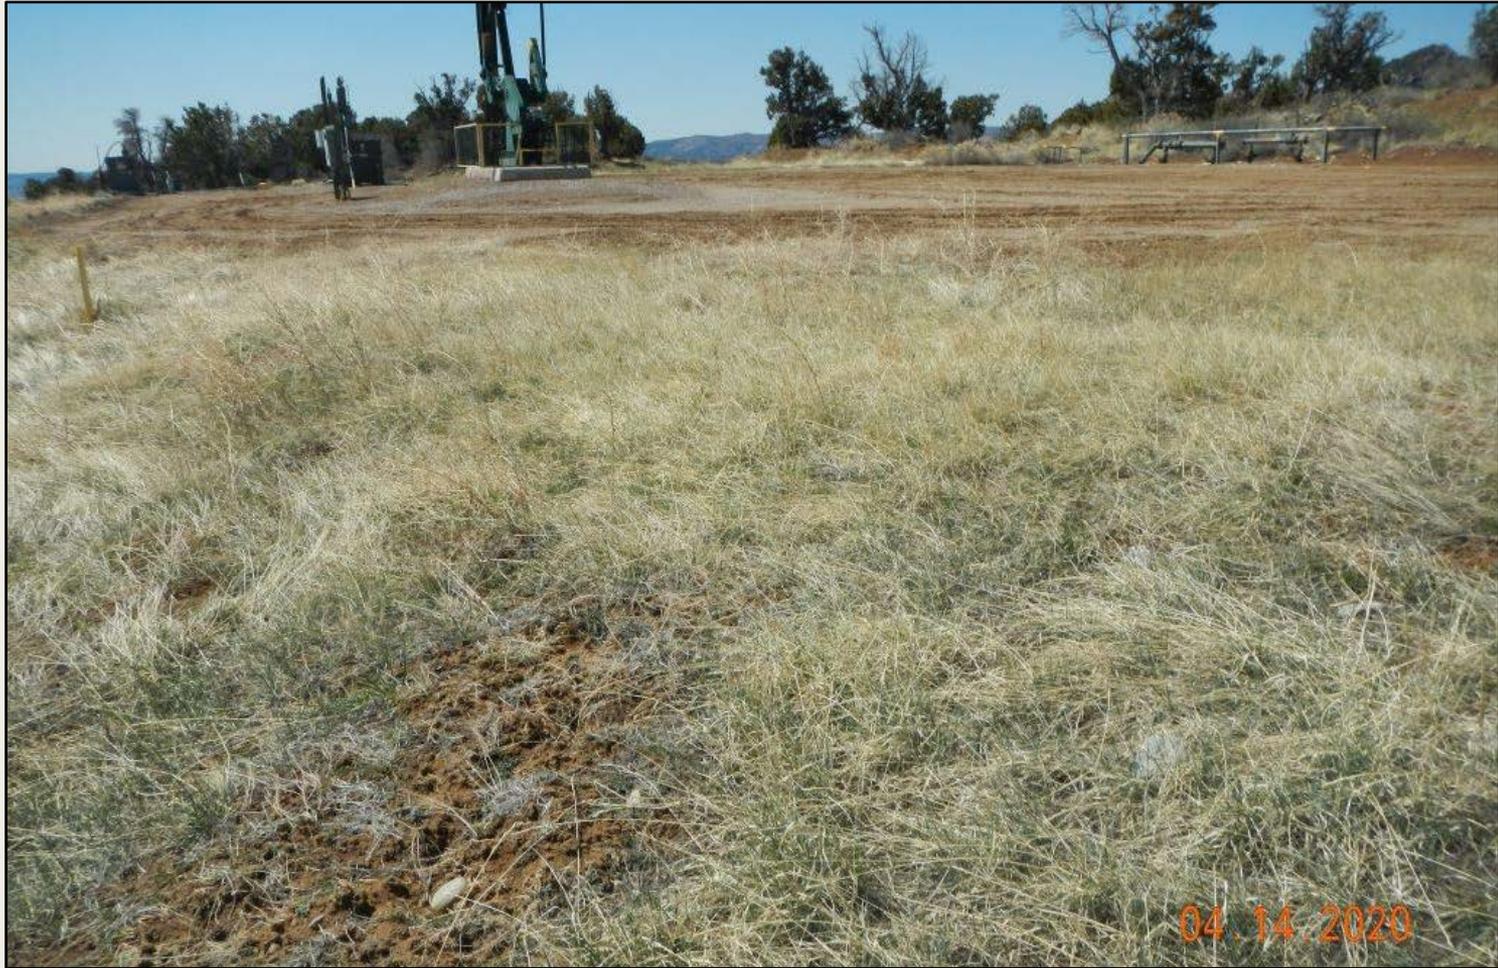
Photo 1. View of the project area from the northeastern corner facing center.

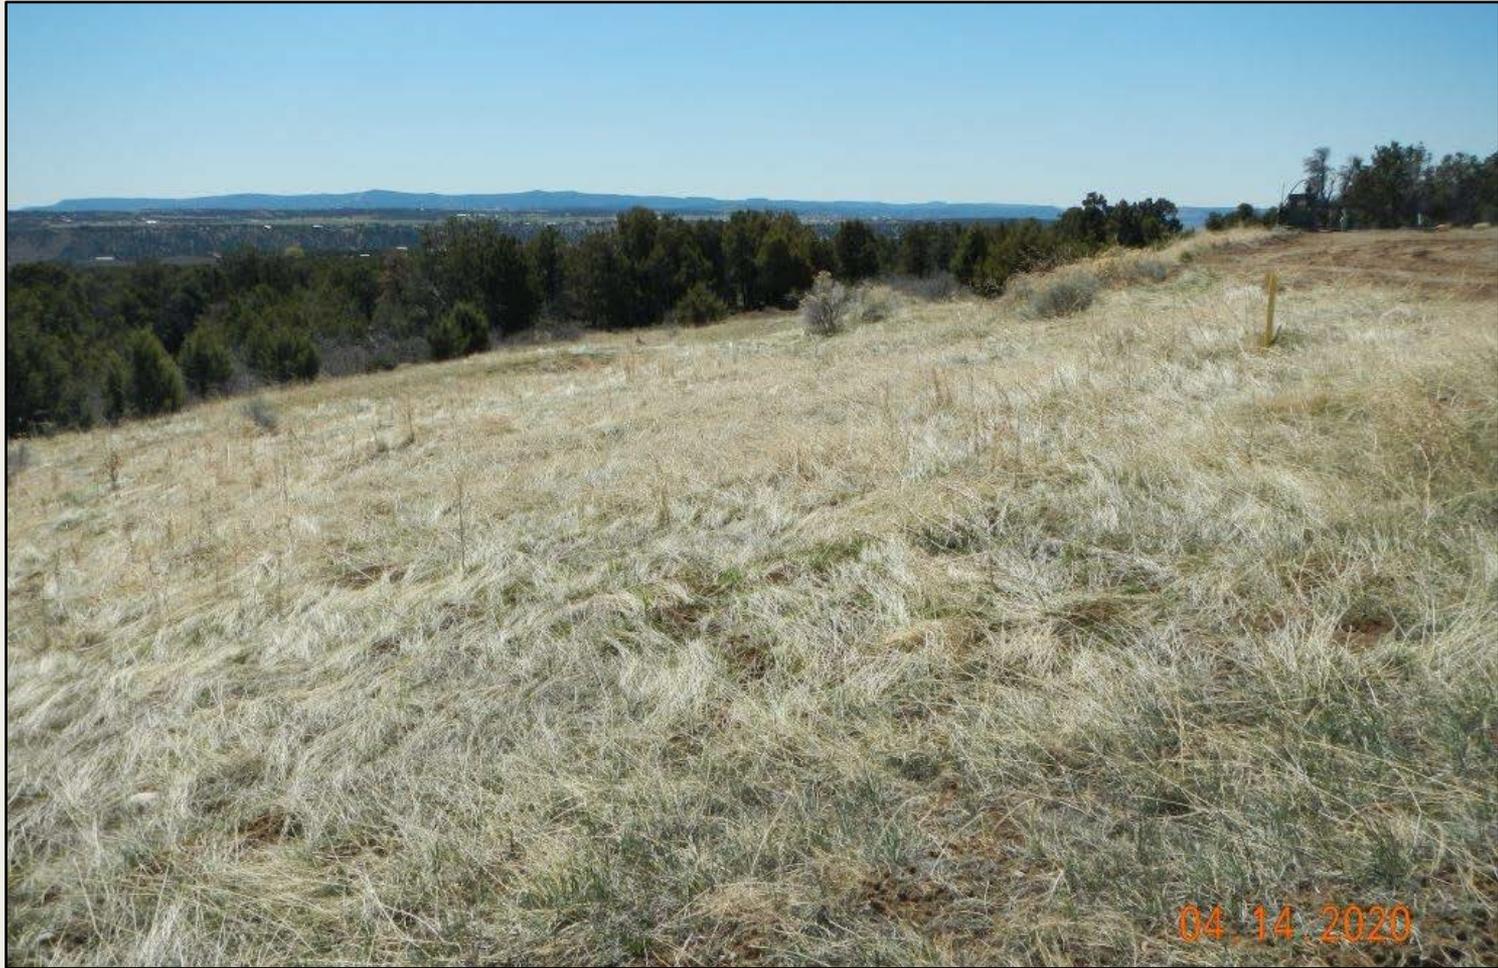
Photo 2. View of the eastern fill slope from the northeastern corner facing southward. Dense jointed goatgrass present on fill slope. Revegetation is progressing in portions of the interim reclamation area that are not infested with jointed goatgrass.

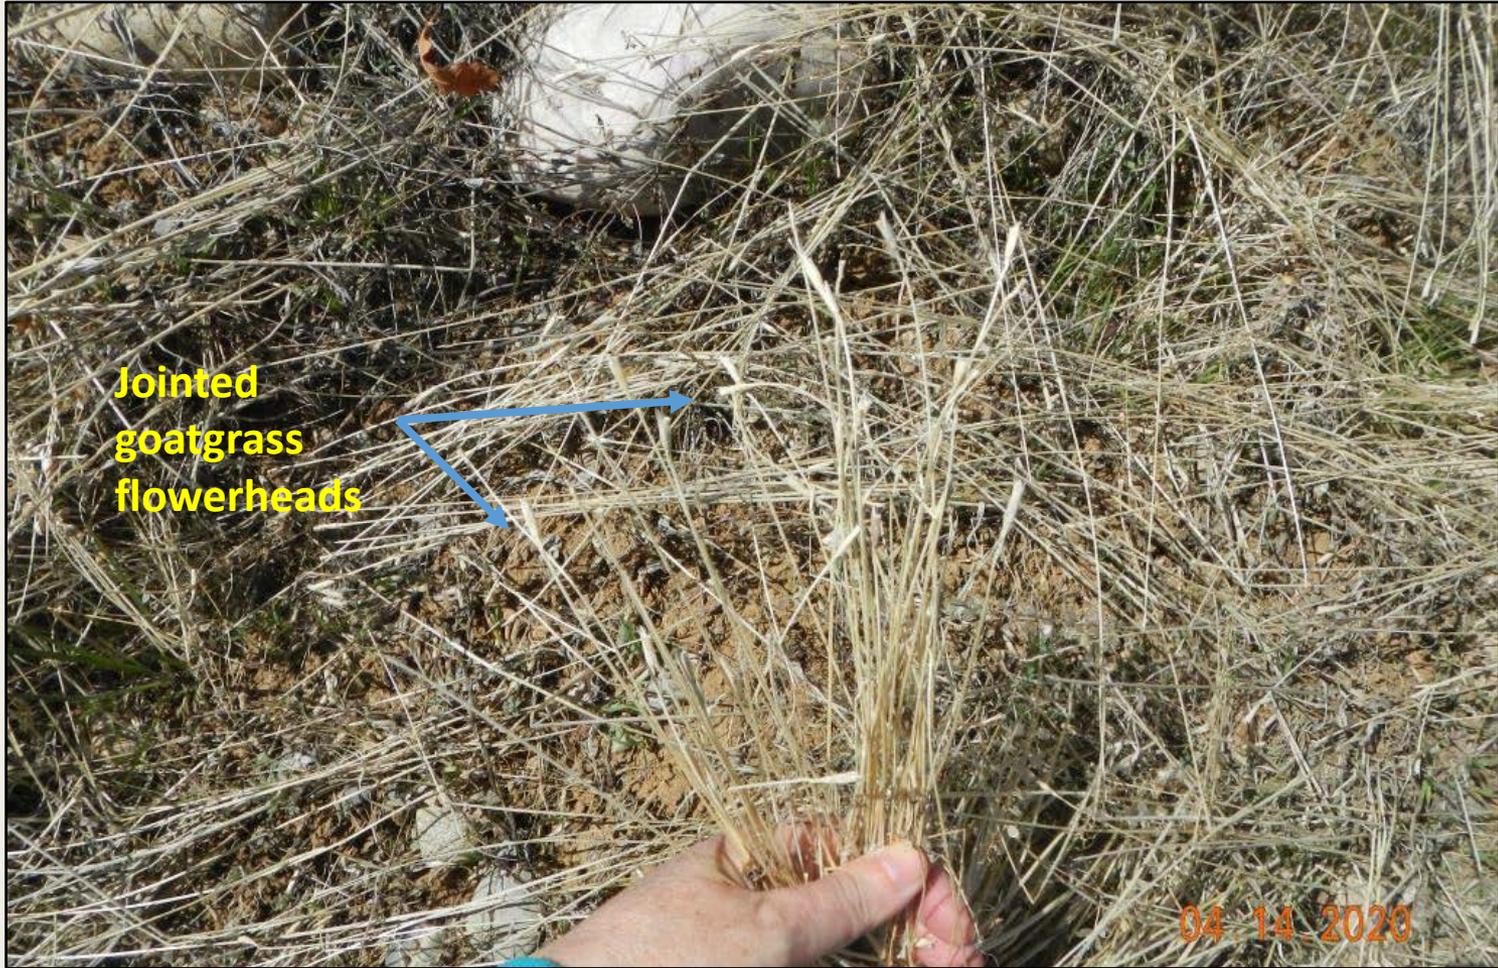
Photo 3. Closeup view of jointed goatgrass from previous year's growing season. Jointed goatgrass is an annual, spring blooming, noxious weed.

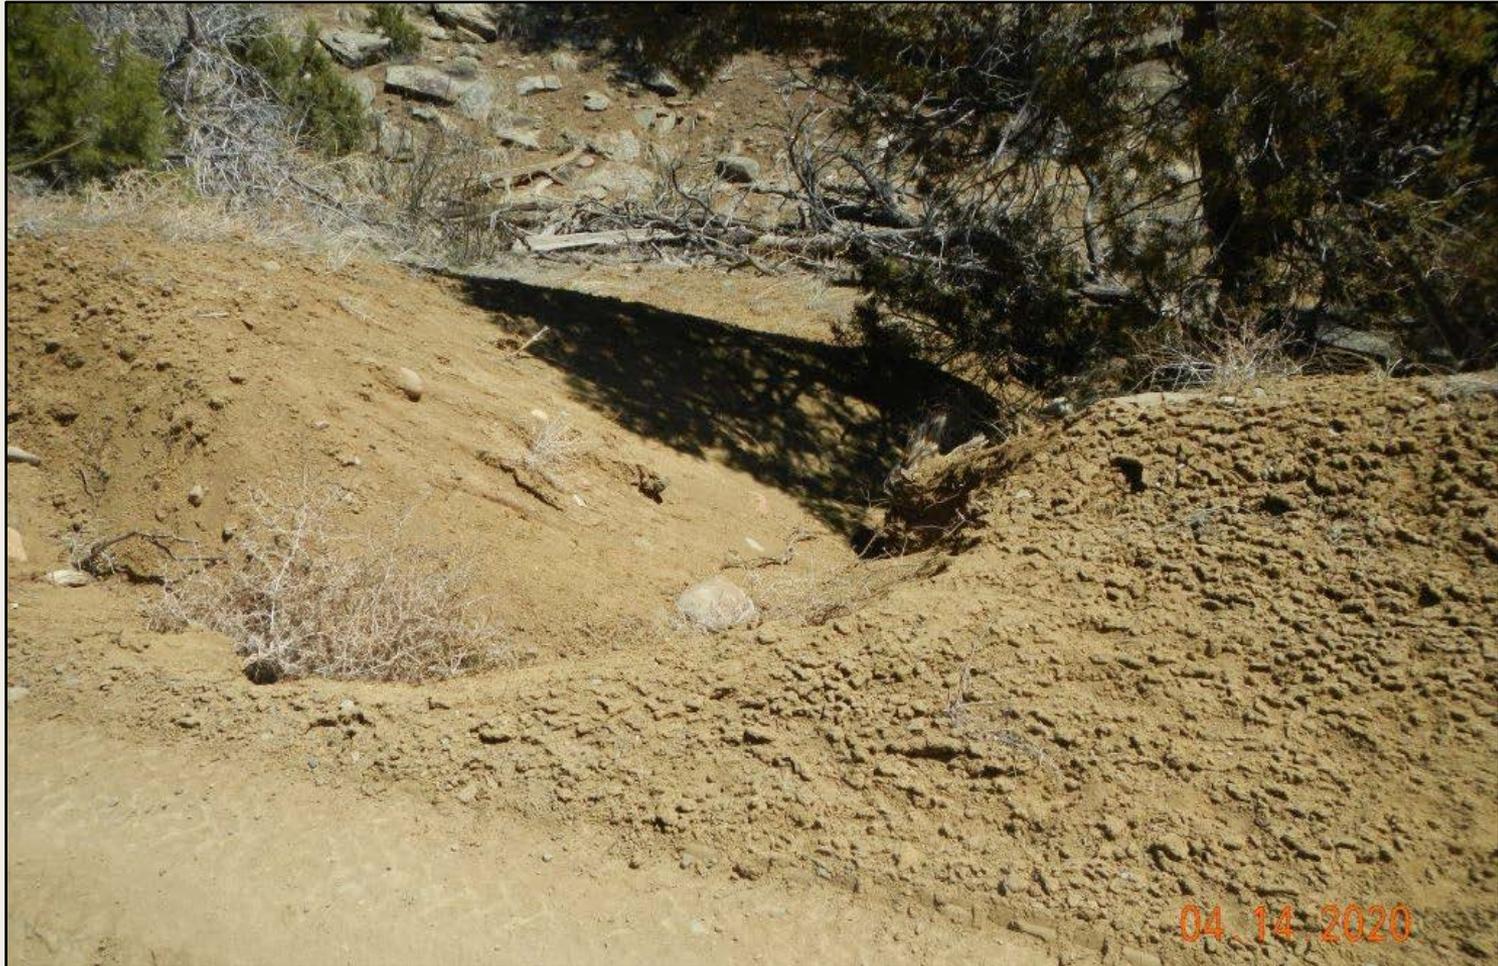
Photo 4. View of erosional channel flowing off of the access road, that is not stabilized. Approximately 2-3 feet wide, and deep.

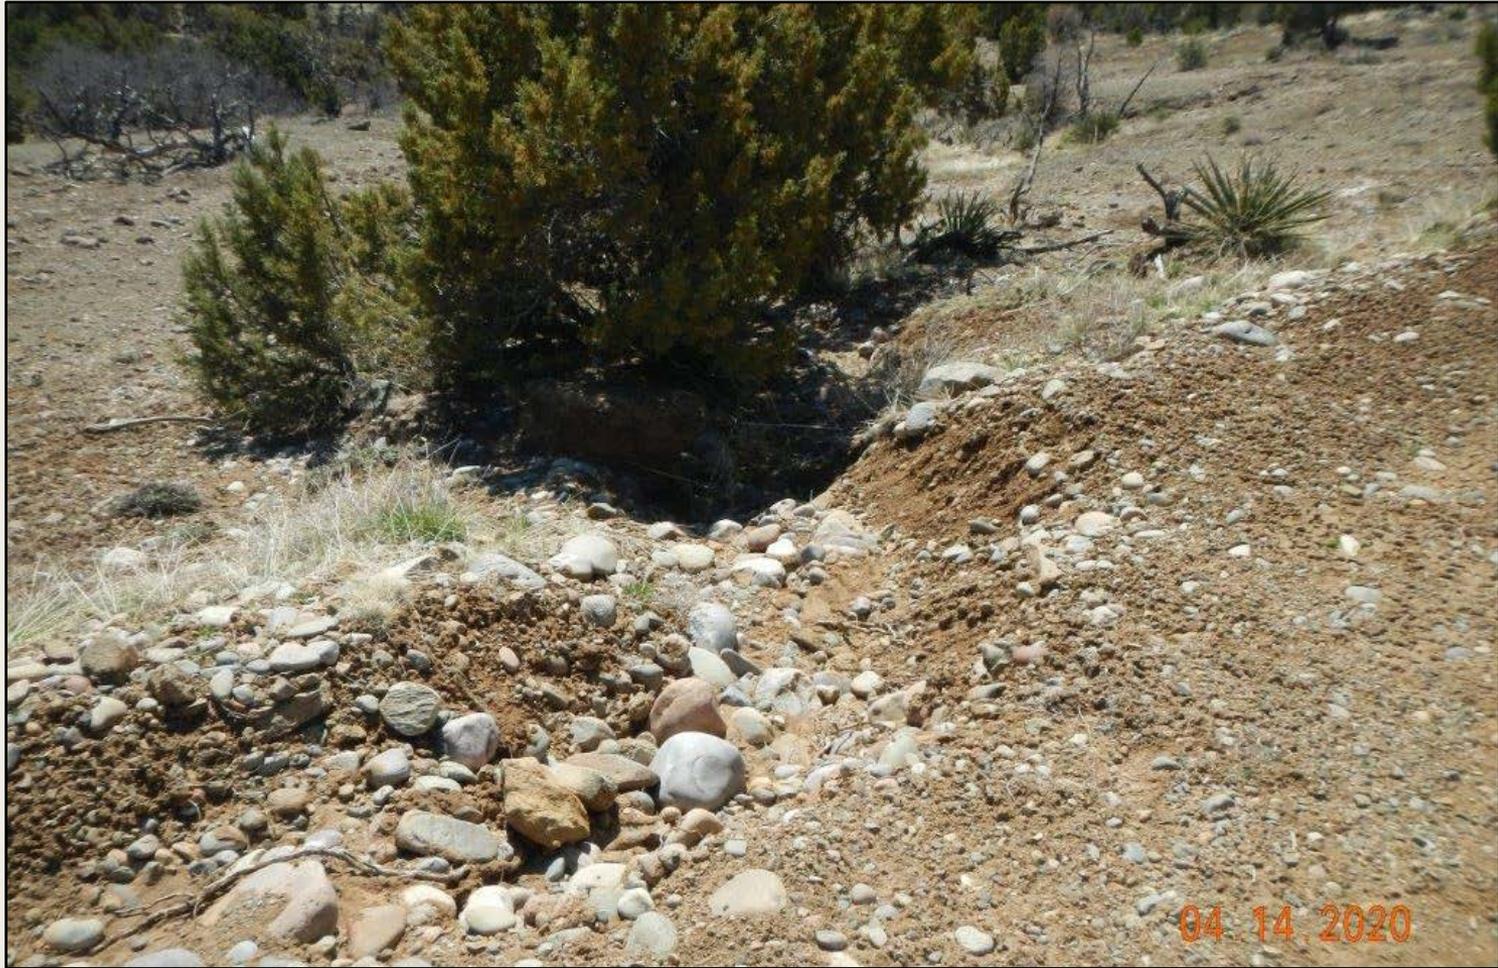
Photo 5. View of another erosional channel flowing off of the access road, that is not stabilized. Approximately 3-4 feet wide and deep.

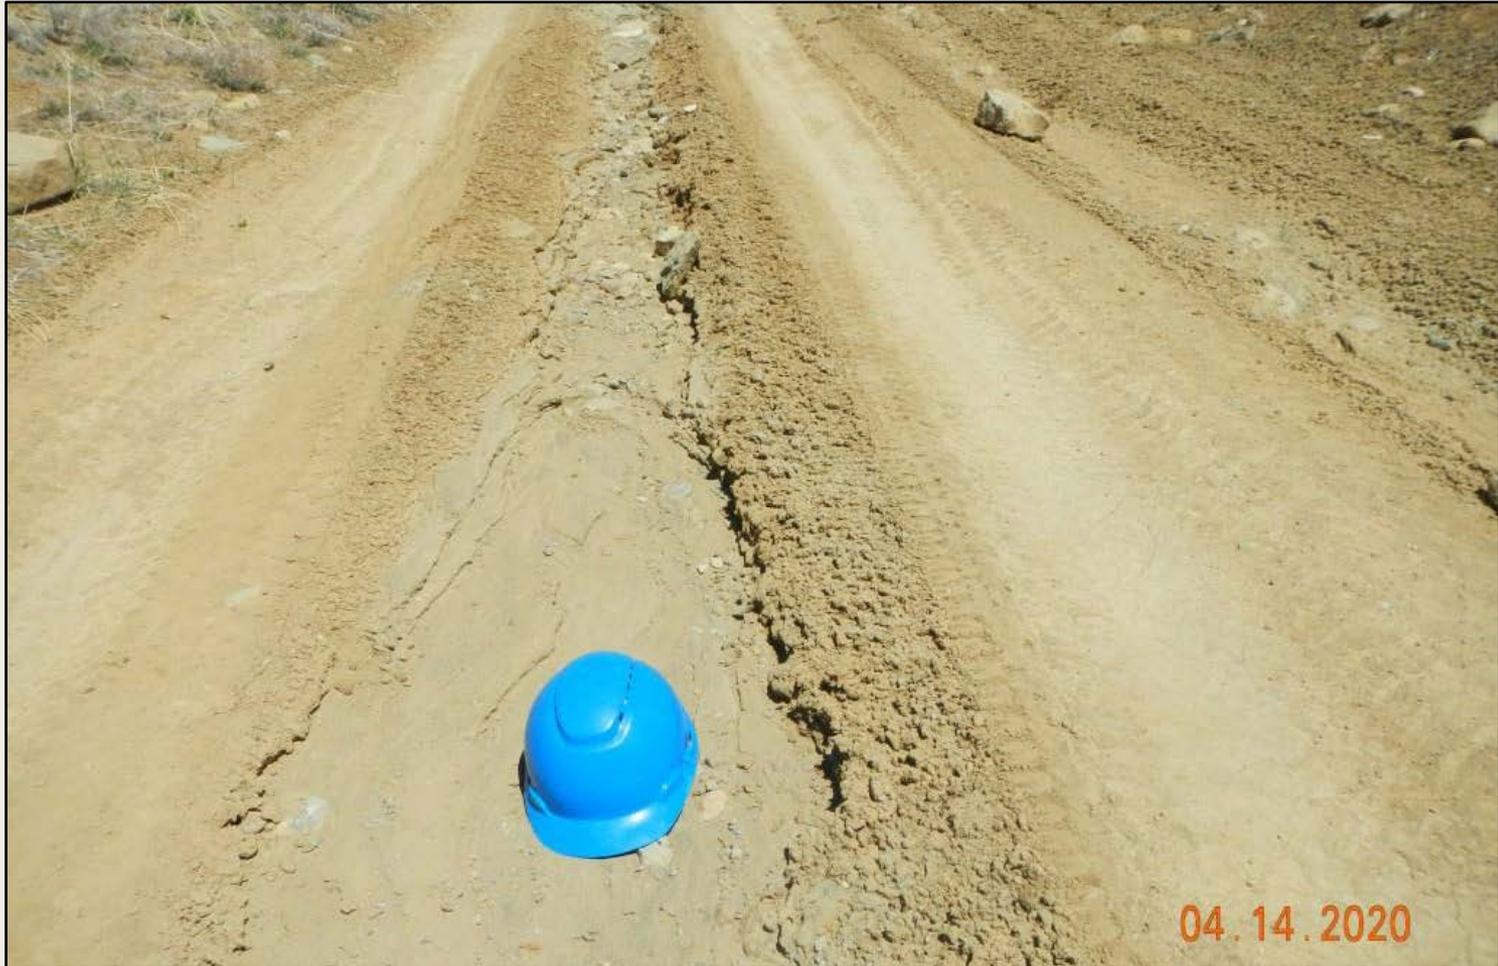
Photo 6. View of rutting and sedimentation on the access road, approximately 1.5 feet deep.

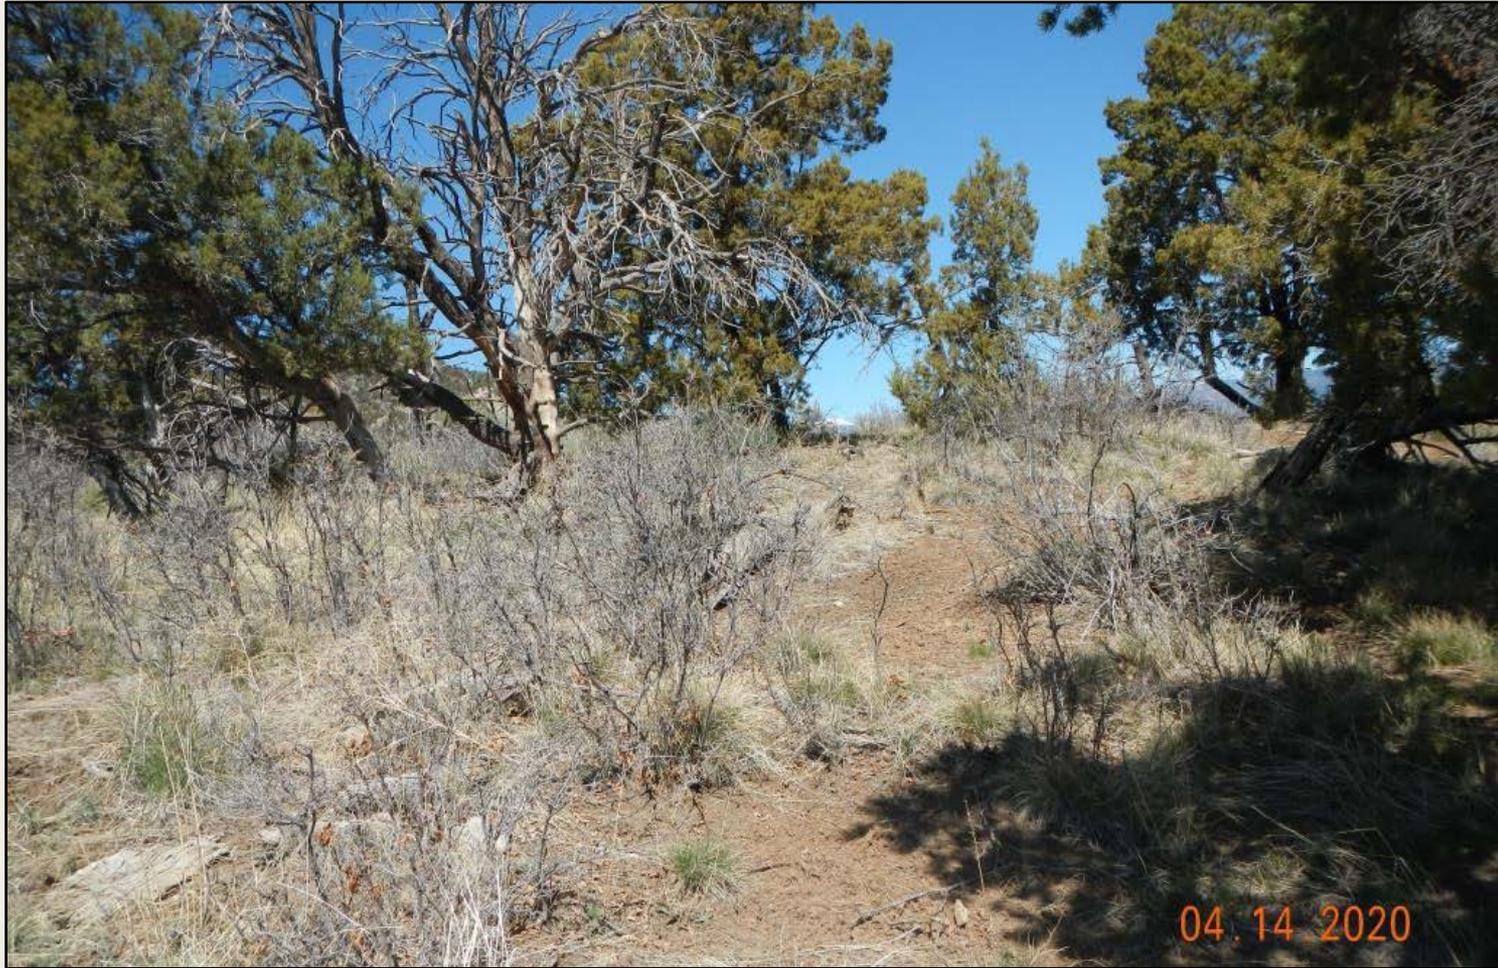
Photo 7. View of reference area, comprised of pinyon-juniper woodland with understory of gambel oak and mountain mahogany with grasses such as Arizona fescue.
