**Inspection Photos**  
**Operator: Enduring Resources**  
**API#: 067-07650**  
**Date: 4/14/2020**

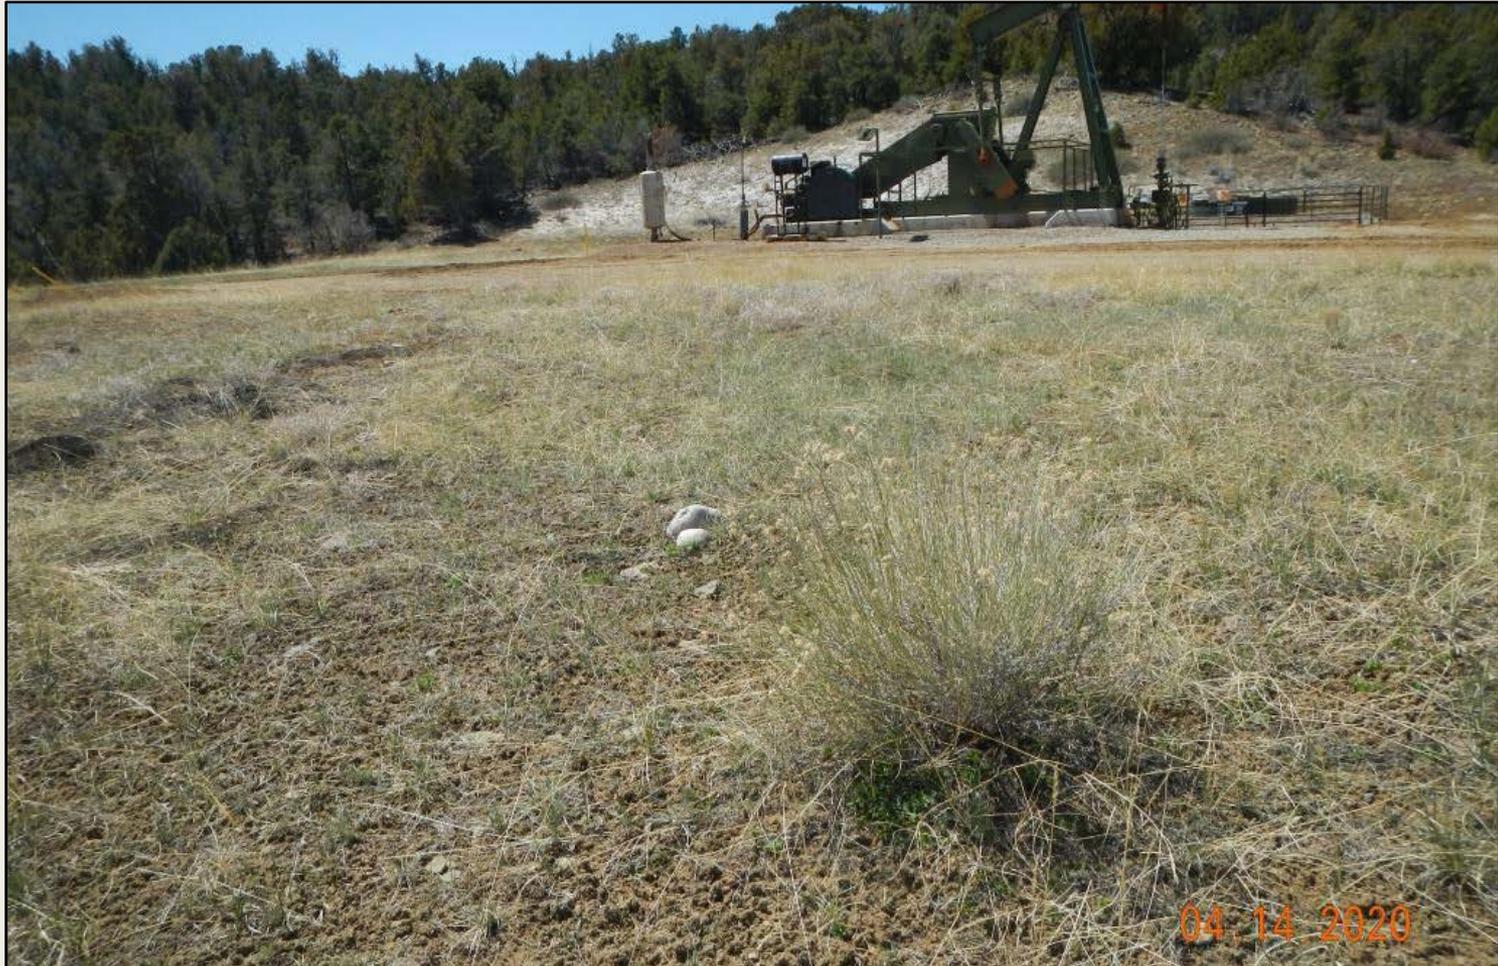
Photo 1. View of the project area from the northeastern corner facing center.

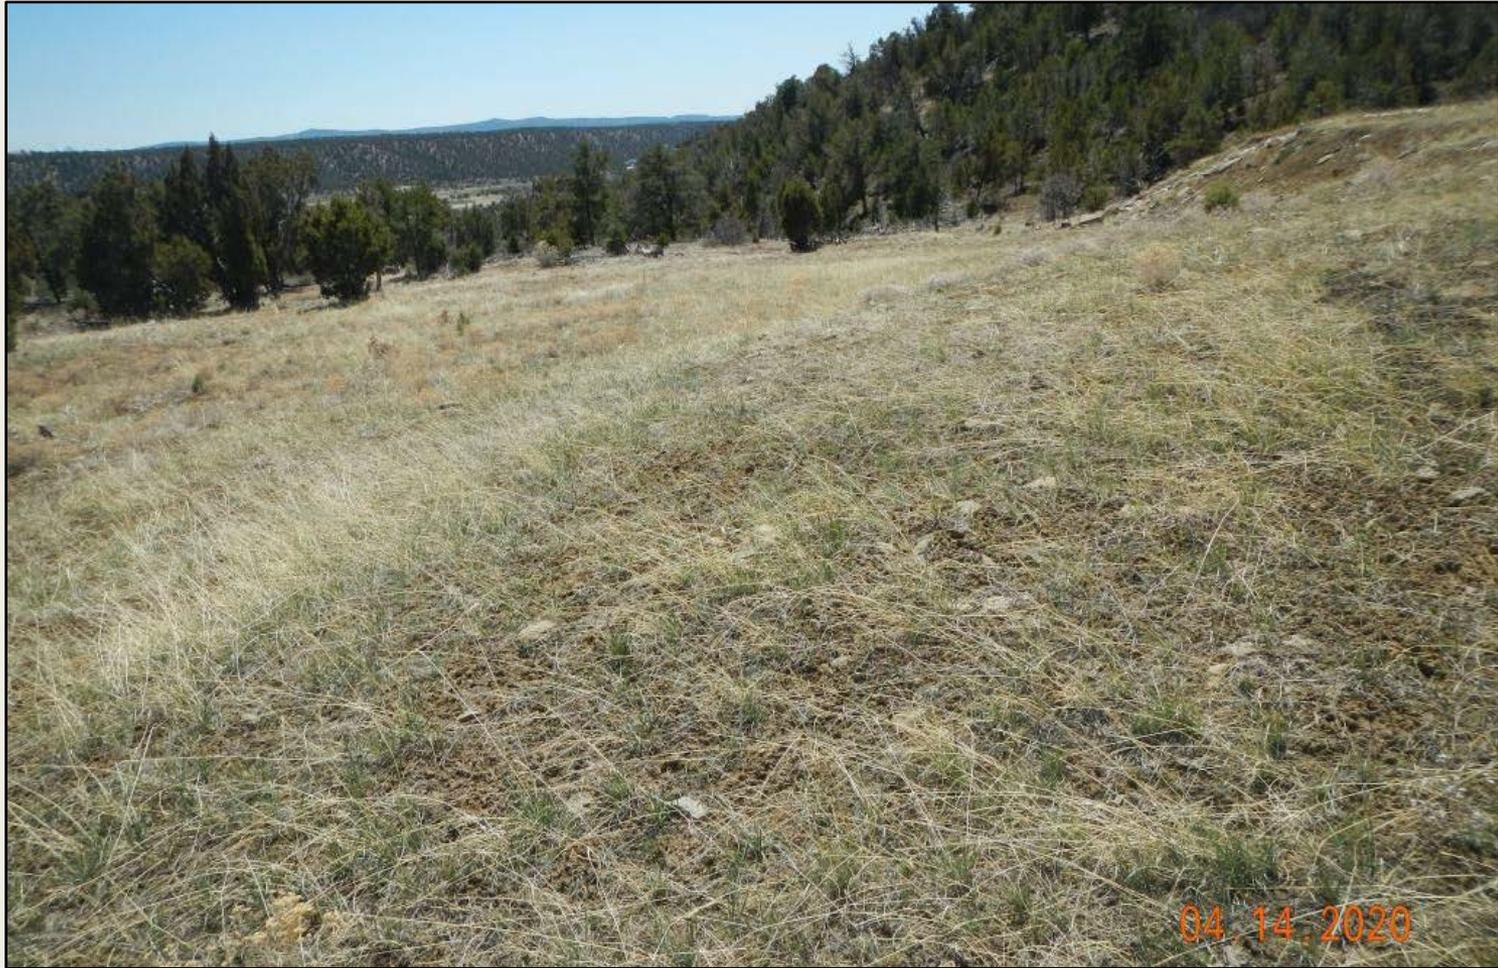
Photo 2. View of the eastern fill slope from the northeastern corner facing southward. Revegetation is progressing with grasses such as western wheatgrass and sand dropseed.

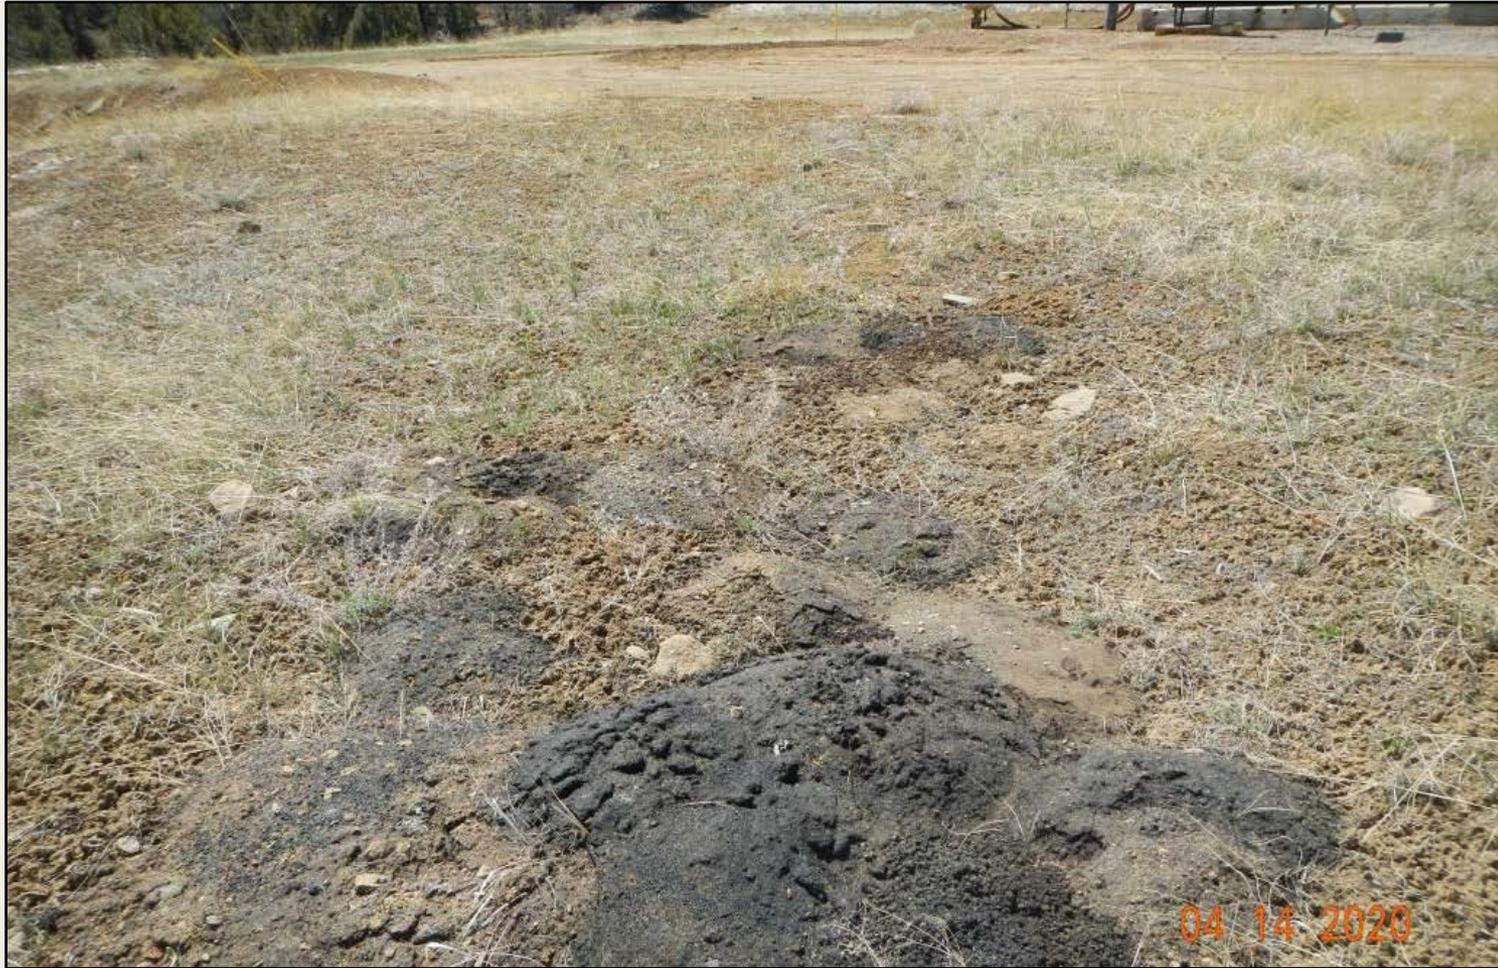
Photo 3. View of the stained soils (approx. 5 feet wide and 10 feet long) placed in the eastern interim reclamation area.

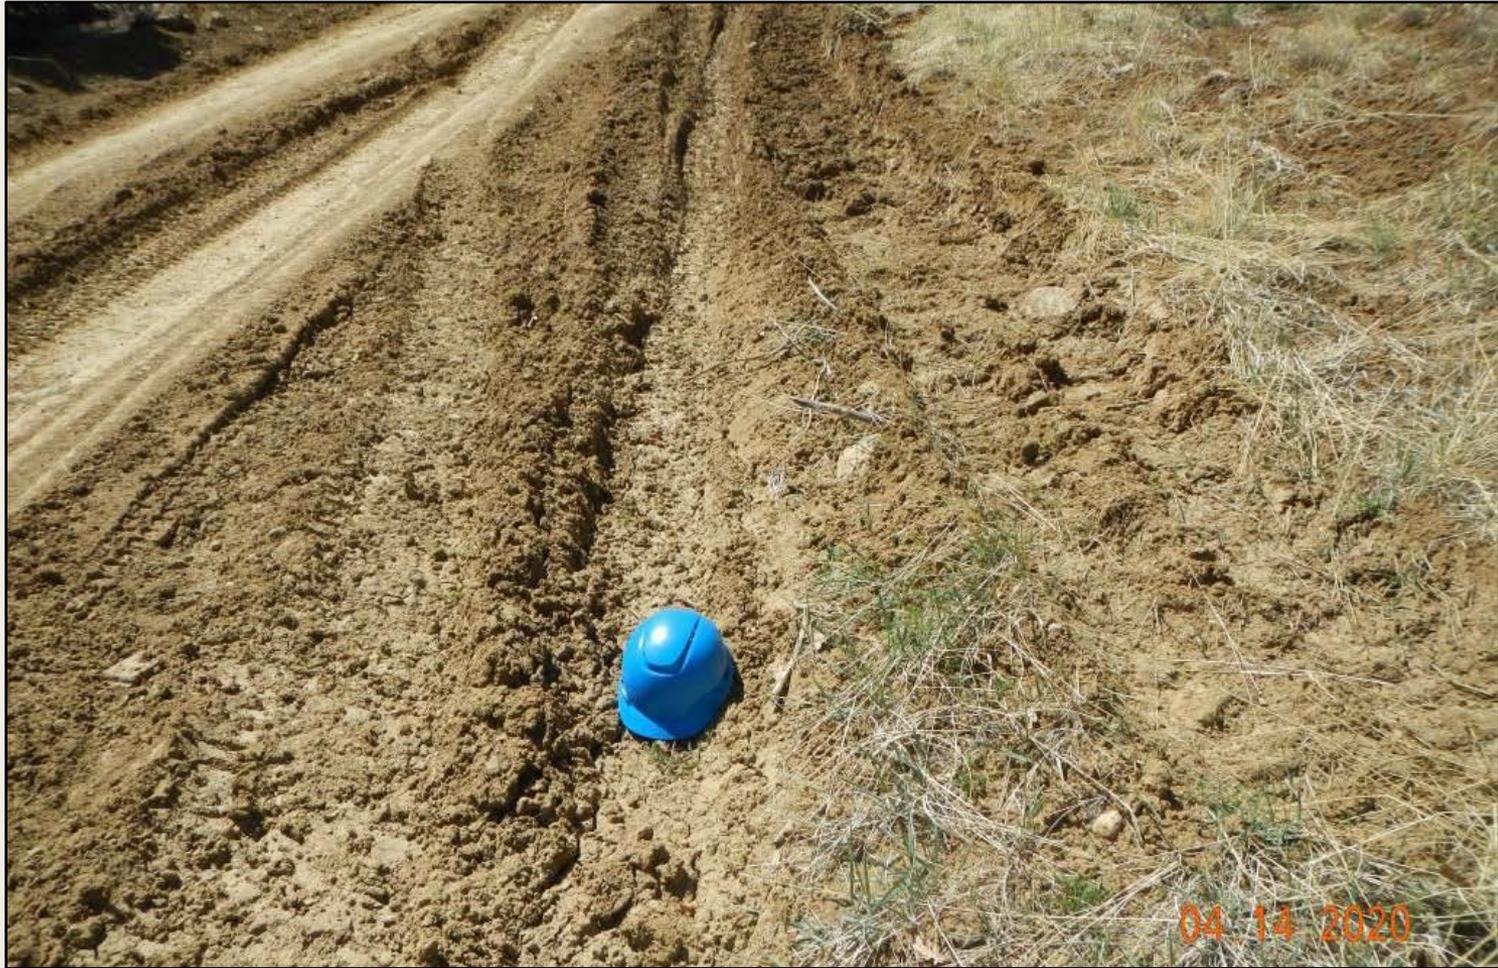
Photo 4. View of deep rutting (approx. 1.5 ft deep) and evidence of vegetation damage along the access road.

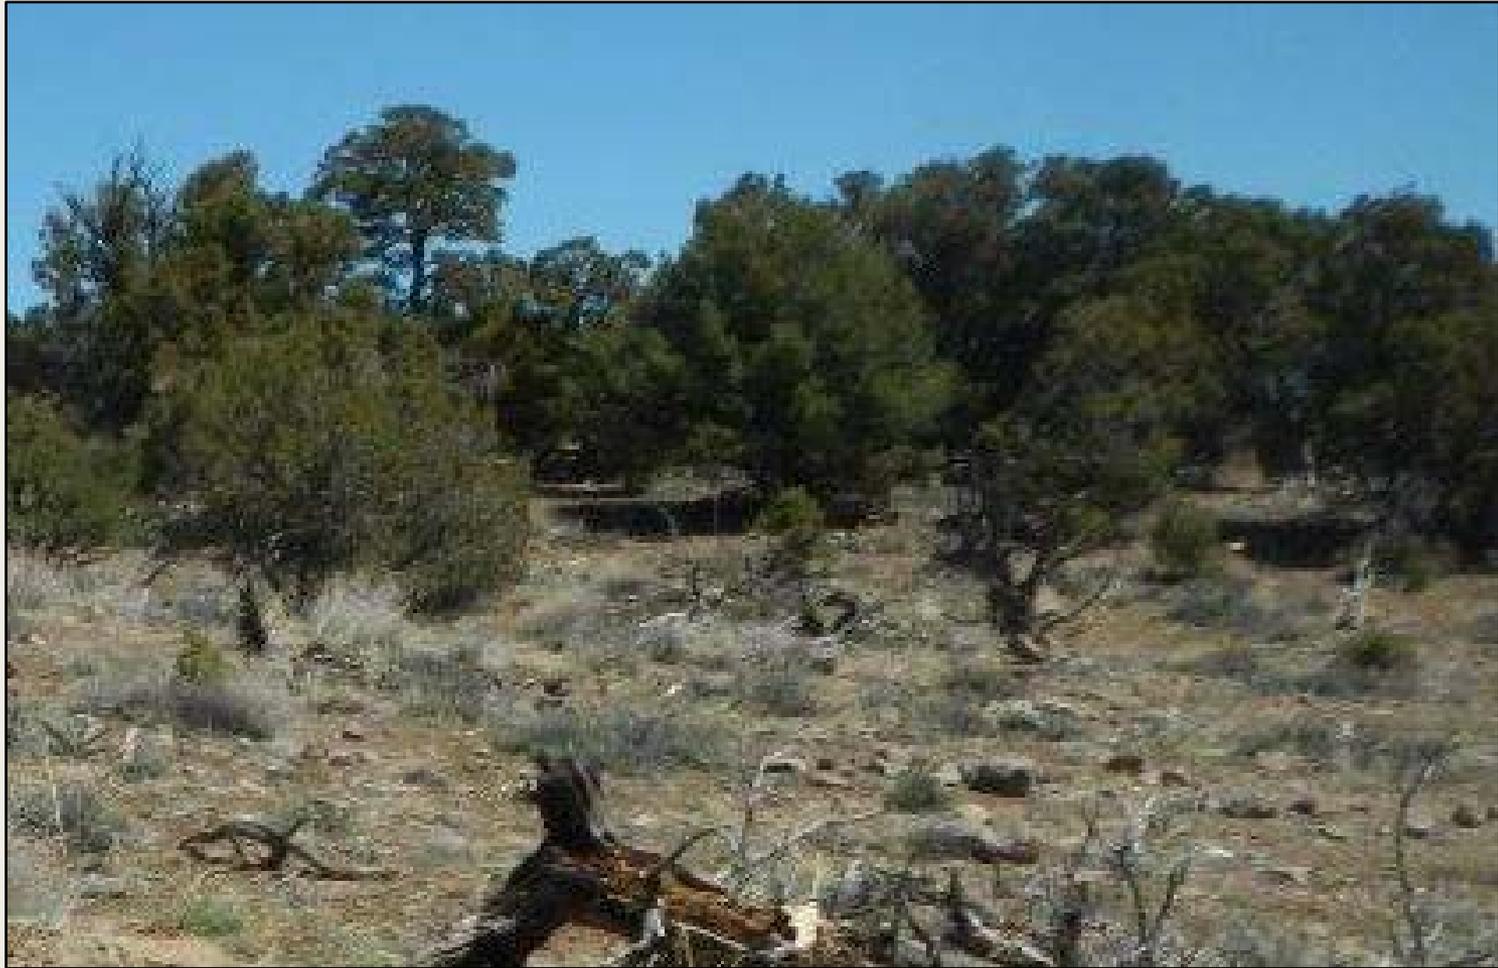
Photo 5. View of reference area, comprised of pinyon-juniper woodland with understory of sagebrush, antelope bitterbrush, and a mixture of grasses and forbs.
