# Inspection Photos

Location Name: GOLDEN EAGLE 21-04

API#: 05-071-08425

INSP. #: 695102714

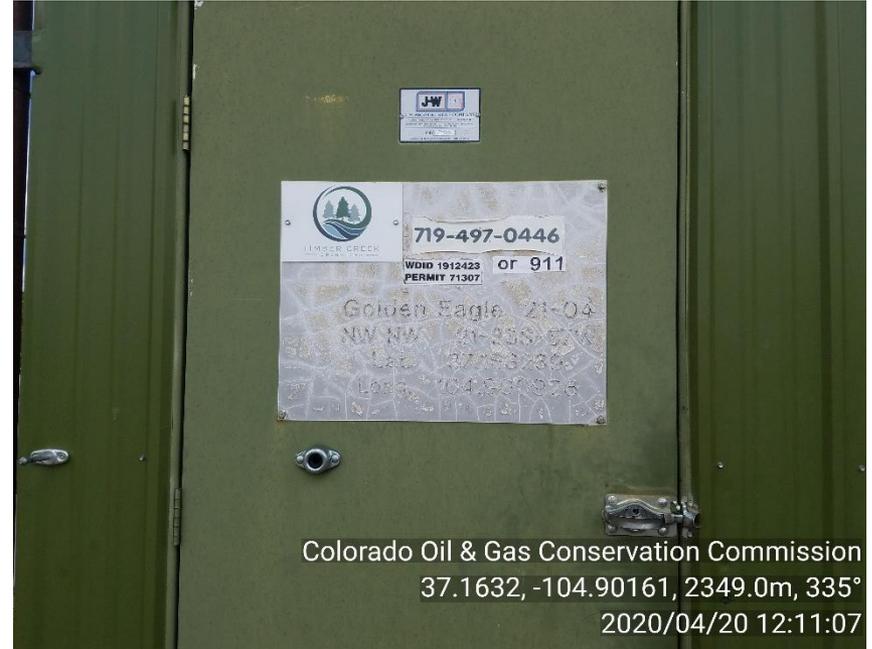
**PHOTO 2: WELL SIGN/ POSTED SIGN NOT LEGIBLE. **COMPLY WITH RULE 210.b. CA DATE 6-20-20.****

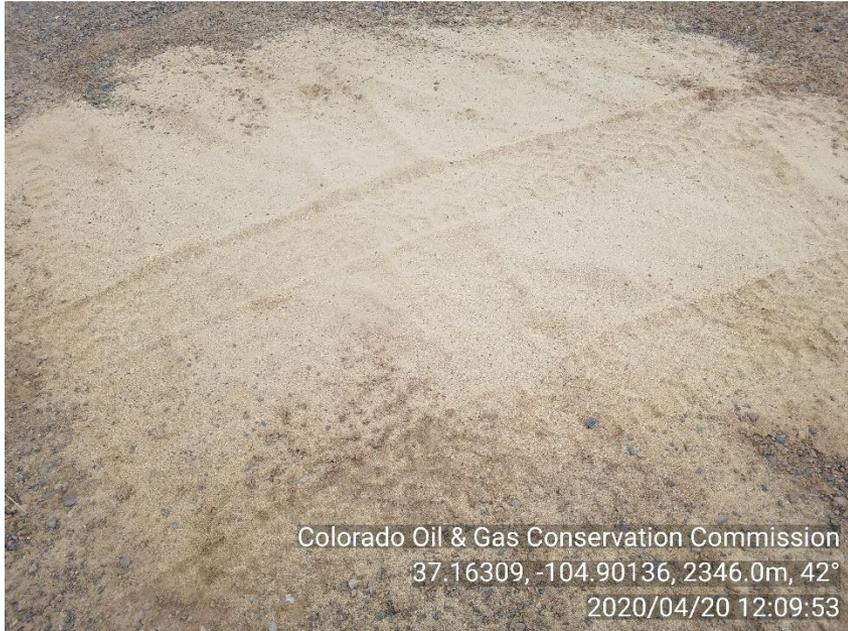
### PHOTO 3: APPEARS TO BE FRAC SAND ON LOCATION.

**Immediately comply with material handling and guidance per MSDS or product data sheet. Submit document, procedures, and waste disposal manifest to COGCC field inspector. Notify area EPS within 24-hrs and report to other agencies as appropriate. CA DATE 4-30-20.**

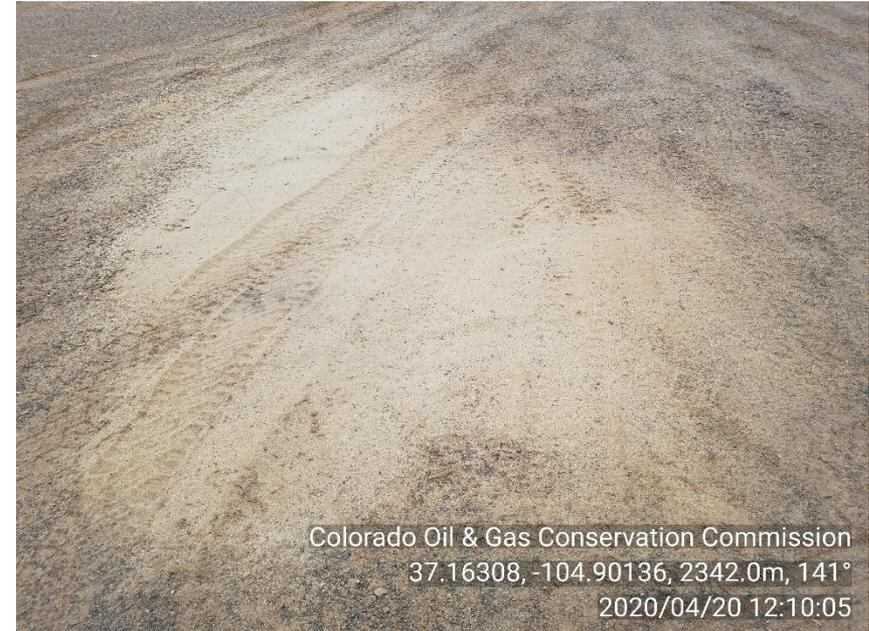
### PHOTO 4: APPEARS TO BE FRAC SAND ON LOCATION.

**Immediately comply with material handling and guidance per MSDS or product data sheet. Submit document, procedures, and waste disposal manifest to COGCC field inspector. Notify area EPS within 24-hrs and report to other agencies as appropriate. CA DATE 4-30-20.**

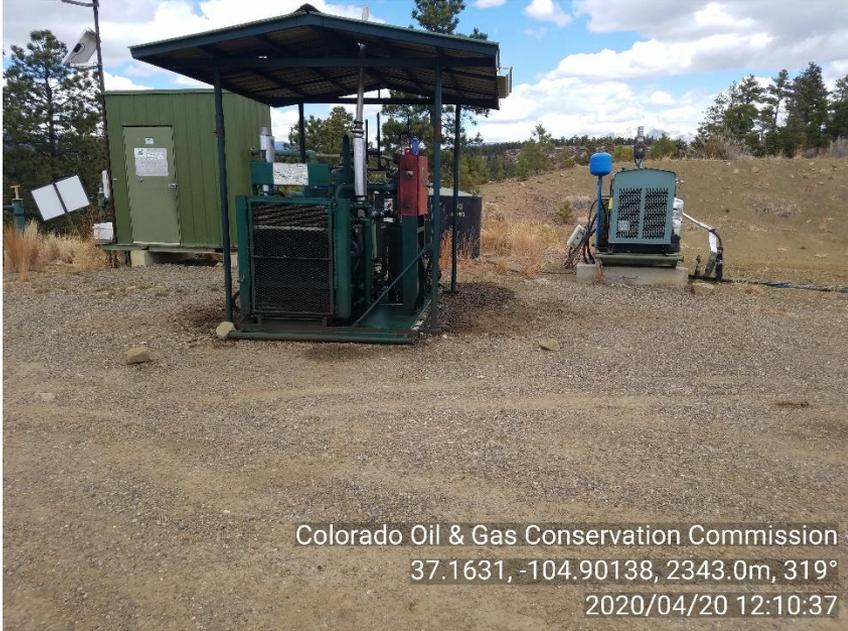
**PHOTO 5: AREA OF IMPACTED SOIL AROUND COMPRESSOR SKID. Conduct maintenance on equipment, cleanup stained material and review self inspection processes. CA DATE 4-25-20.**

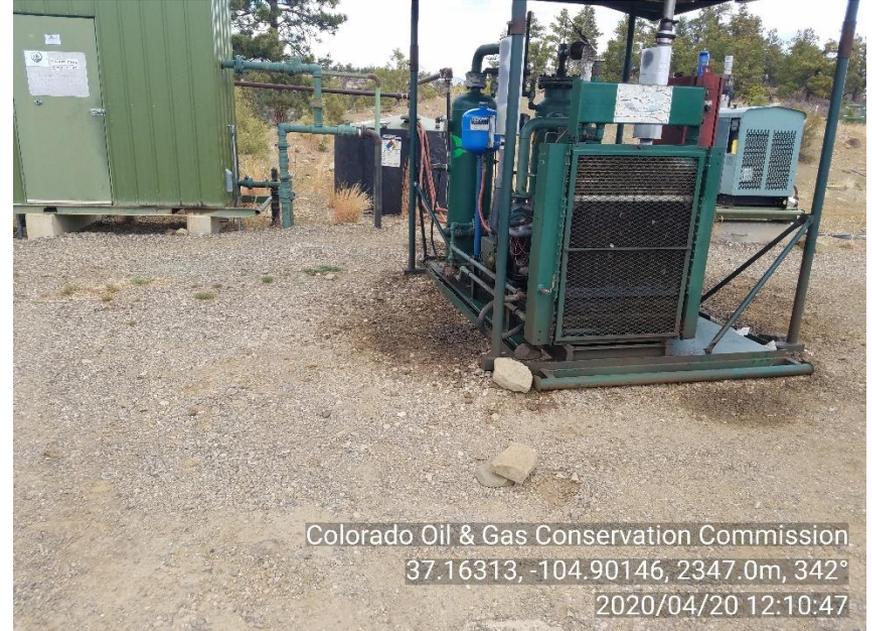
**PHOTO 6: AREA OF IMPACTED SOIL AROUND COMPRESSOR SKID. Conduct maintenance on equipment, cleanup stained material and review self inspection processes. CA DATE 4-25-20.**

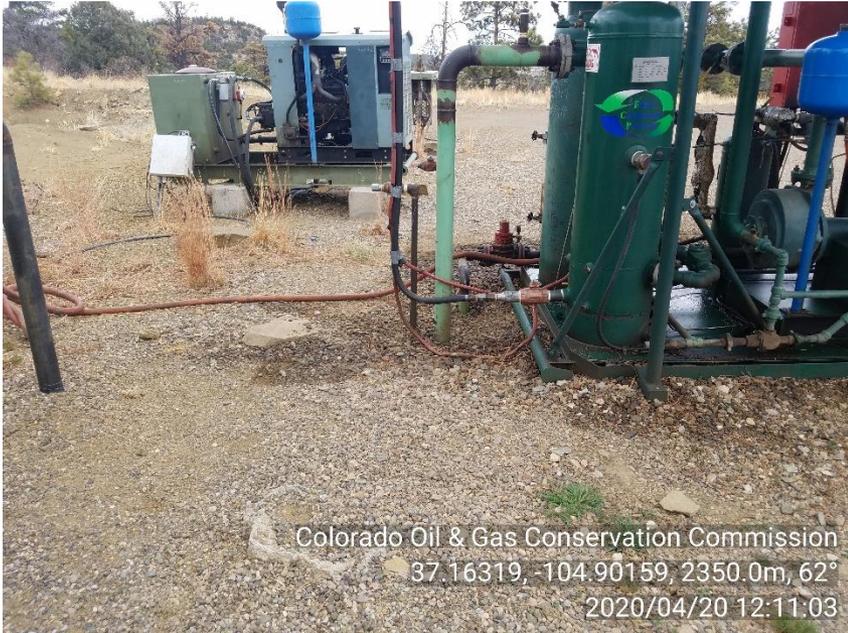
**PHOTO 7: AREA OF IMPACTED SOIL AROUND COMPRESSOR SKID. Conduct maintenance on equipment, cleanup stained material and review self inspection processes. CA DATE 4-25-20.**

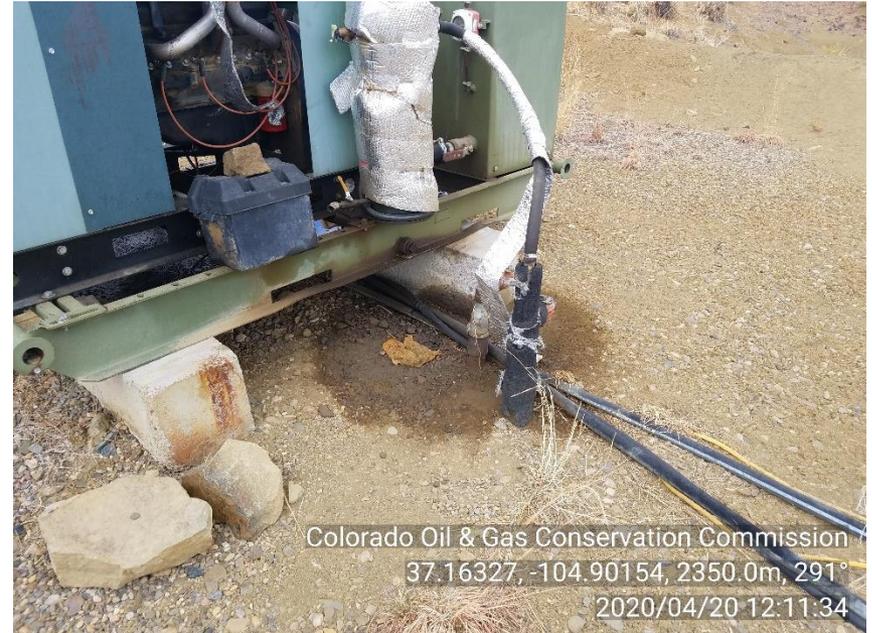
**PHOTO 8: AREA OF IMPACTED SOIL AROUND ENGINE SKID. Conduct maintenance on equipment, cleanup stained material and review self inspection processes. CA DATE 4-25-20.**

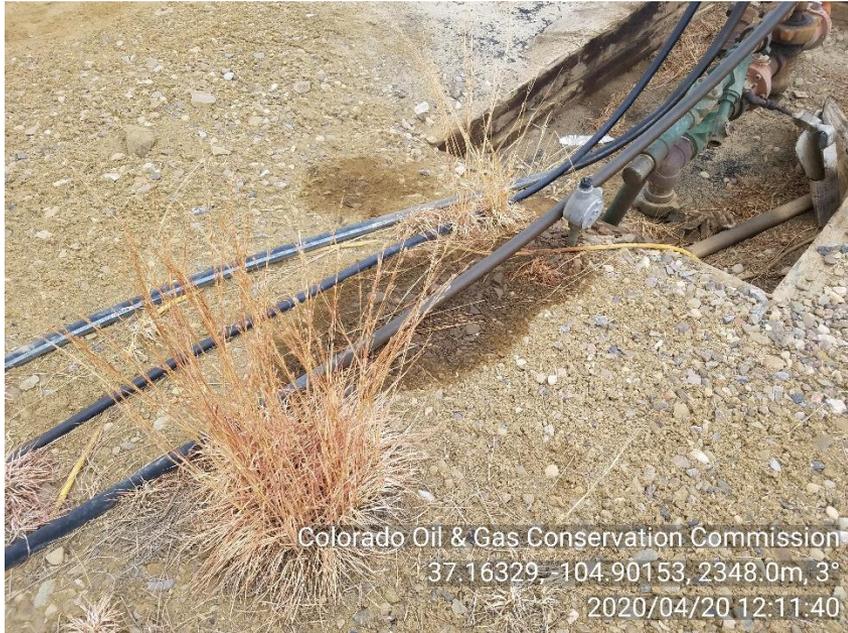
**PHOTO 7: AREA OF IMPACTED SOIL NEAR WELLHEAD APPEARS TO BE FROM HYDRAULIC HOSED. Conduct maintenance on equipment, cleanup stained material and review self inspection processes. CA DATE 4-25-20.**

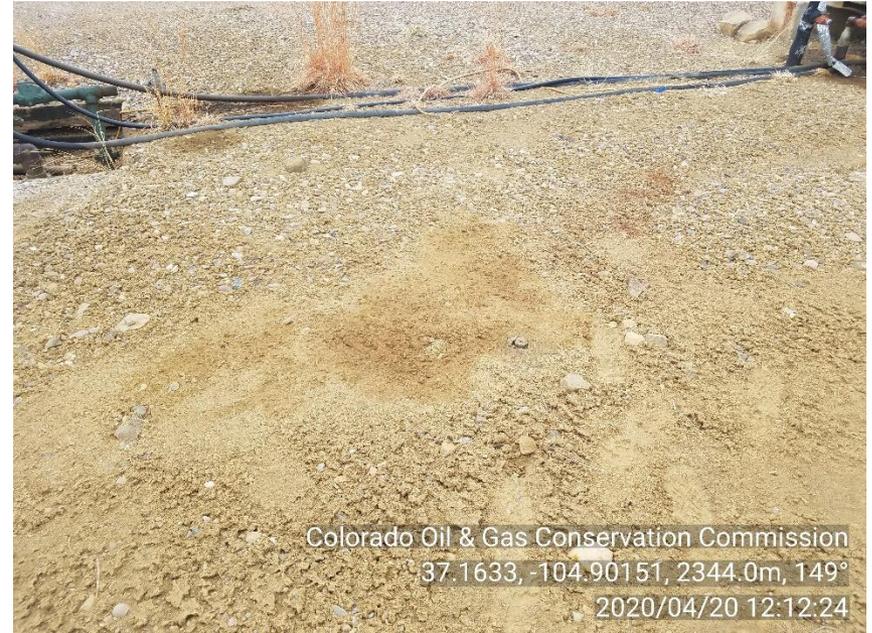
**PHOTO 8: AREA OF IMPACTED SOIL NEAR HYRDAULIC HOSED BETWEEN ENGINE SKID AND WELLHEAD. Conduct maintenance on equipment, cleanup stained material and review self inspection processes. CA DATE 4-25-20.**

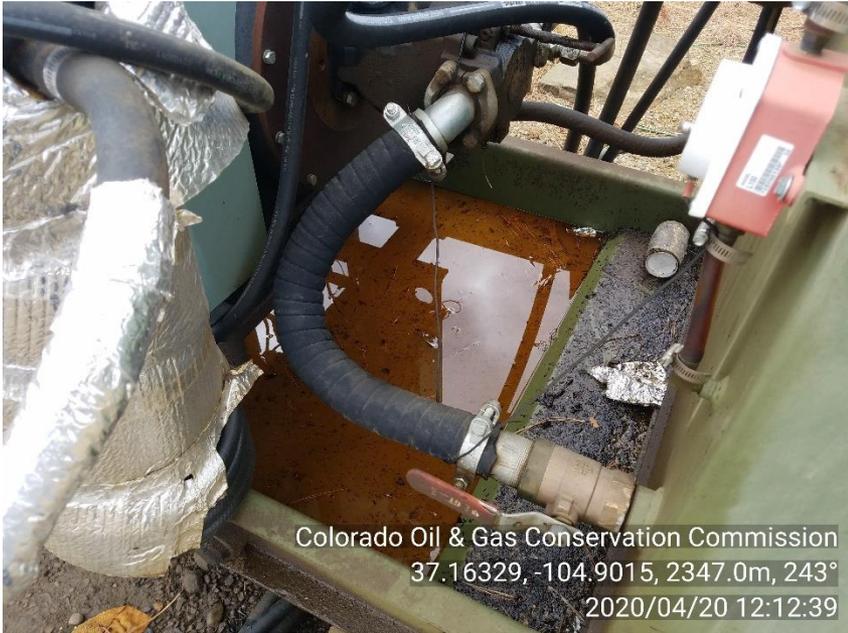
**PHOTO 9: STANDING OILY WATER IN ENGINE SKID. Comply with general provisions of the oil and gas act for wildlife protection. CA DATE 5-20-20.**

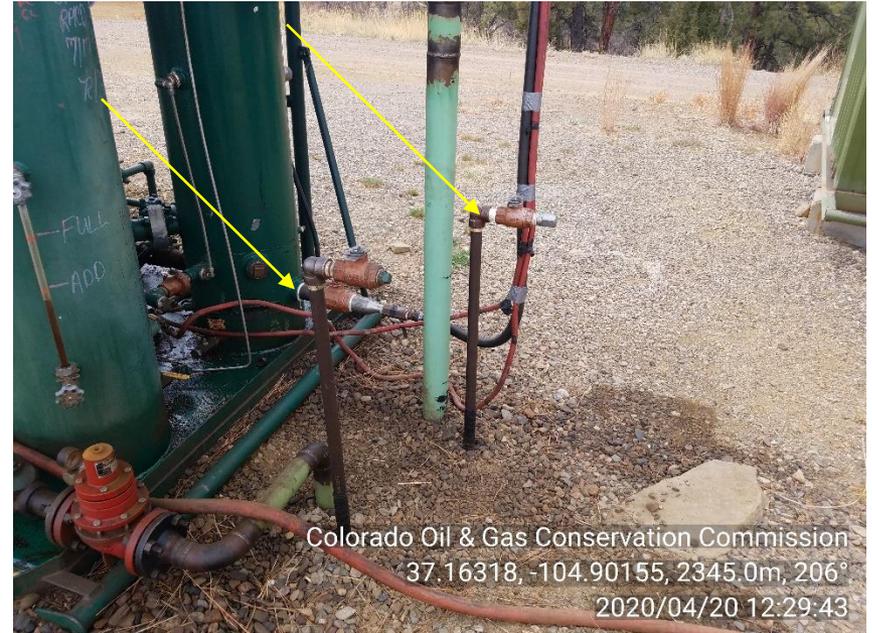
**PHOTO 10: TWO 1" UNUSED RISERS NEAR COMPRESSOR SKID. COMPLY WITH RULE 603.f. CA DATE 5-20-20.**
