**Inspection Photos**  
**Location Name: William D Lansdown unit D #1**  
**Location ID: 318987**

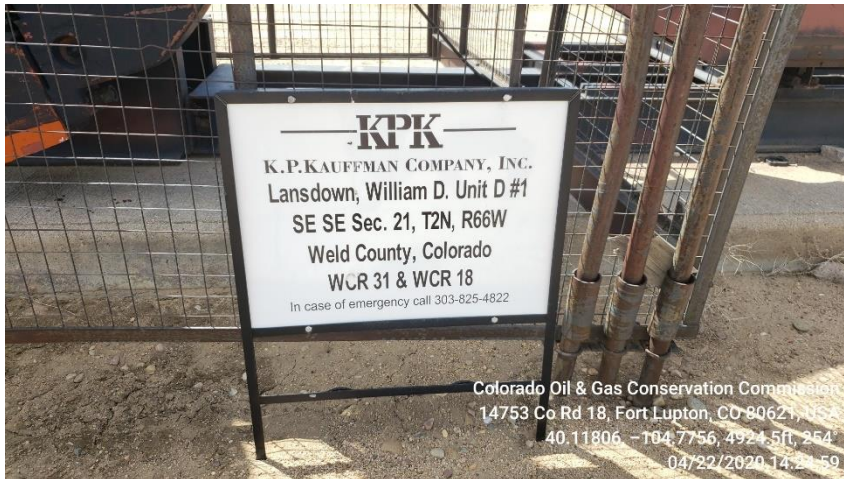
**Photo 1 WH sign**

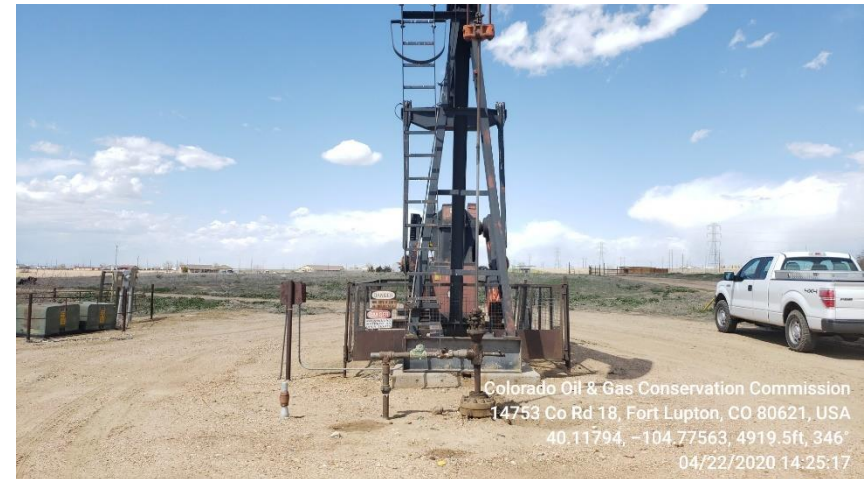
**Photo 2 WH**

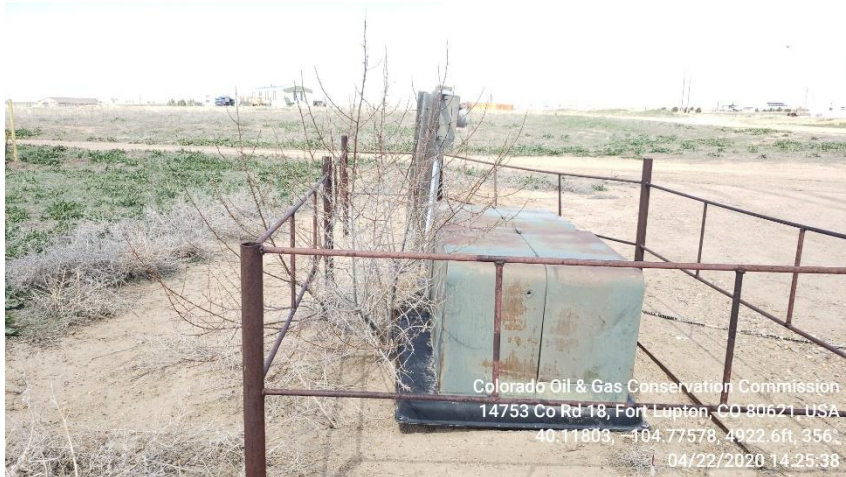
**Photo 3 tree growing under transformer**

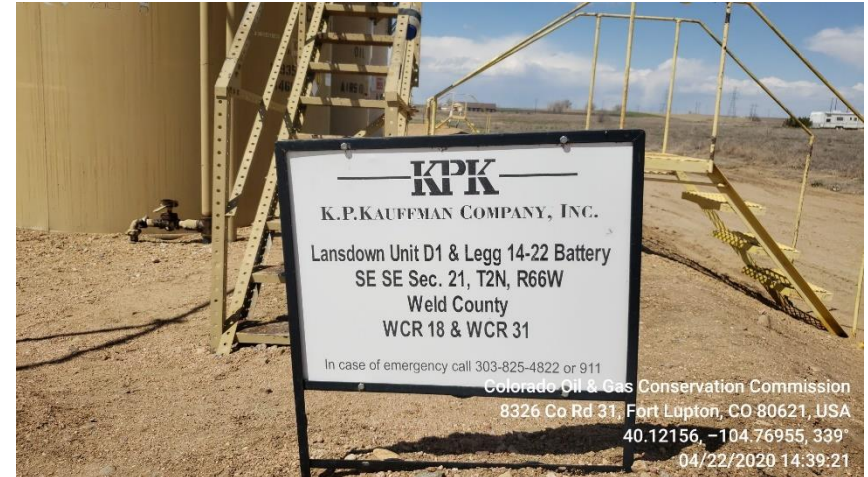
**Photo 4 TB sign**

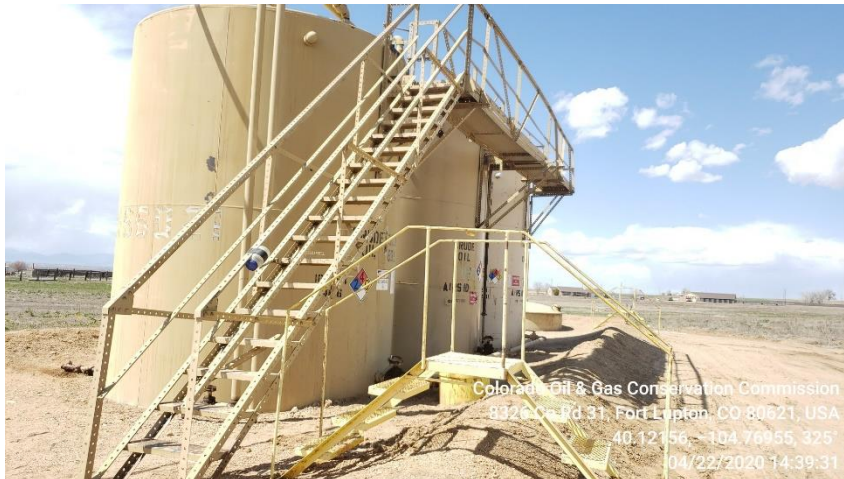
**Photo 5 TB**

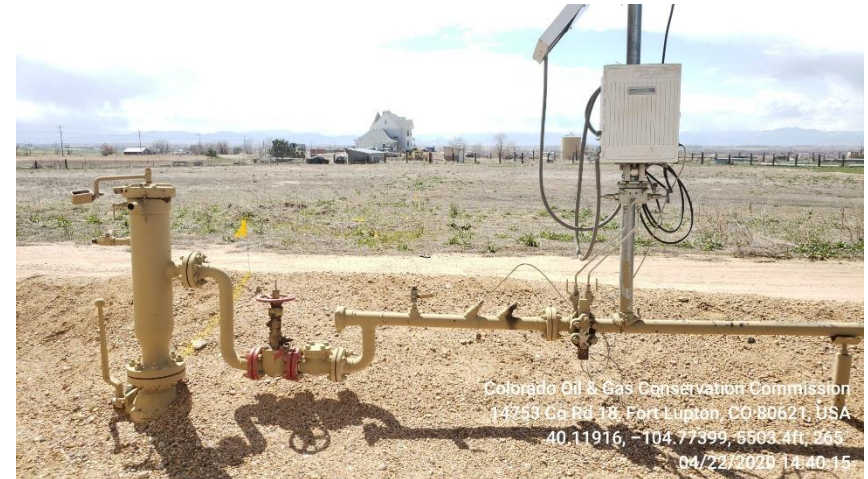
**Photo 6 Gas meter run**

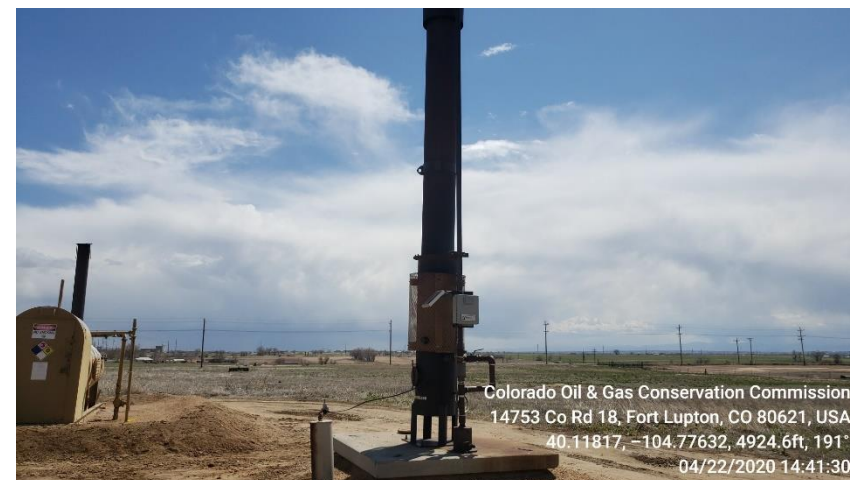
**Photo 8 ECD**

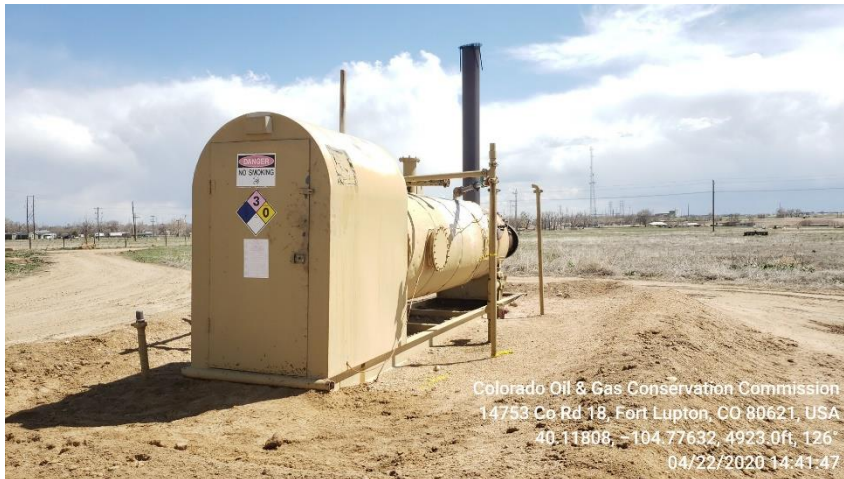
**Photo 9 Horizontal Heated Separator**

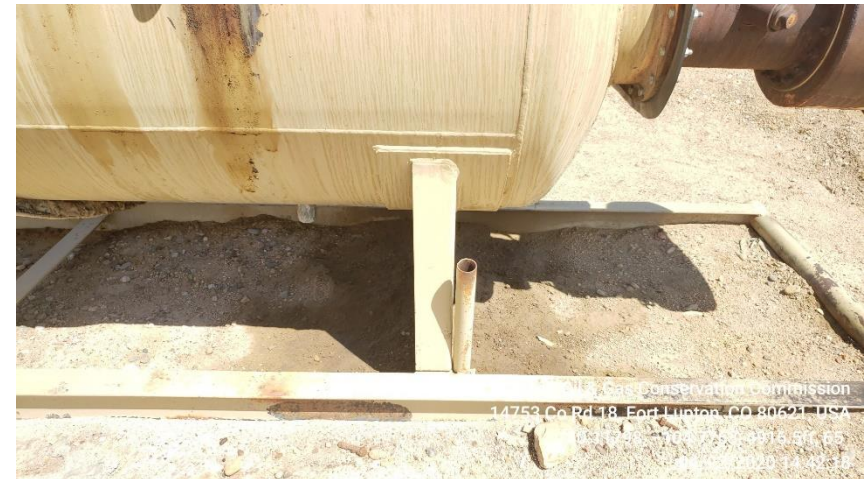
**Photo 10 stained soil under separator**

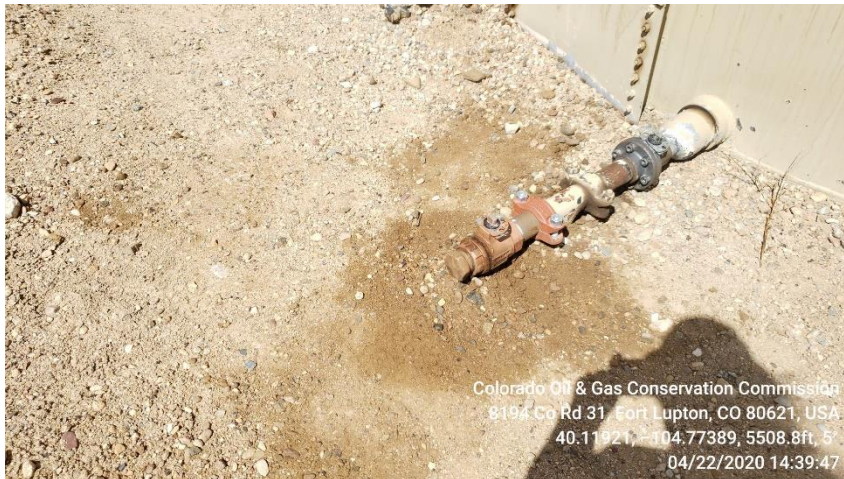
**Photo 11 stained soil under crude tank valve**

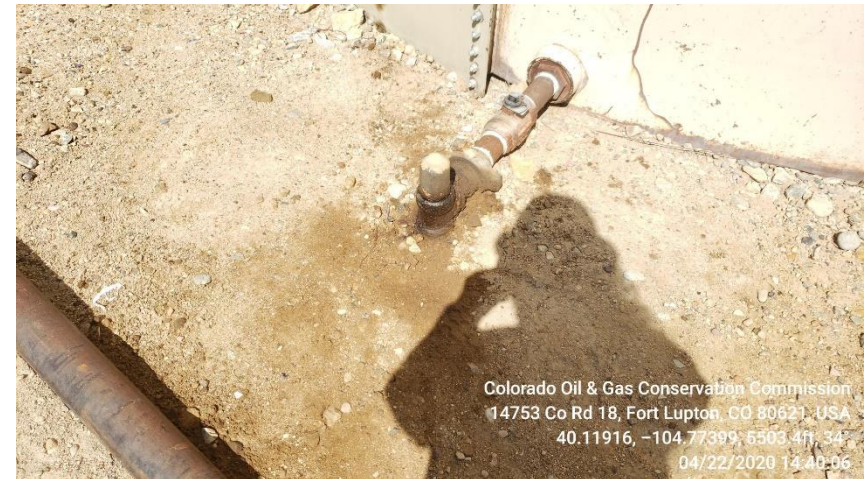
**Photo 12 stained soil by crude tank valve**

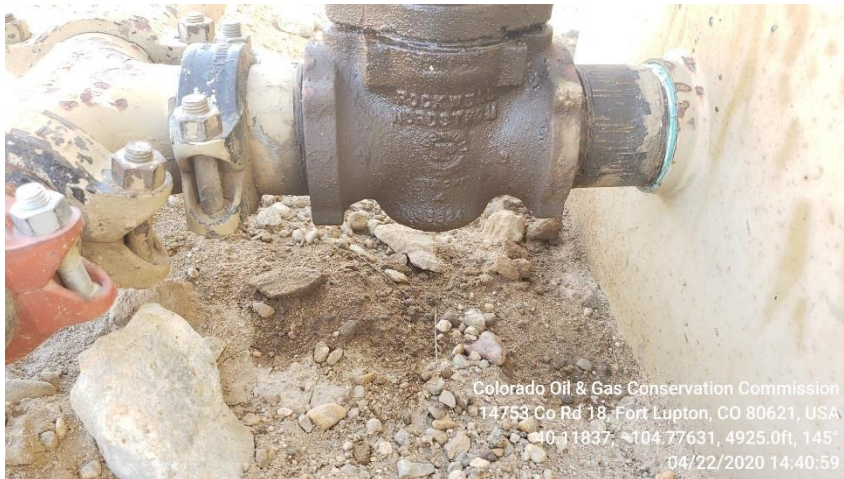
**Photo 13 stained soil under crude tank valve**

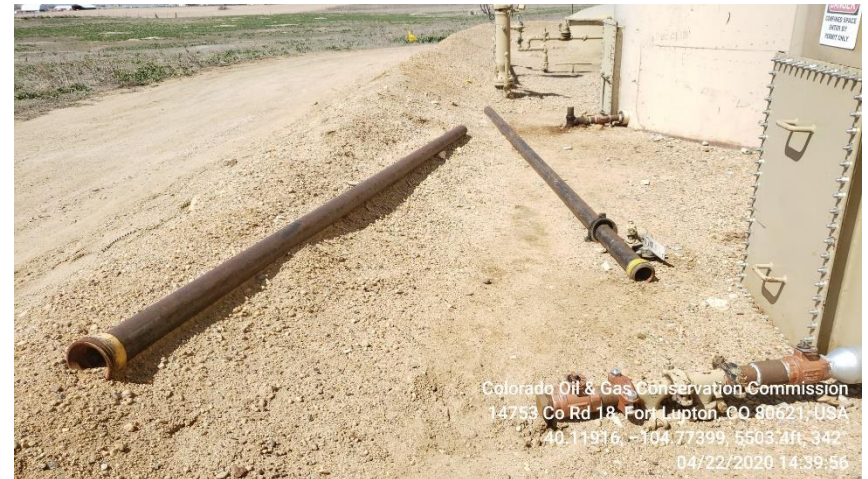
**Photo 14 trash in tank berm**
