Inspection Photos

API: 055-06142

Operator: TABULA RASA ENERGY

Inspection Date: 4/22/2020

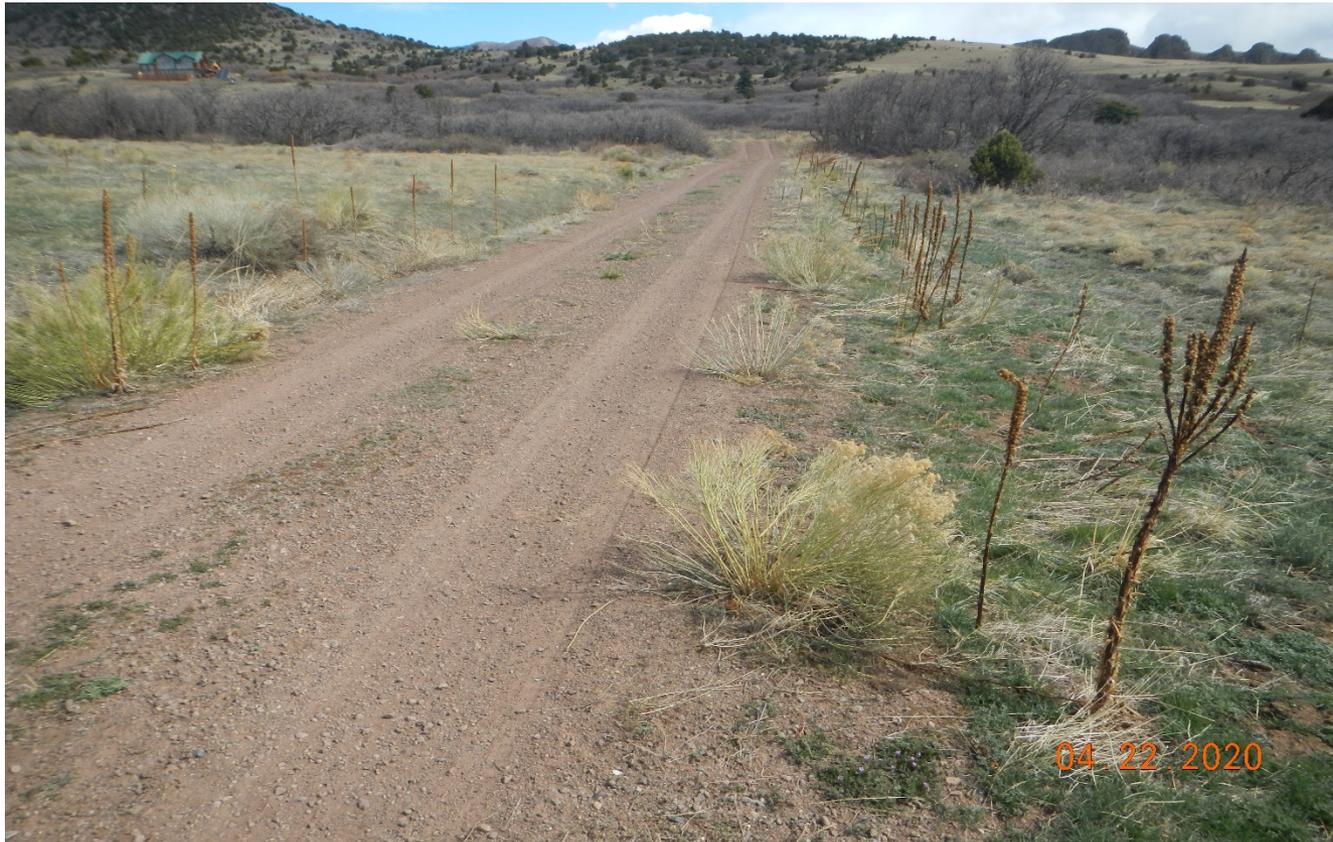
Photo 1. Facing north along the access road which is maintained.

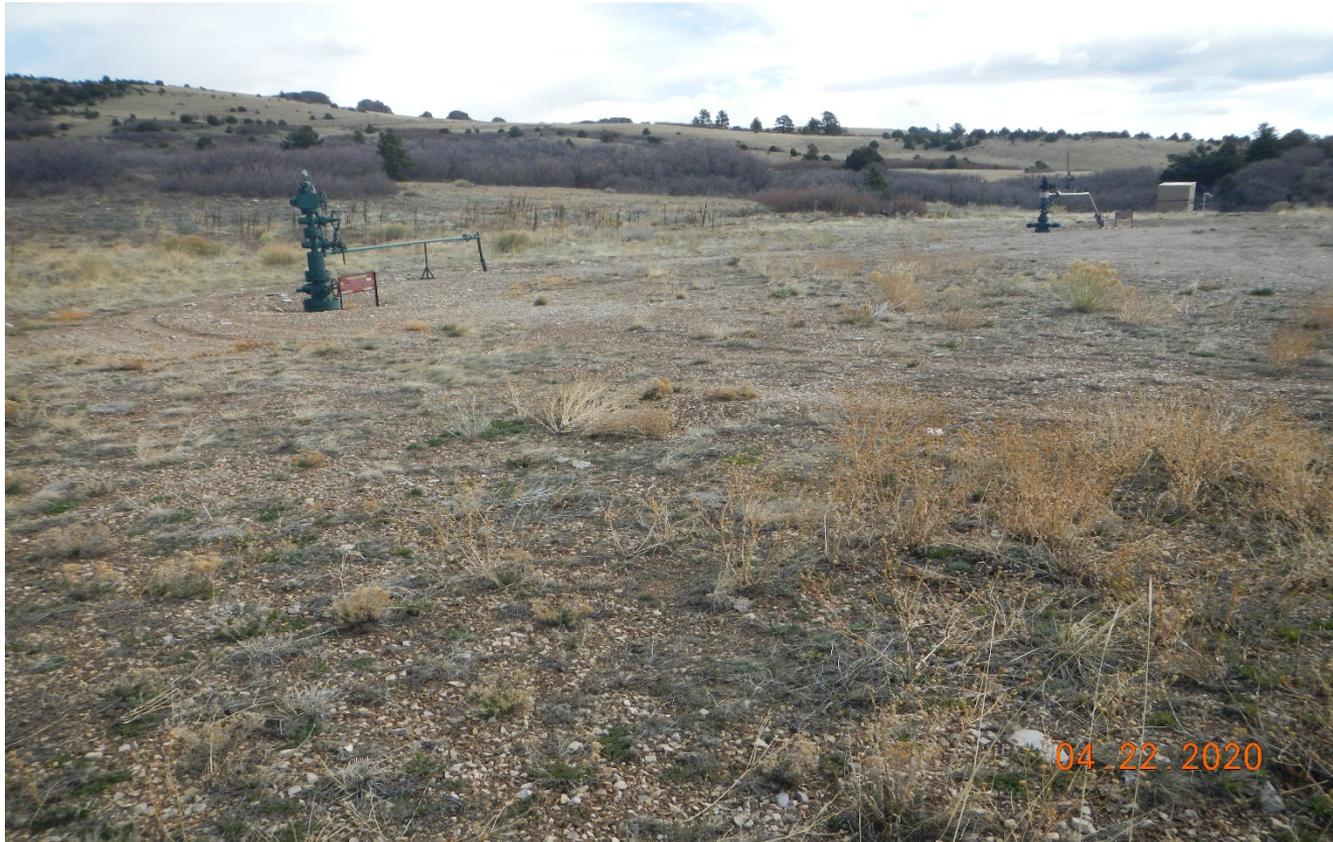
Photo 2. Facing northeast toward the location.

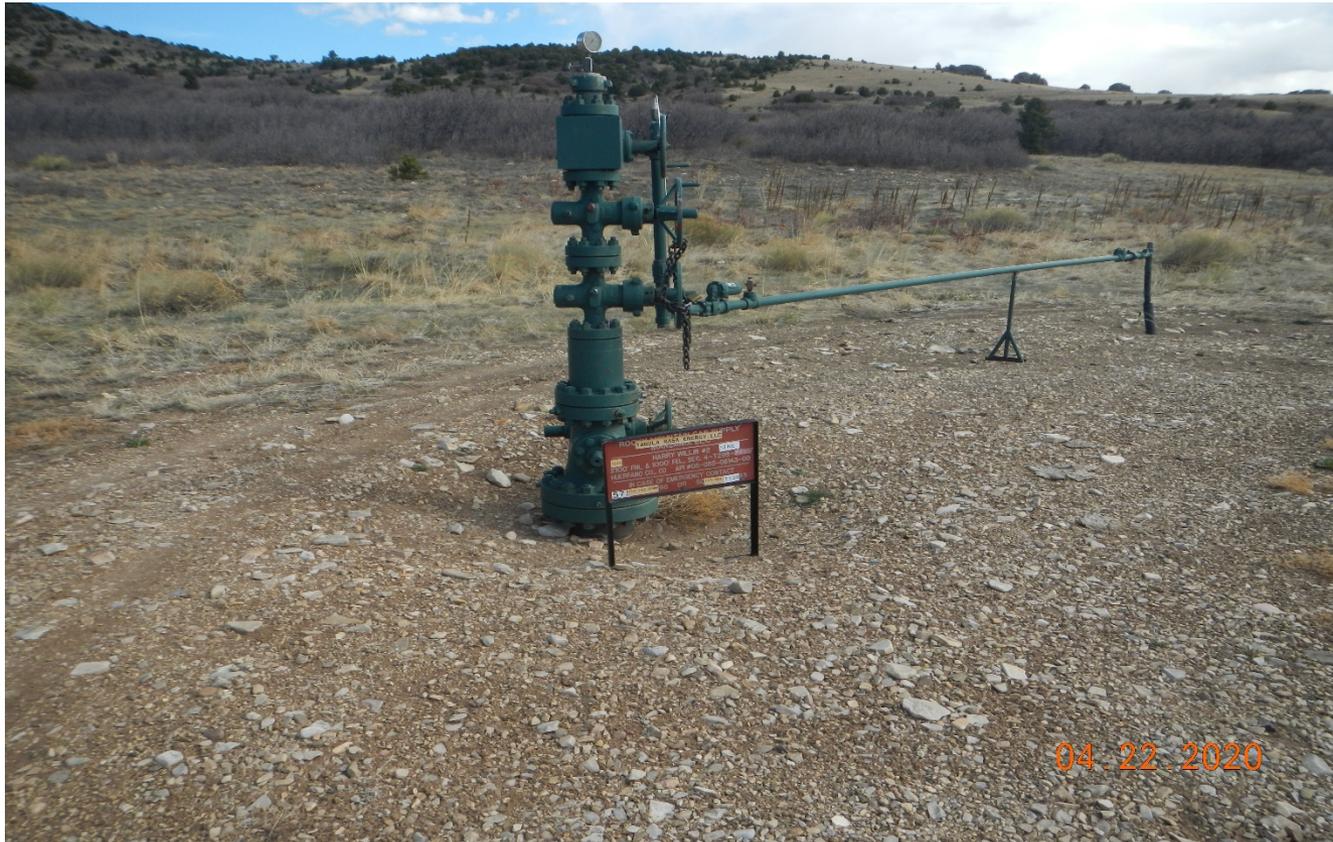
Photo 3. Well sign is posted at the well head. Emergency contact number on the sign needs to be updated.

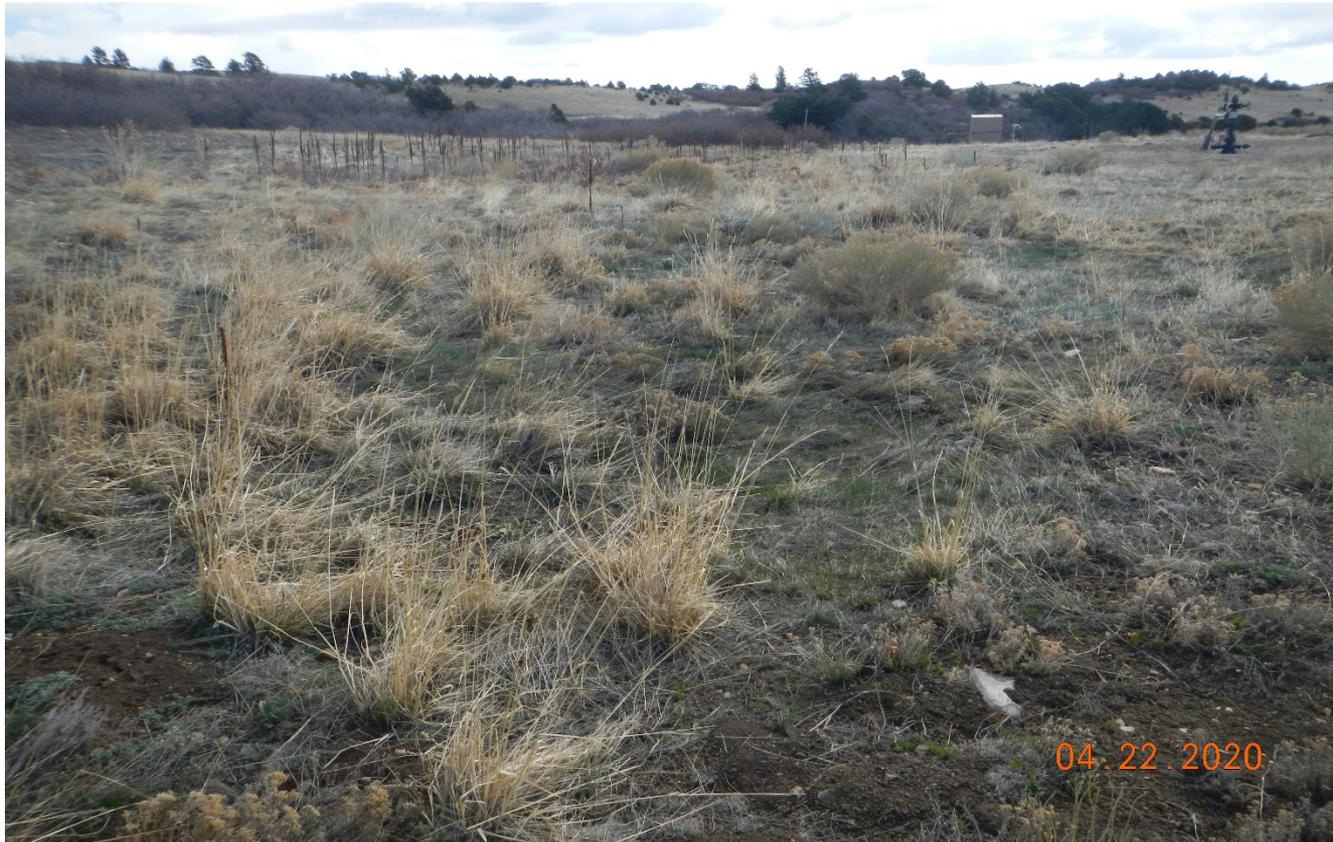
Photo 4. Facing northeast toward the interim reclamation area.

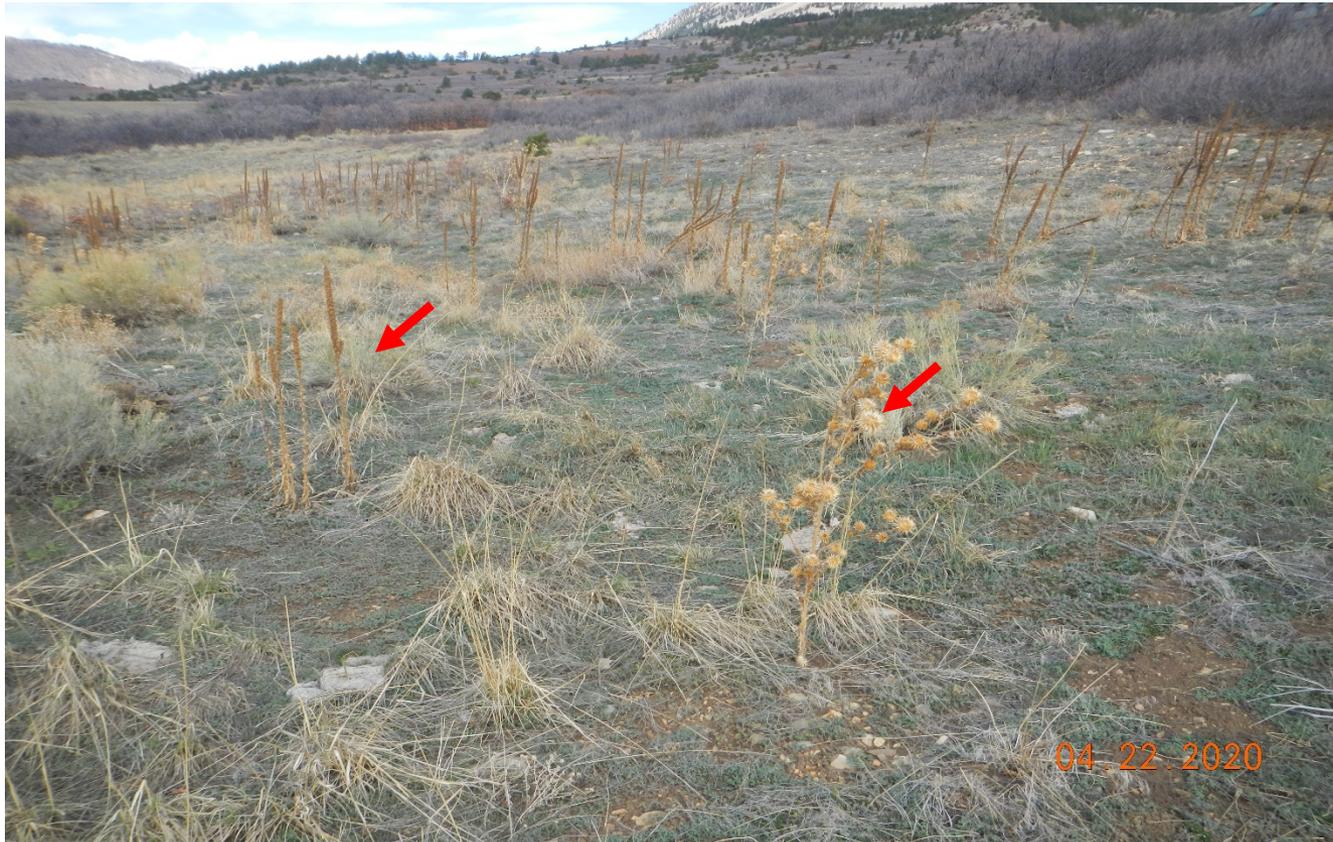
Photo 5. There are some noxious weeds along the north side of the location. Arrows points to Common mullein and Musk thistle.

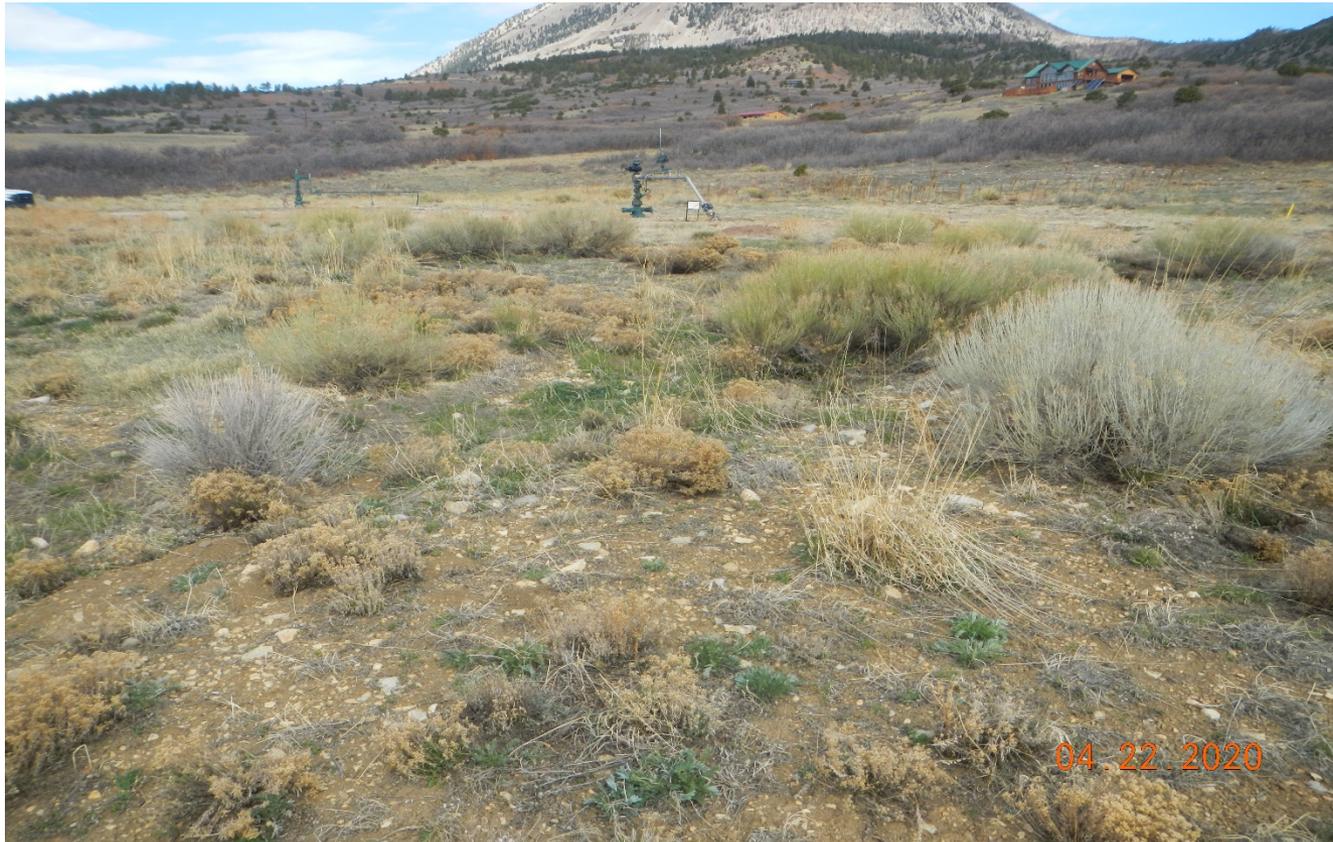
Photo 6. Facing northwest toward the location.

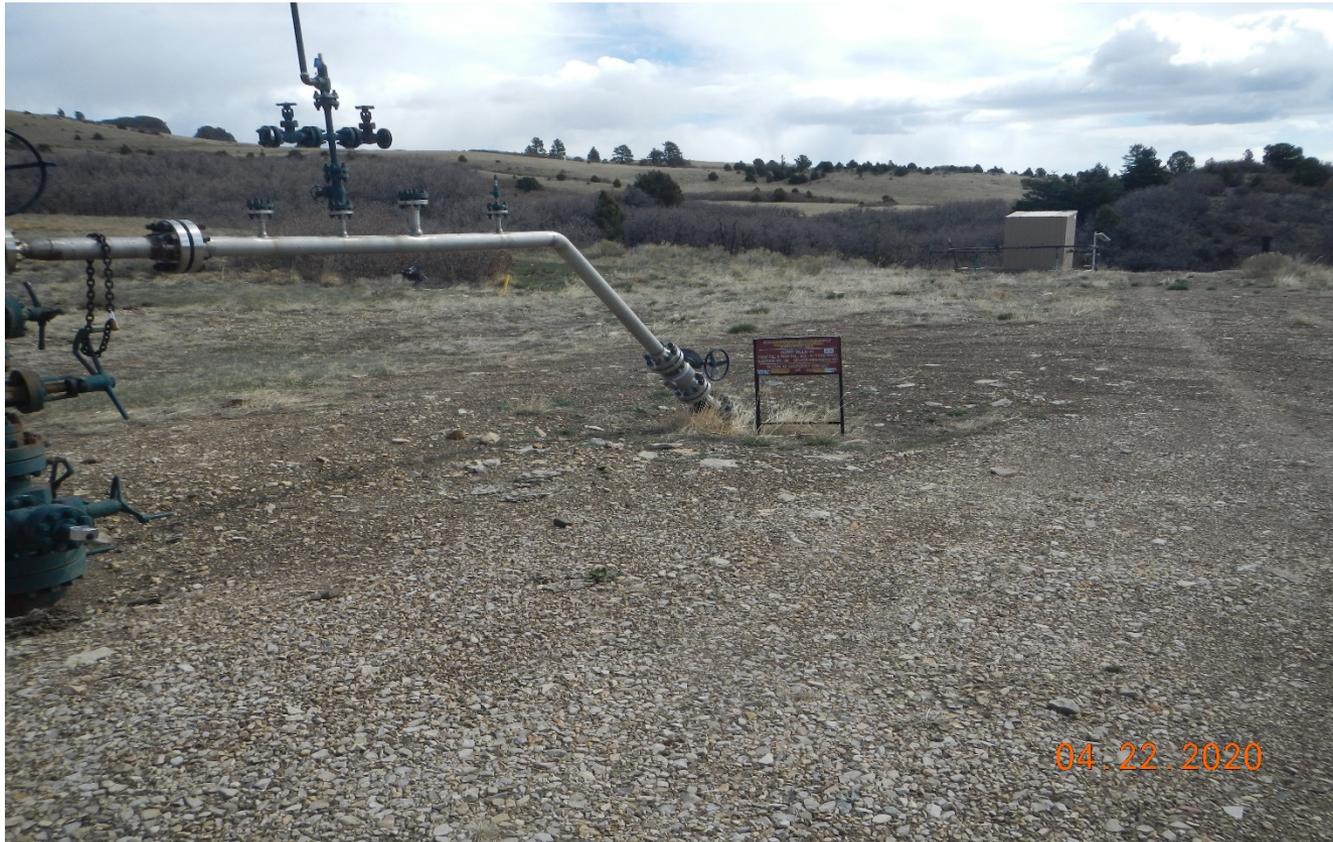
Photo 7. Facing northeast toward well and meter shed. Well sign is posted at the well head. Emergency contact number on the sign needs to be updated.
