## Stormwater Inspection Report

<b>Operator:</b>	Laramie Energy, LLC
<b>Project:</b>	Collbran
<b>Location:</b>	Hells Gulch 26-11
<b>Date:</b>	Friday, April 24, 2020
<b>Weather:</b>	Mostly Cloudy, Light Winds, High 52° Lo 39°

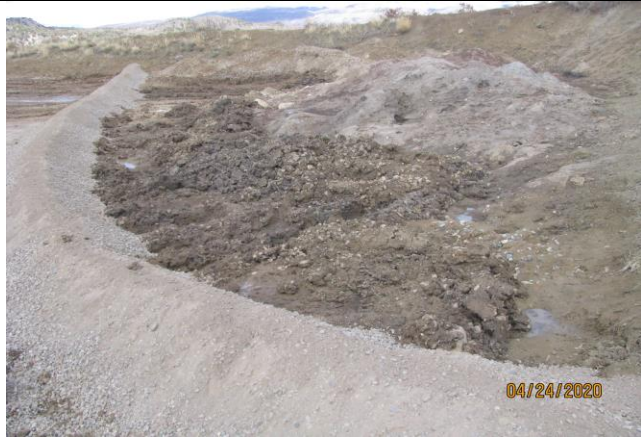
**Photo 1**

*Containment Berm Installed around the Cuttings Pile in the SE Corner of the Hells Gulch 26-11 Pad*

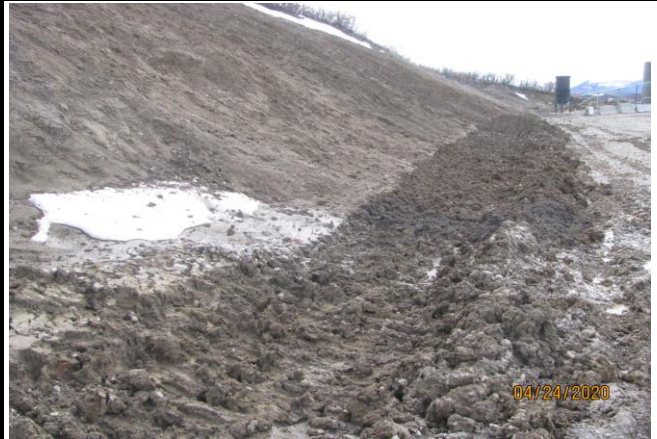
**Photo 2**

*Berm Installation along the Cut Slope on the Hells Gulch 26-11 Pad*

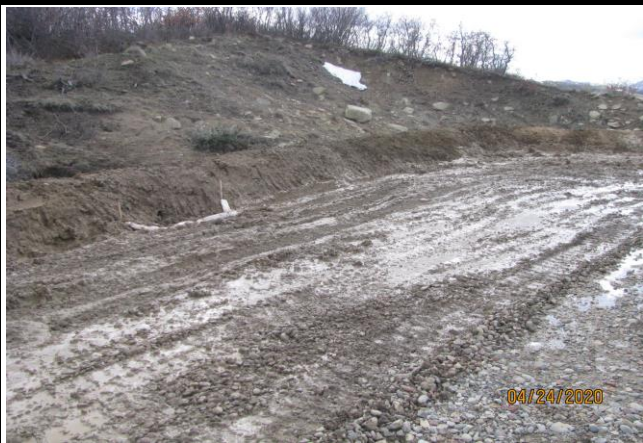
**Photo 3**

*Flex Pipe Outlet UnBlocked & Maintained in the SW Corner of the Hells Gulch 26-11 Pad*

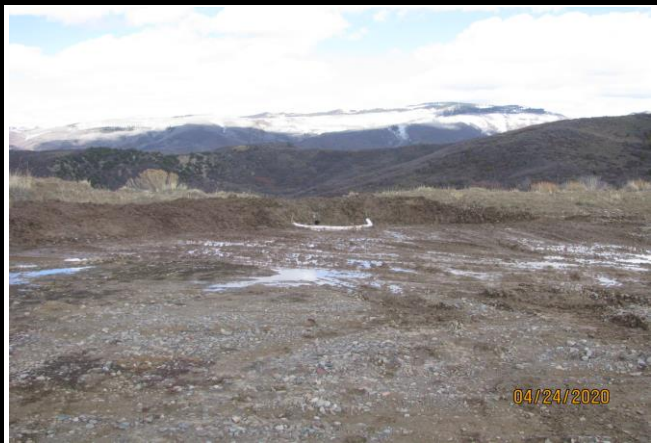
**Photo 4**

*Flex Pipe Outlet UnBlocked & Maintained in the NE Corner of the Hells Gulch 26-11 Pad*
