Inspection Photos

4/24/2020

Operator: CAERUS PICEANCE LLC - 10456

Facility ID: 416157

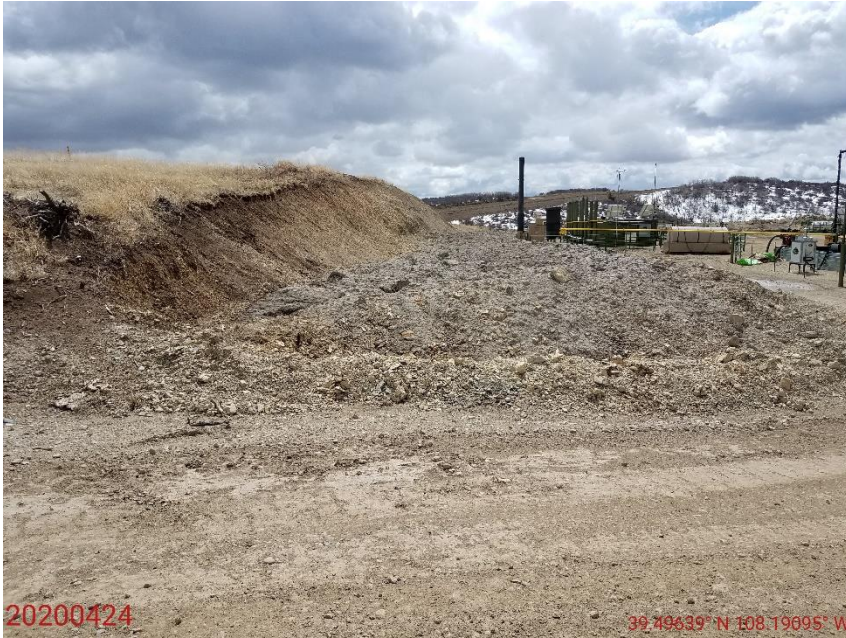
Photo 1: Photo taken from the northwest corner of the Location, facing east. Photo 1-3 provide an overview of the Location from east, southeast to south.

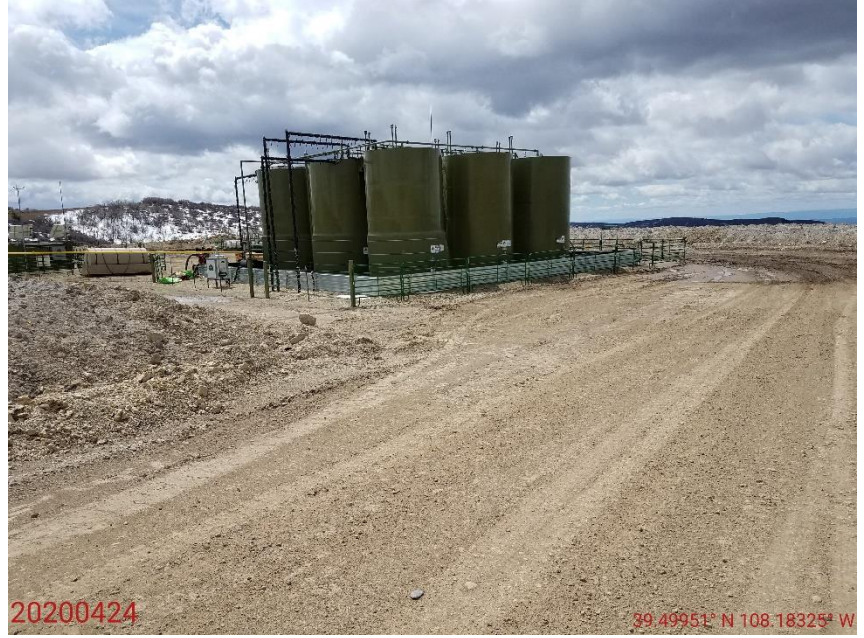
Photo 2: See comments under photo 1.

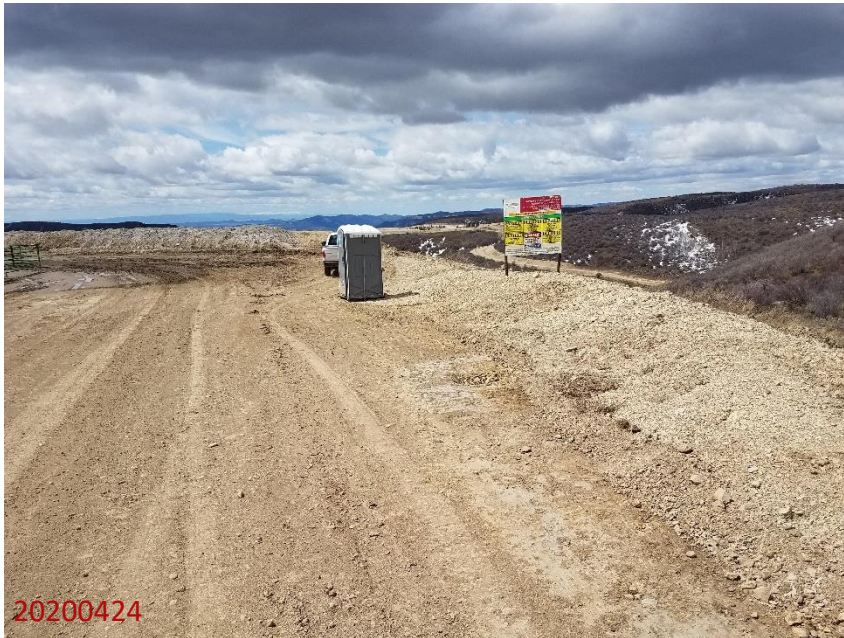
Photo 3: See comments under photo 1.

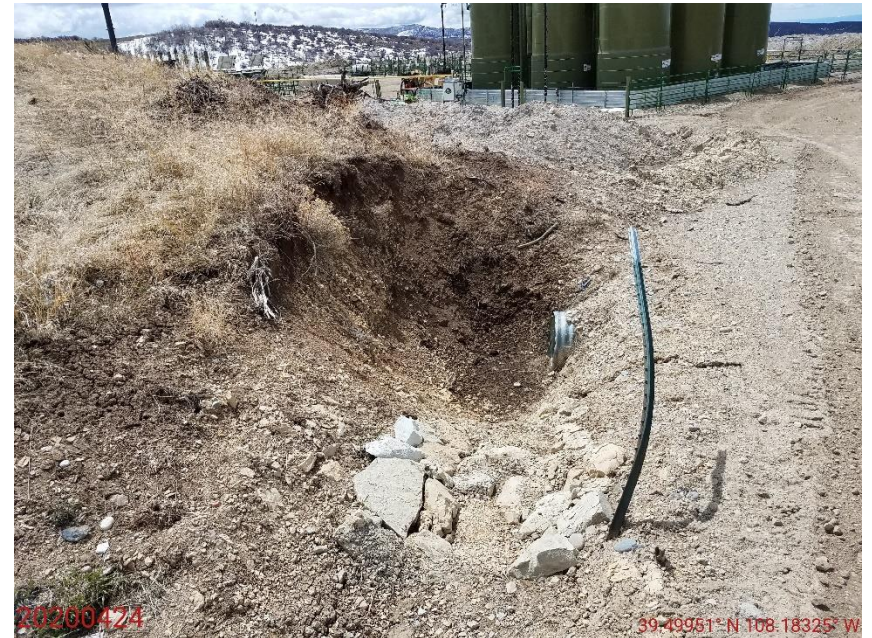
Photo 4: Photo of sediment trap on the northwest corner of the location.

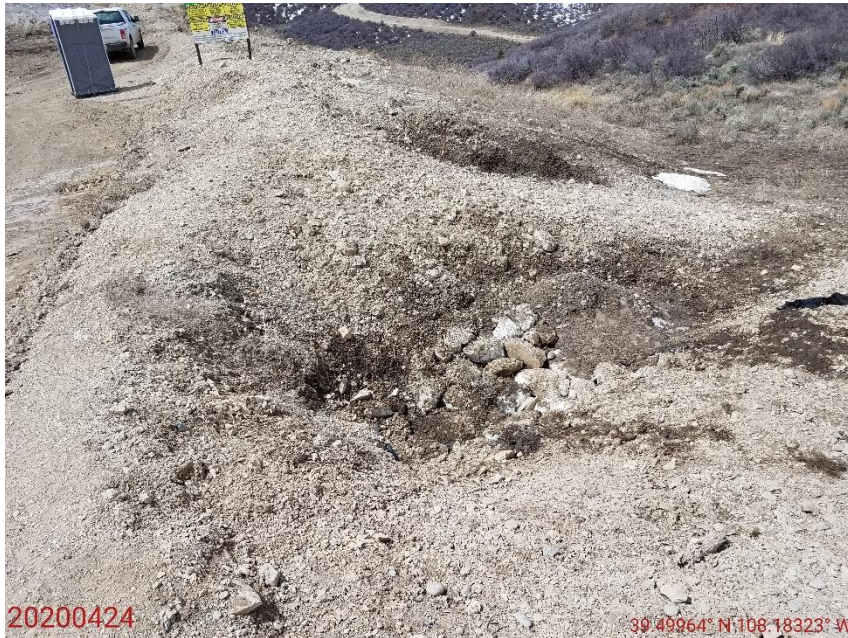
Photo 5: Photo of outlet/culvert on the northwest corner of the location.

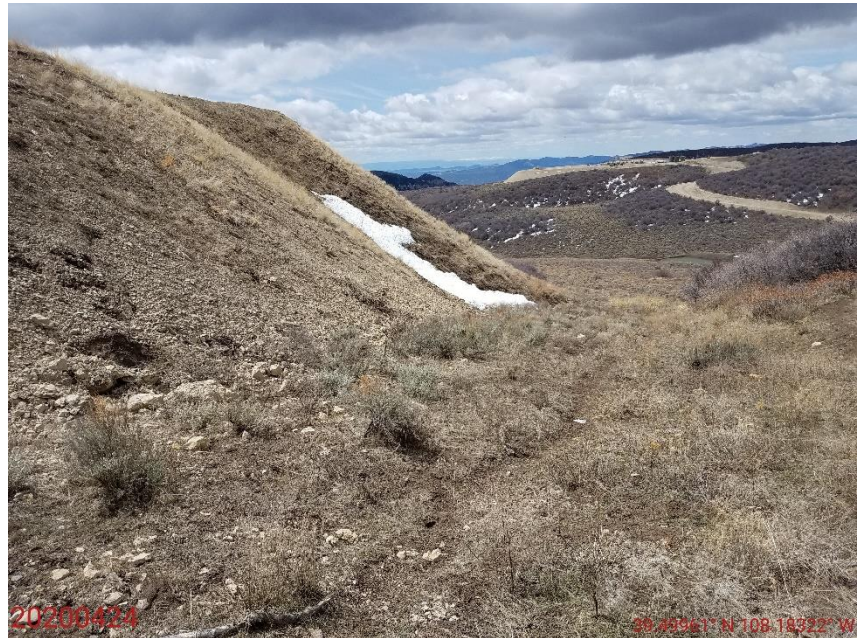
Photo 6: Photo taken from the northwest perimeter of the disturbance area, facing south. Photo shows fill slopes are predominantly exposed, or vegetated by undesirable weedy annual species (cheat grass). Photo also shows perimeter stormwater BMPs missing.

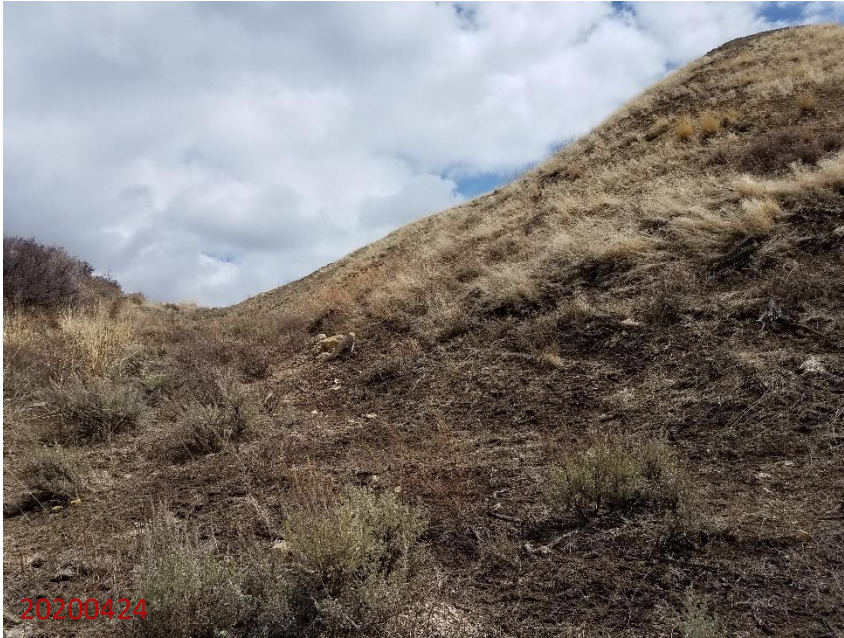
Photo 7: Photo taken from the southwest perimeter of the disturbance area, facing north. See comments under photo 6.

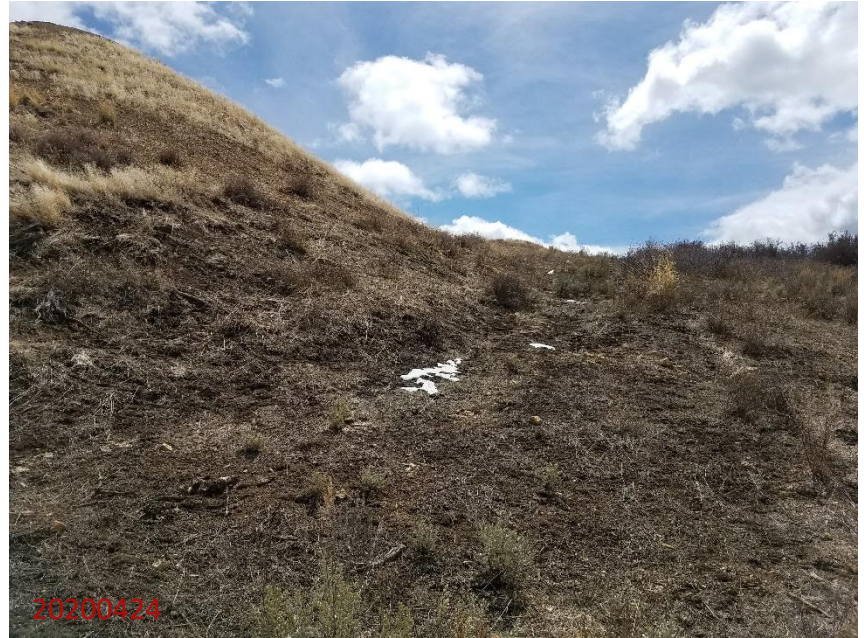
Photo 8: Photo taken from the southwest perimeter of the disturbance area, facing east. See comments under photo 6.

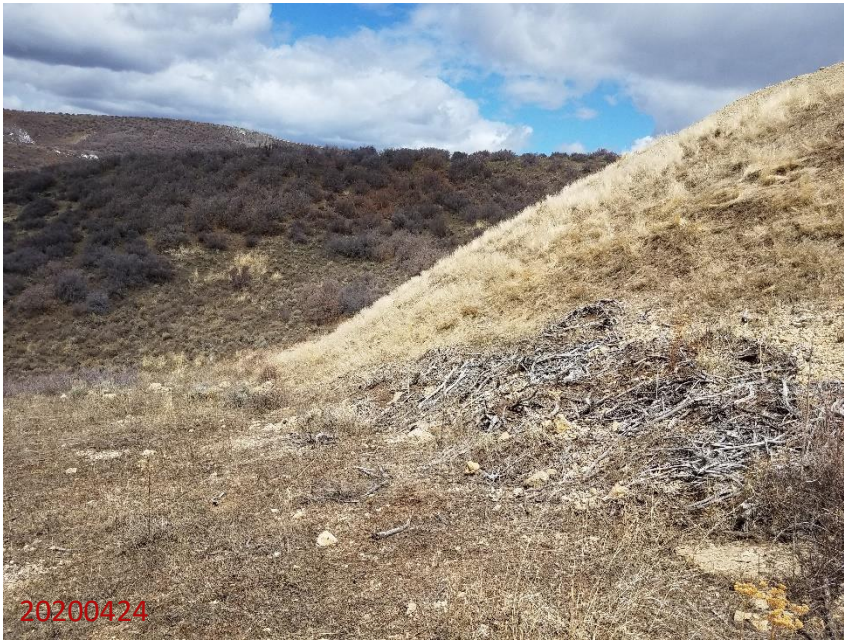
Photo 9: Photo taken from the fill slopes on the south end of the Location, facing west. See comments under photo 6.

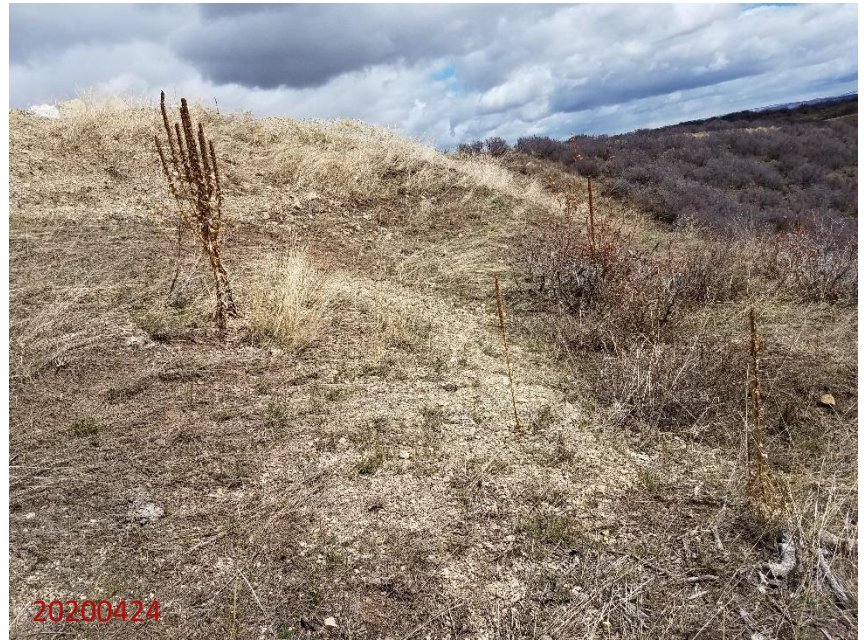
Photo 10: Photo taken from east end of the topsoil pile, facing northeast. Photo shows Common Mullein establishment on the Location. This is a Colorado State listed Noxious weed and requires management.

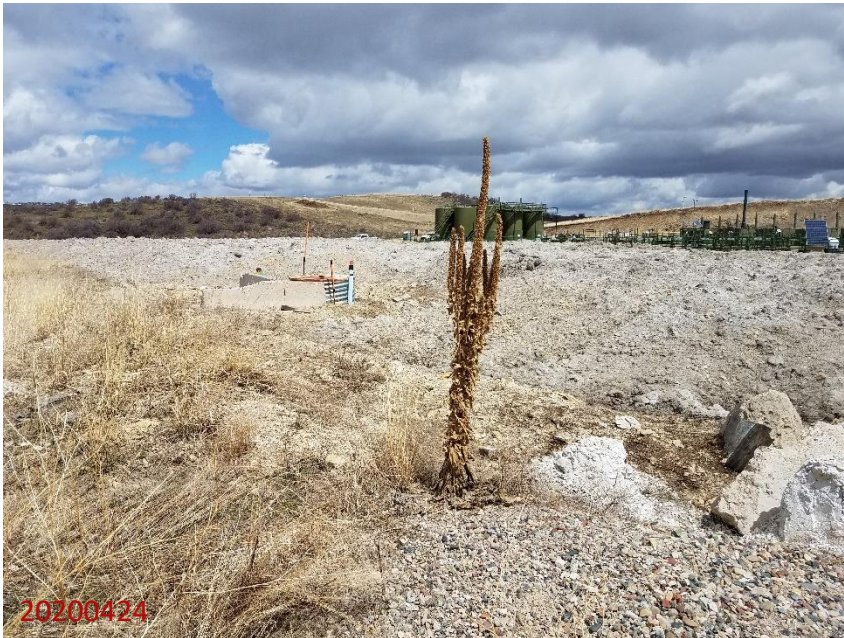
Photo 11: Photo taken from the southeast corner of the current pad, facing northwest. Photo shows Common Mullein establishment on the Location. This is a Colorado State listed Noxious weed and requires management.

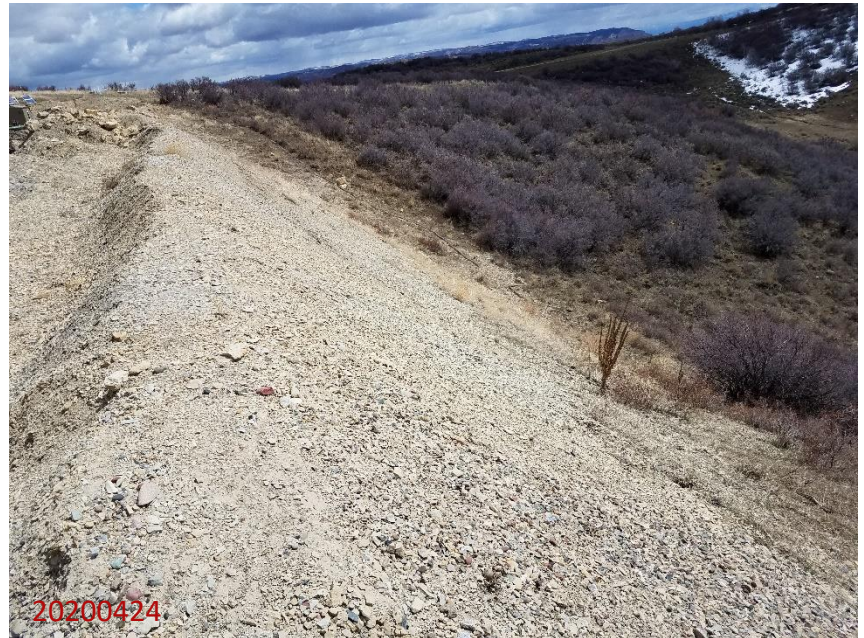
Photo 12: Photo taken from the southeast corner of the current pad, facing northeast. Photo shows Common Mullein establishment on the Location. Photo shows fill slopes are predominantly exposed.

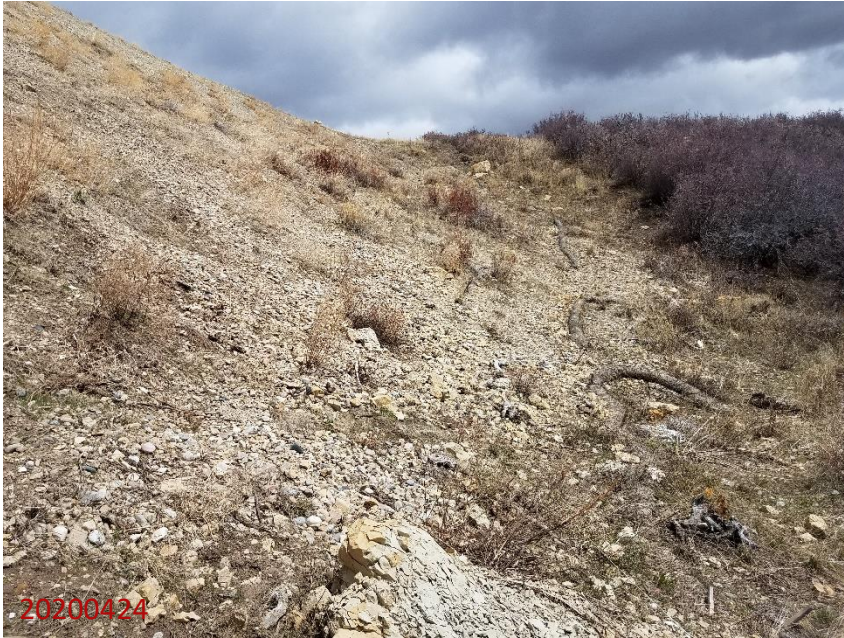
Photo 13: Photo taken from the eastern perimeter of the location, facing north. Photo shows wattles in disrepair.

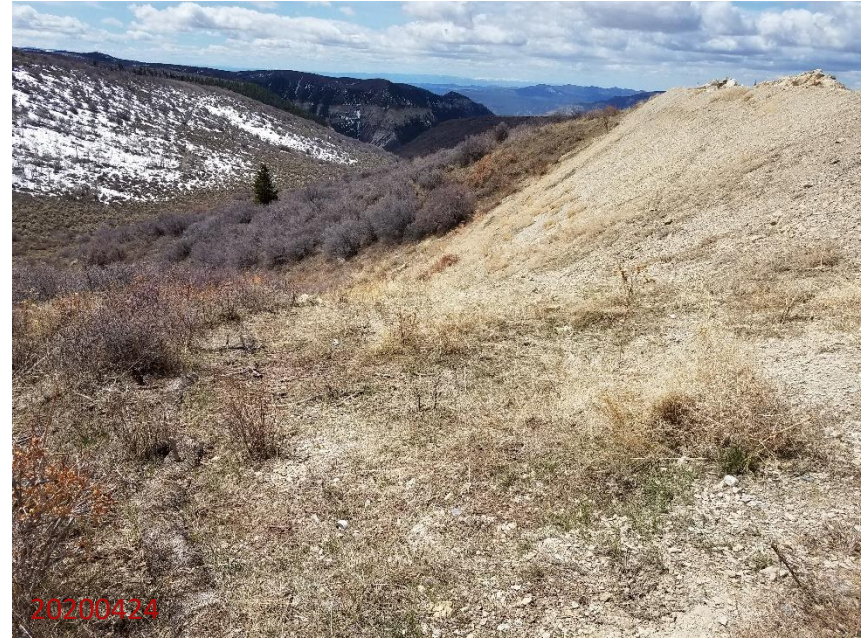
Photo 14: Photo taken from the northeast perimeter of the Location, facing south. See comments under photo 12 and 13.

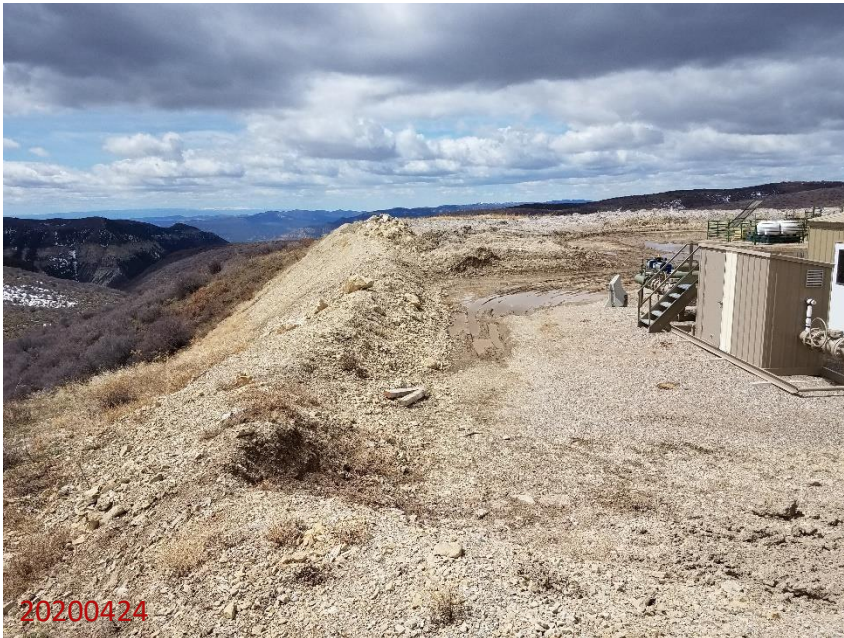
Photo 15: Photo taken from the northeast corner of the production area, facing south. Photos 15-17 provide an overview of the Location from south, southwest to west.

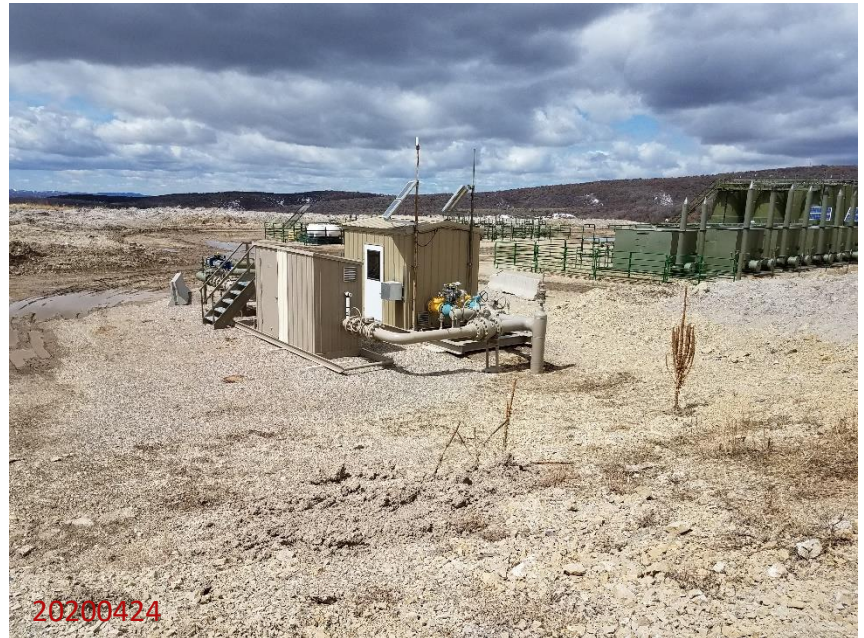
Photo 16: See comments under photo 15. Photo also shows Common Mullein establishment on the Location.

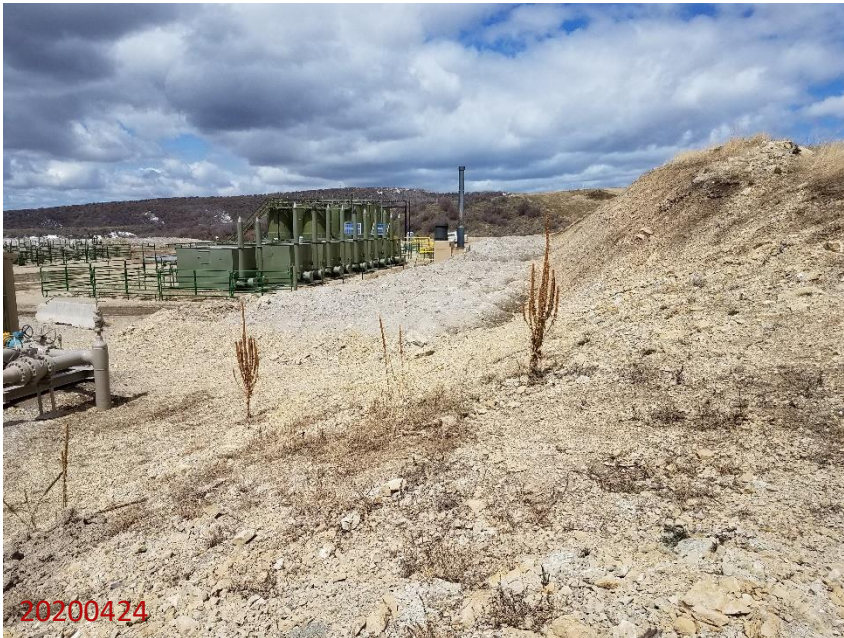
Photo 17: See comments under photo 15. Photo also shows Common Mullein establishment on the Location.

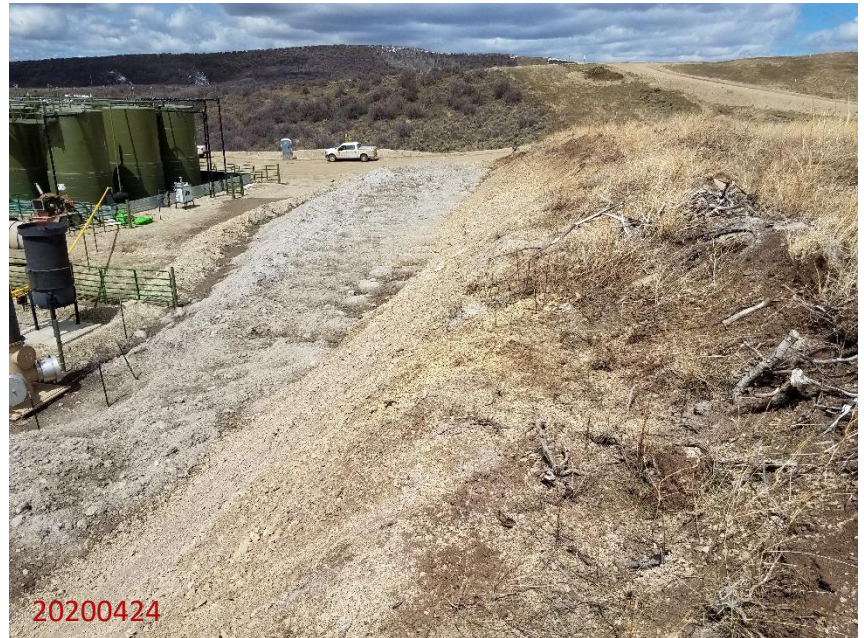
Photo 18: Photo taken from the cut slope on the north end of the Location. Photo shows cut slopes are predominantly exposed; stabilization BMPs missing.

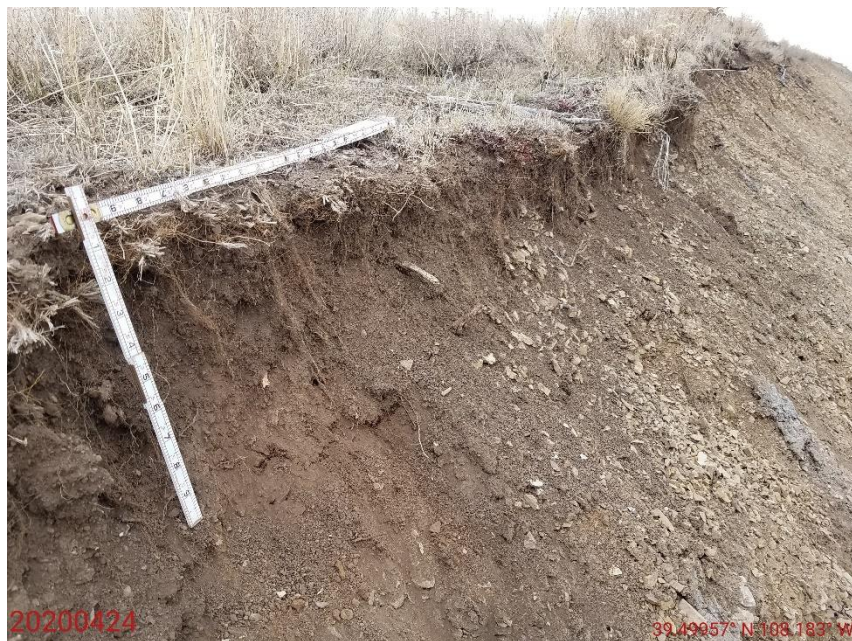
Photo 19: Photo shows the topsoil layer visible from the cut slope.

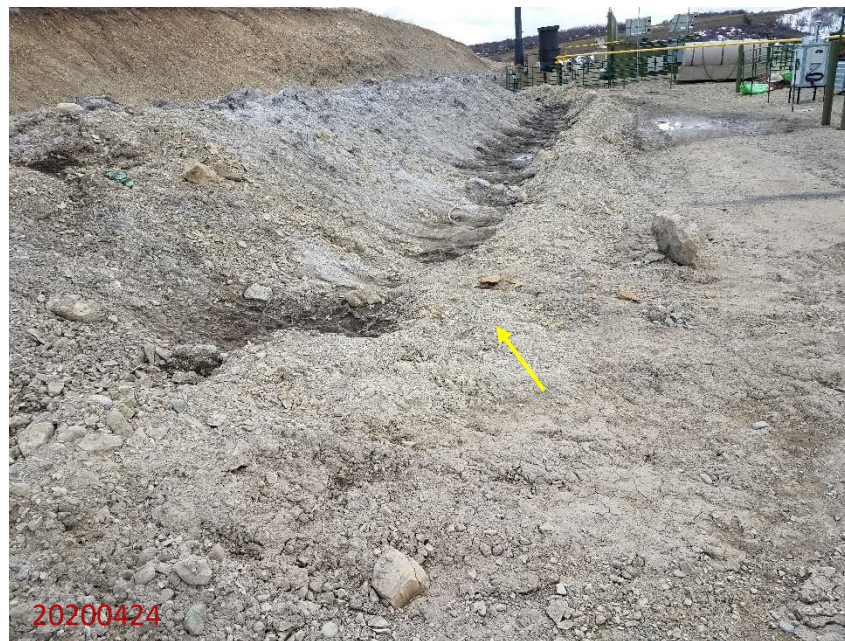
Photo 20: Photo taken from the northwest corner of the Location, facing east. Photo shows area of the berm along the drill cuttings in disrepair.

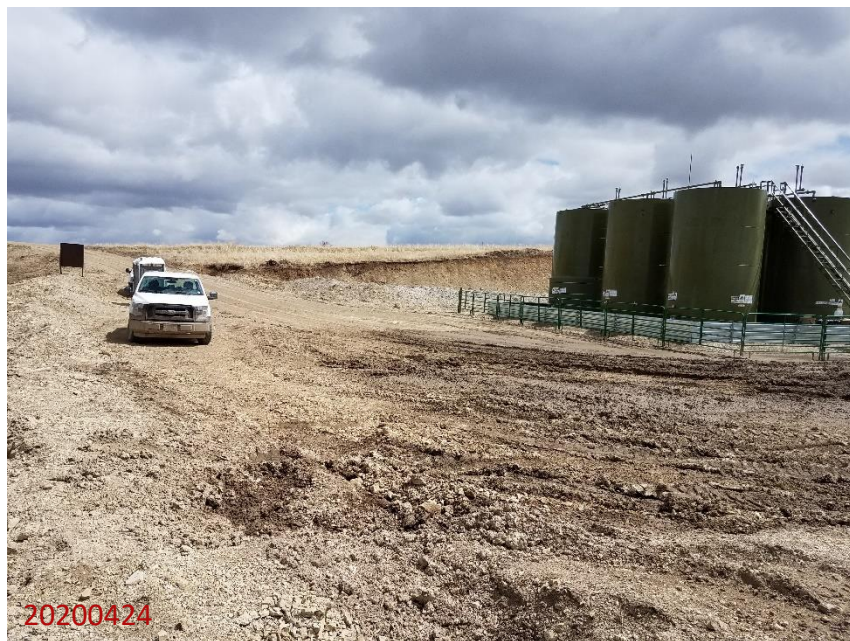
Photo 21: Photo taken from the west end of the Location, facing northeast. Photo shows stormwater ponding on the Location; Pad does not appear to have been constructed in such a manner to allow for proper stormwater discharge from the location; this does not comport with 1002.f

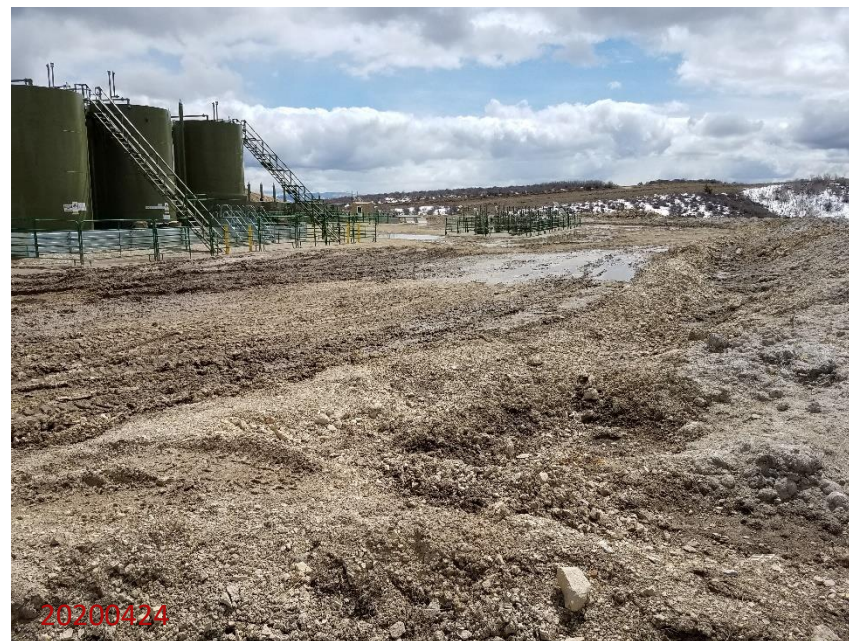
Photo 22: See comments under photo 21.

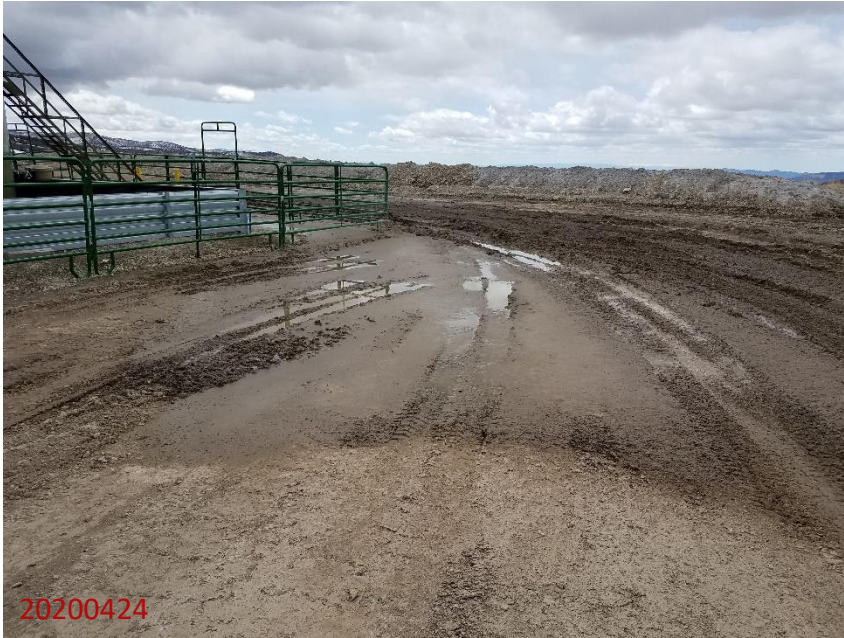
Photo 23: See comments under photo 21.

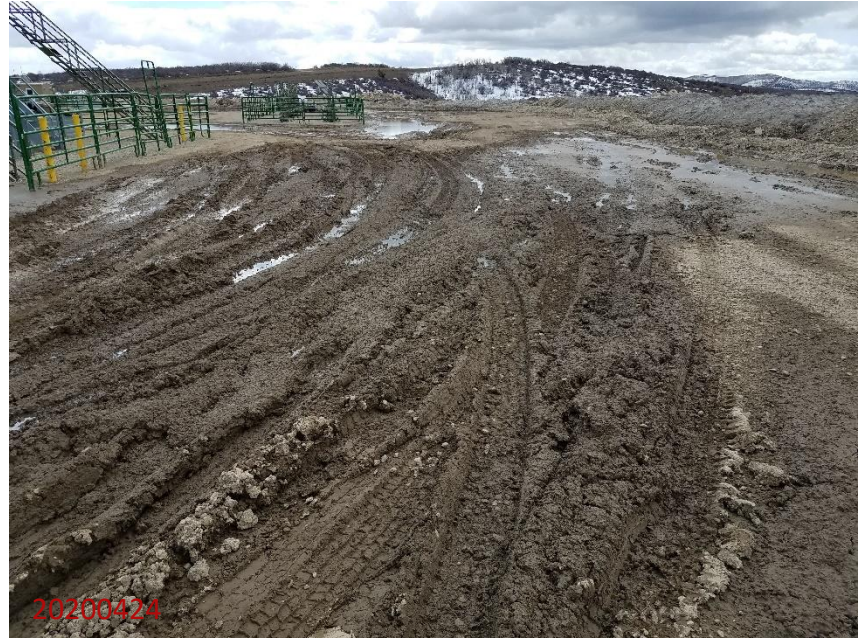
Photo 24: See comments under photo 21.

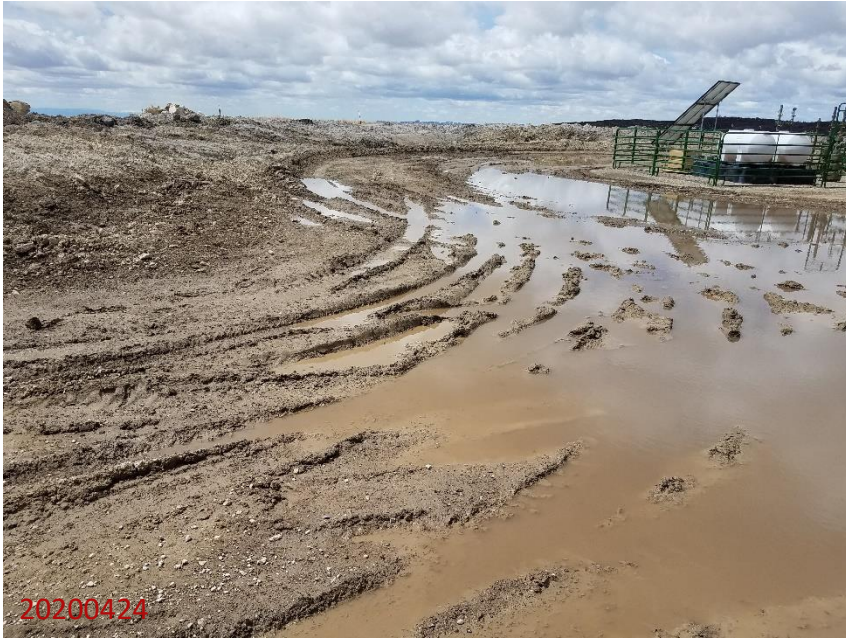
Photo 25: See comments under photo 21.

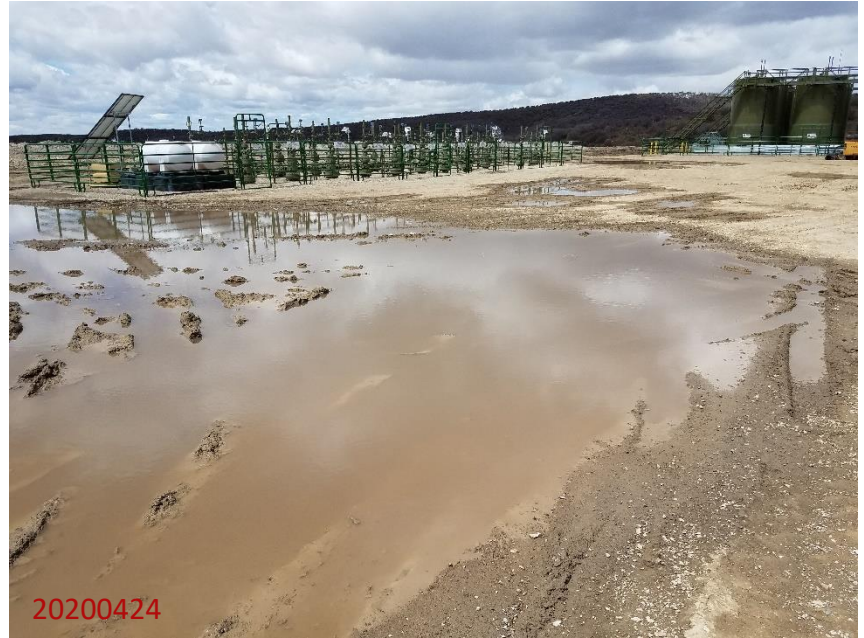
Photo 26: See comments under photo 21.

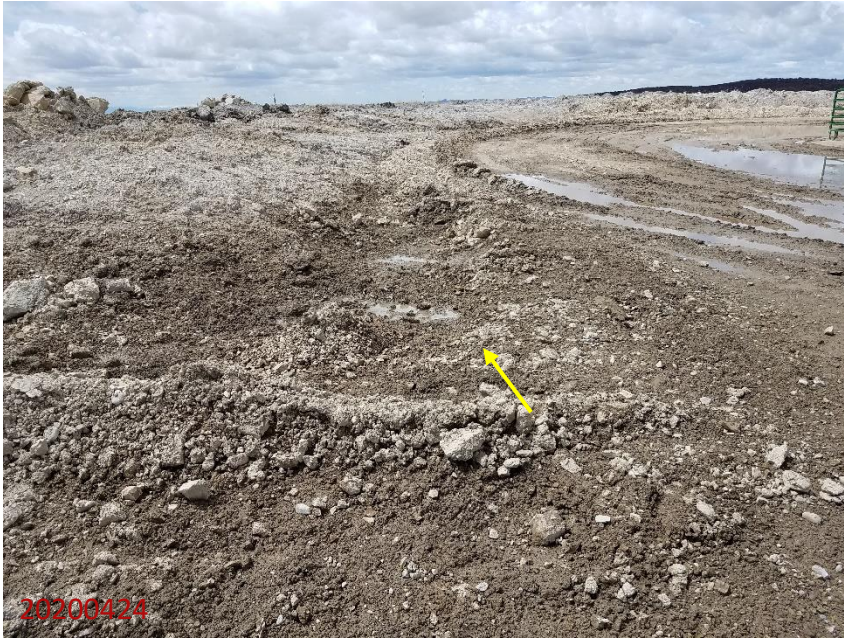
Photo 27: Photo taken from the northeast corner of the Location, facing south. Photo shows area of the berm along the drill cuttings in disrepair.

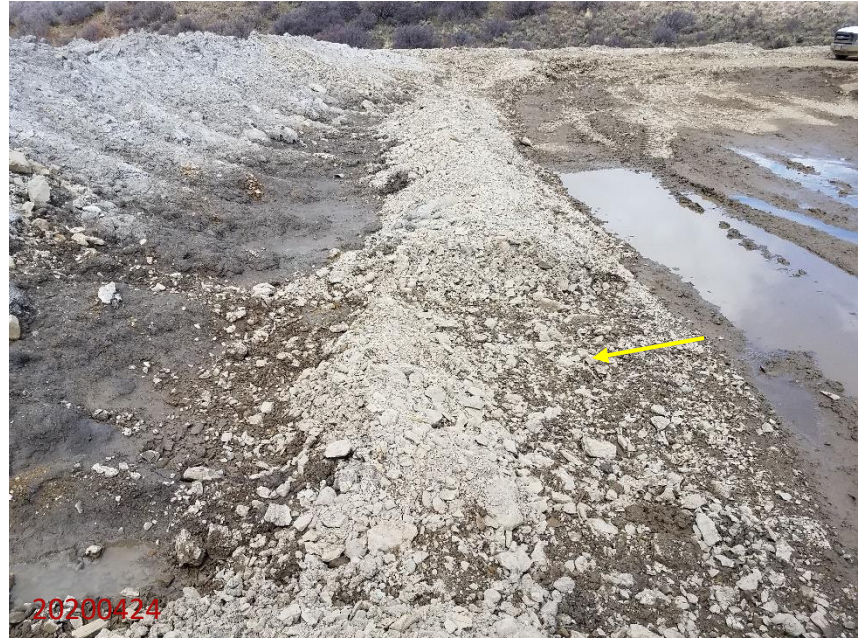
Photo 28: Photo taken from the south end of the Location, facing west. Photo shows area of the berm along the drill cuttings in disrepair.

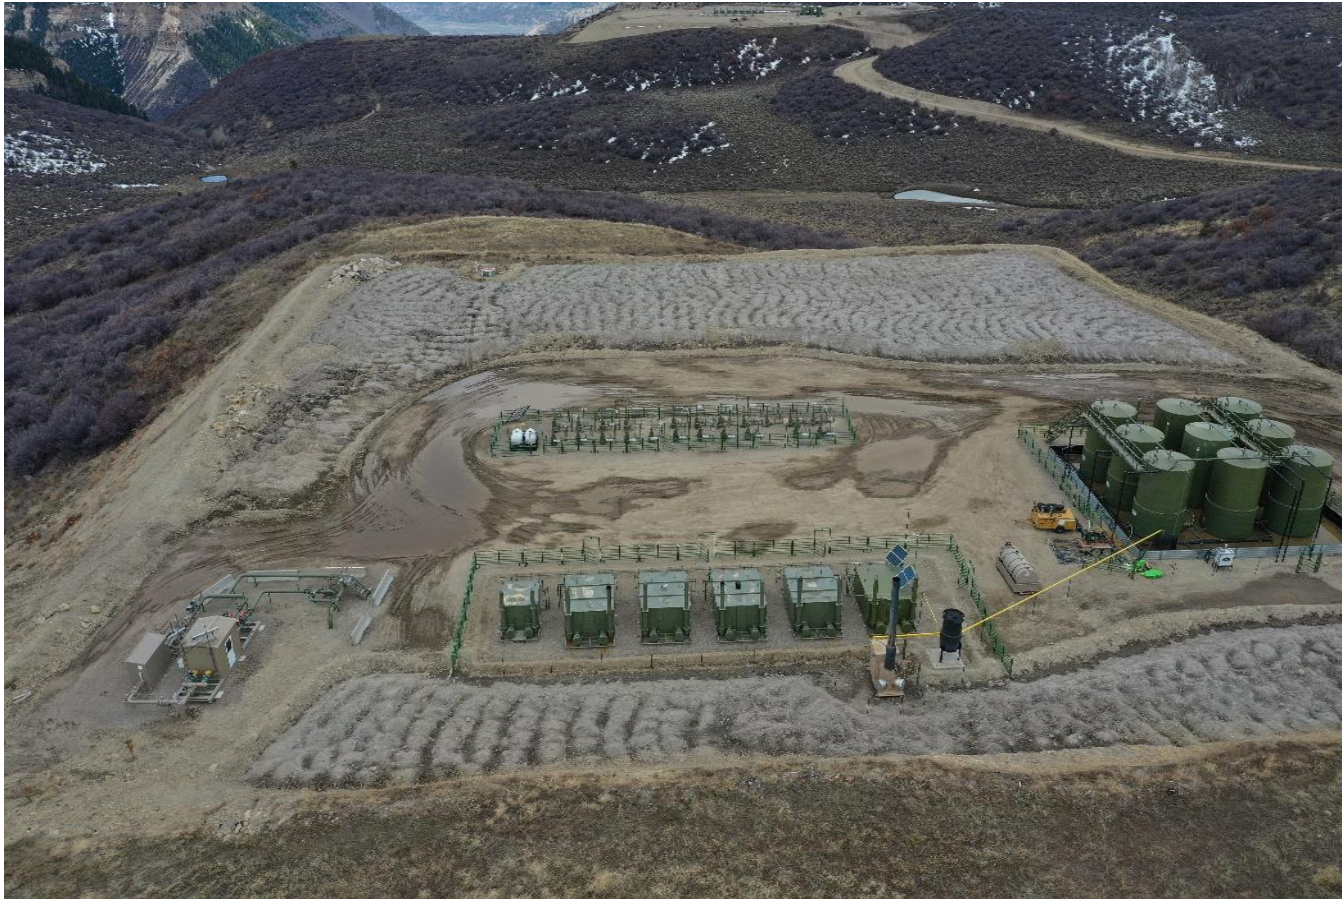
Photo 29: On 4/24/2020, Reclamation specialist Trujillo utilized a SUA to capture an aerial image of the Location; Photo taken from the north end of the Location, facing south. Photo shows large areas on the Northern and southern ends of the current pad where drill cuttings remain stored; these areas are not needed for production and are subject to 1003 interim reclamation. Photo also shows stormwater ponding on Location.

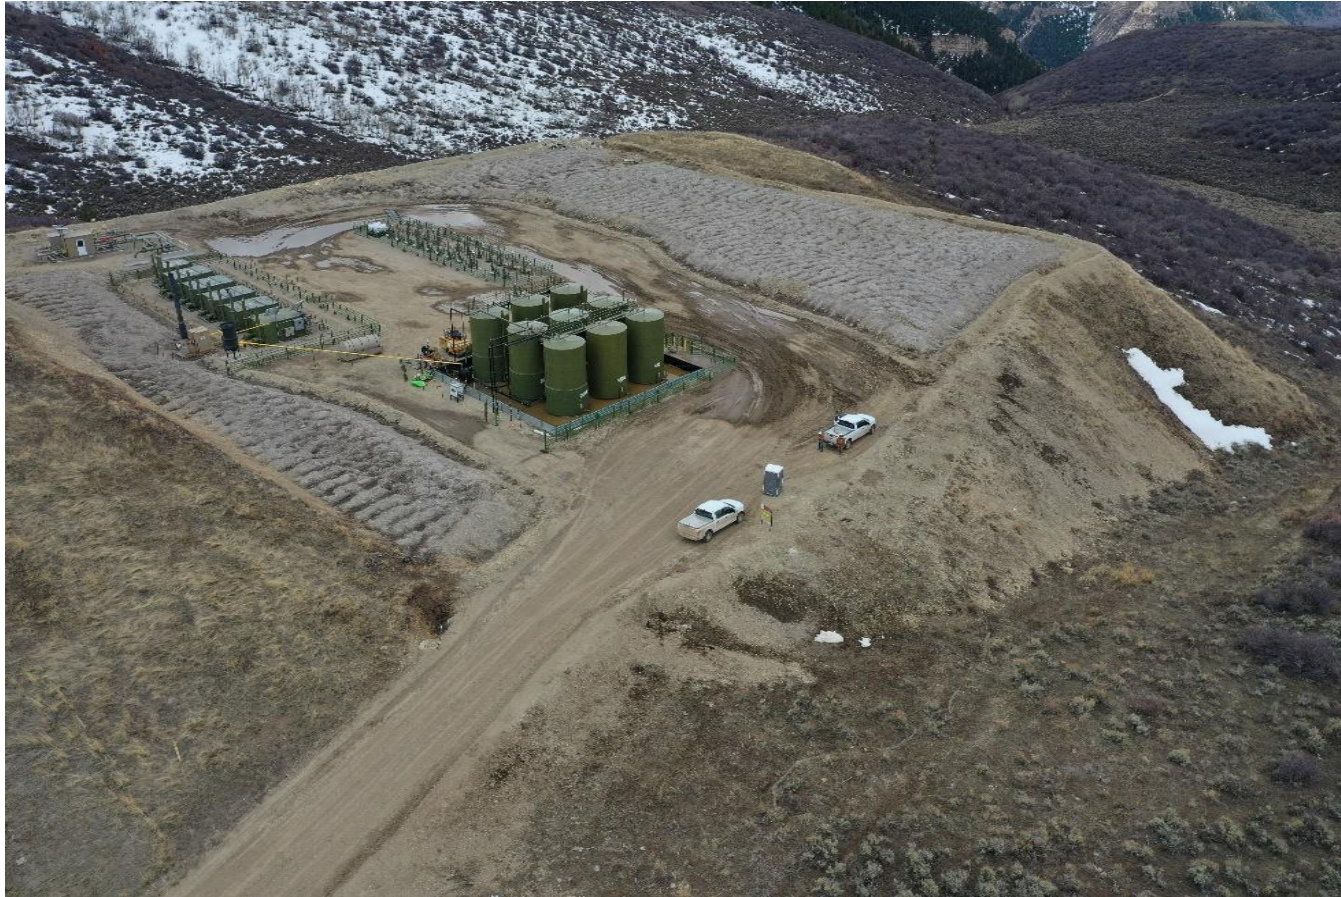
Photo 30: On 4/24/2020, Reclamation specialist Trujillo utilized a SUA to capture an aerial image of the Location; Photo taken from the northwest end of the Location, facing southeast. See comments under photo 29. Photo also show fill slopes on the west end of the location are predominantly exposed. Photo also shows perimeter BMPs are either in disrepair, or missing.

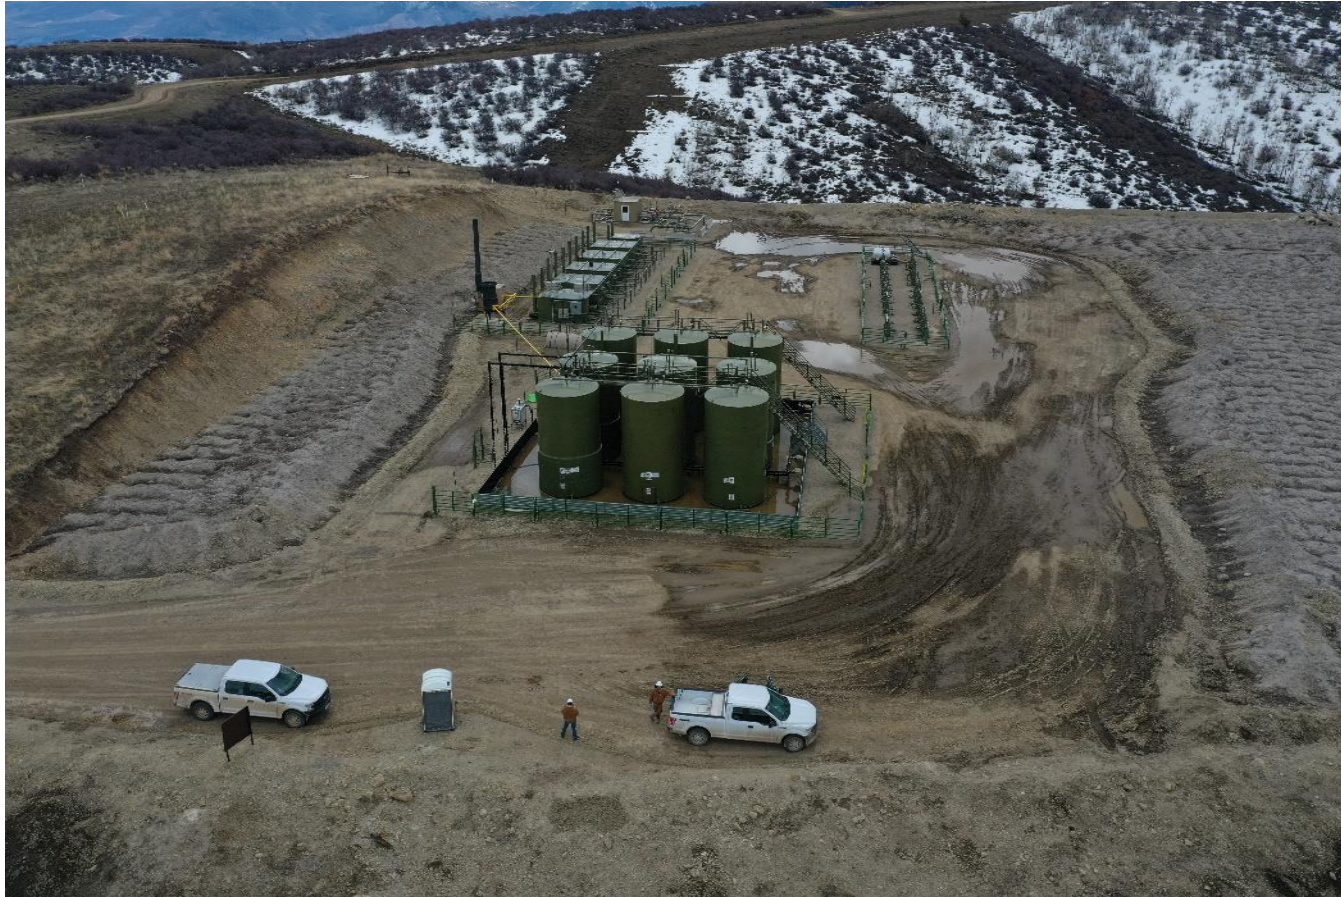
Photo 31: On 4/24/2020, Reclamation specialist Trujillo utilized a SUA to capture an aerial image of the Location; Photo taken from the west end of the Location, facing east. See comments under photo 29

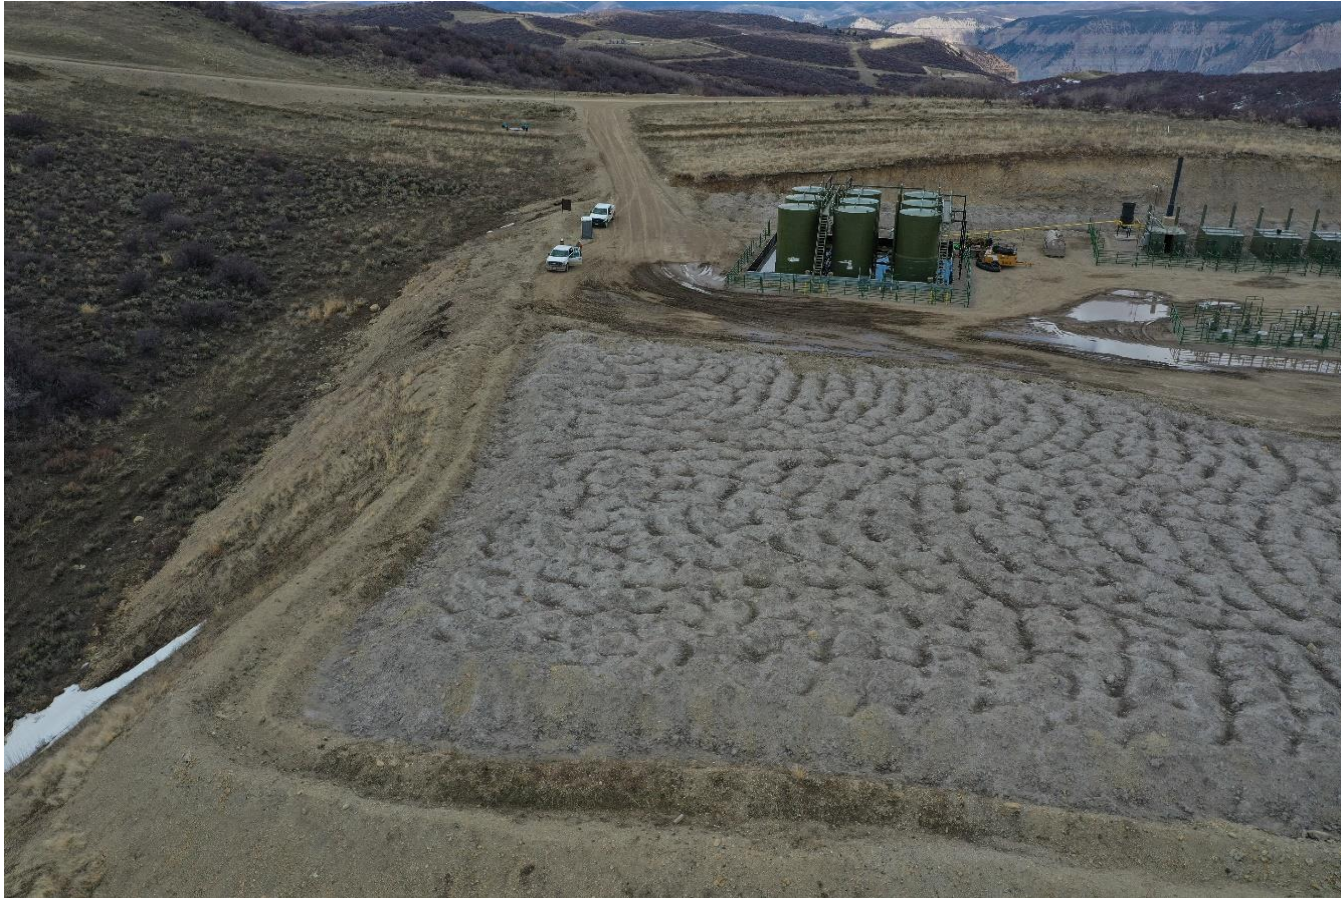
Photo 32: On 4/24/2020, Reclamation specialist Trujillo utilized a SUA to capture an aerial image of the Location; Photo taken from the south end of the Location, facing north. See comments under photo 29

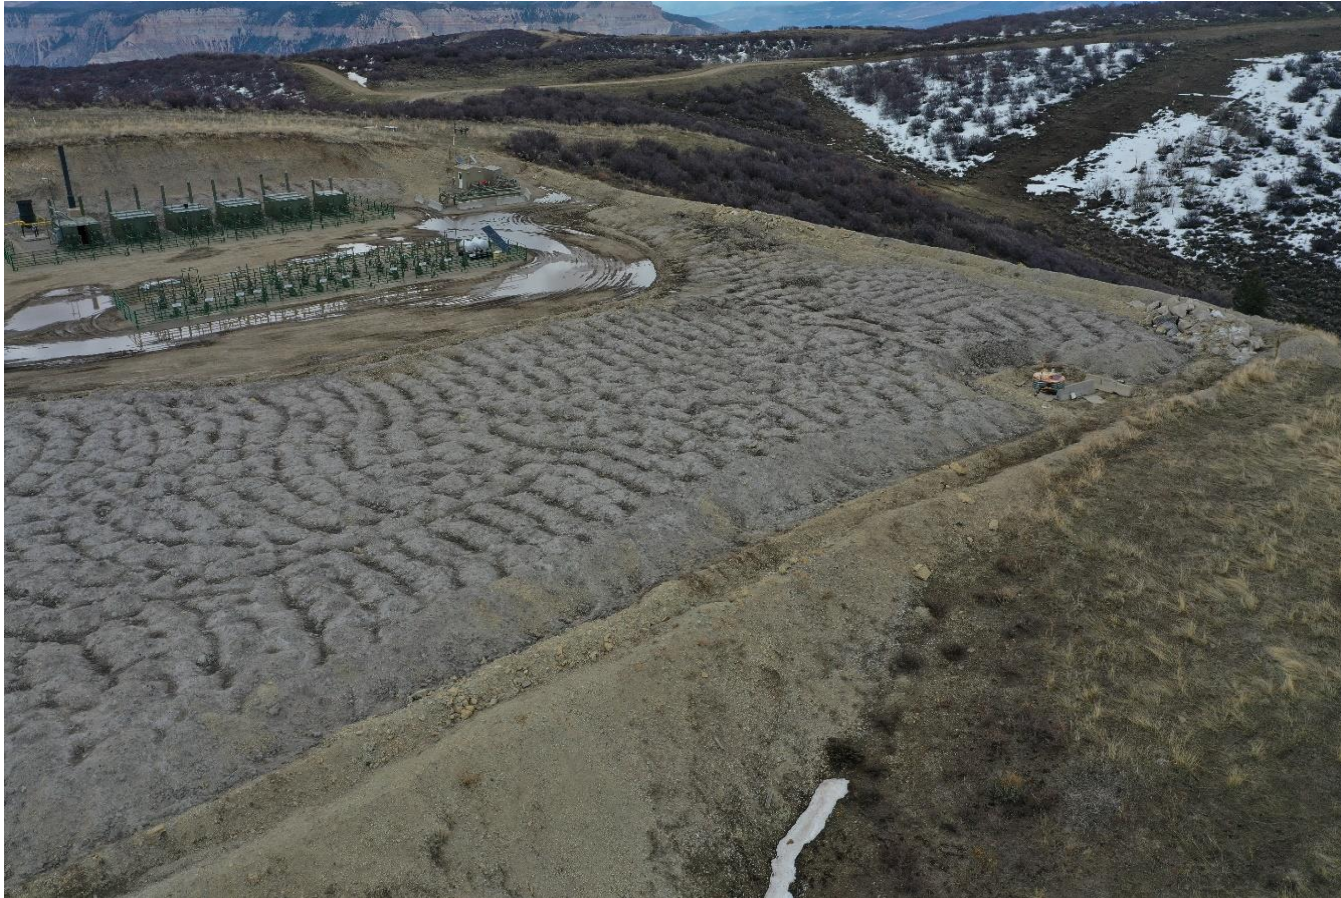
Photo 33: On 4/24/2020, Reclamation specialist Trujillo utilized a SUA to capture an aerial image of the Location; Photo taken from the south end of the Location, facing northeast. See comments under photo 29. Photo also show fill slopes on the south end of the location are predominantly exposed.
