Inspection Photos

4/24/2020

Operator: CAERUS PICEANCE LLC - 10456

Facility ID: 416157

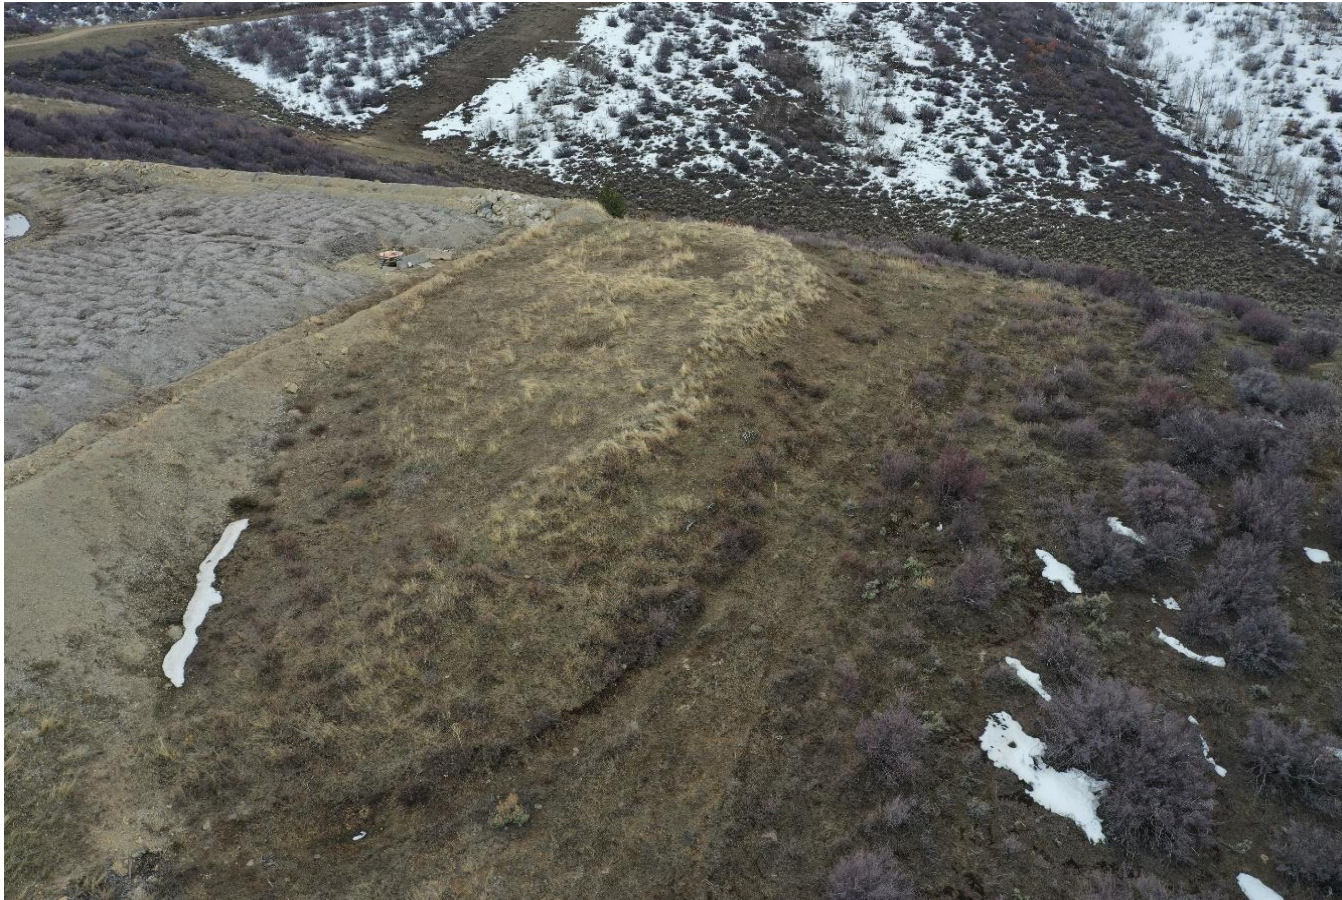
Photo 34: Photo of topsoil pile on the south end of the Location. Photo also show fill slopes on the west end of the location are predominantly exposed. Photo also shows perimeter BMPs are either in disrepair, or missing.

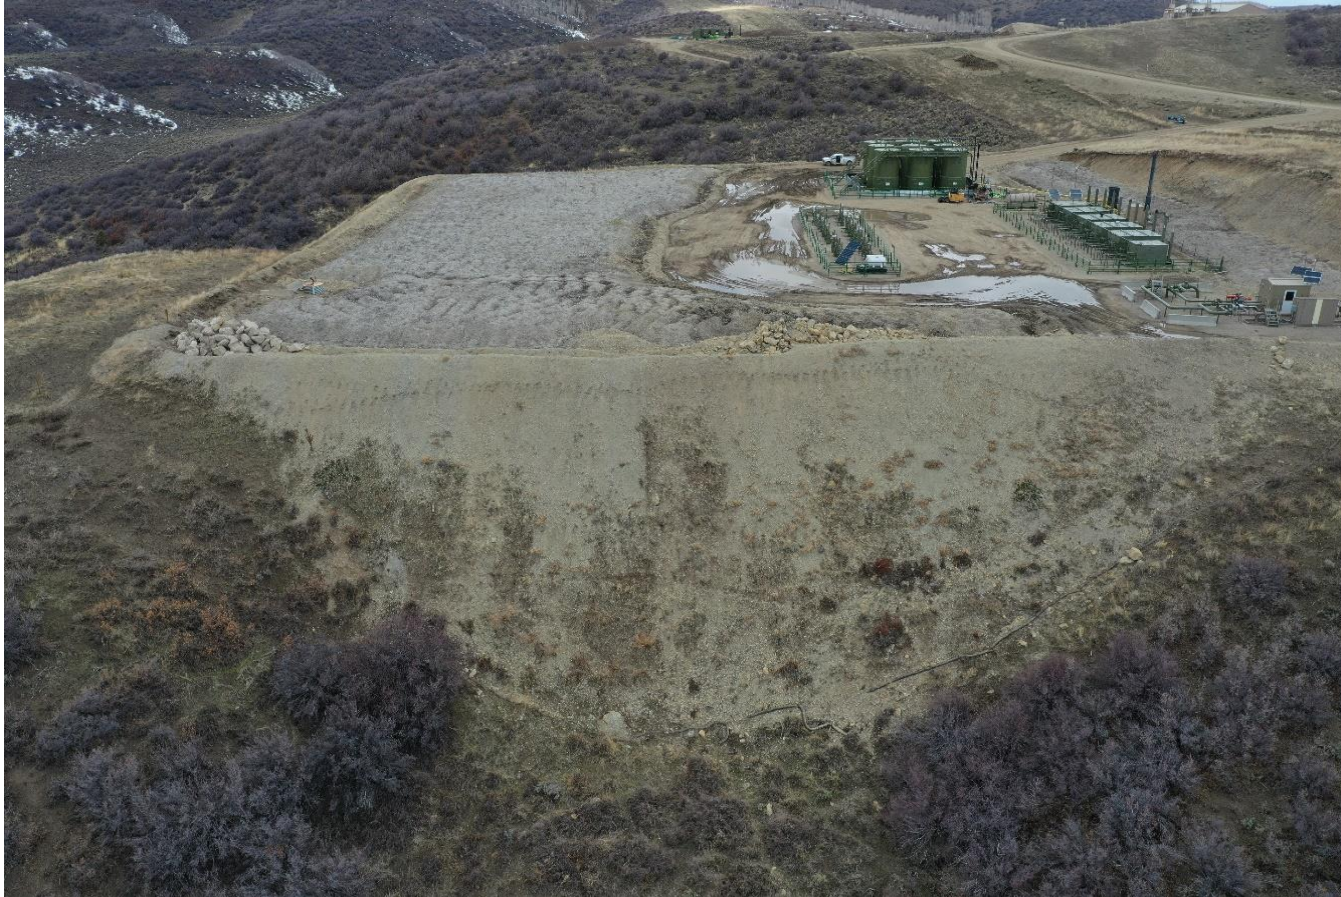
Photo 29: On 4/24/2020, Reclamation specialist Trujillo utilized a SUA to capture an aerial image of the Location; Photo taken from the north end of the Location, facing south. Photo shows large areas on the Northern and southern ends of the current pad where drill cuttings remain stored; these areas are not needed for production and are subject to 1003 interim reclamation. Photo also shows stormwater ponding on Location.

Photo 35: On 4/24/2020, Reclamation specialist Trujillo utilized a SUA to capture an aerial image of the Location; Photo taken from the east end of the Location, facing west. See comments under photo 29. Photo also show fill slopes on the east end of the location are predominantly exposed. Photo also show fill slopes on the west end of the location are predominantly exposed. Photo also shows perimeter BMPs are either in disrepair, or missing.

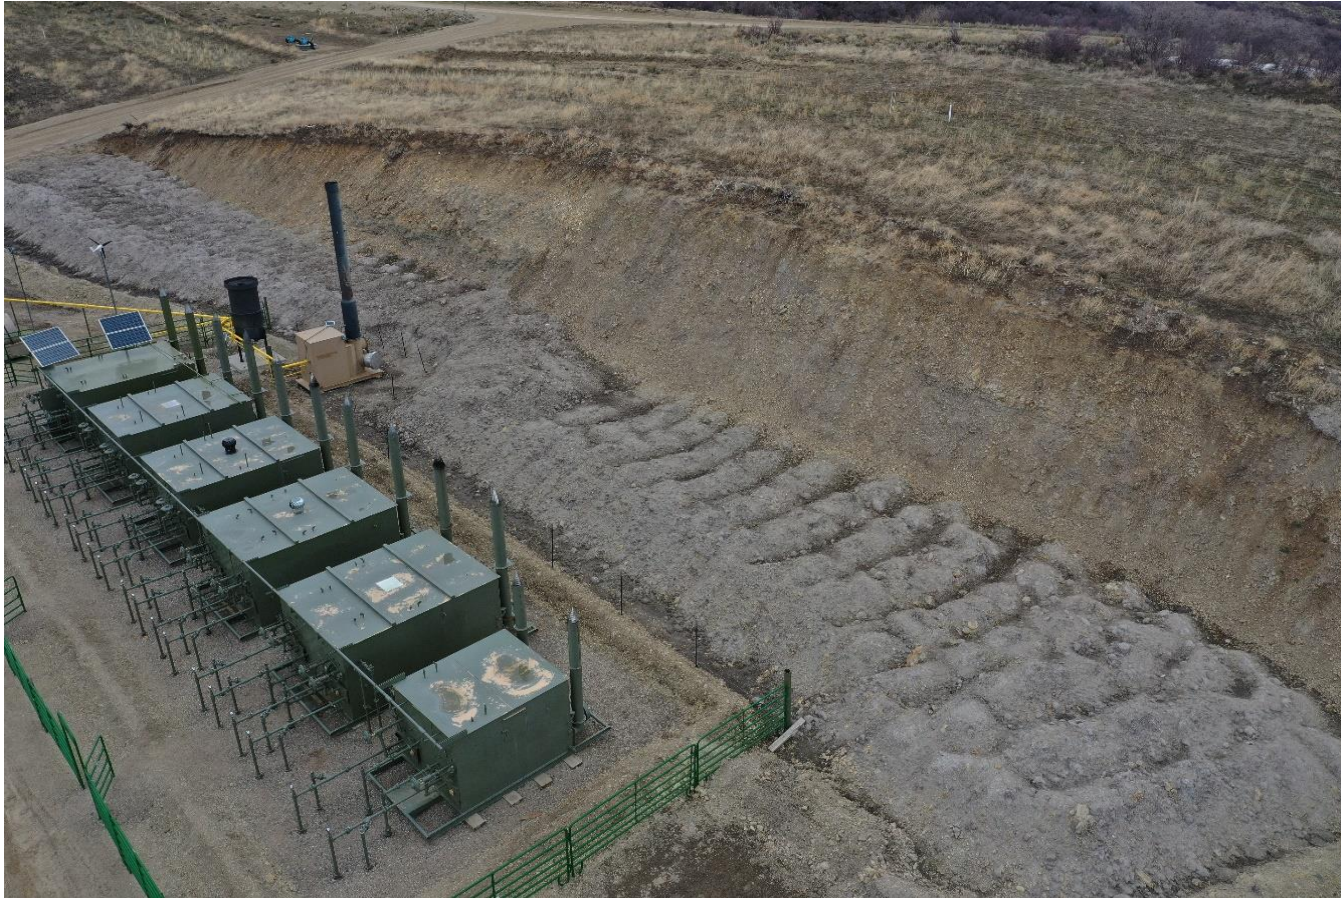
Photo 36: On 4/24/2020, Reclamation specialist Trujillo utilized a SUA to capture an aerial image of the Location; Photo taken from the north end of the Location, facing northwest. See comments under photo 29. Photo shows cut slope of the location is predominantly exposed.
