Inspection Photos

API: 043-06215

Operator: WINN EXPLORATION CO INC

Inspection Date: 4/27/2020

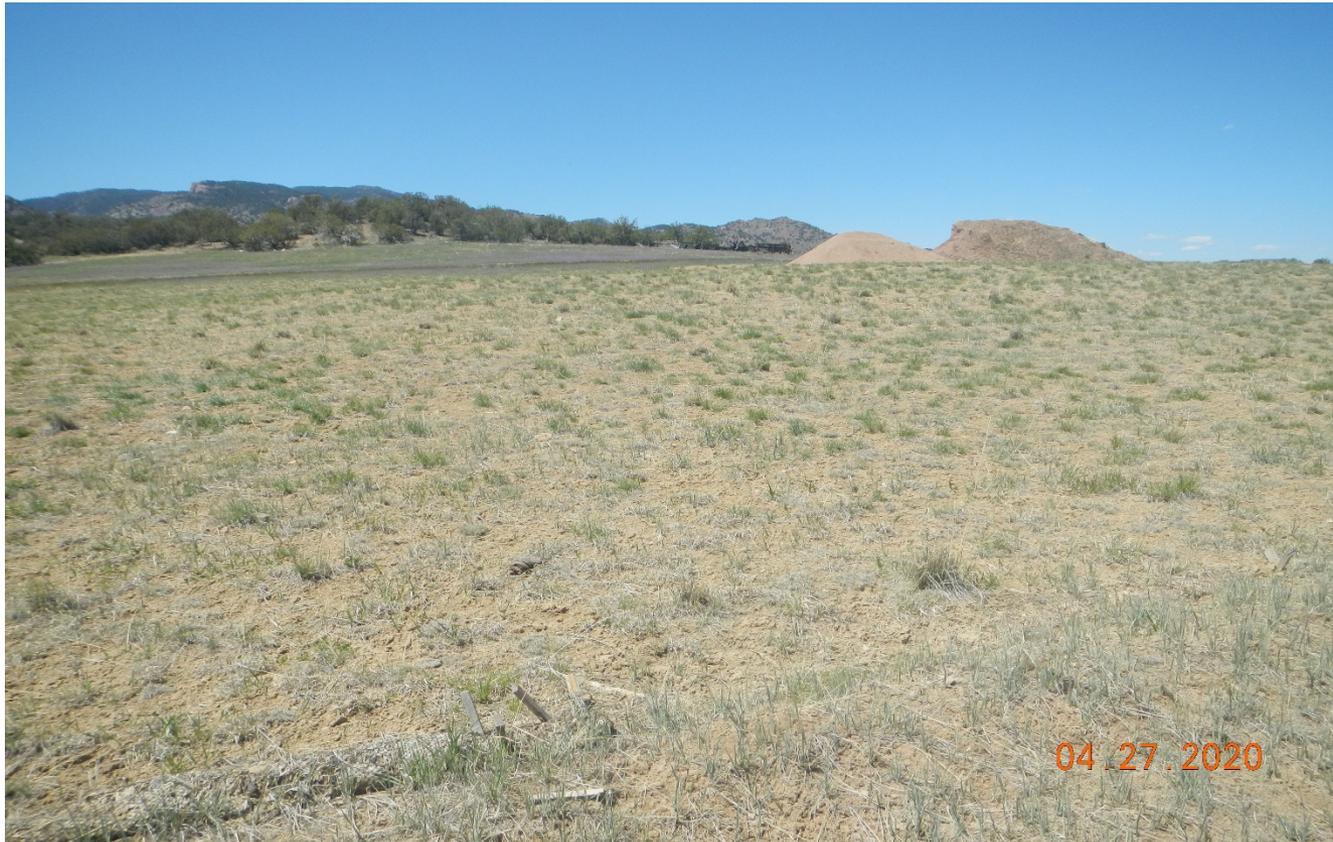
Photo 1. Facing west toward the location. A gravel pile remains at the center of the location.

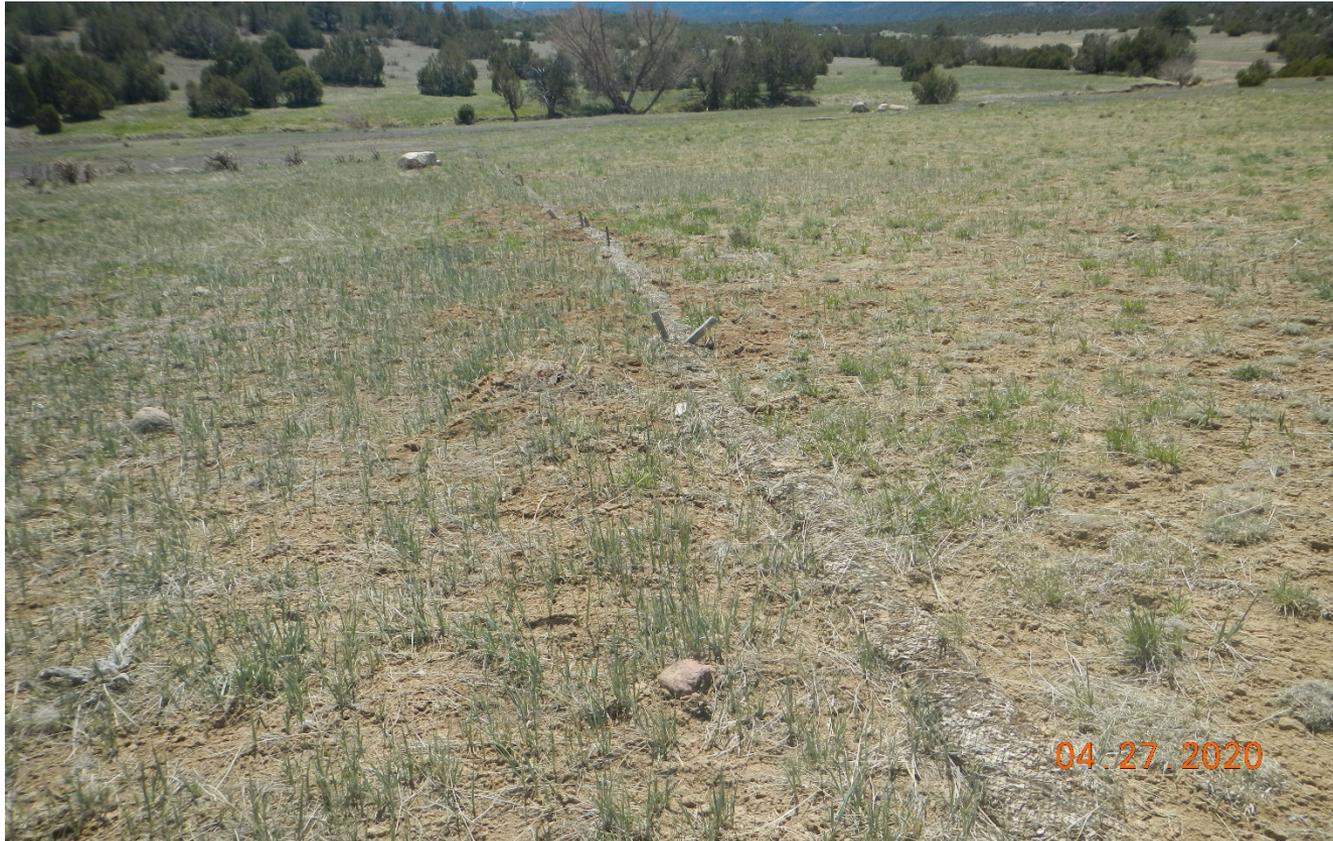
Photo 2. The degraded wattles remain around the eastern perimeter. The degraded wattles and stakes need to be removed.

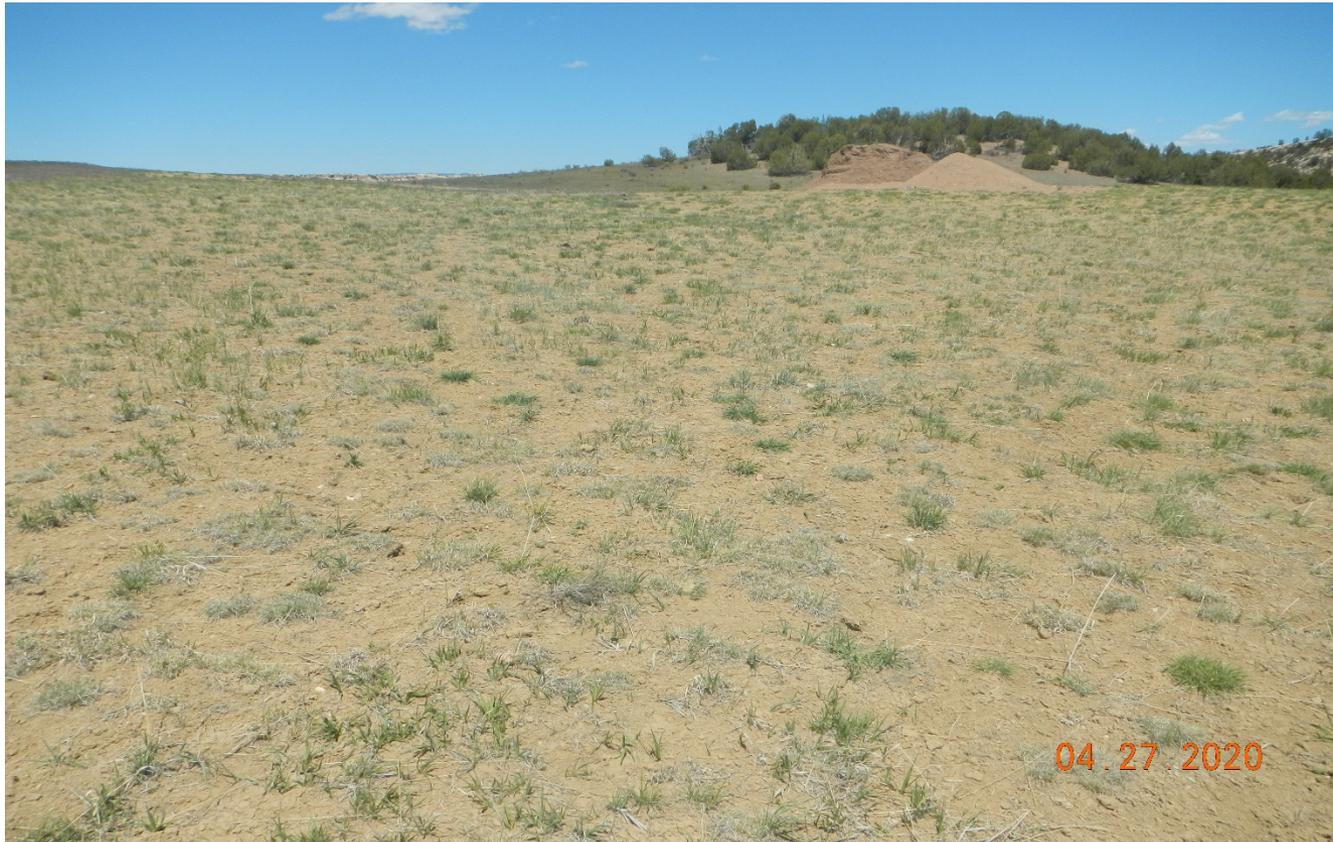
Photo 3. Facing northwest toward the location. Vegetation is progressing throughout the reclamation area but does not appear to be fully established.

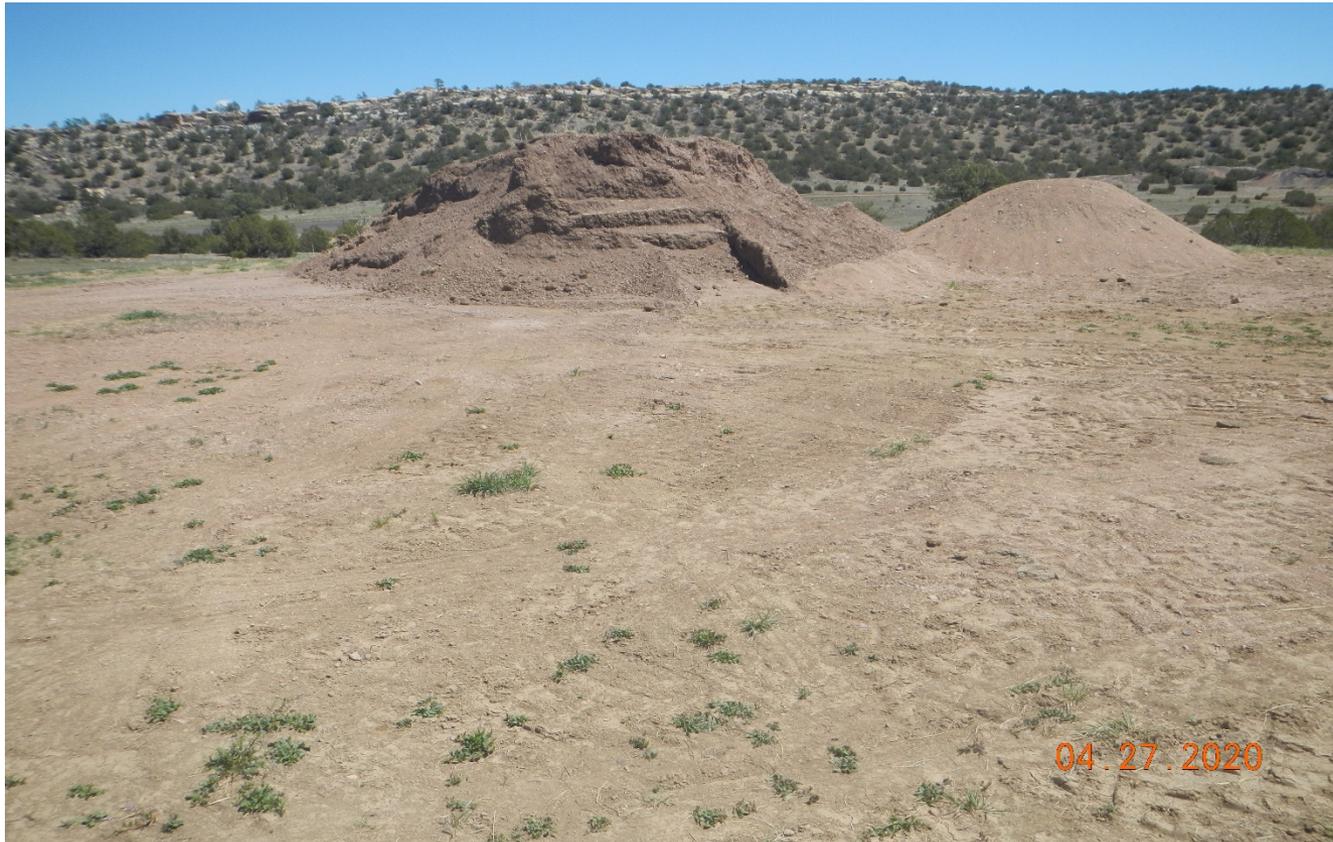
Photo 4. There is a gravel pile stored at the location causing disturbance.

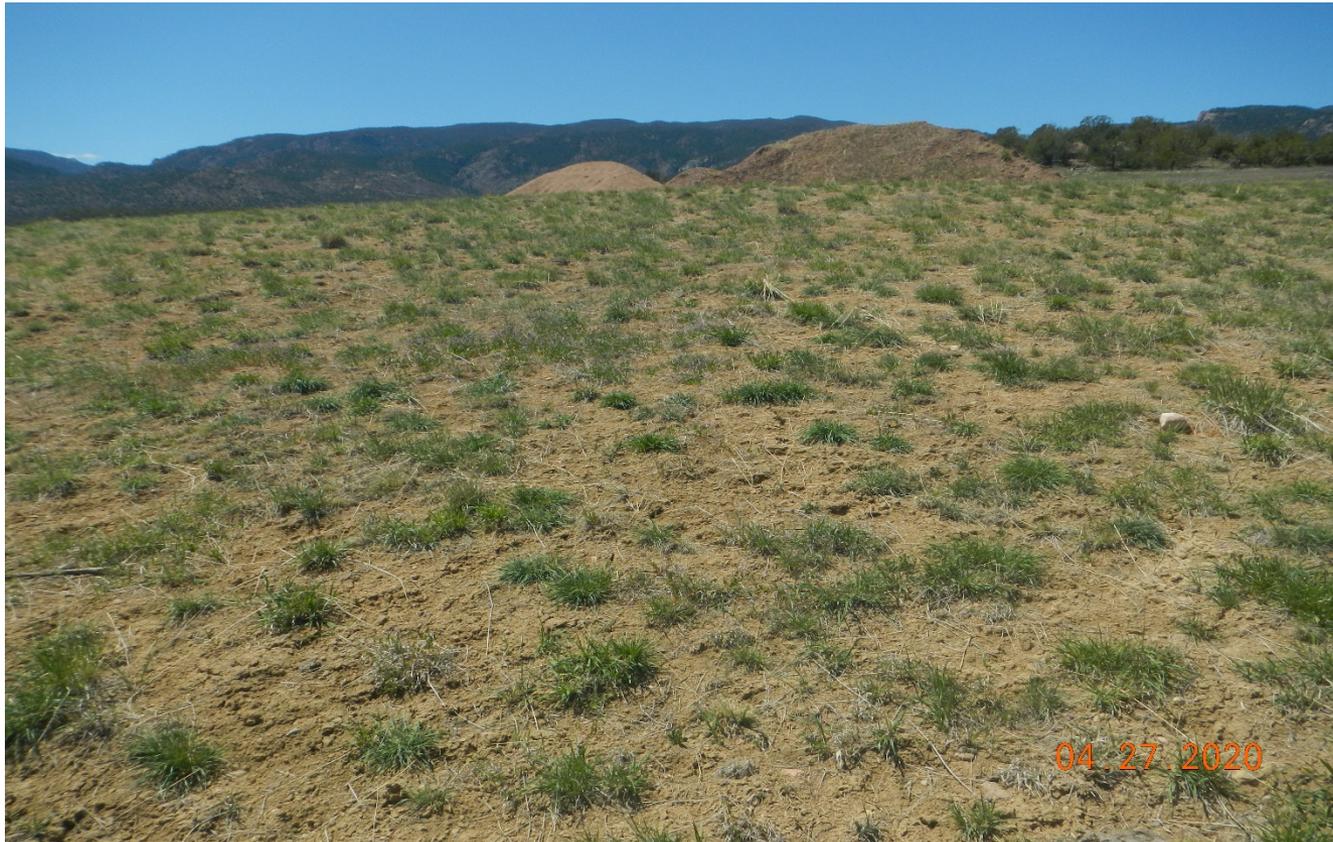
Photo 5. Facing southwest toward the location. Vegetation appears to be establishing in this area of the location.

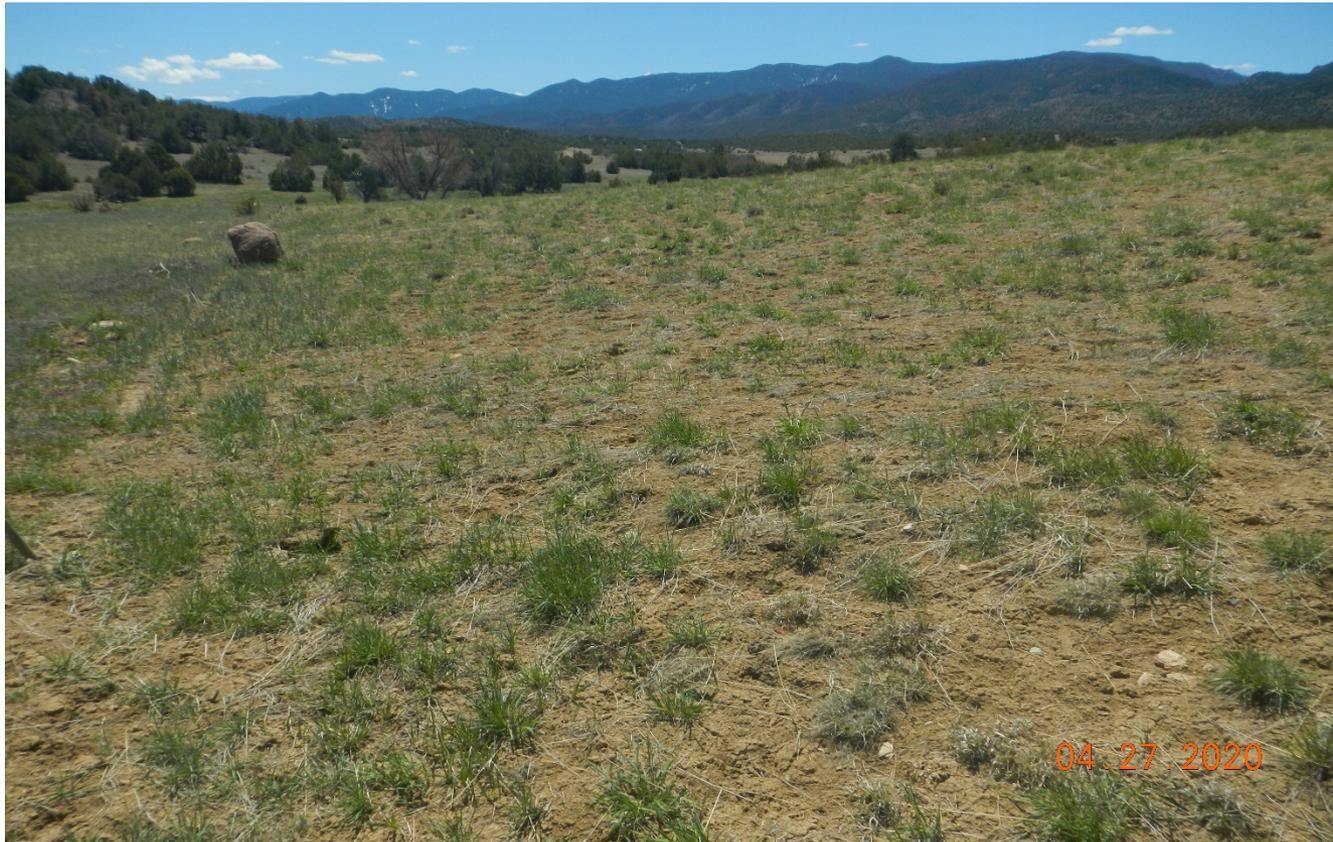
Photo 6. Facing south at the eastern side of the location.

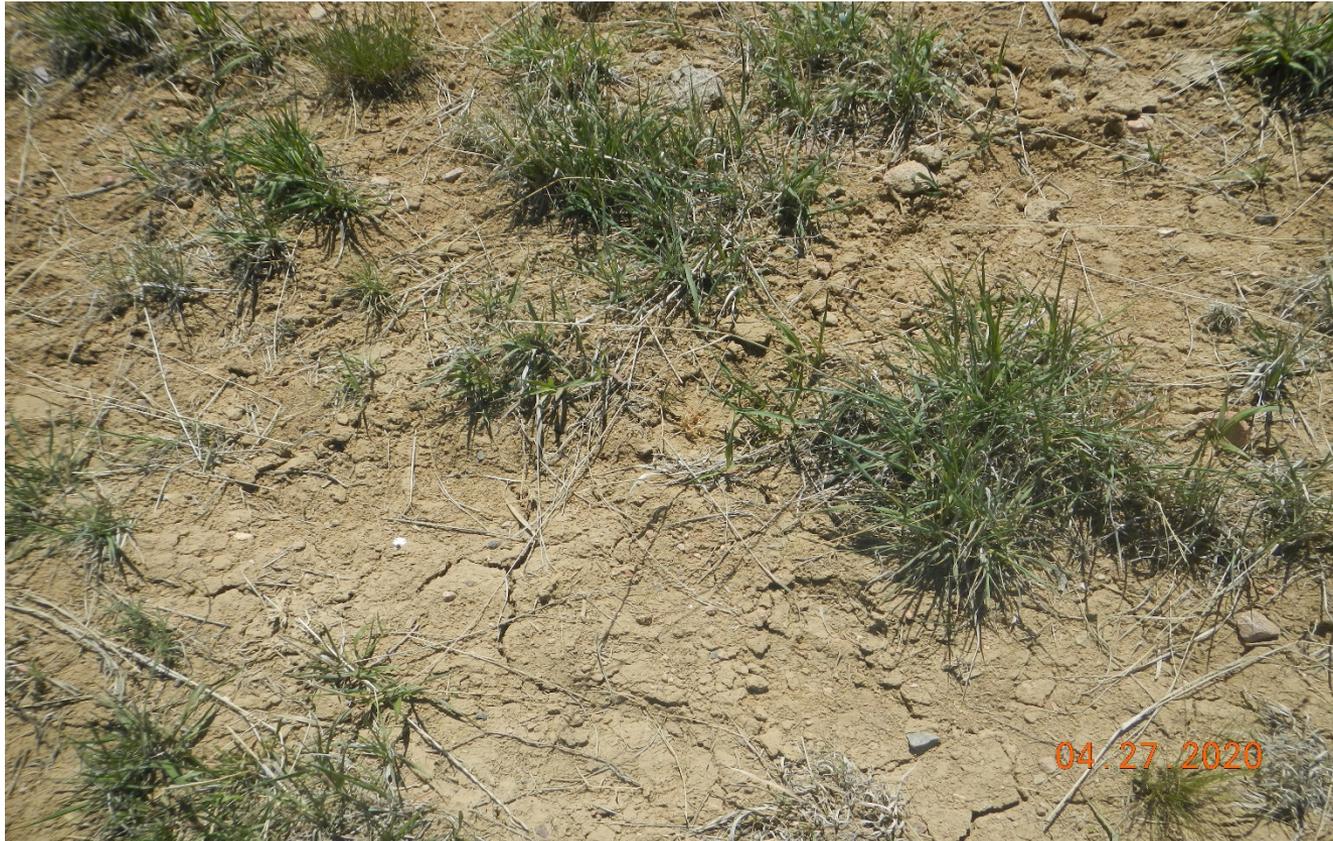
Photo 7. The vegetation observed at the location included Sand dropseed, Blue grama, and Western wheat grass.
