Stormwater Inspection Report

Operator:	Laramie Energy, LLC
Project:	Homer Deep
Location:	HD 7-23AH Pad
Date:	Tuesday, April 28, 2020
Weather:	Partly Cloudy, Light Winds, High 77° Lo 48°

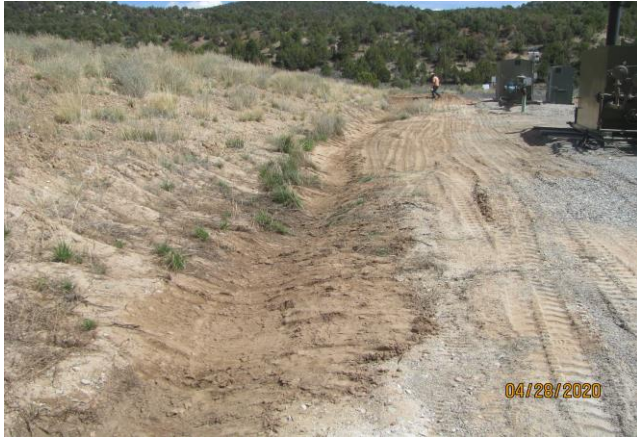
Photo 1

Diversion Ditch Maintenance on the HD 7-23AH Pad

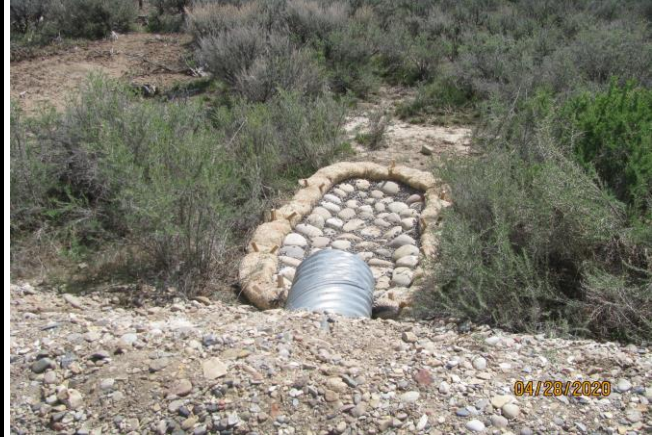
Photo 2

BMPs Installed at Culvert Outlet on the HD 7-23AH Pad

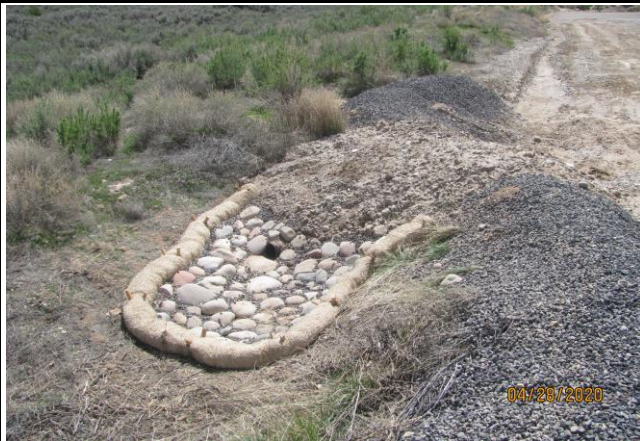
Photo 3

BMPs Installed at Flex Pipe Outlet on the HD 7-23AH Pad

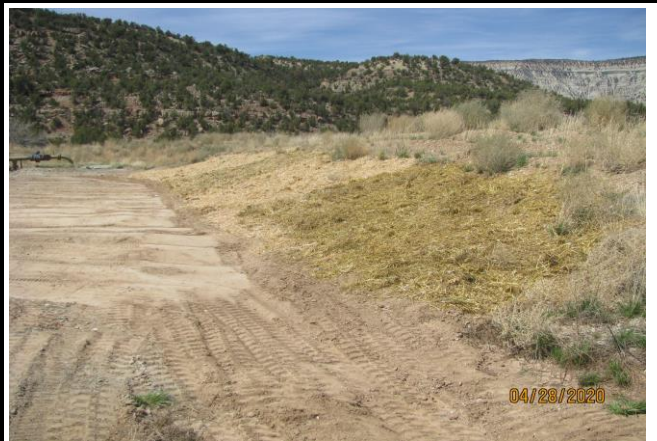
Photo 4

Slope Seeded & Mulched on the NW side of the HD 7-23AH Pad
