Inspection Photos

Operator: CHEVRON USA INC - 16700

Location ID: 398839

Rio Blanco County, CO

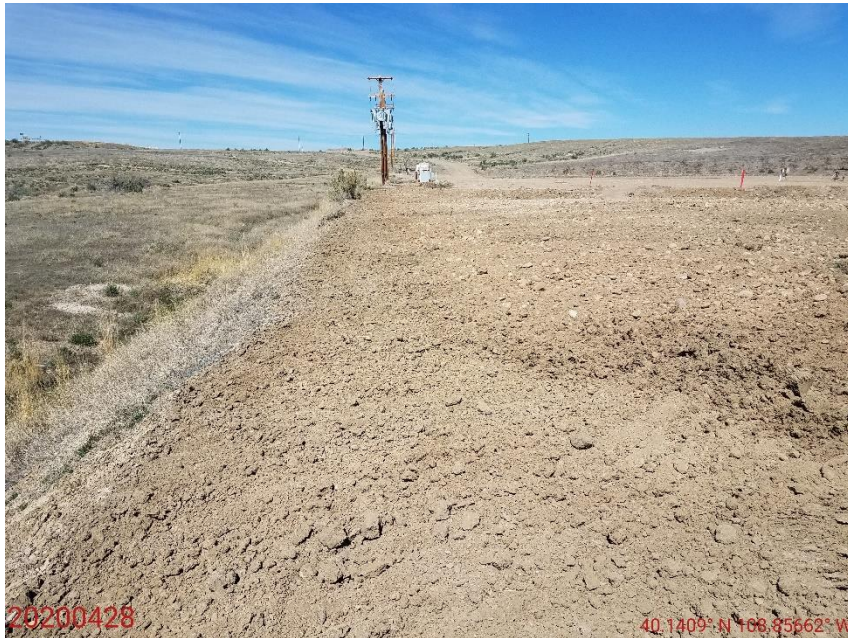
Photo 1: Photo taken from the southeast end of the location, facing west. Photos 1-3 provide an overview of the Location from west, northwest to north. Photos show Operator has constructed a berm between the production area, and areas not needed for production to the east; interim areas have not been contoured to their original grade; fill material has not been removed; Interim reclamation of the Location has not been conducted in accordance with 1003 requirements.

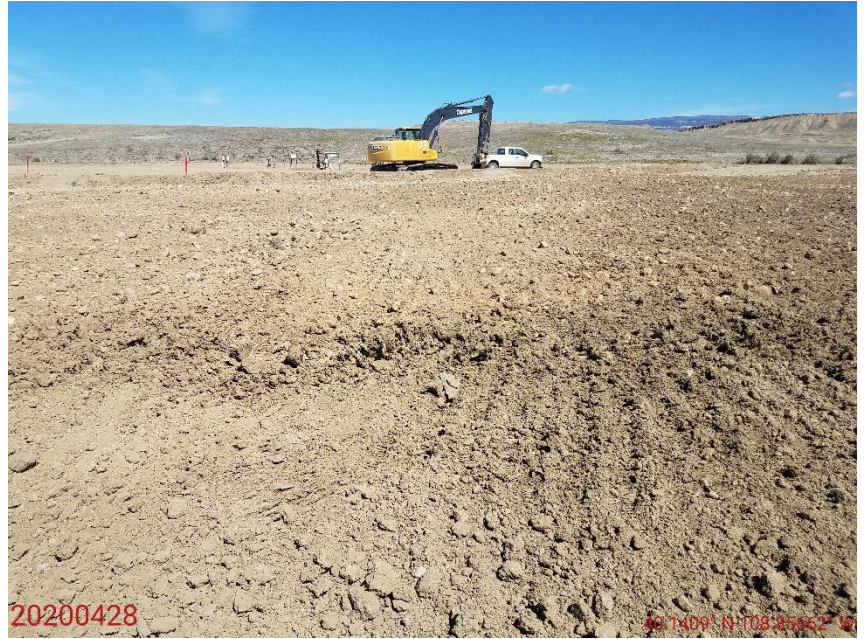
Photo 2: See comments under photo 1.

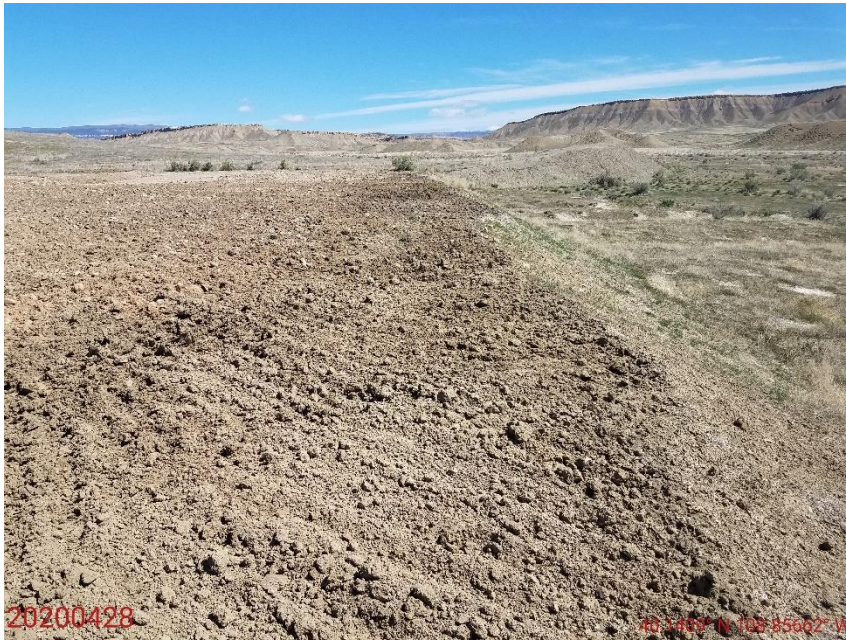
Photo 3: See comments under photo 1.

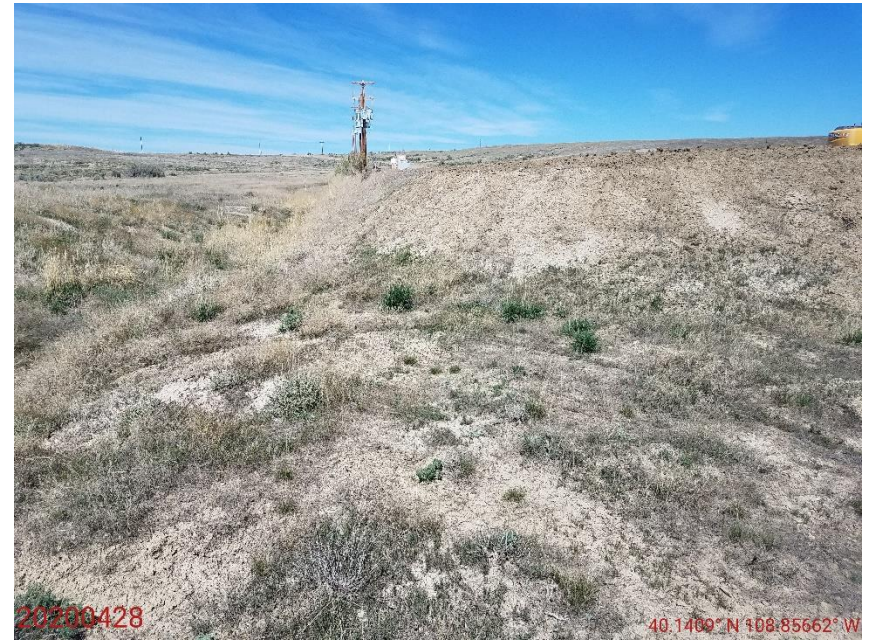
Photo 4: Photo taken from the east of the Location, facing west. Photo shows Operator has not removed fill material on areas subject to 1003 interim reclamation, and lands have not been contoured to their original grade. Interim reclamation of the Location has not been conducted in accordance with 1003 requirements.

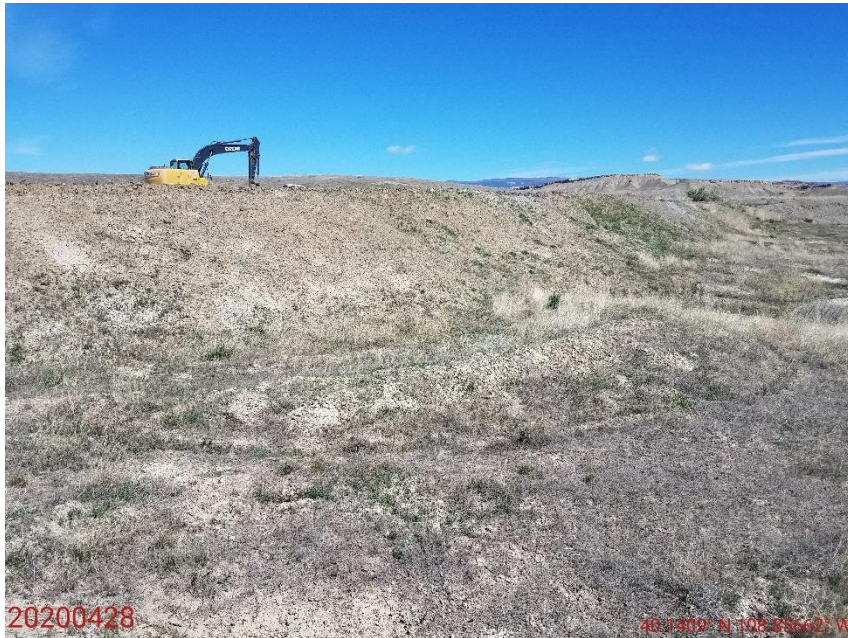
Photo 5: Photo taken from the east of the Location, facing northwest. See comments under photo 4.

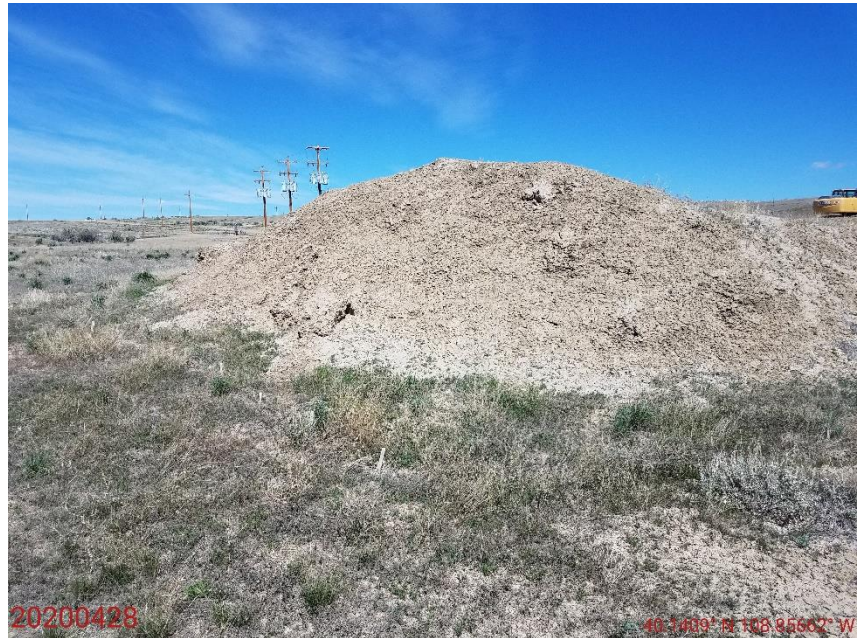
Photo 6: Photo taken from the soil stockpile to the southeast of the Location. Photo shows soils remain bare and exposed; no BMPs have been installed to protect soils in accordance with Rule 1002.c, or to prevent sediment discharge in accordance with Rule 1002.f.

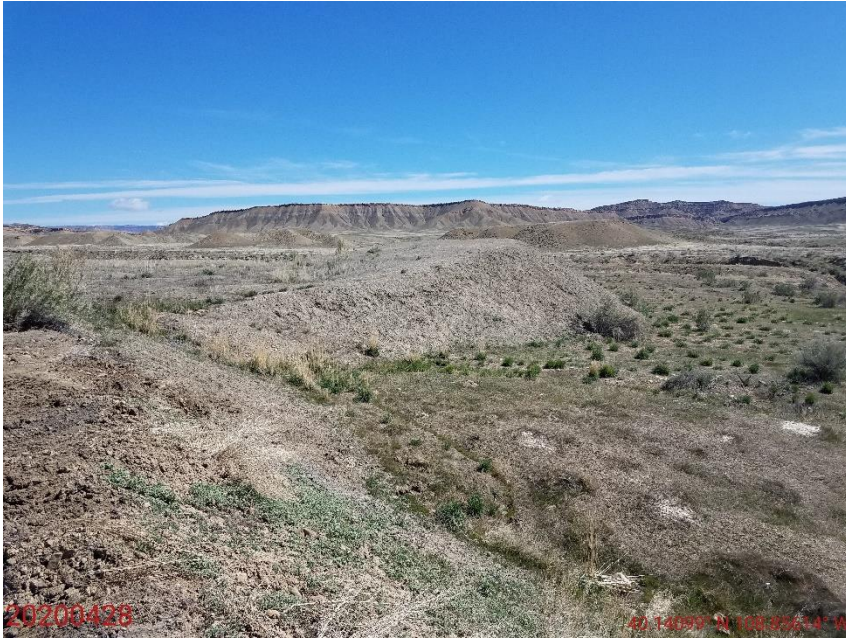
Photo 7: Photo taken from east end of the Location, facing northeast. Photo shows soil stockpile on the northeast end of the Location remains bare and exposed; no BMPs have been installed to protect soils in accordance with Rule 1002.c, or to prevent sediment discharge in accordance with Rule 1002.f.

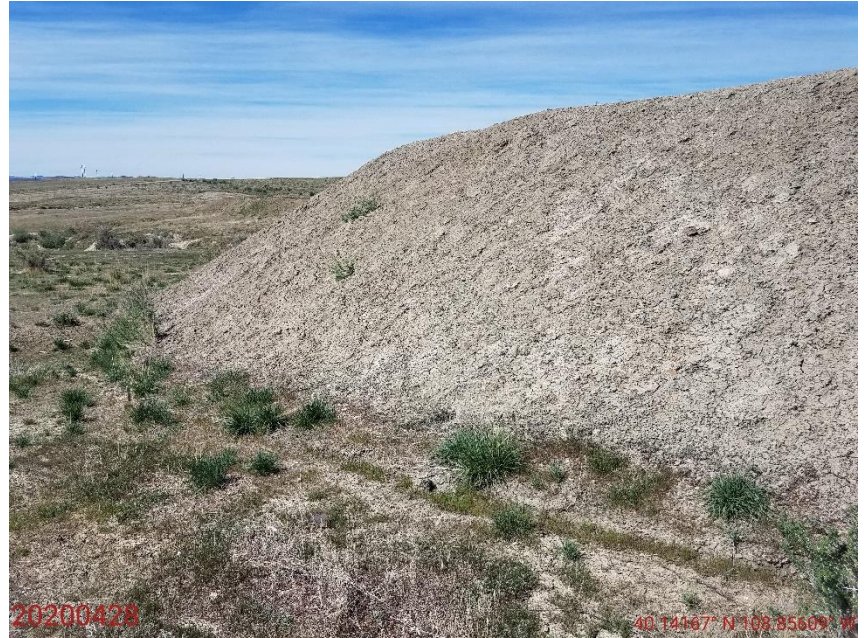
Photo 8: See comments under photo 7.

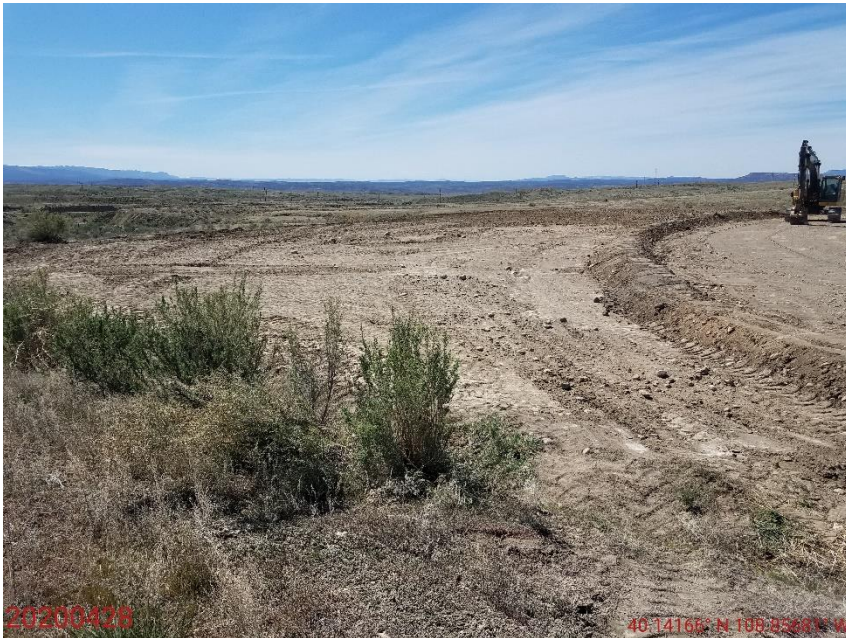
Photo 9: Photo taken from the northeast end of the location, facing south. Photos 1-3 provide an overview of the Location from south, southwest to west. Photos show Operator has constructed a berm between the production area, and areas not needed for production to the east; interim areas have not been contoured to their original grade; fill material has not been removed; Interim reclamation of the Location has not been conducted in accordance with 1003 requirements.

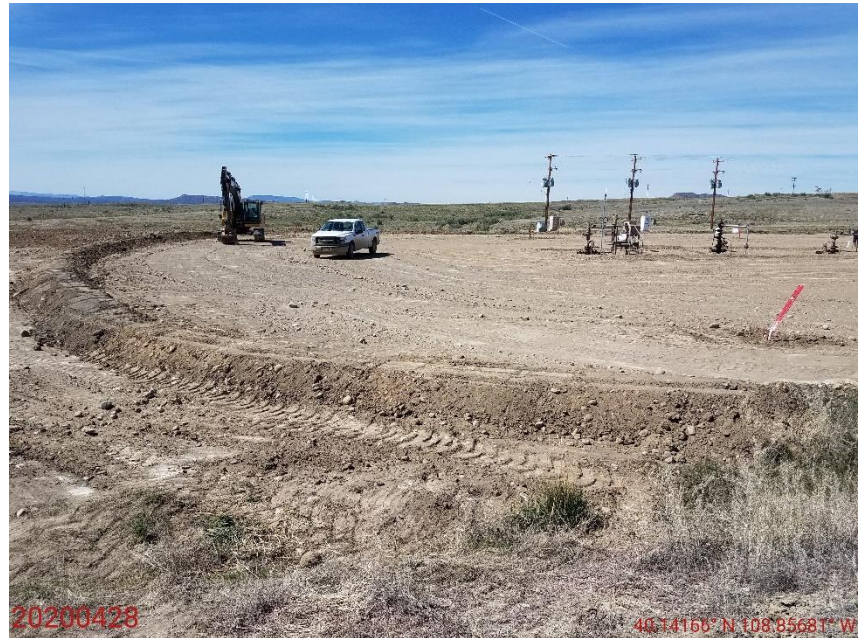
Photo 10: See comments under photo 9.

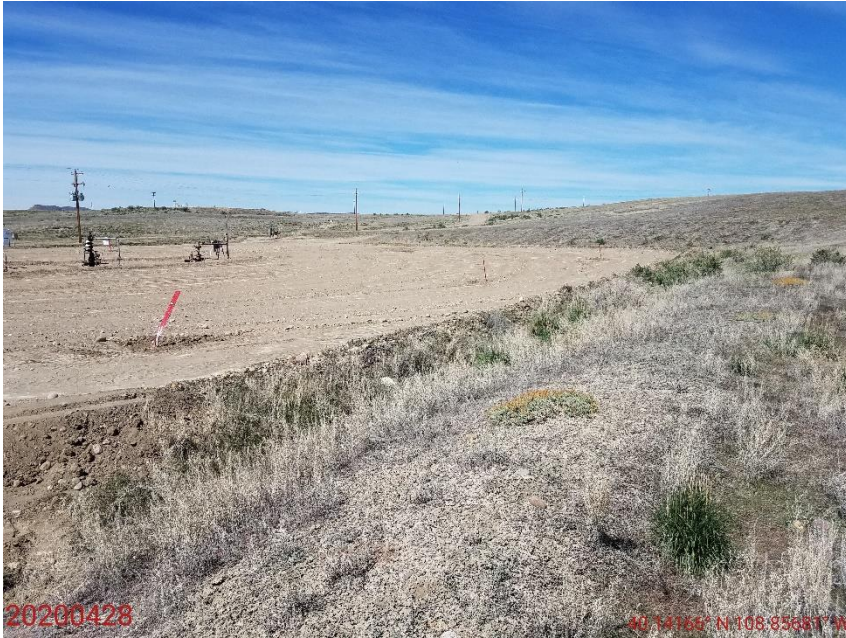
Photo 11: See comments under photo 9.

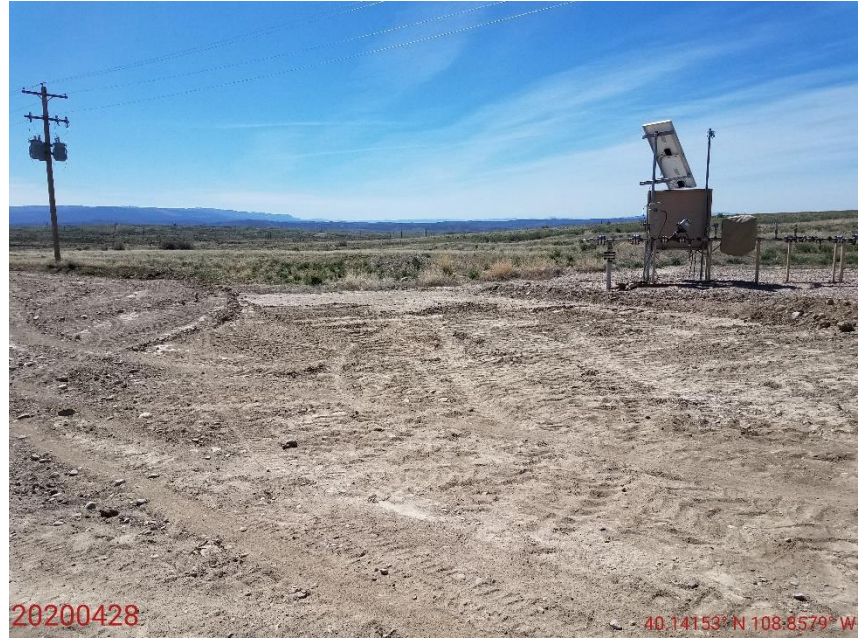
Photo 12: Photo taken from the southwest end of the Location. Photo shows barrier equipment has been removed from the Location

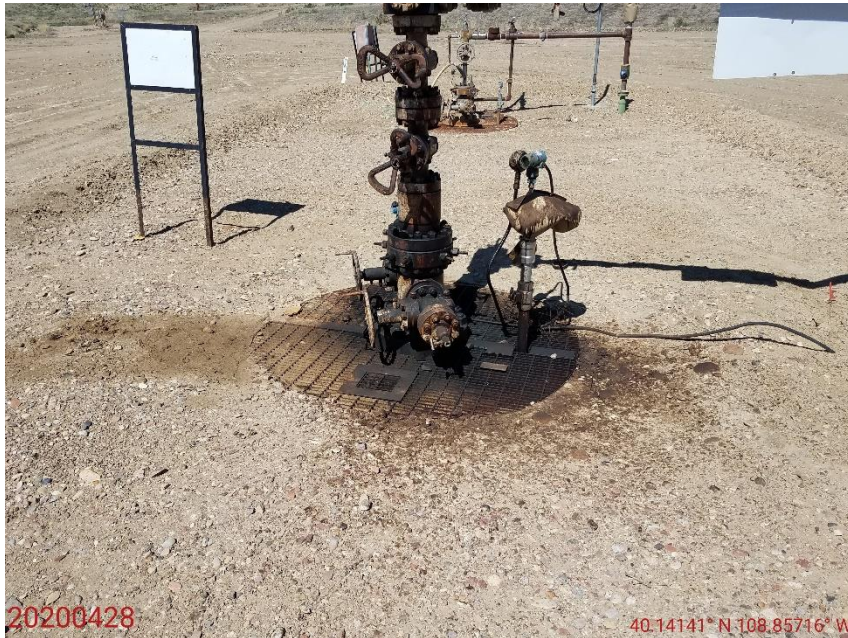
Photo 13: Photo taken from the 153X16 well (103-11464). Photo shows a spill appears to have occurred at well; Stained soils around well and containment cellar.

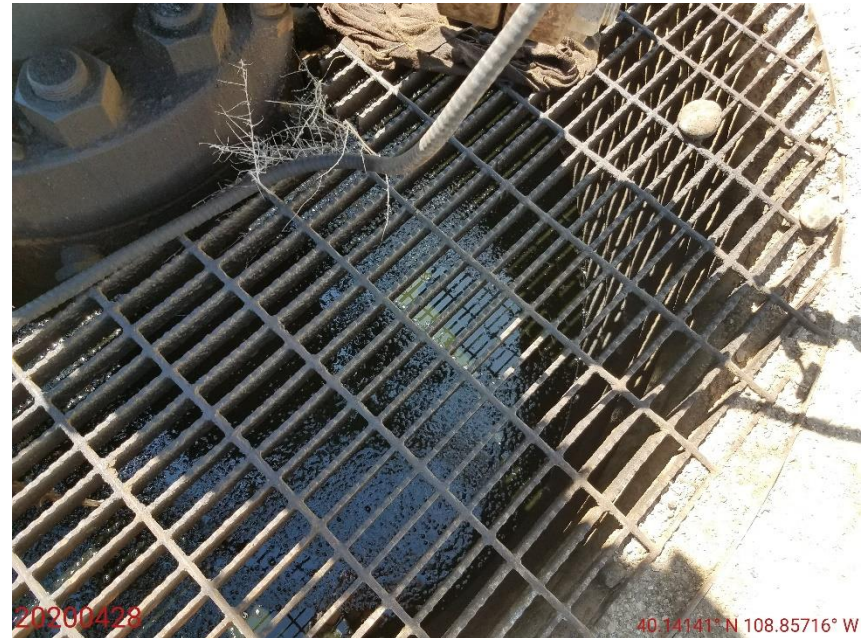
Photo 14: Continued from photo 13. Photo shows oily fluids within the containment cellar; a spill appears to have occurred at well.

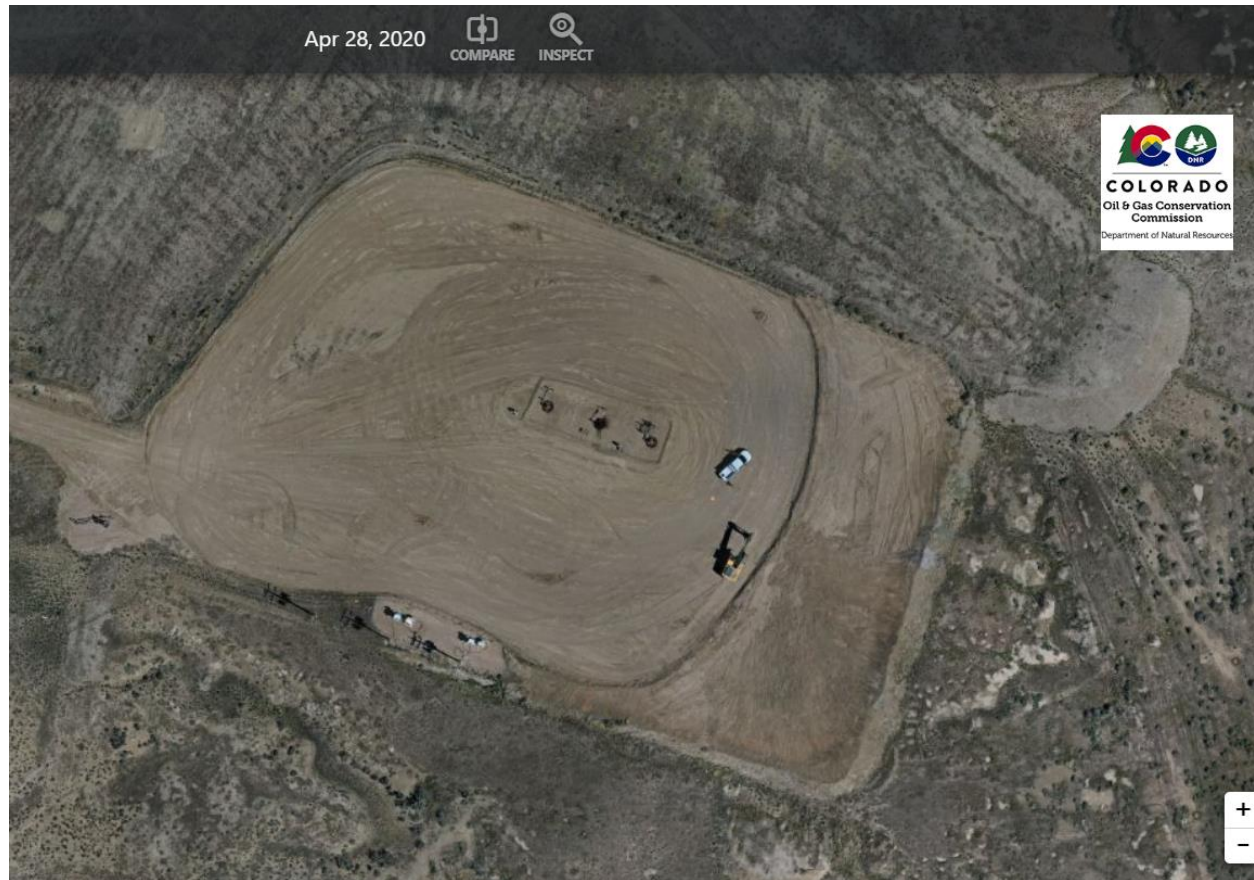
Photo 15: On 4/28/2020, Reclamation specialist Trujillo utilized a SUA to capture aerial imagery of the Location; Photo shows overview of the current pad. Photo shows Operator has constructed a berm between the production area, and areas not needed for production to the east; no additional reclamation activities appear to have been conducted per Rule 1003.b.

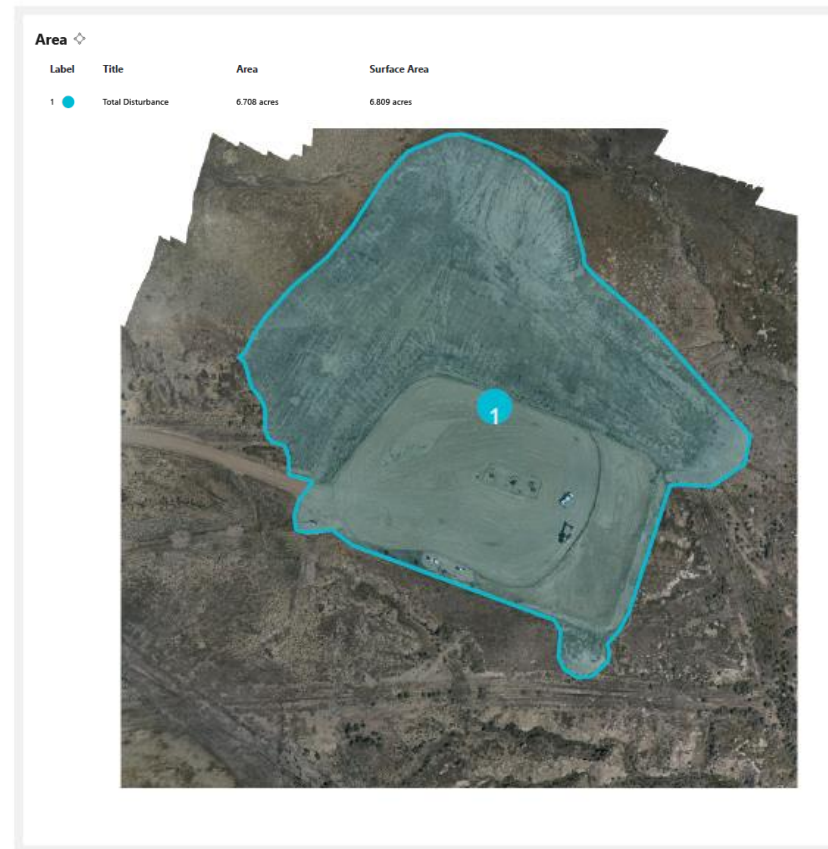
Photo 16: On 4/28/2020, Reclamation specialist Trujillo utilized a SUA to capture aerial imagery of the Location; Based on data collected with a SUA, the total disturbance encompasses approximately 6.6 acres. This exceeds the permitted disturbance area of 4.25 acres based on the information Operator provided in its Oil and Gas Location Assessment Form 2A (#400098646).

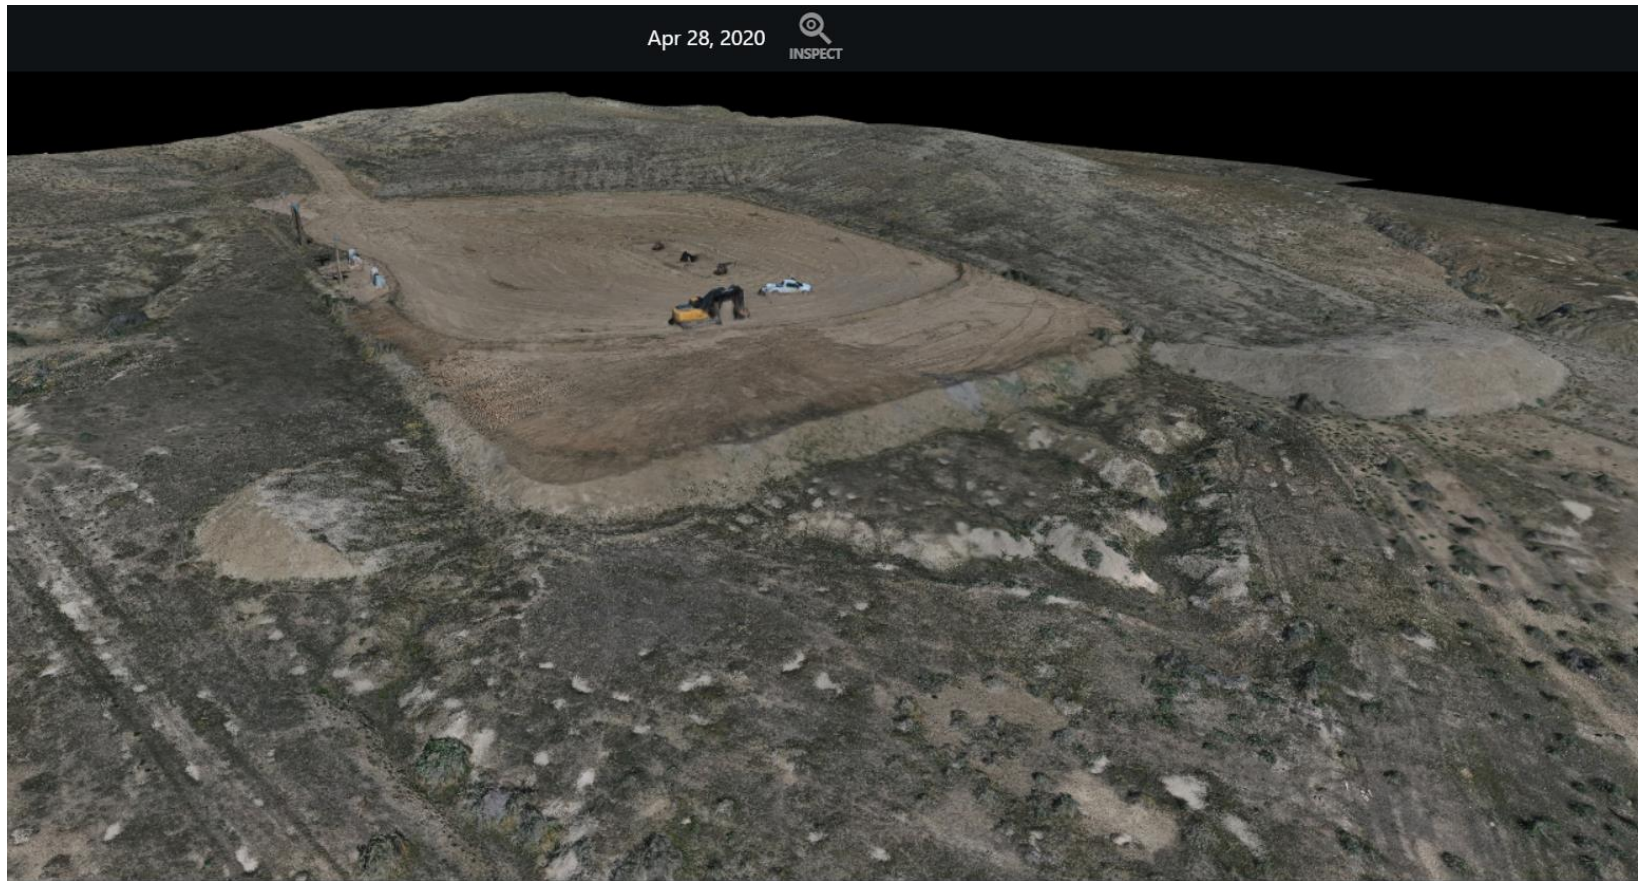
Photo 17: On 4/28/2020, Reclamation specialist Trujillo utilized a SUA to capture aerial imagery of the Location and create a 3-dimensional model of the topography; Photo shows the fill slopes/disturbance on the east end of the location has not been reclaimed and areas returned to their original grade in accordance with Rule 1003.b
