Inspection Photos  
Operator: BP America  
API#: 067-06532  
Date: 4/28/2020

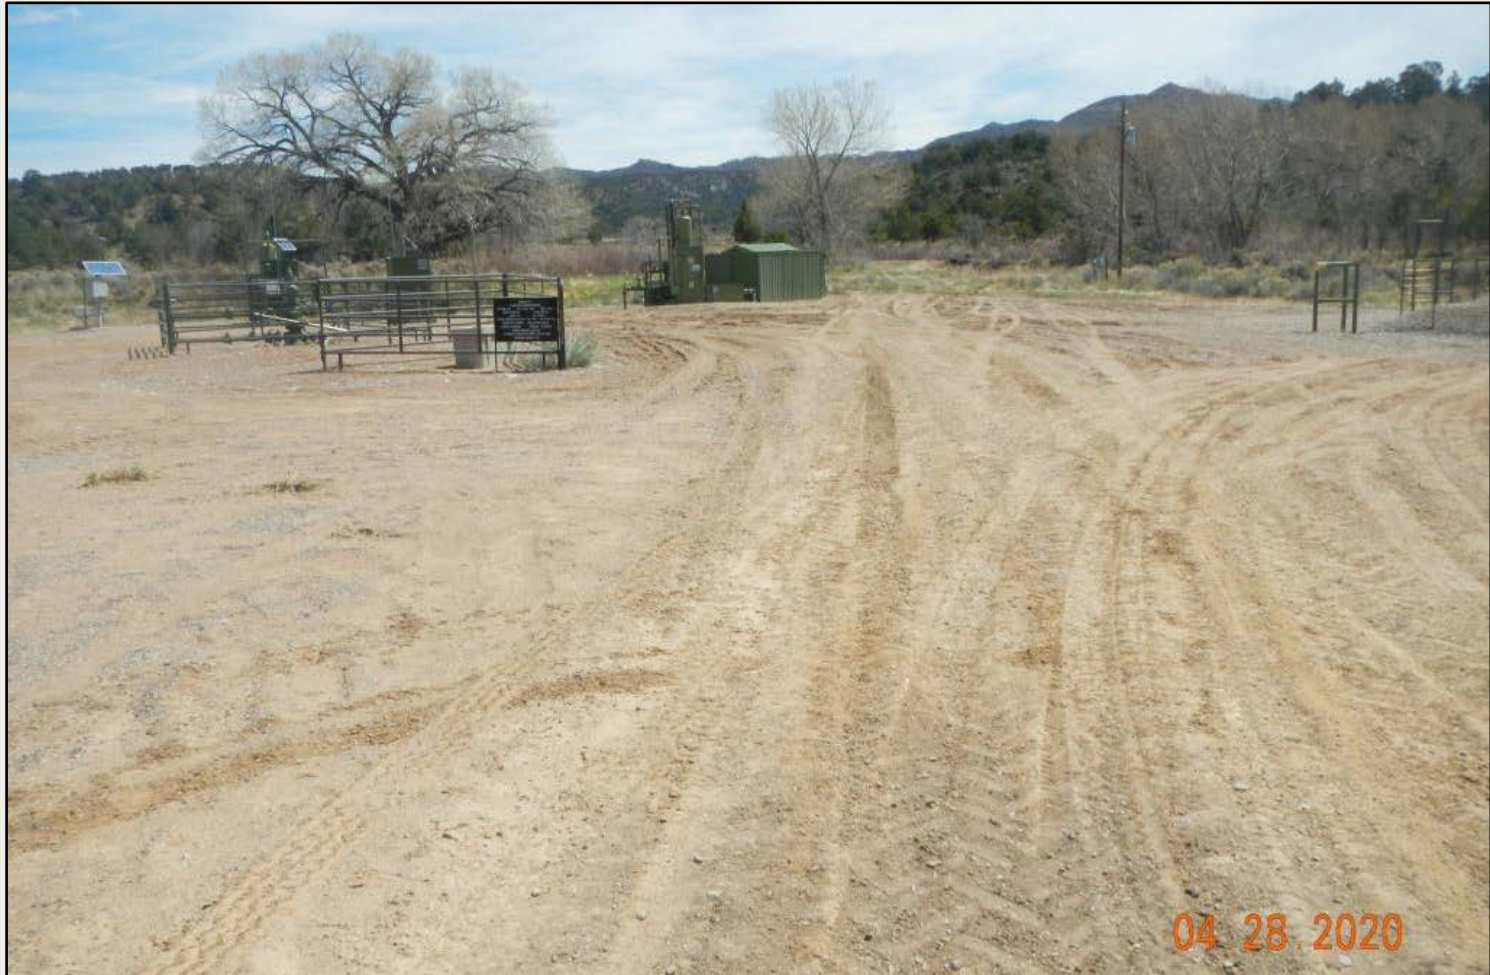
Photo 1. View of the project area from the well pad entrance facing center.

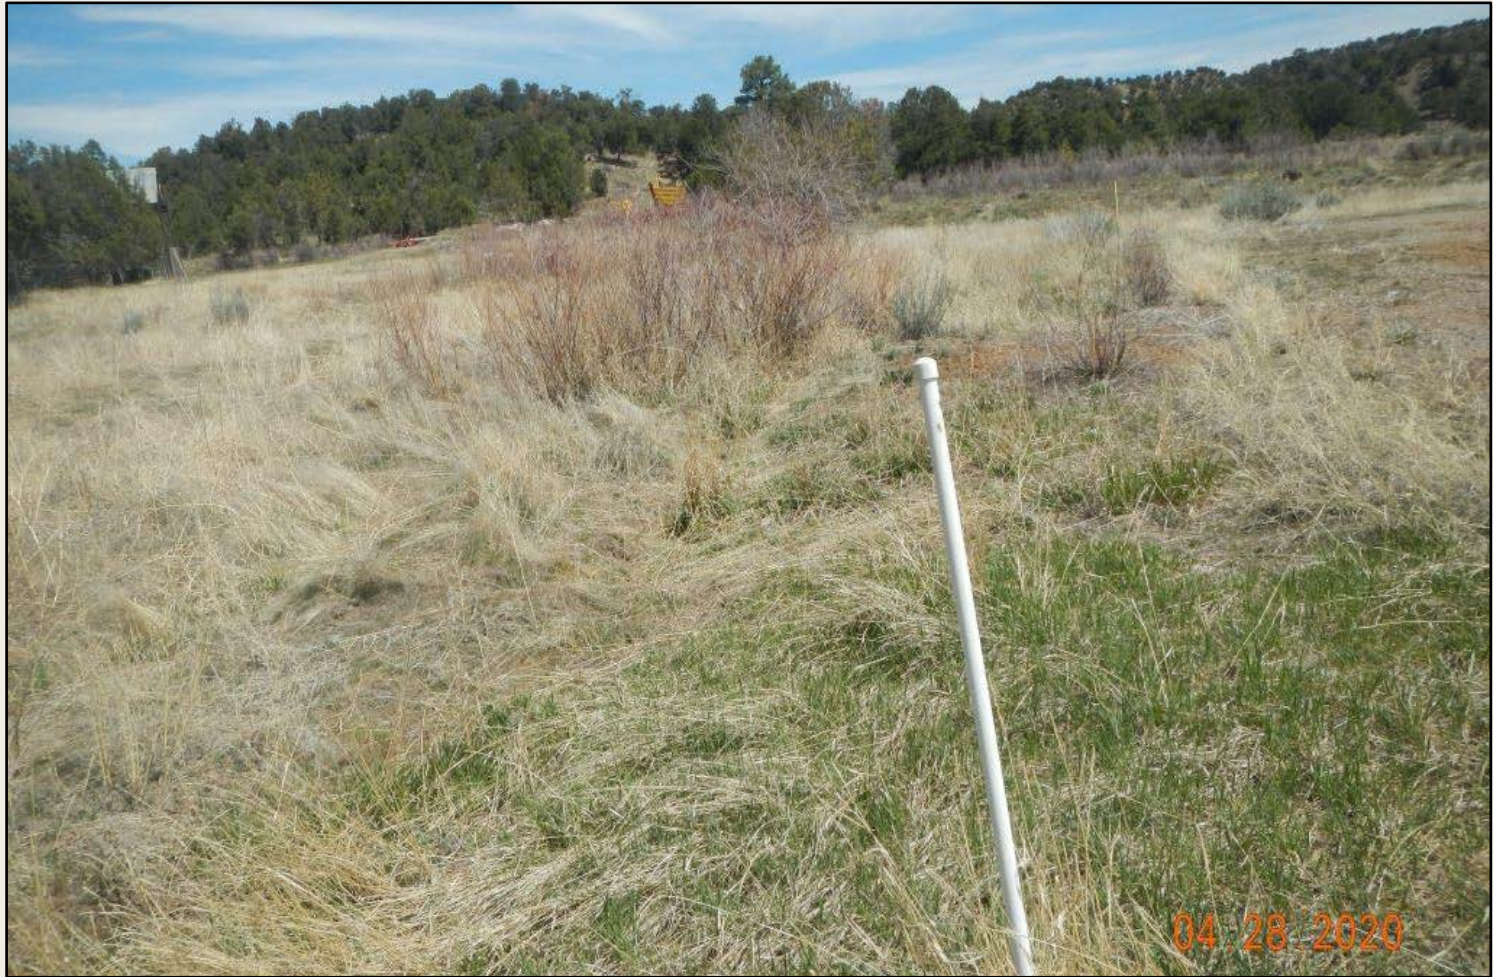
Photo 2. View of the northern project area from the northwestern corner facing eastward. Revegetation is progressing with a mixture of grasses such as smooth brome and sand dropseed, as well as shrubs such as rubber rabbitbrush.

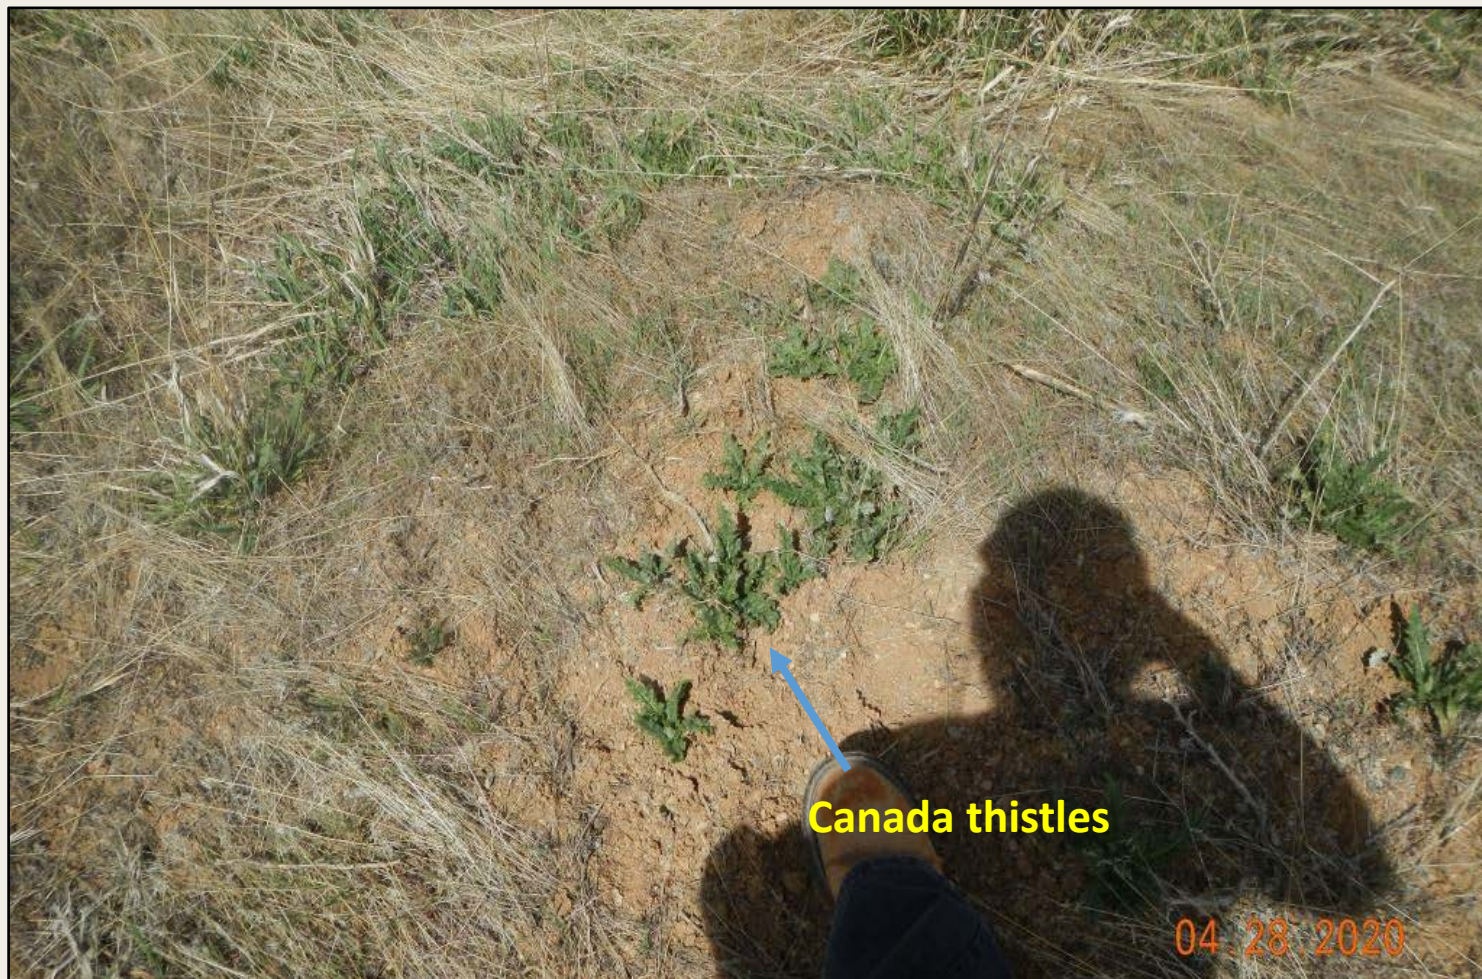
Photo 3. View of Canada thistles within the northern project area. Approximately 50 individuals observed.

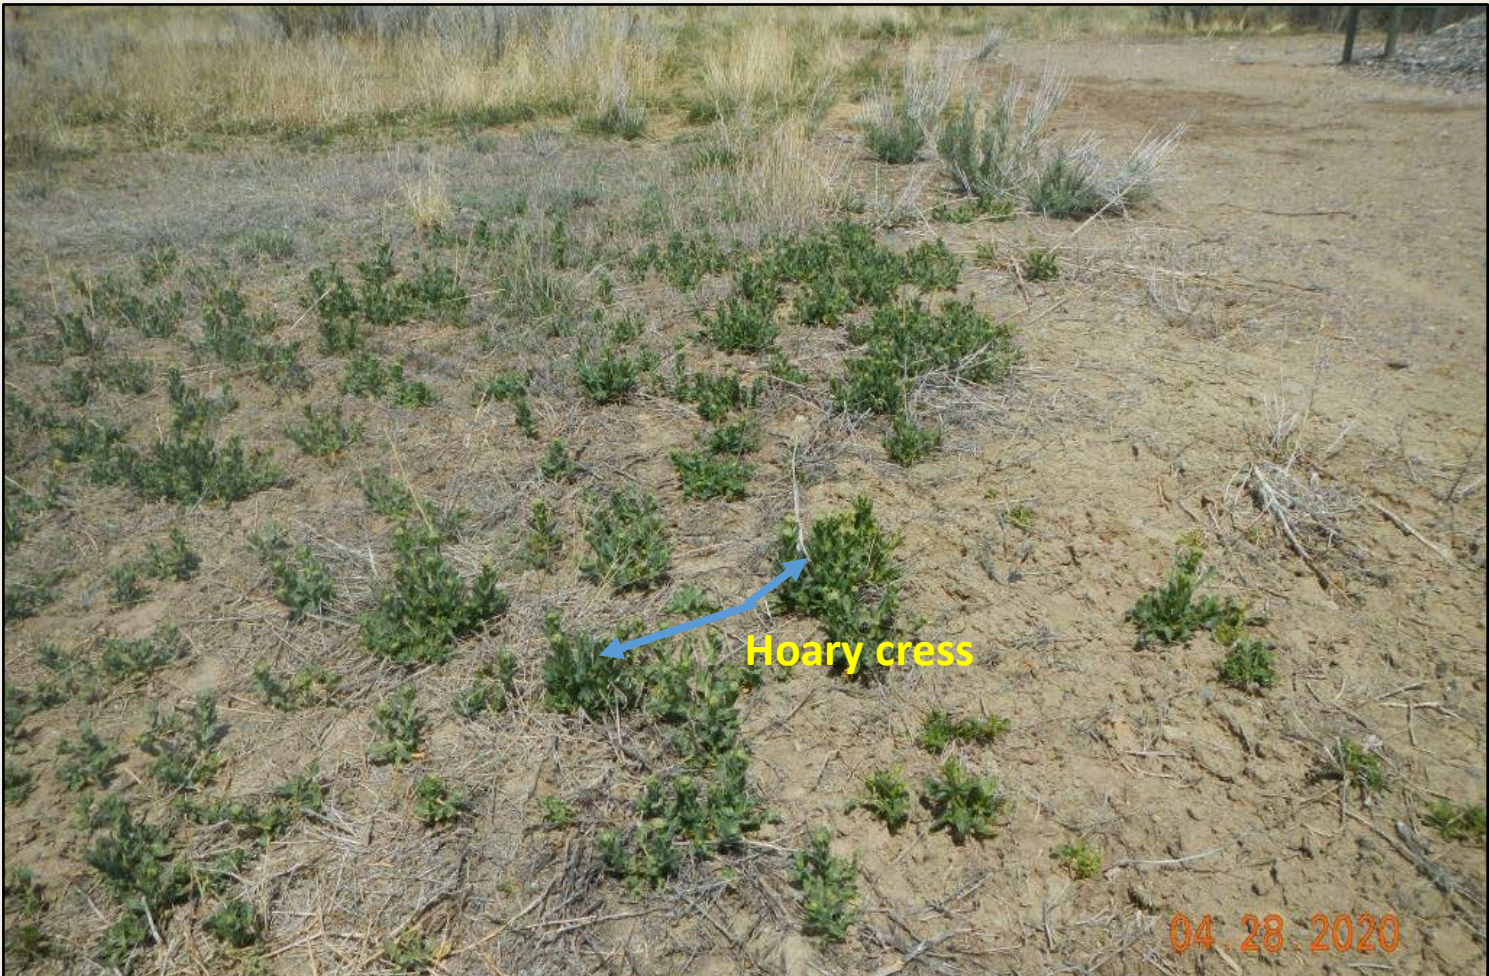
Photo 4. View of hoary cress (*Cardaria draba*) within the western project area. Approximately 200 individuals observed.

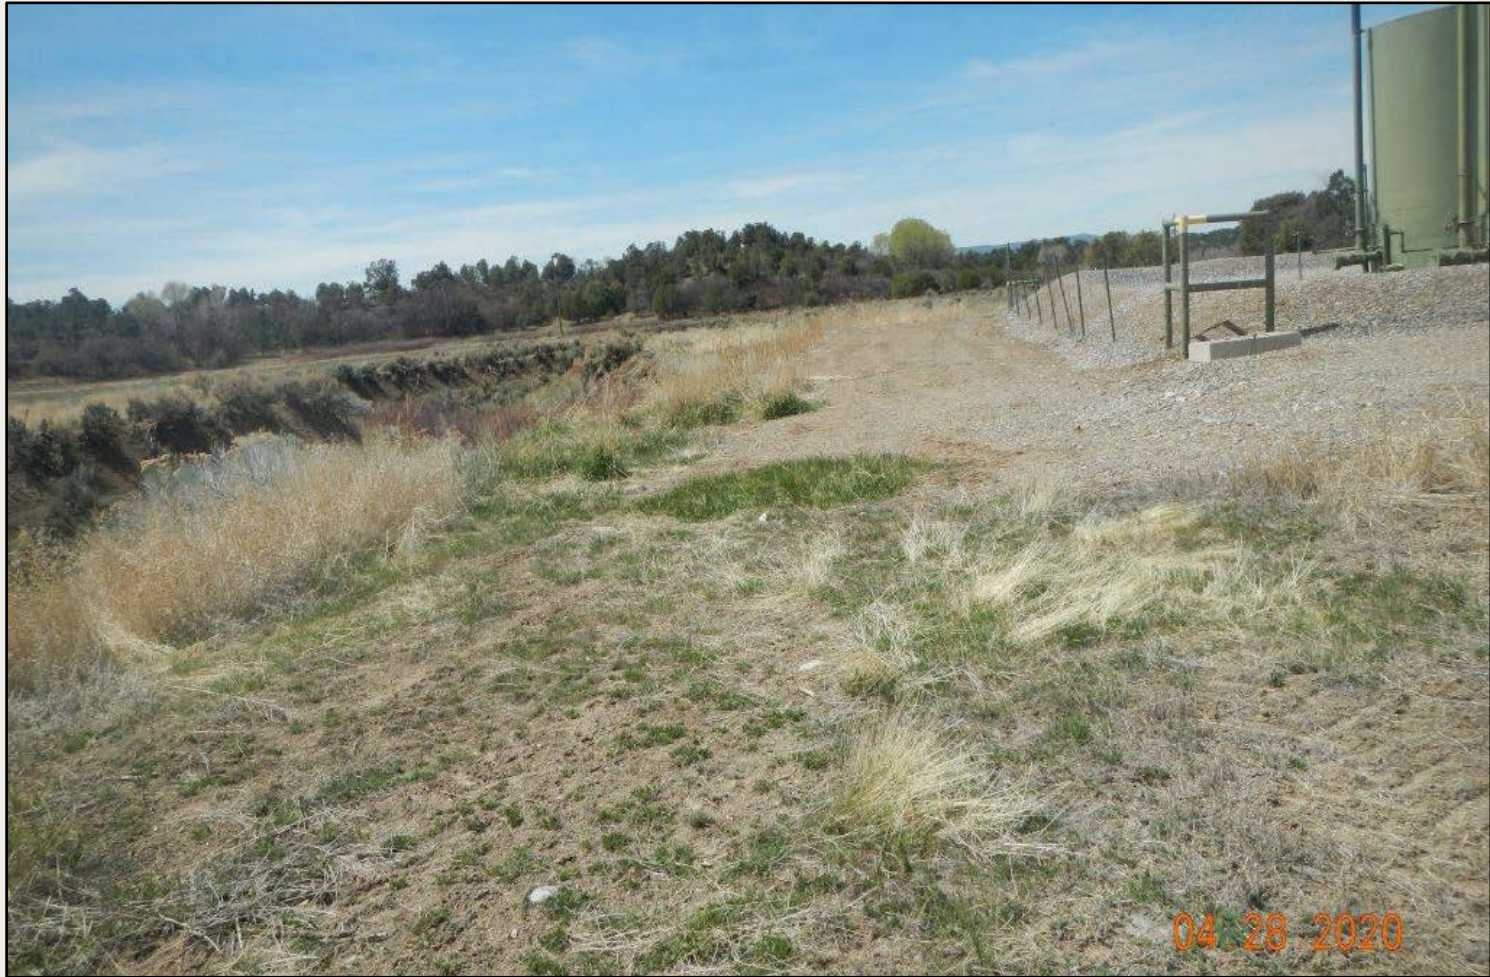
Photo 5. View of the southern project area from the southeastern corner facing eastward. A steep arroyo runs adjacent to the southern project area. Stormwater erosion appears to be controlled at this time but needs to continue to be monitored.

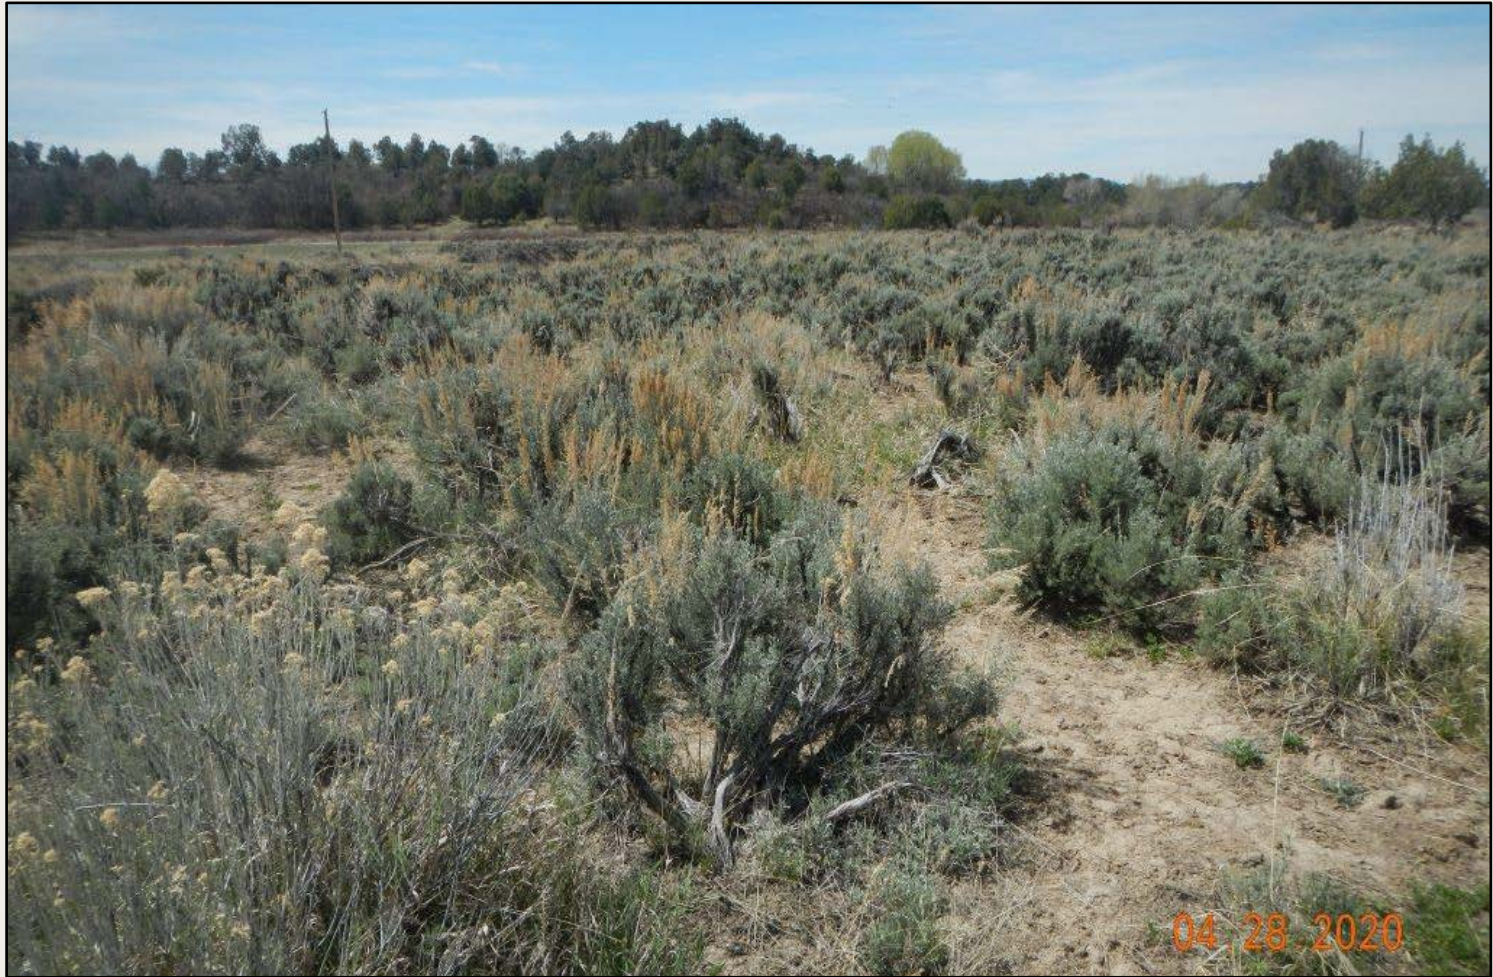
Photo 6. View of reference area vegetation comprised of open sagebrush shrubland, with understory grasses and forbs such as western wheatgrass, blue grama, sand dropseed, and milkvetch.
