Inspection Photos

5/04/2020

Operator: TEP ROCKY MOUNTAIN LLC - 96850

Location ID: 454383

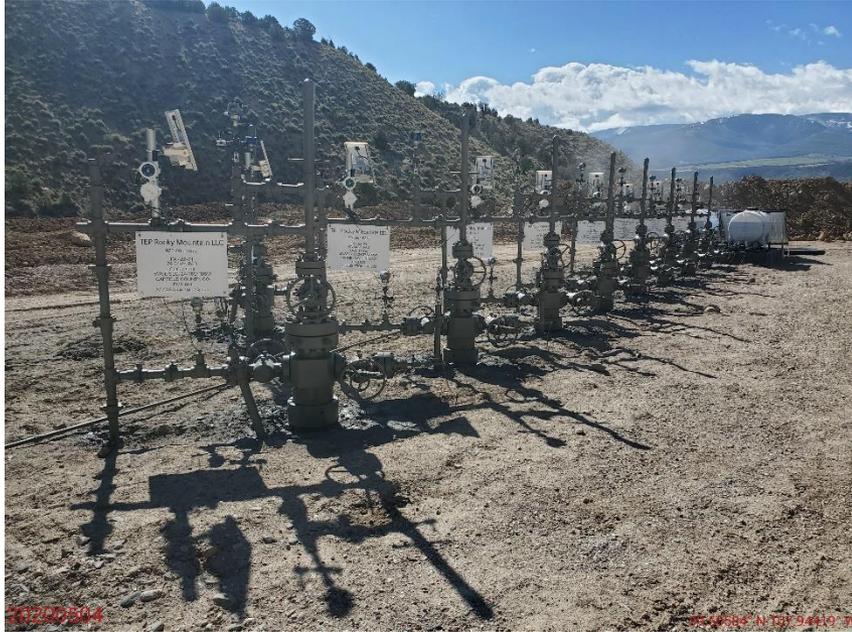
Photo 1: Photo taken from the wells, facing south. Photo shows the active/producing wells on the Location; Records show all wells appear to be producing by 11/26/2019.

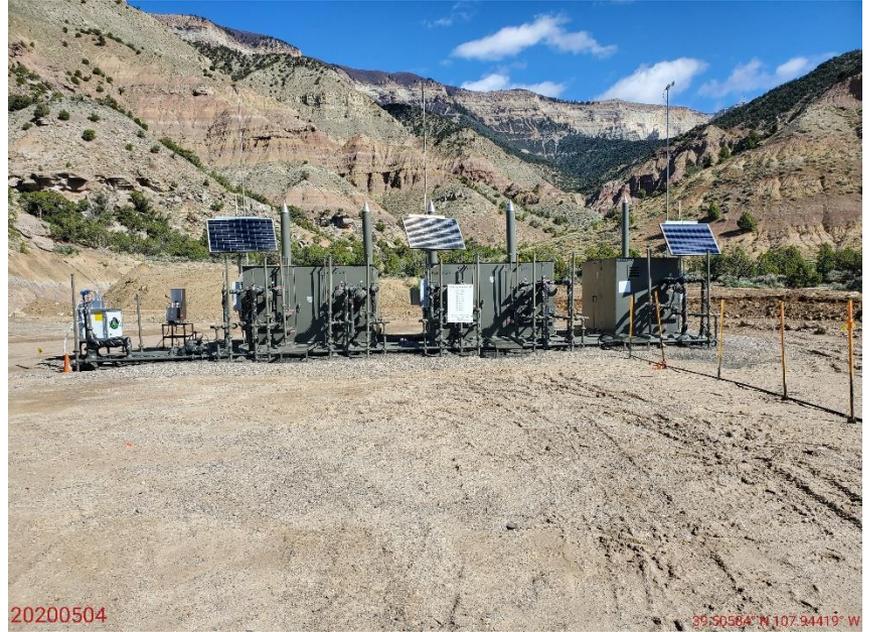
Photo 2: Photo taken from the Location facing north. Photo shows separators on Location.

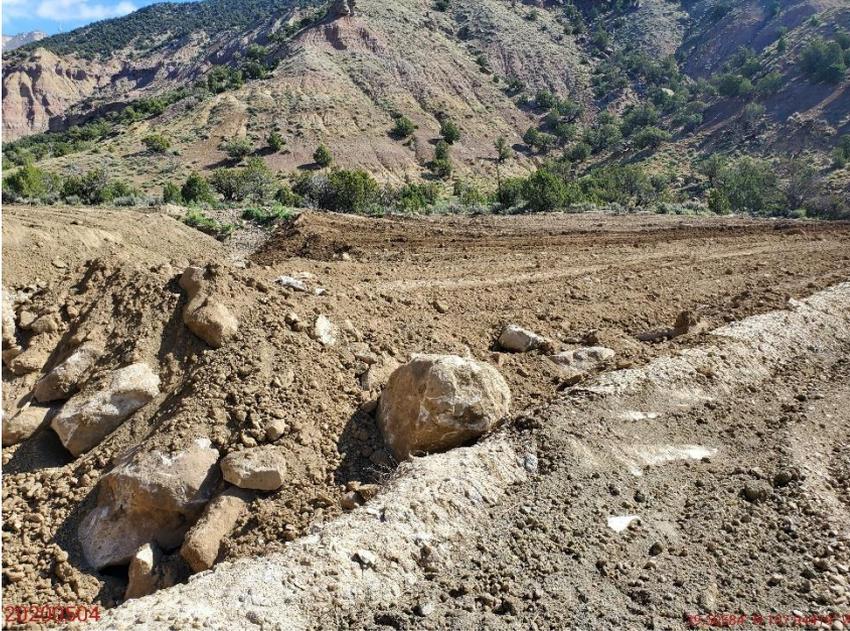
Photo 3: Photo taken from the northwest end of the Location, facing north. Photos 3-5 provide an overview of the Location from north, east to south. Photo shows interim reclamation activities are in process.

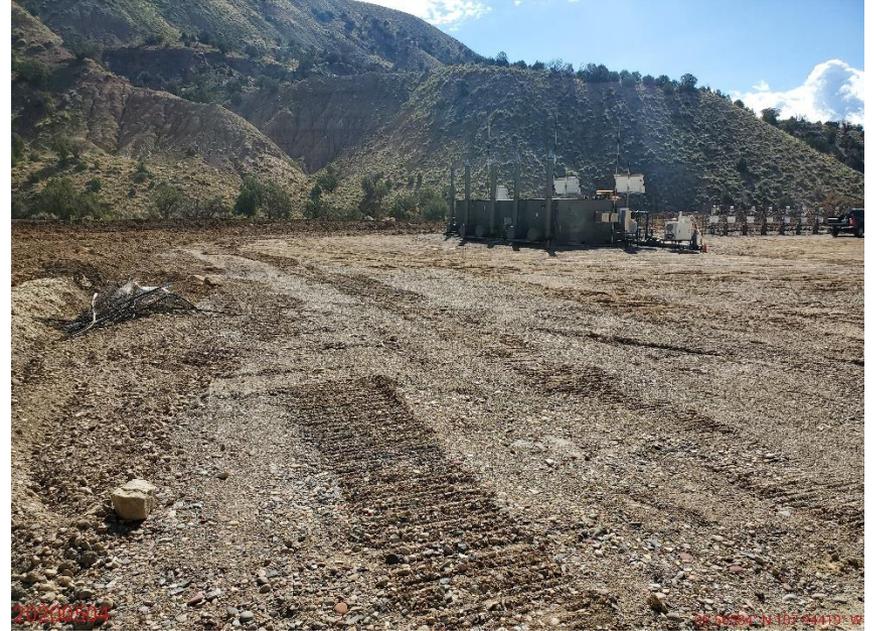
Photo 4: See comments under photo 3.

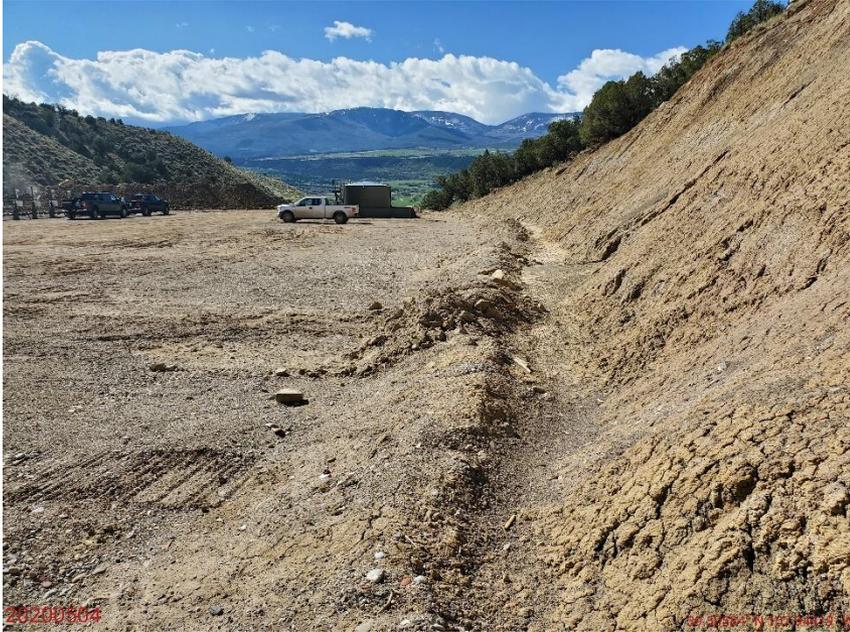
Photo 5: See comments under photo 3.

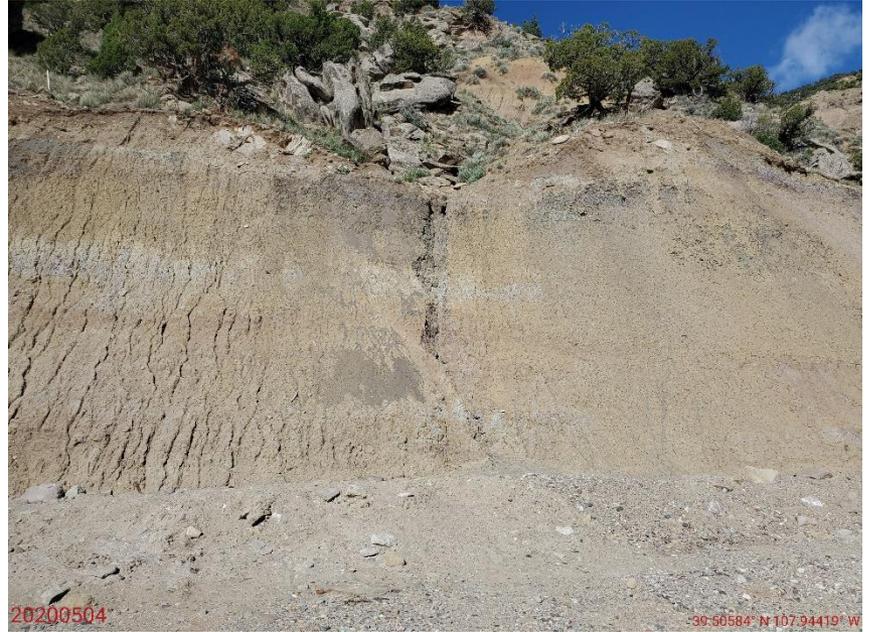
Photo 6: Photo taken from the west end of the Location, facing west. Photo shows erosion degradation on the cut slopes; Insufficient BMPs, or BMPs missing, to stabilize the slopes, manage runoff and prevent degradation to the Location.

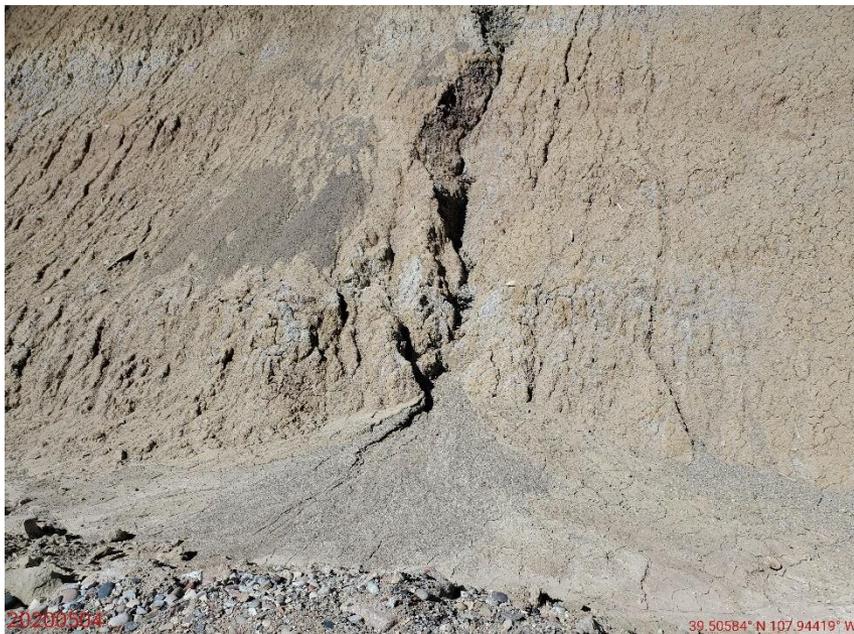
Photo 7: See comments under photo 6.

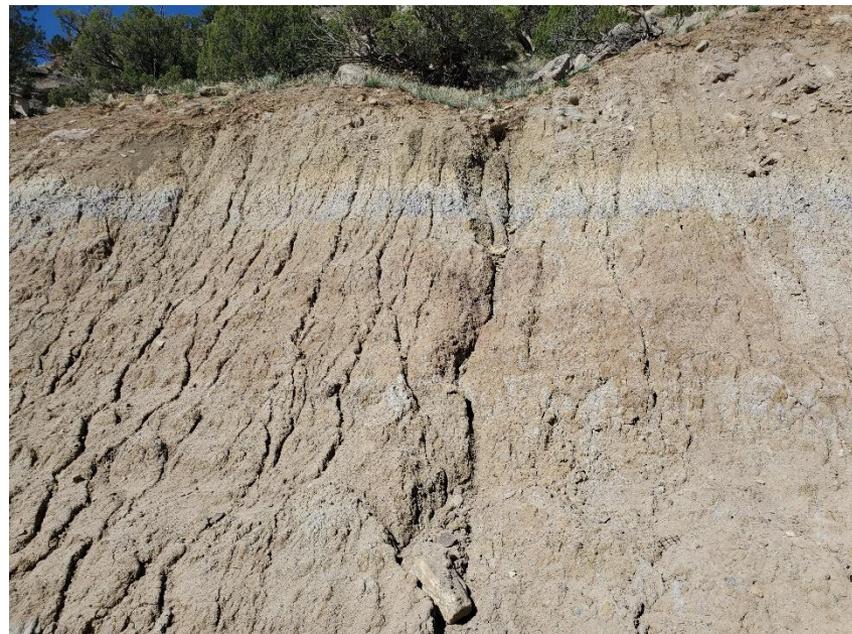
Photo 8: See comments under photo 6.

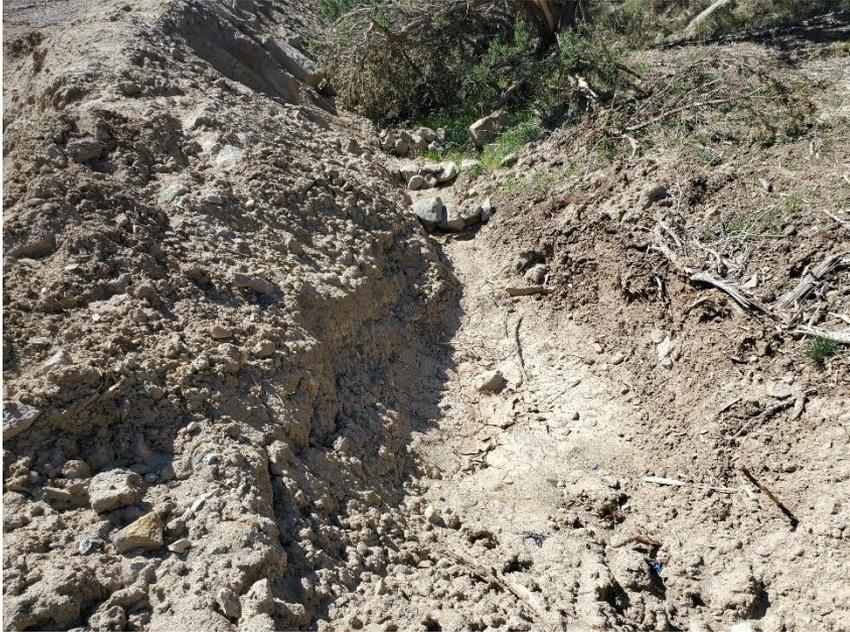
Photo 9: Photo taken from the southwest end of the Location. Photo shows velocity checks within stormwater diversion ditch.

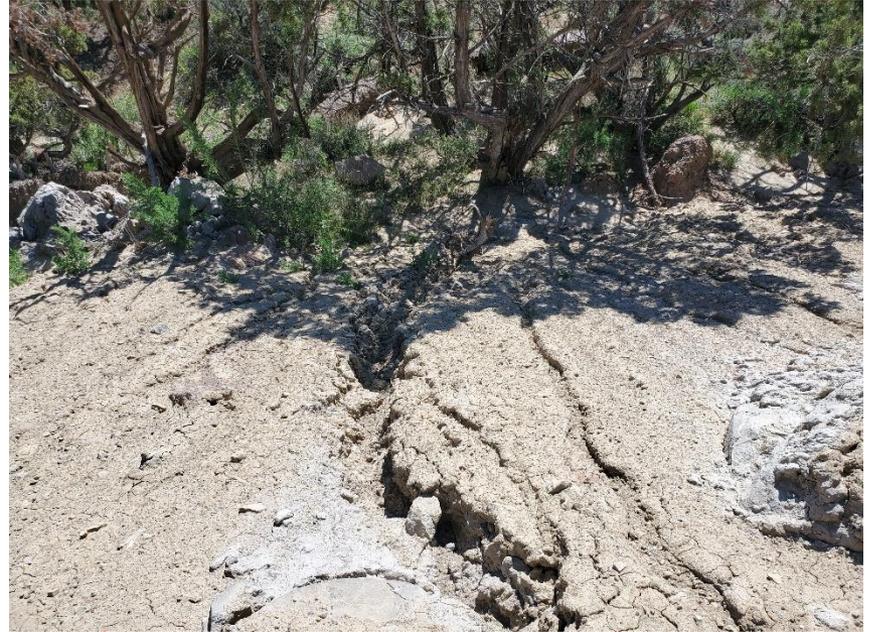
Photo 10: Photo taken from the southeast end of the Location/Location entrance, facing east from the access road. Photo shows erosion degradation and sediment deposition; Insufficient BMPs, or BMPs missing, to stabilize the slopes, manage runoff and prevent degradation to the Location.

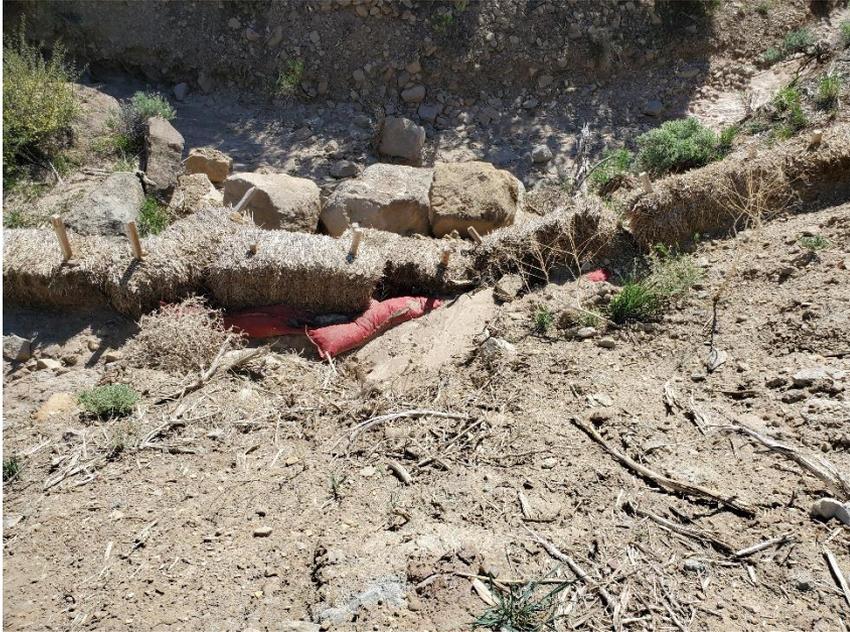
Photo 11: Photo taken from the access road, facing east. Photo shows erosion bales have not been installed in accordance with good engineering practices (entrenched) and/or maintained in proper functioning condition. Sediment discharge into an intermittent stream evident.

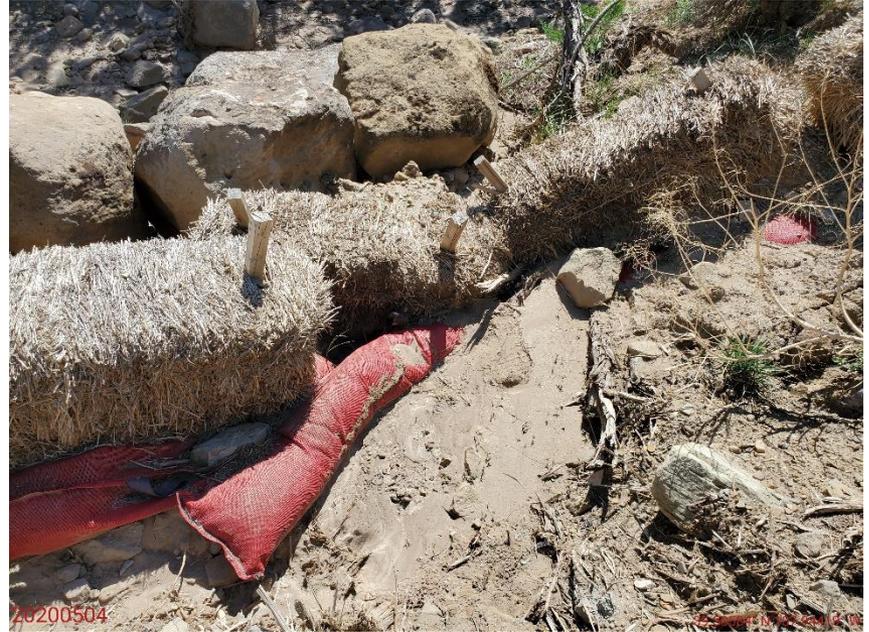
Photo 12: See comments under photo 11.

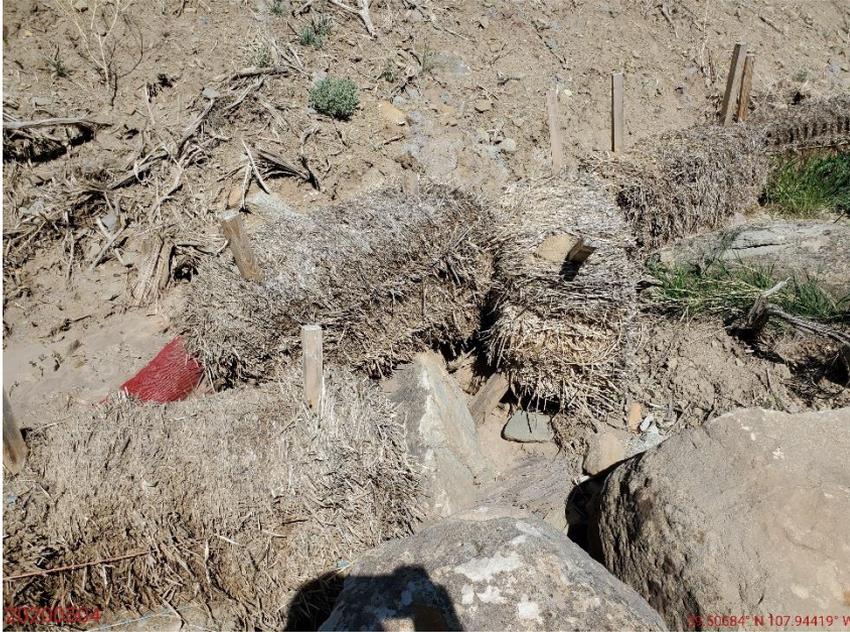
Photo 13: See comments under photo 11.

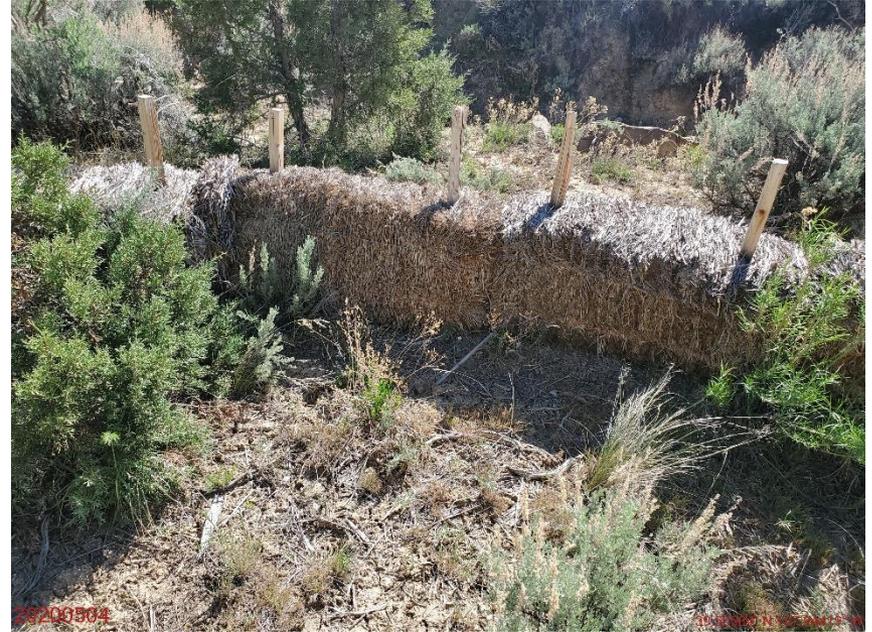
Photo 14: Photo of erosion bales on the eastern perimeter of the Location. Erosion bales are temporary sediment control structures that are required to be entrenched. Photo shows BMP has not been entrenched; BMP has not been installed in accordance with good engineering practices.

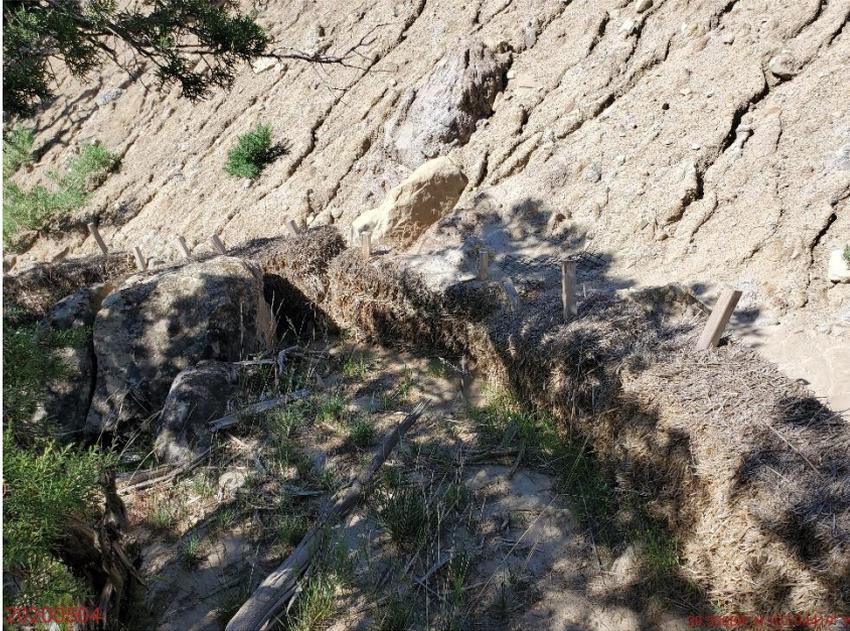
Photo 15: Photo taken from the southeast end of the Location/Location entrance, facing south. Photo shows sediment has filled areas between the slope and the erosion bales. BMP is no longer in proper functioning condition.

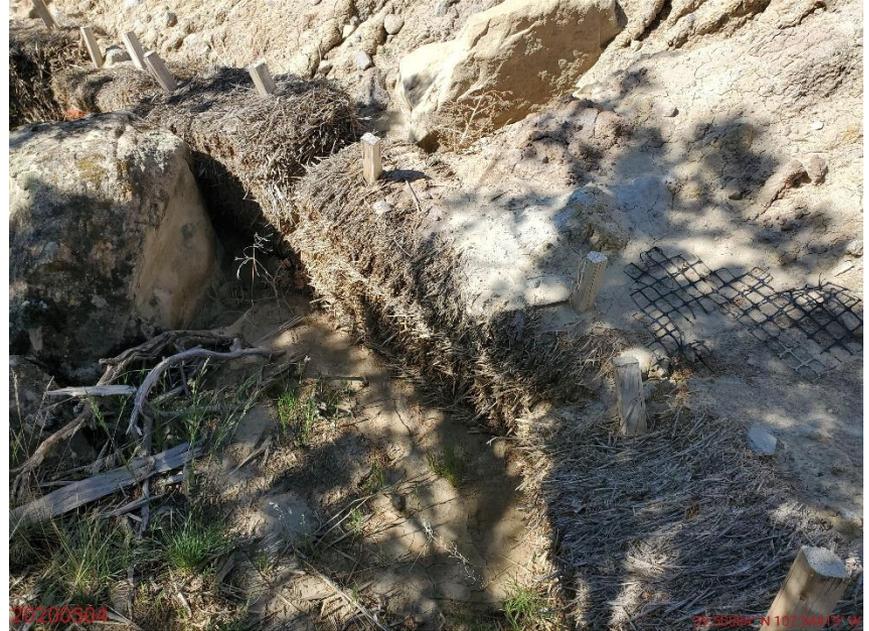
Photo 16: Continued from photo 15.
