# Inspection Photos

5/04/2020

Operator: TEP ROCKY MOUNTAIN LLC - 96850

Location ID: 335275

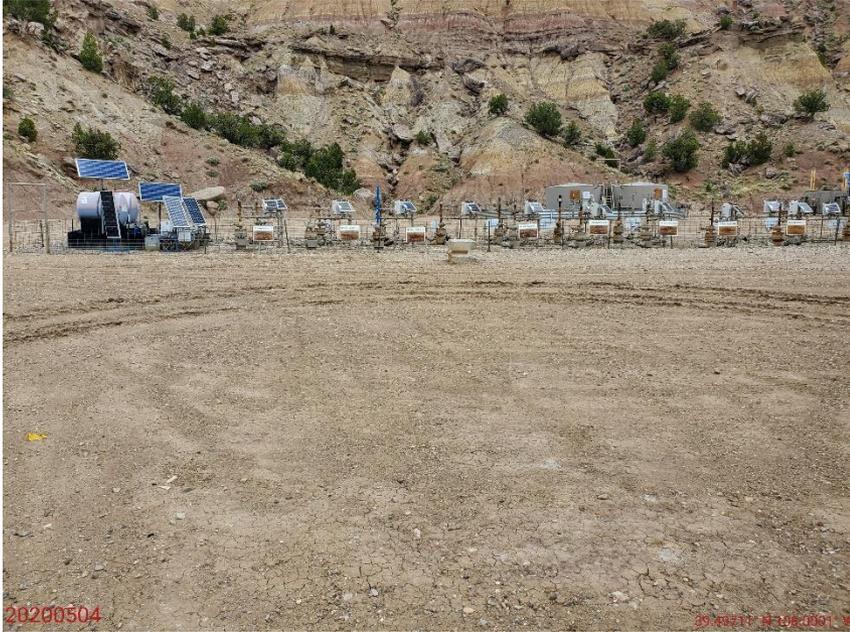
**Photo 1:** Photo taken from the Location, facing north. Photo shows the active wells on the Location.

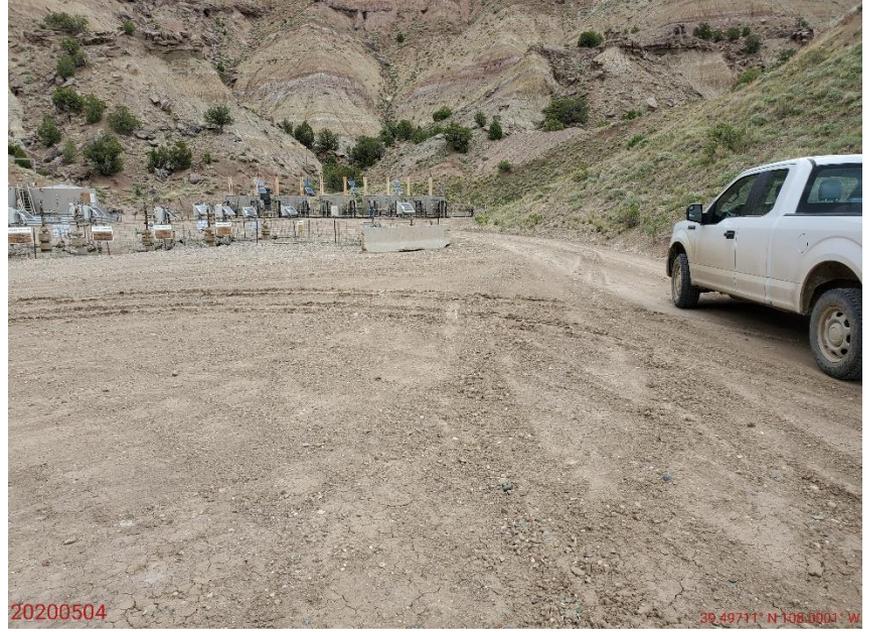
**Photo 2:** Photo taken from the Location, facing northeast. Photo shows the active wells on the Location.

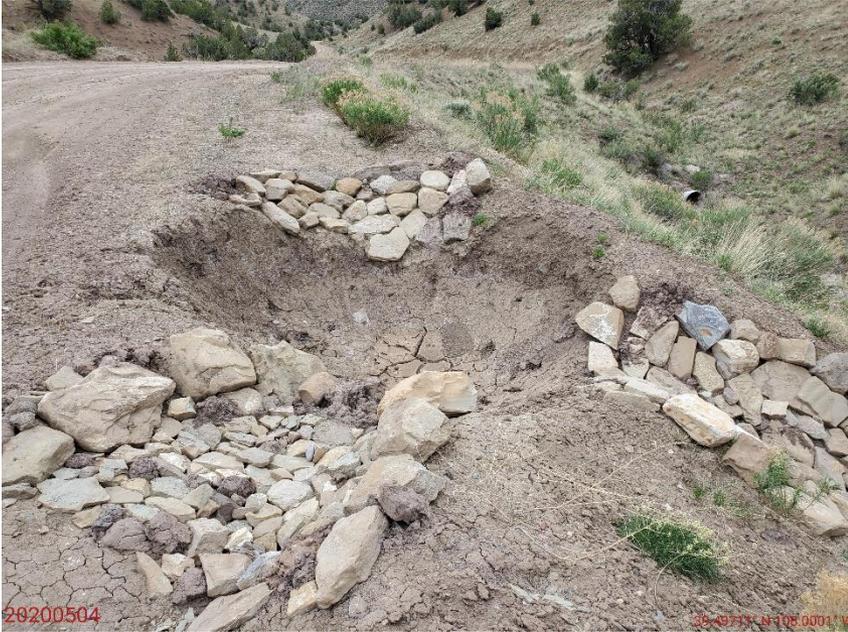
**Photo 3:** Photo taken from the west end of the Location, facing south. Photo shows sediment trap; Trap appears to have sufficient inlet/outlet armoring.

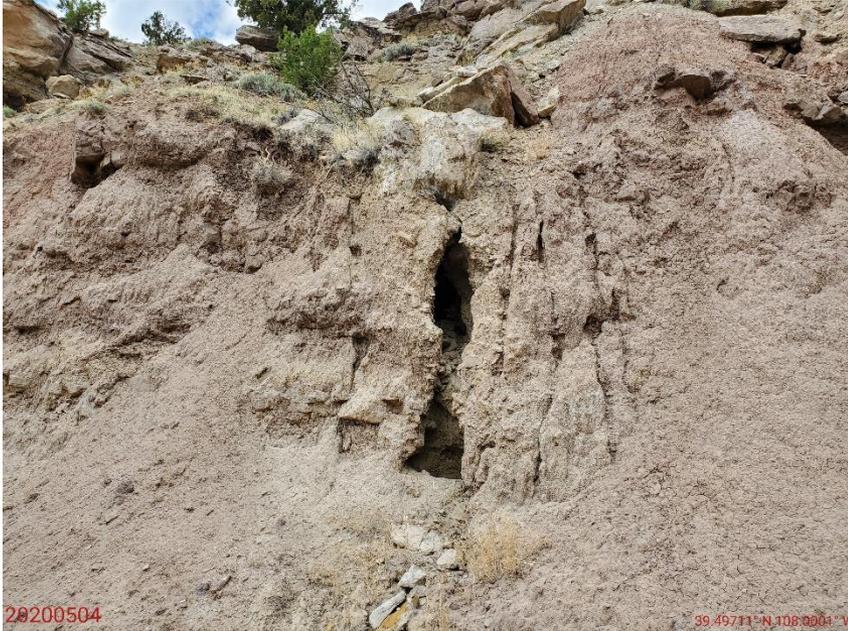
**Photo 5:** Photo taken from the west end of the Location. Photo shows stormwater runoff has caused erosion degradation on the slopes, cutting into the hillside; Water appears to be undercutting large rocks; potential rockfall risk.

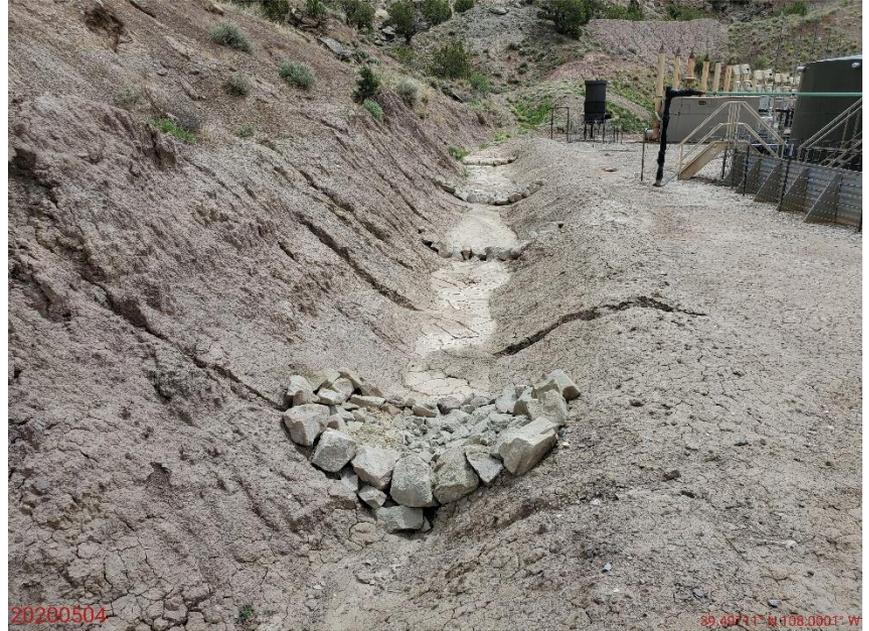
**Photo 6:** Photo taken from the stormwater diversion ditch on the northeast end of the Location. Photo shows velocity checks within ditch appear to be in proper functioning condition. Erosion degradation along areas of the ditch evident; Sediment deposition with ditch (advise maintenance).

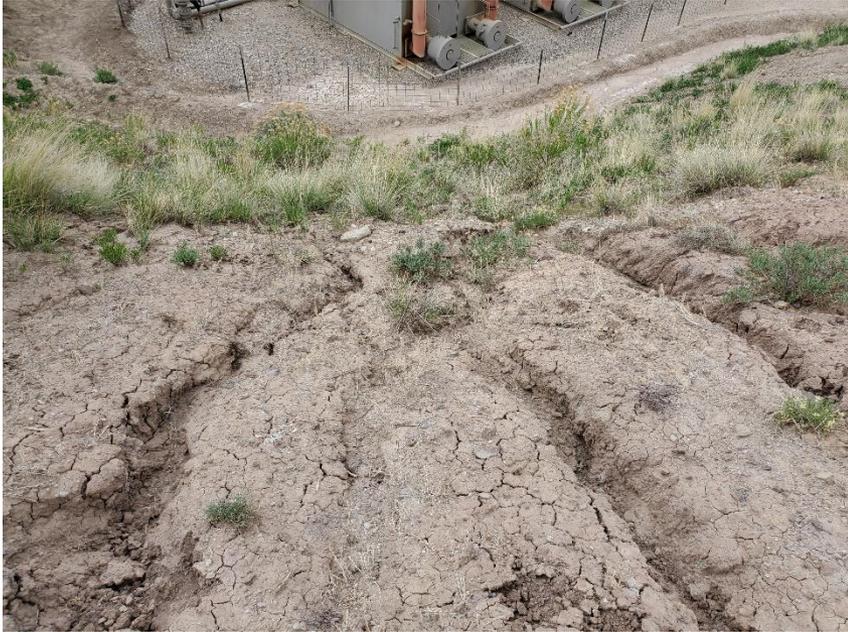
**Photo 9:** Photo taken from the slopes on the east end of the Location, facing west. Photo shows areas where Operator appears to have pushed soils upon a hillside of the Location. Photo shows slopes have not been stabilized and erosion degradation is evident

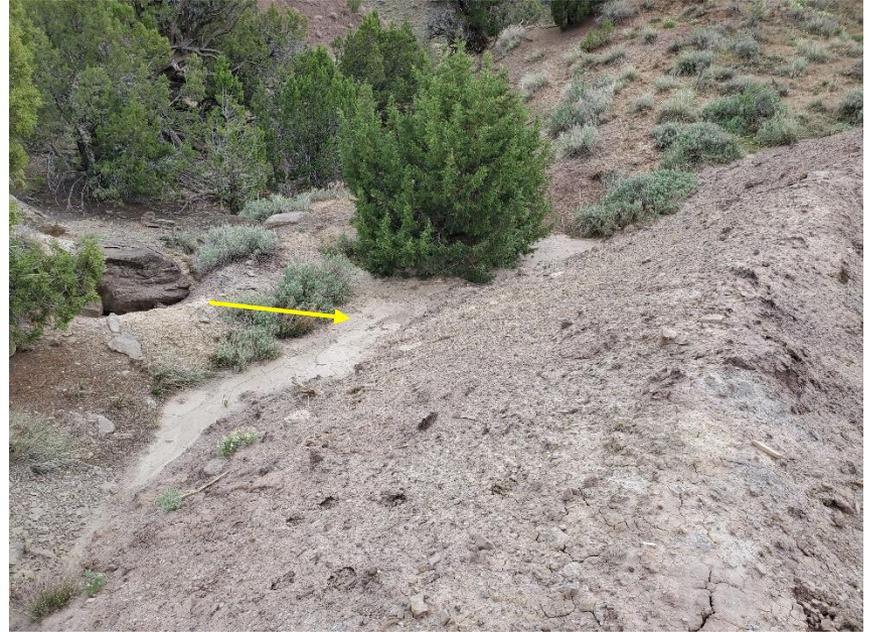
**Photo 10:** Photo taken from the slopes on the east end of the Location, facing east. Photo shows areas where Operator appears to have pushed soils upon a hillside of the Location. Photo shows missing or insufficient BMPs in places on the eastern end of the soils to prevent sediment transport off location into another drainage; Photo also shows sediment deposition off Location.

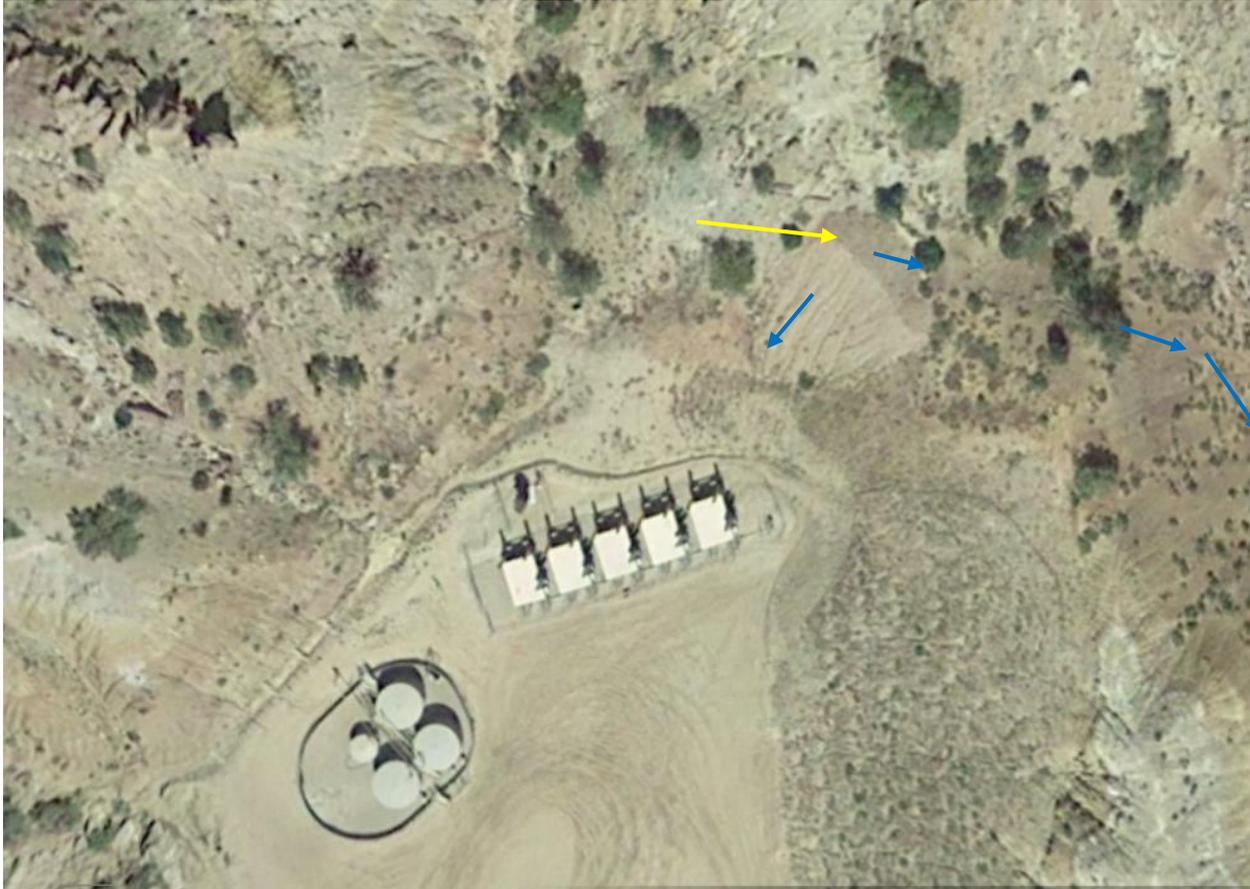
**Photo 11:** Google Earth aerial image. Photo shows areas where Operator appears to have pushed soils upon a hillside of the Location (yellow arrow). Insufficient BMPs, or BMPs missing from the slopes to prevent from erosion or sediment transport off Location. Blue arrows represent water flow direction.
