Inspection Photos
Location Name: Challenger 1-32
Location ID: 05-123-11703

COGCC Environmental Inspection
40.37558, -104.92383, 4711.4ft, 357°
05/05/2020 10:24:22 AM

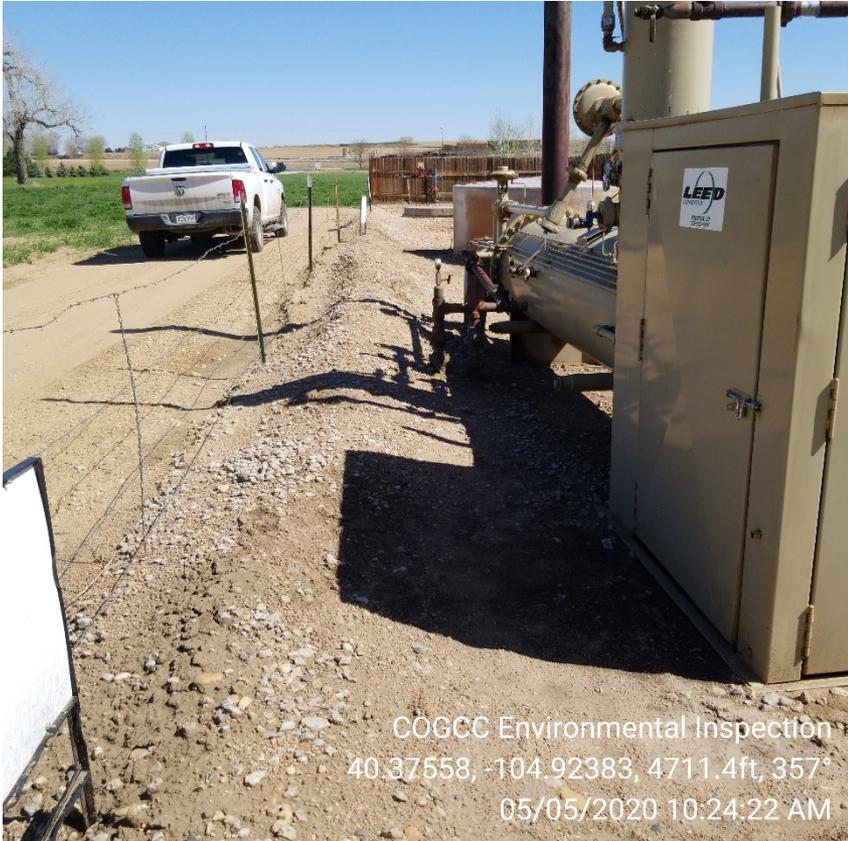
Photo 1 – Separator and fiberglass produced water vault.

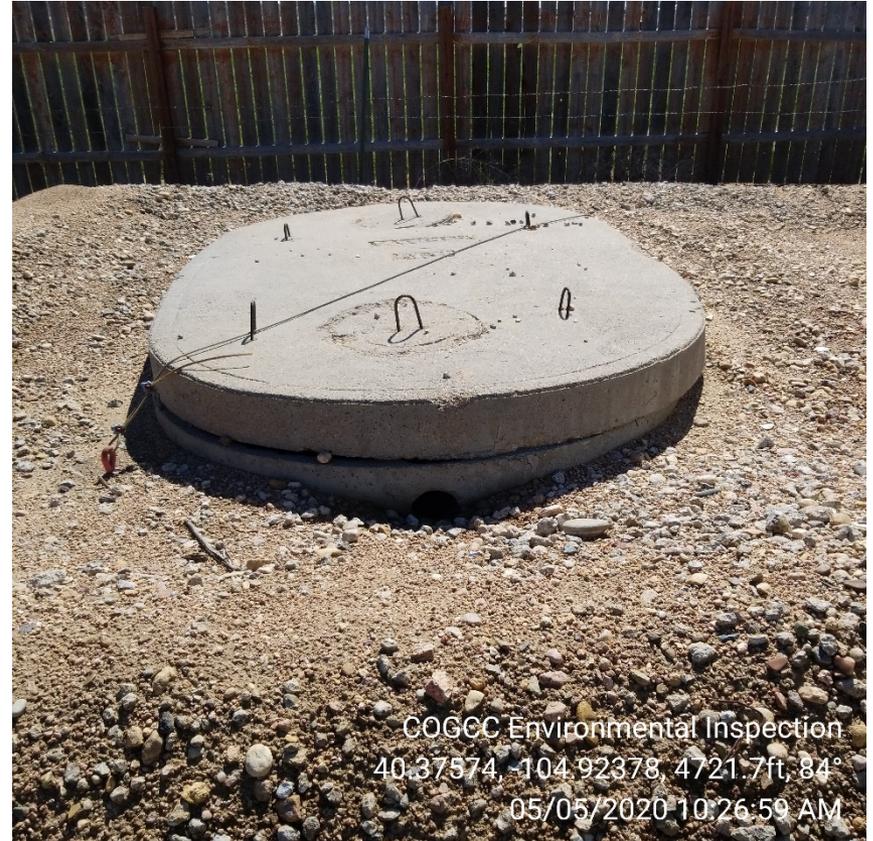
Photo 2 – Concrete produced water vault.

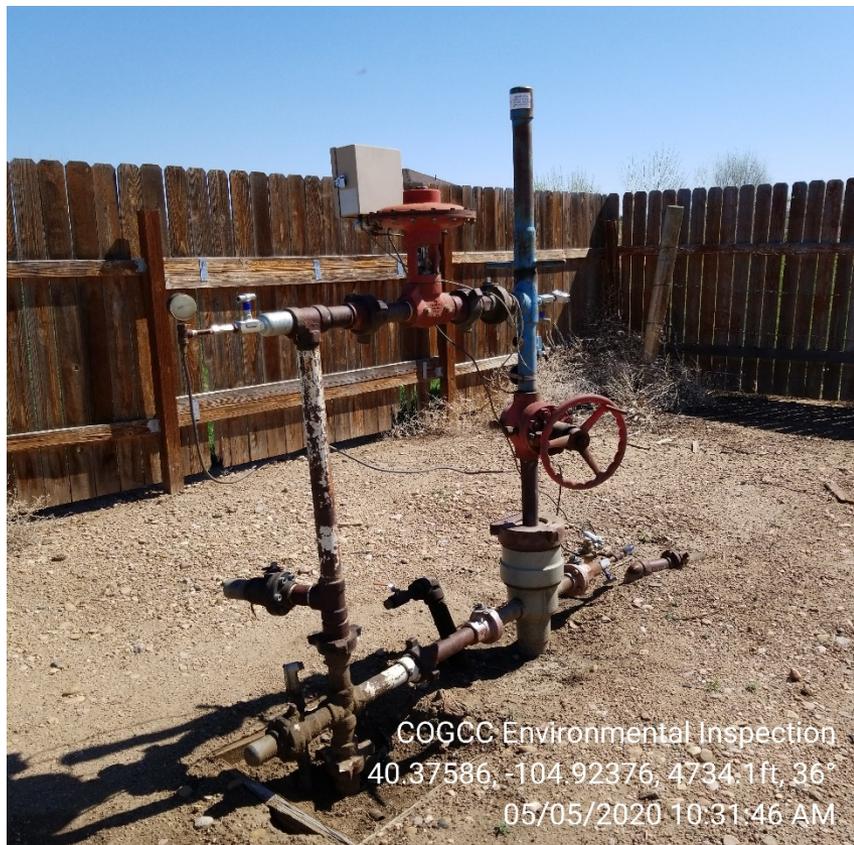
Photo 3 – Challenger 1-32 wellhead

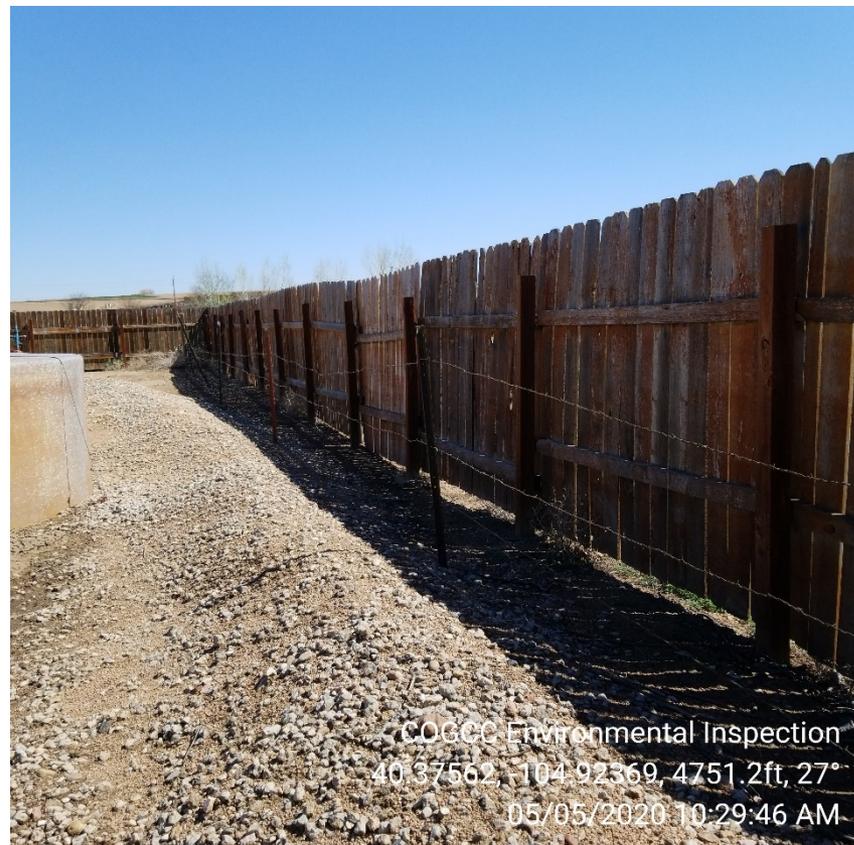
Photo 4 – Wooden fence along southeastern edge of the tank battery.

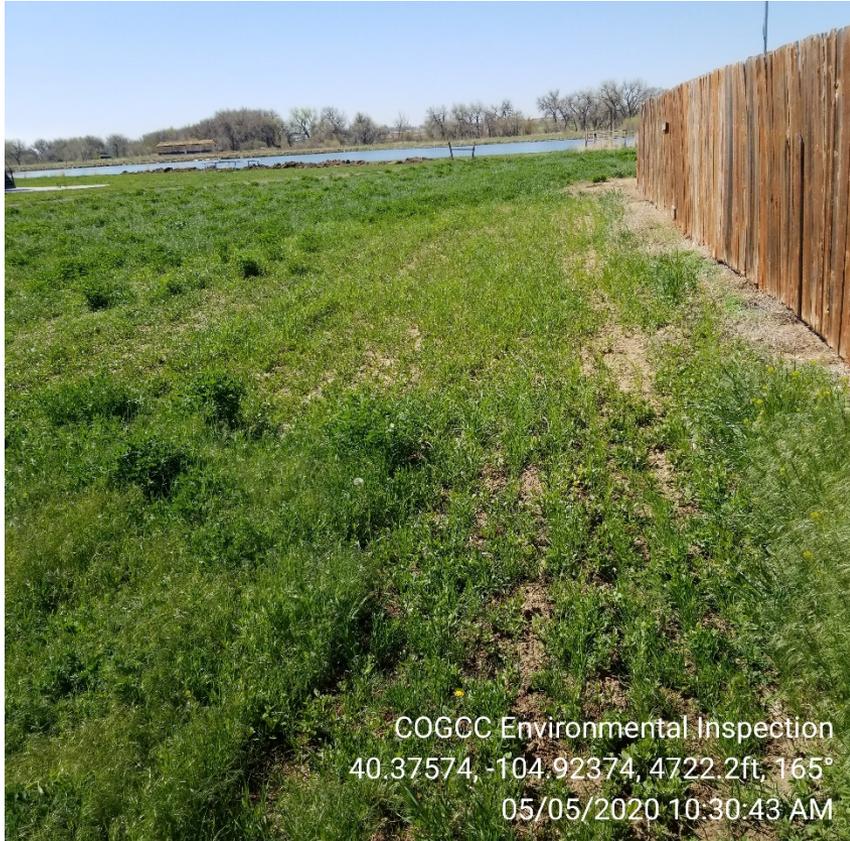
Photo 5 – Vegetation outside the southeast perimeter of the fence.

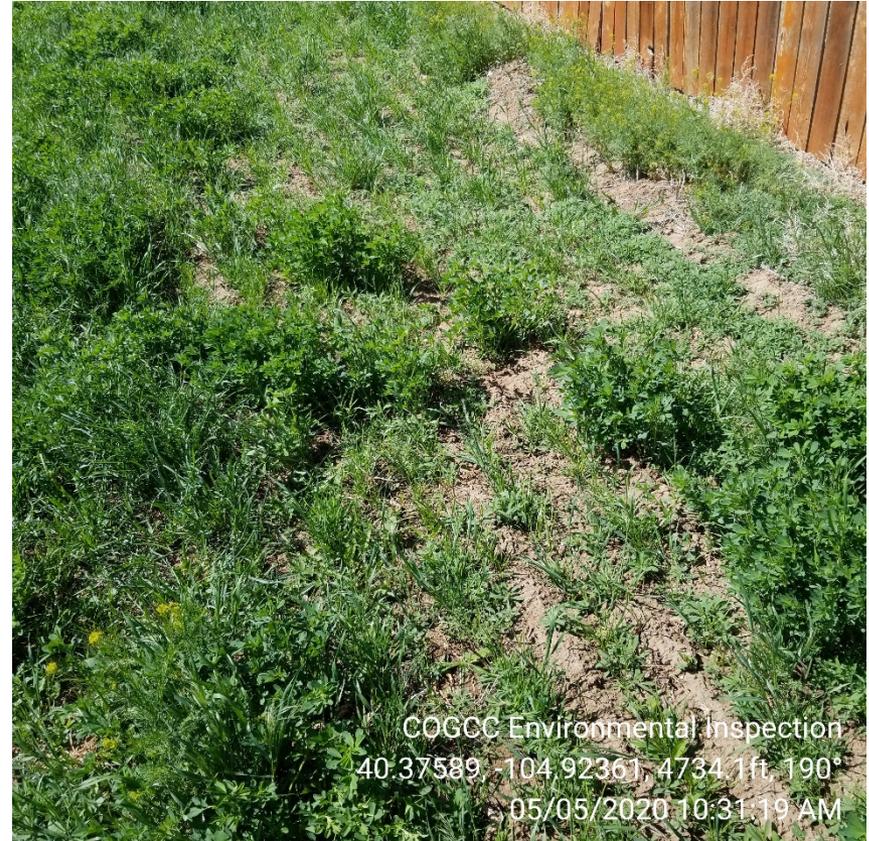
Photo 6 – Vegetation outside the southeast perimeter of the fence.

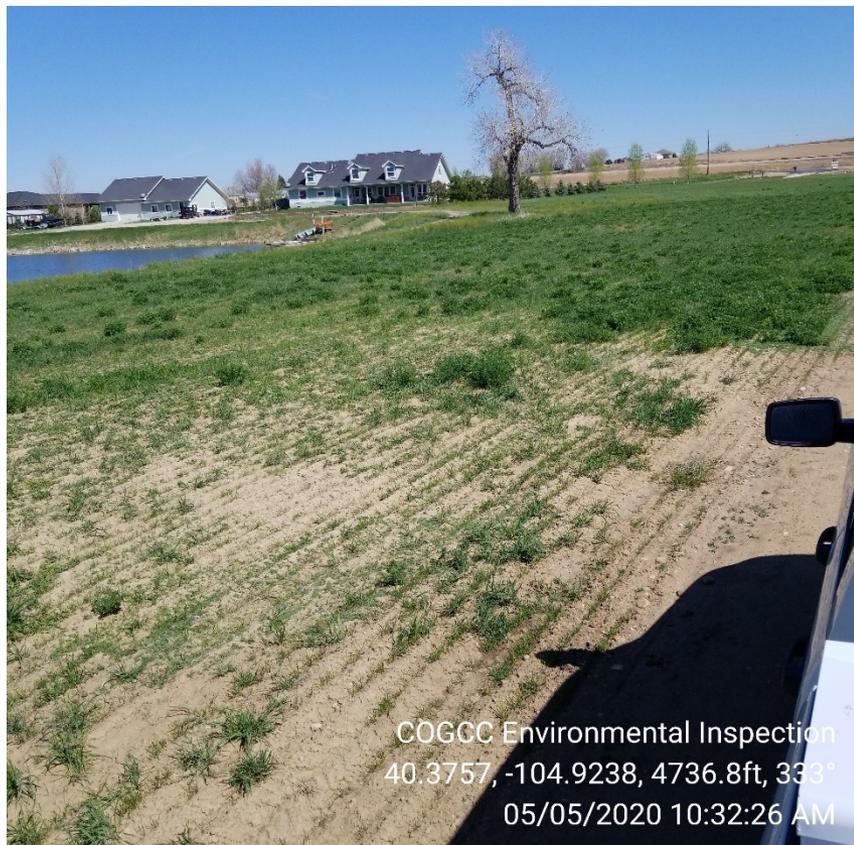
Photo 7 – Vegetation on the northwestern side of the facility (facing northwest).

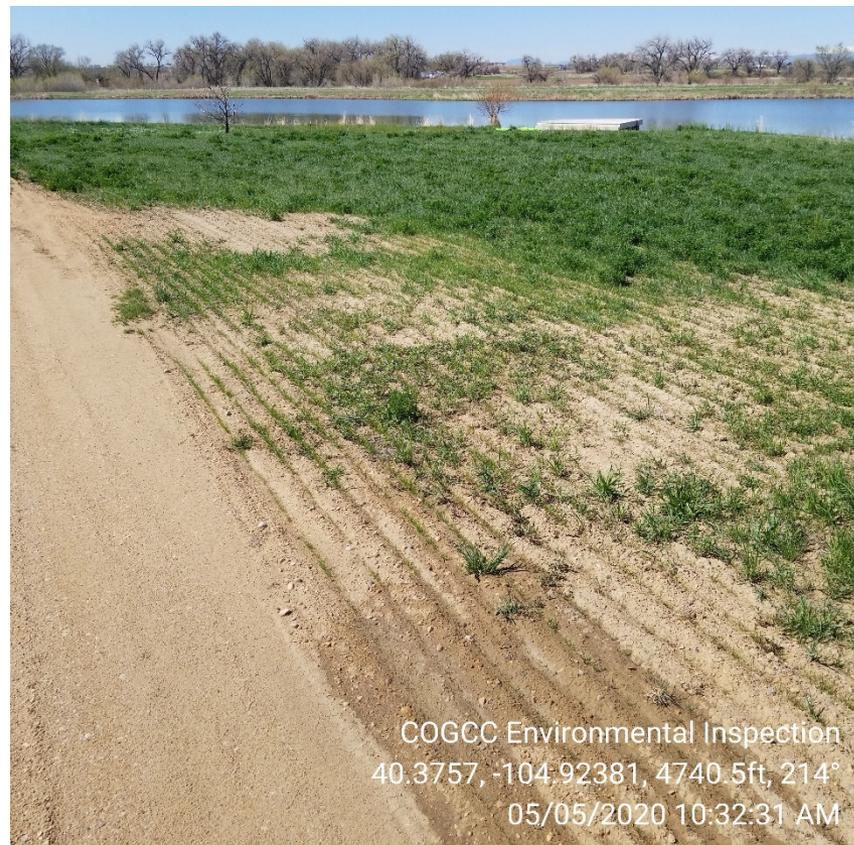
Photo 8 – Vegetation on the northwestern side of the facility (facing southwest).

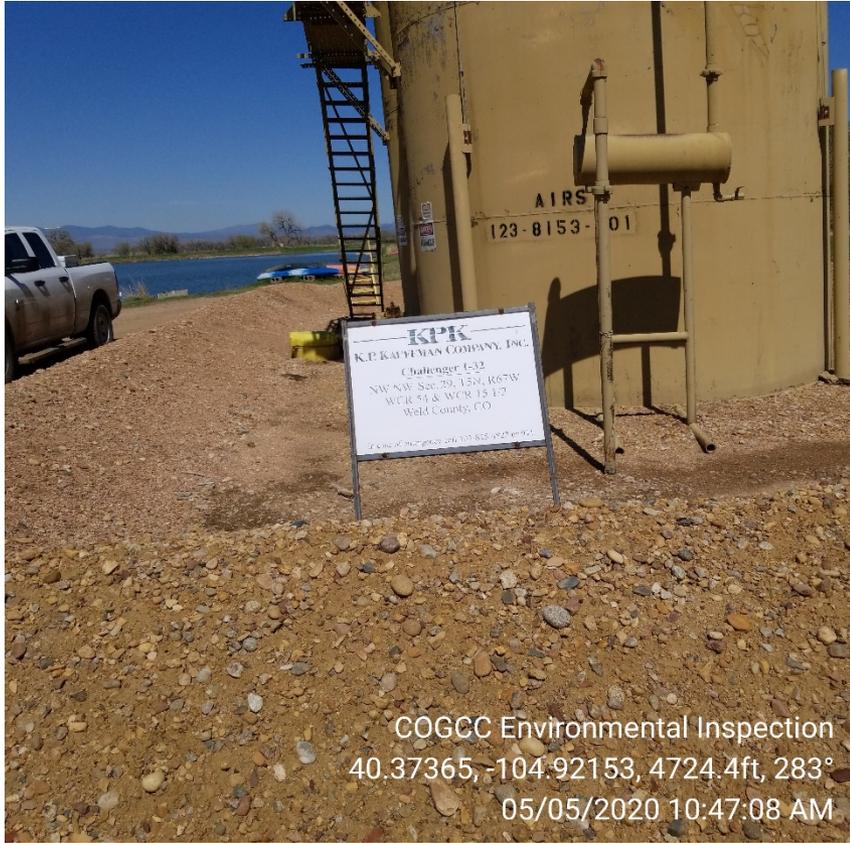
Photo 9 – Tank Battery

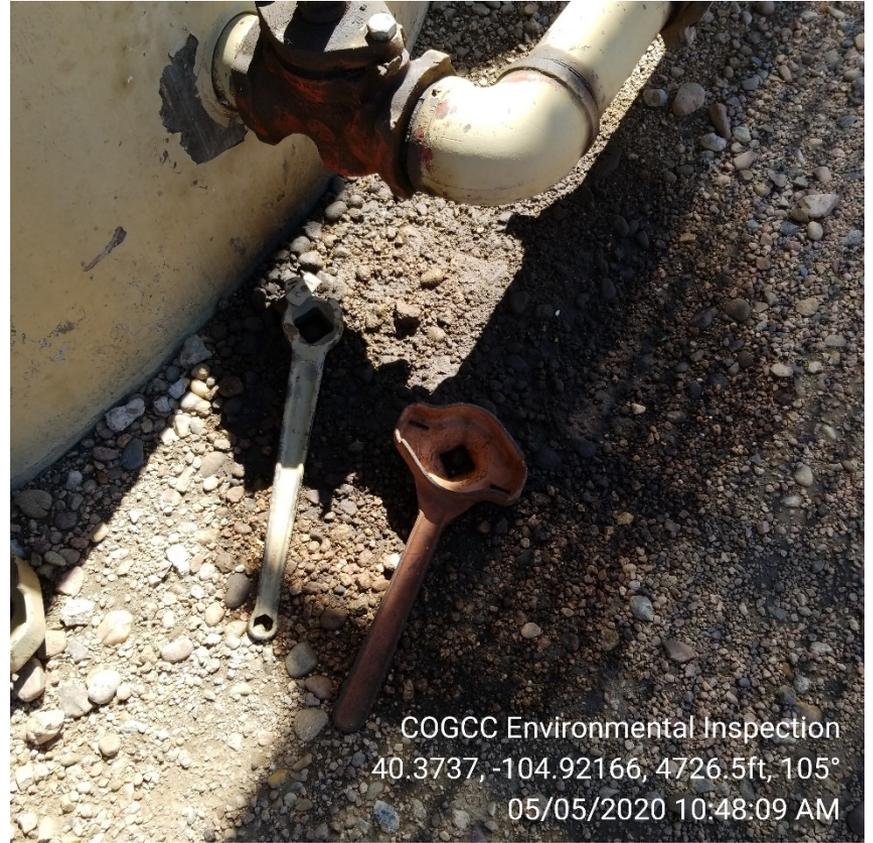
Photo 8 – Staining at NW tank.
