Inspection Photos

Location 430051

ASI 081-07747

Inspection Date: 5/5/2020

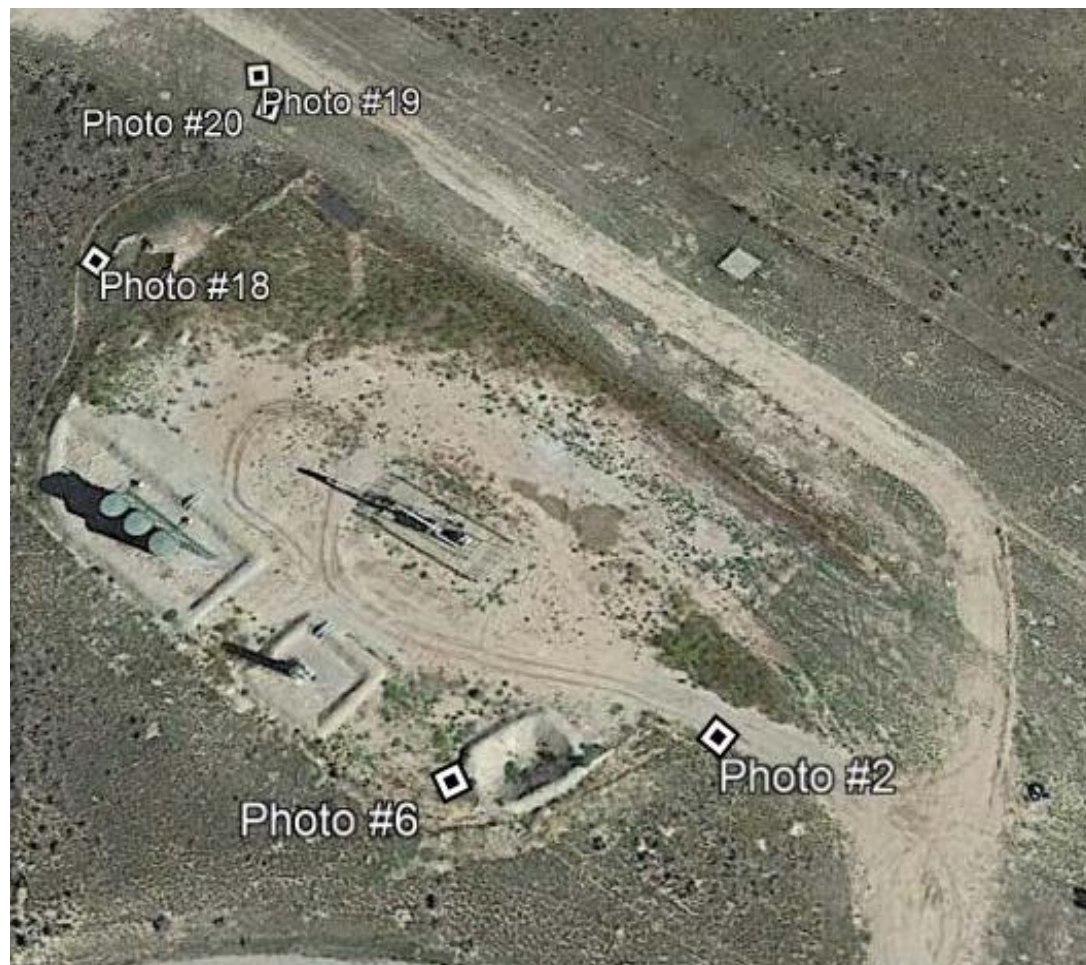
Overview of location of Photos

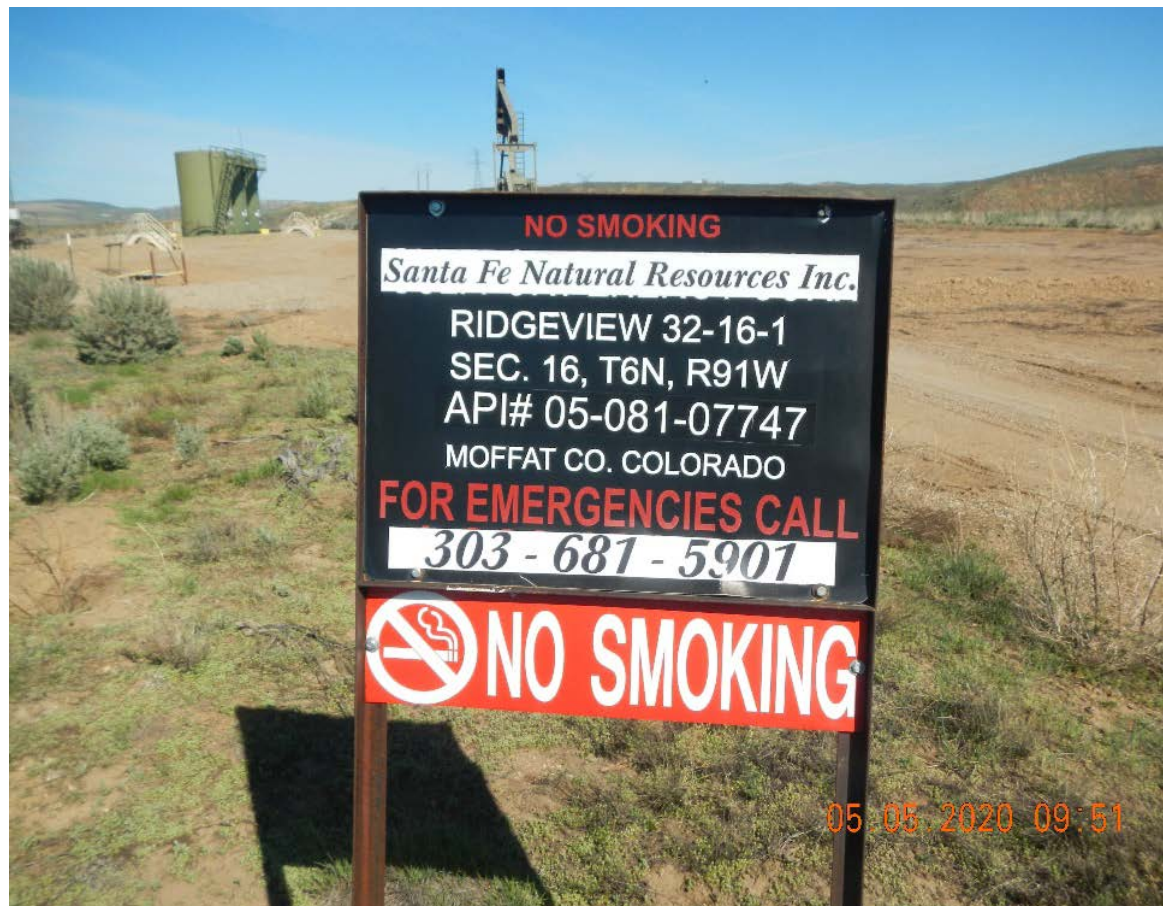
Photo #1 sign at location

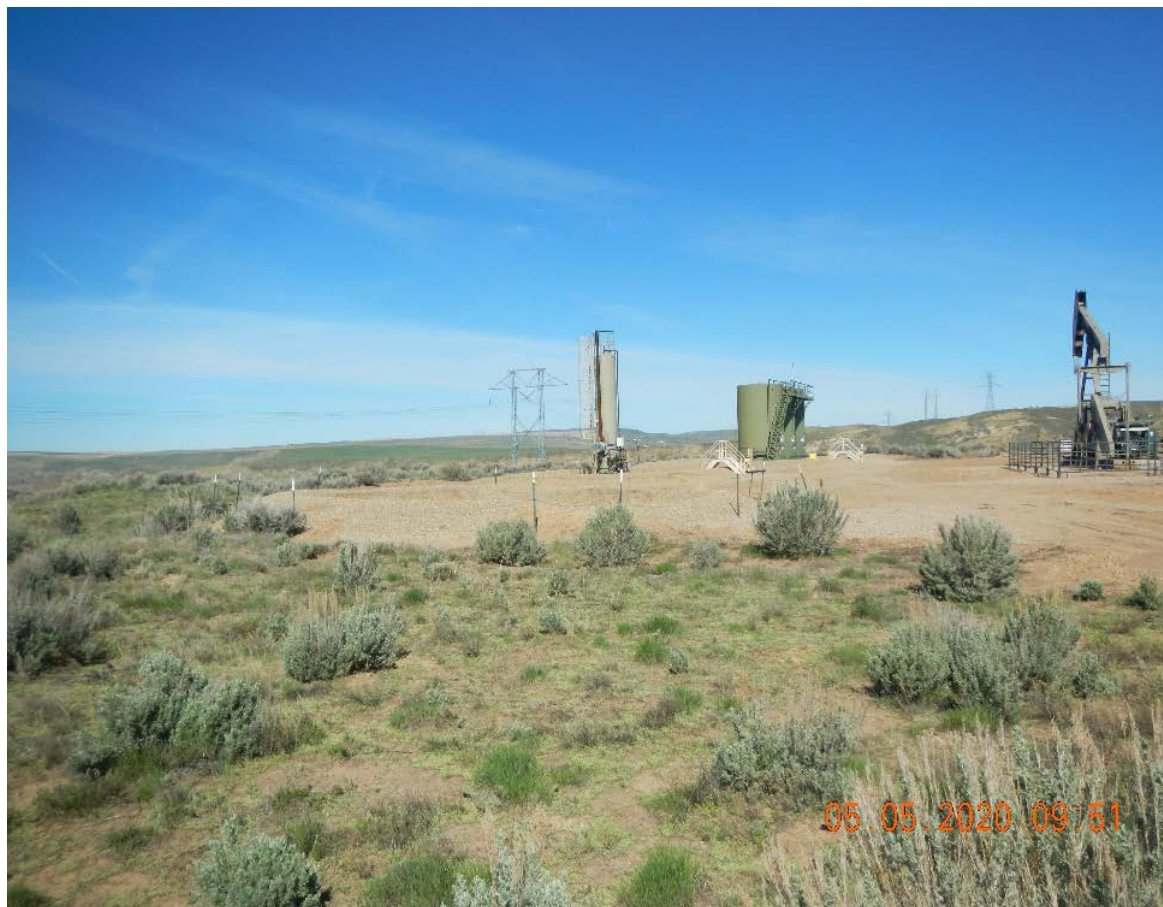
Photo #2 looking west. Note berm and fence, this is a flare pit.
The pit is not permitted.

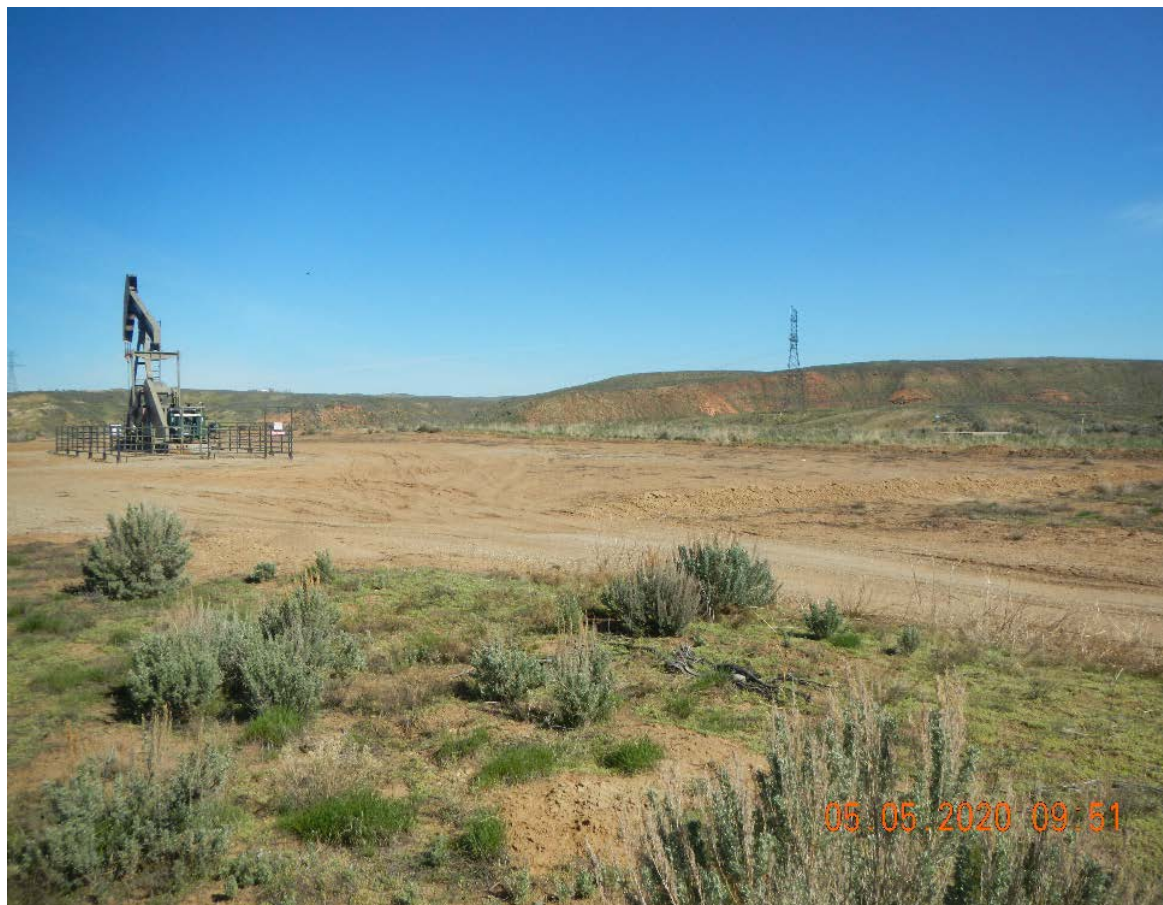
Photo #3 Looking North.

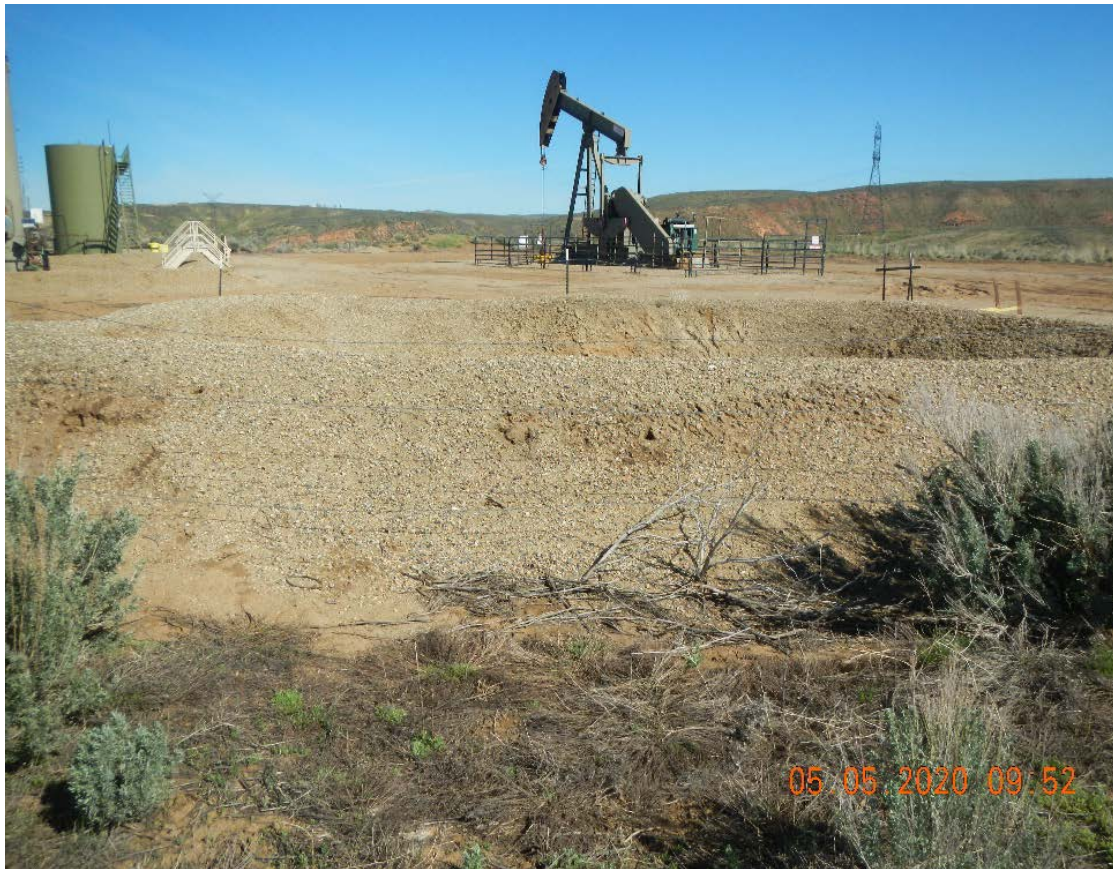
Photo #4 looking west, camera is at east side of fence to flare pit.

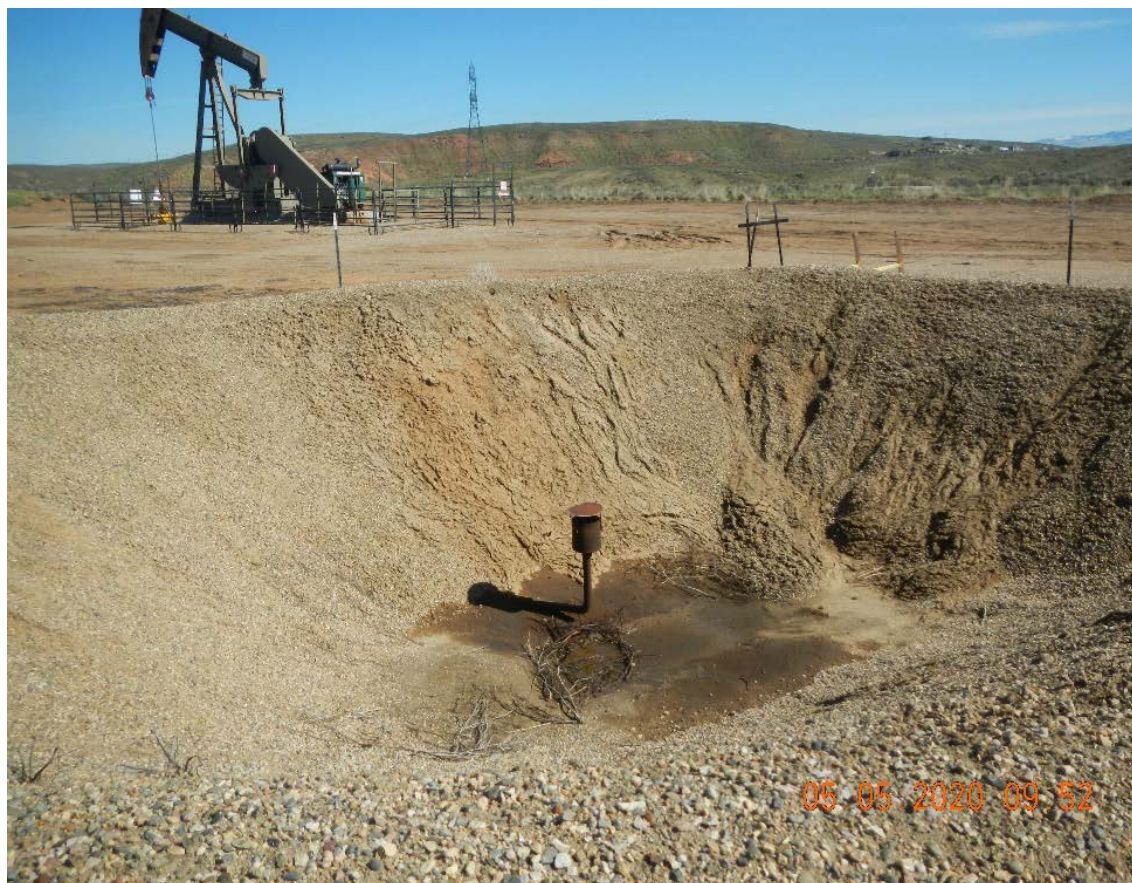
Photo #5 flare pit, appears to be oil. Oil has been seen in this pit in the past. Pit should be closed with a Form 27.

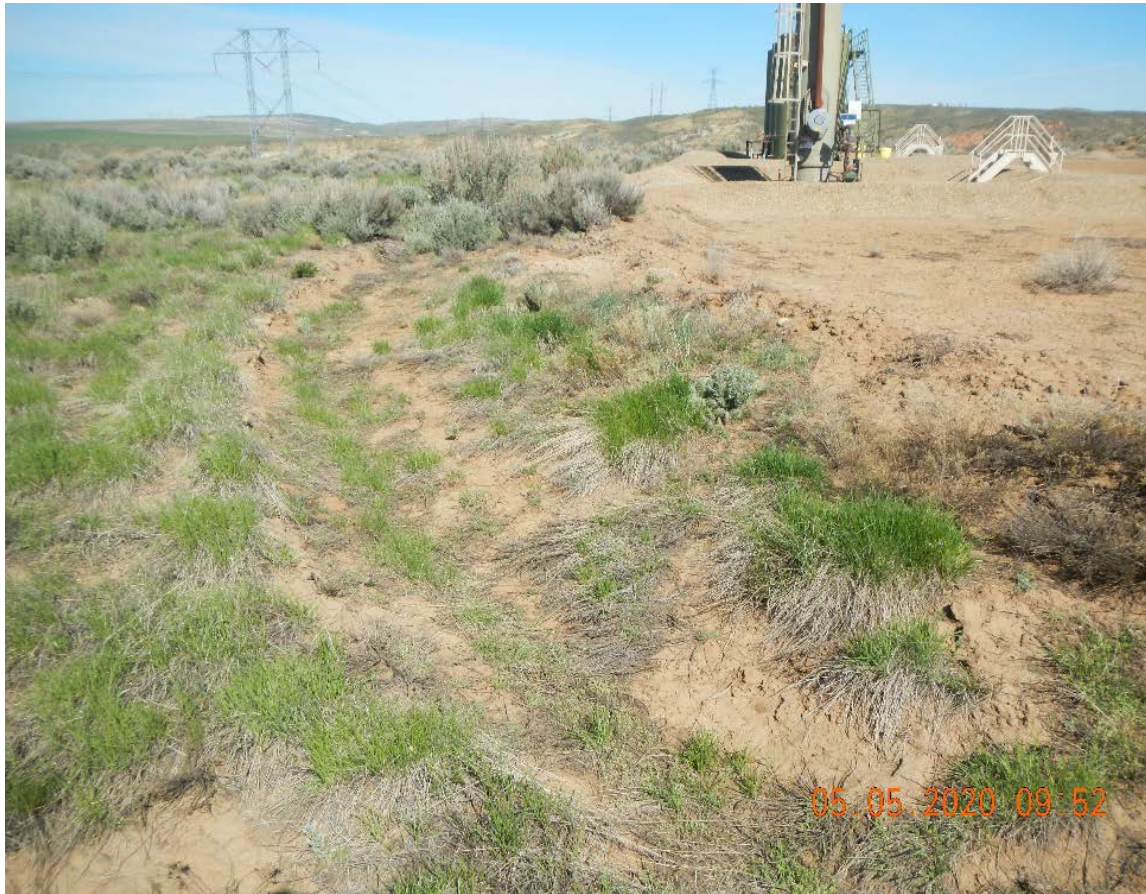
Photo #6 Looking west on south boundary of location.

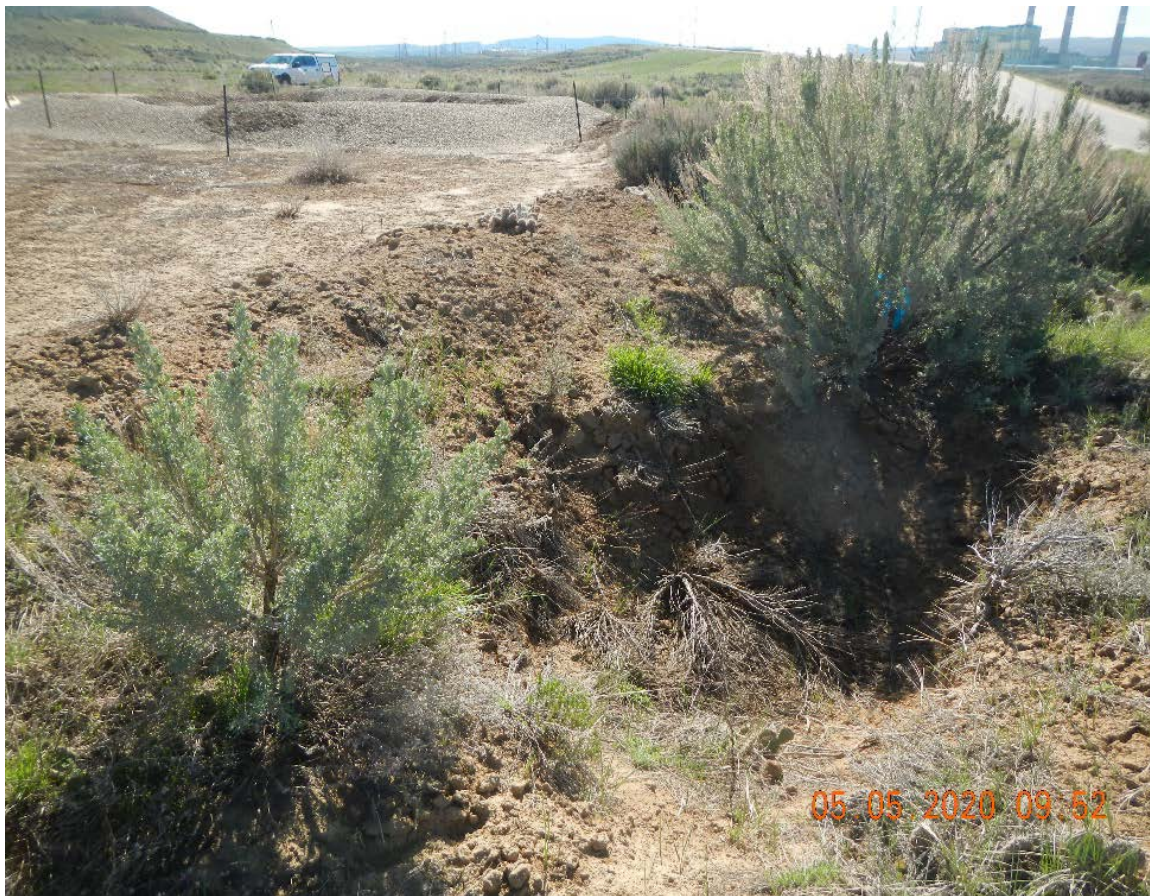
Photo #7 west side of flare pit.

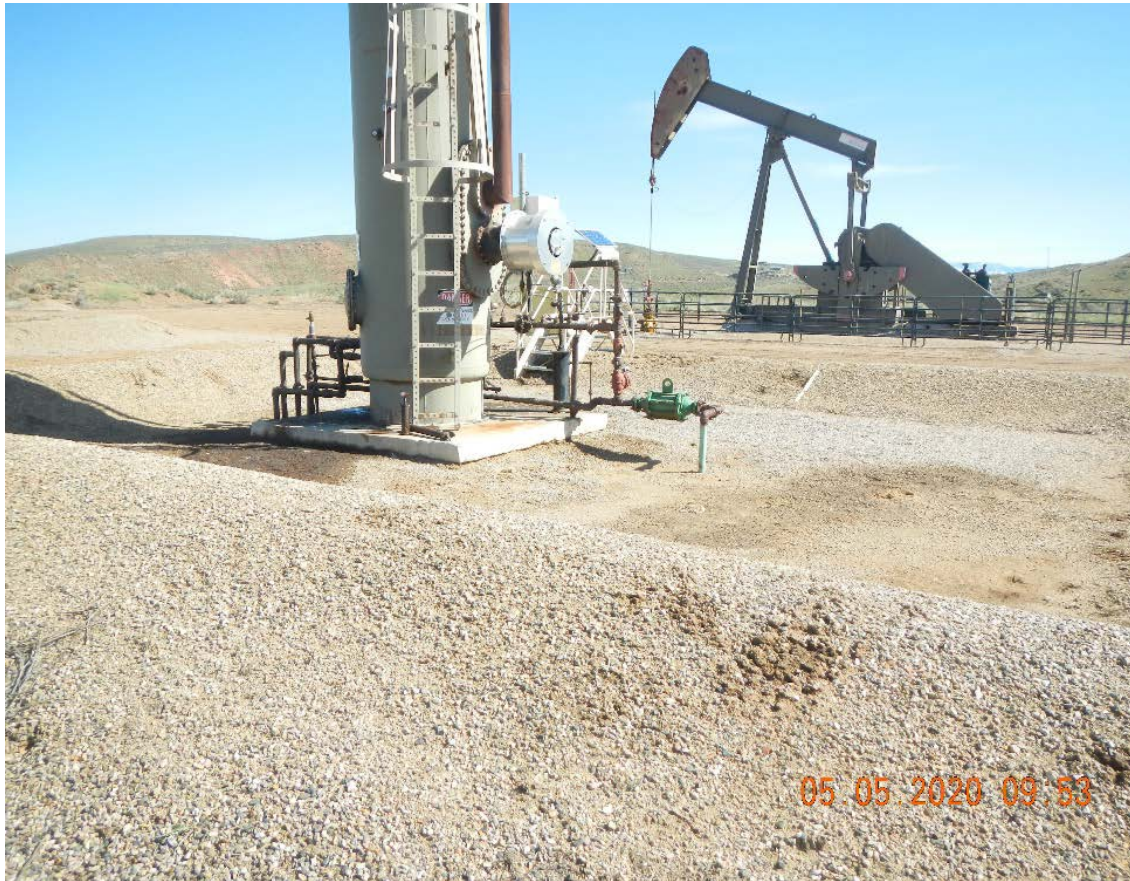
Photo #8 Vertical Separator, oil staining on ground.

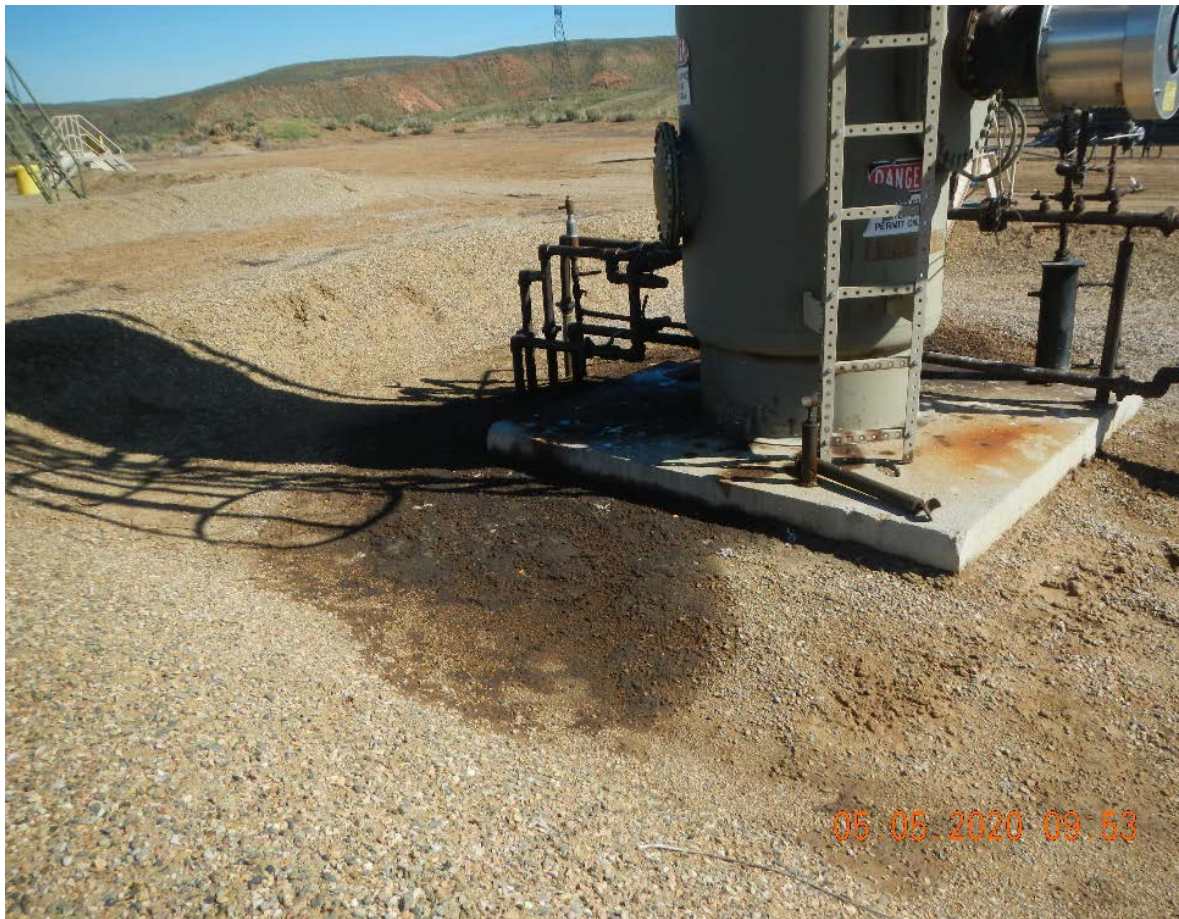
Photo #9 Oil staining at vertical separator.

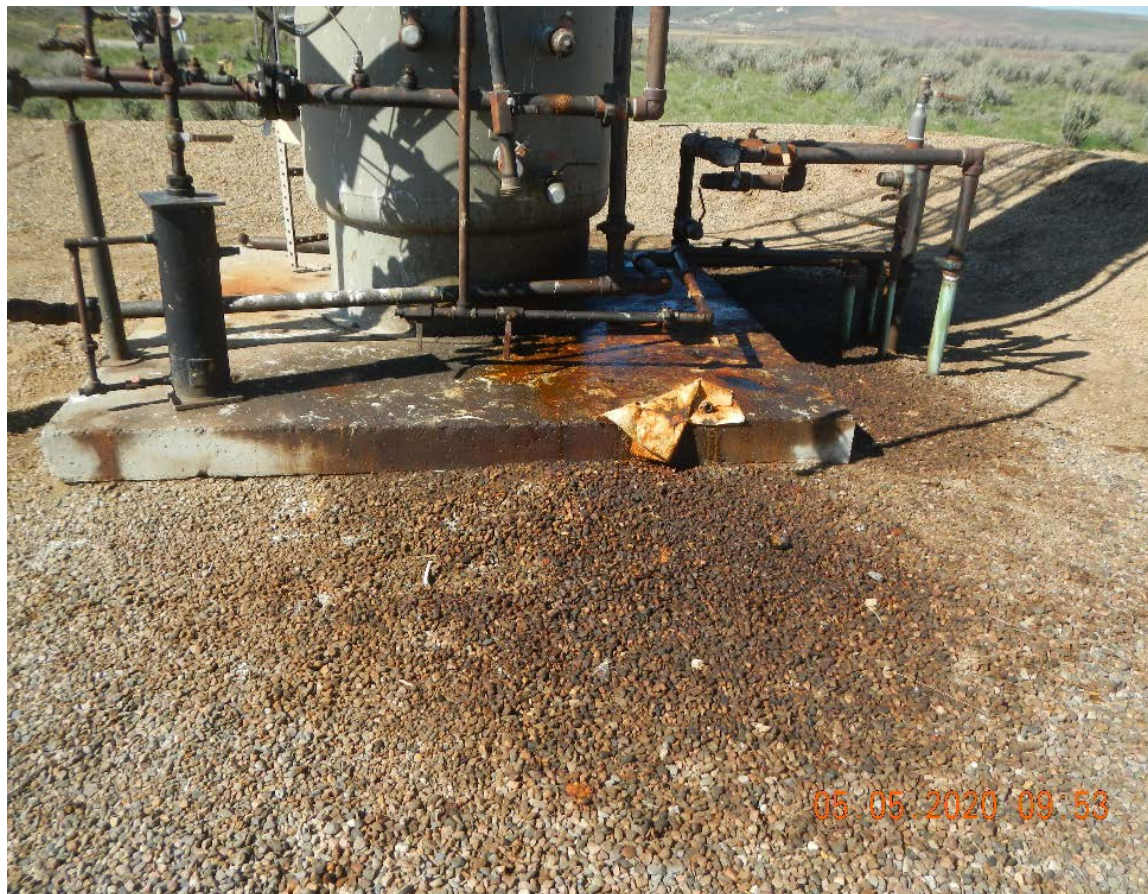
Photo #10 Oil staining at vertical separator.

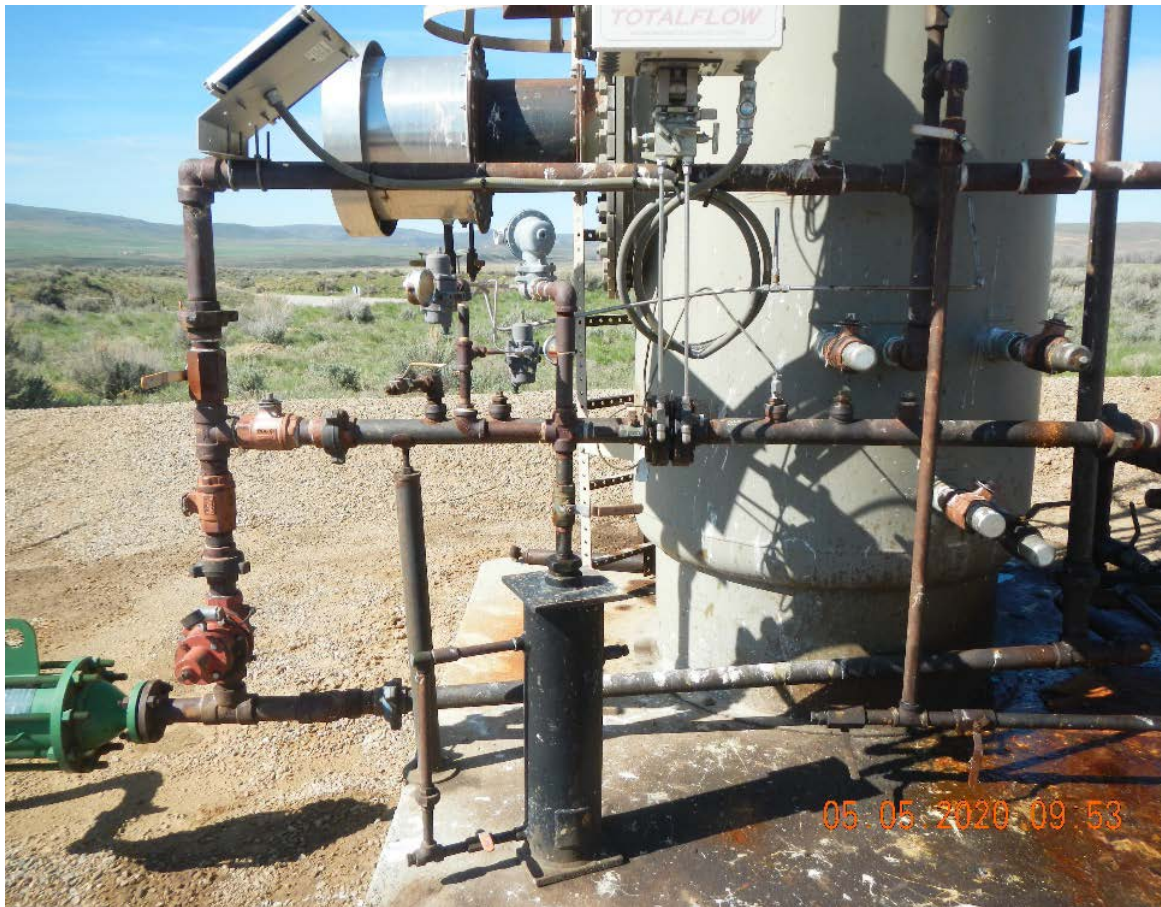
Photo #11 9 Close-up, vertical separator.

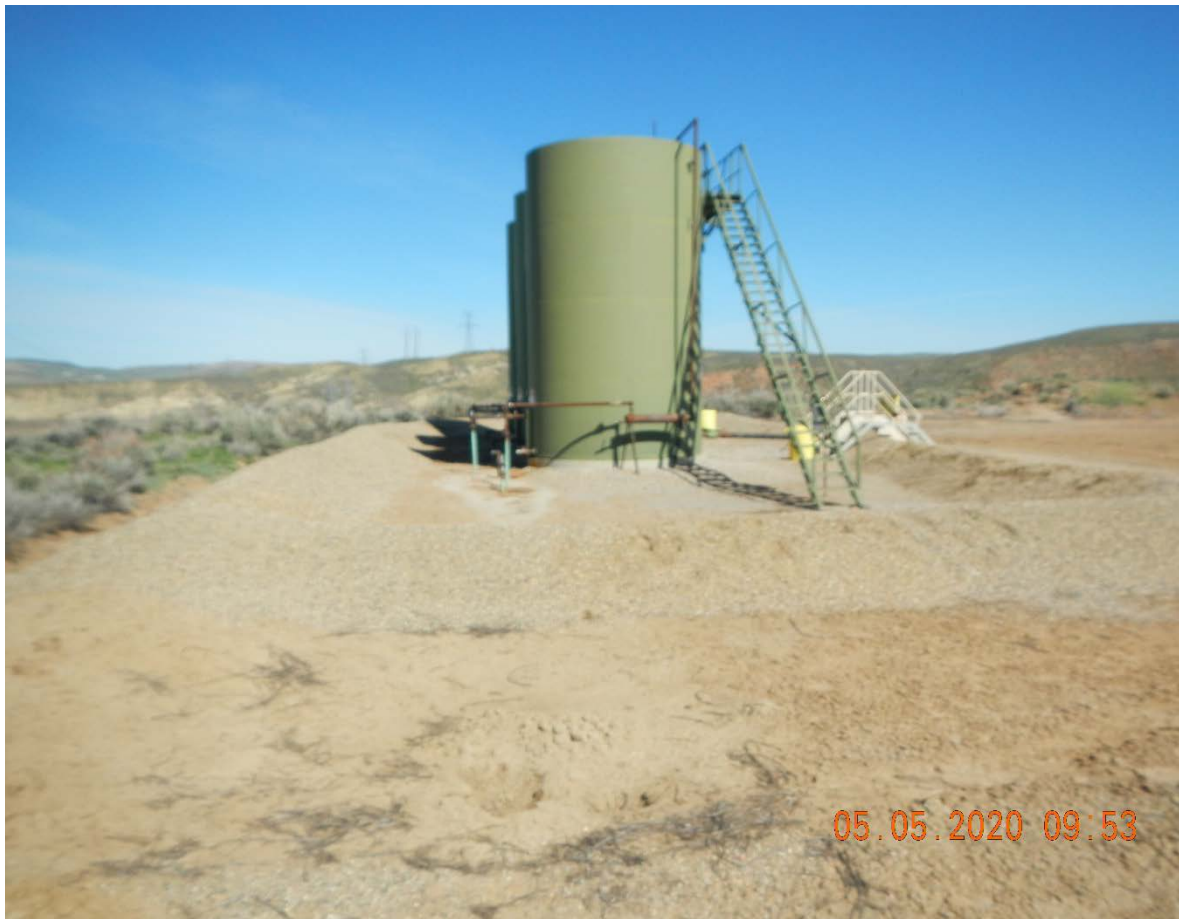
Photo #12 3-400BBL tanks, gravel berm

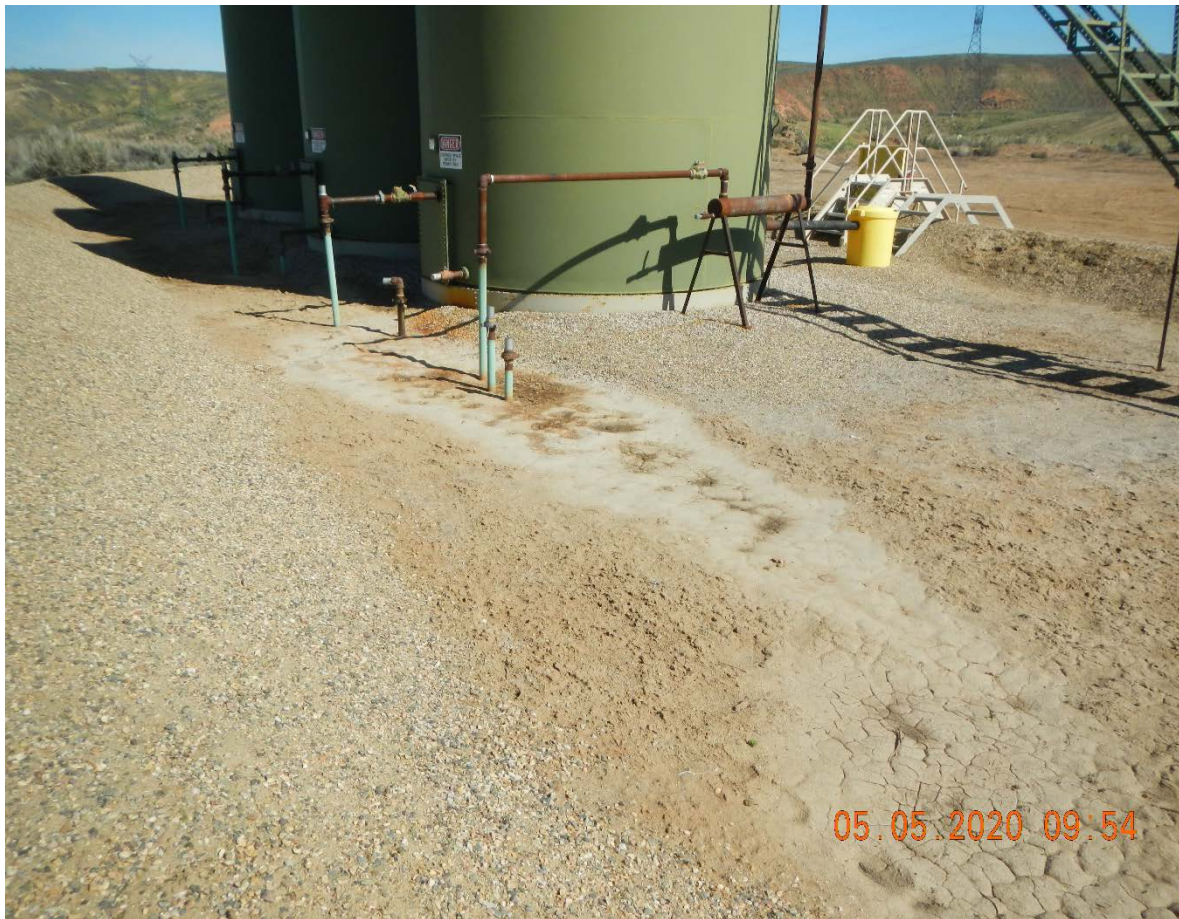
Photo #13 observed staining on ground from failed pipe, see previous inspection, 10/28/2019.

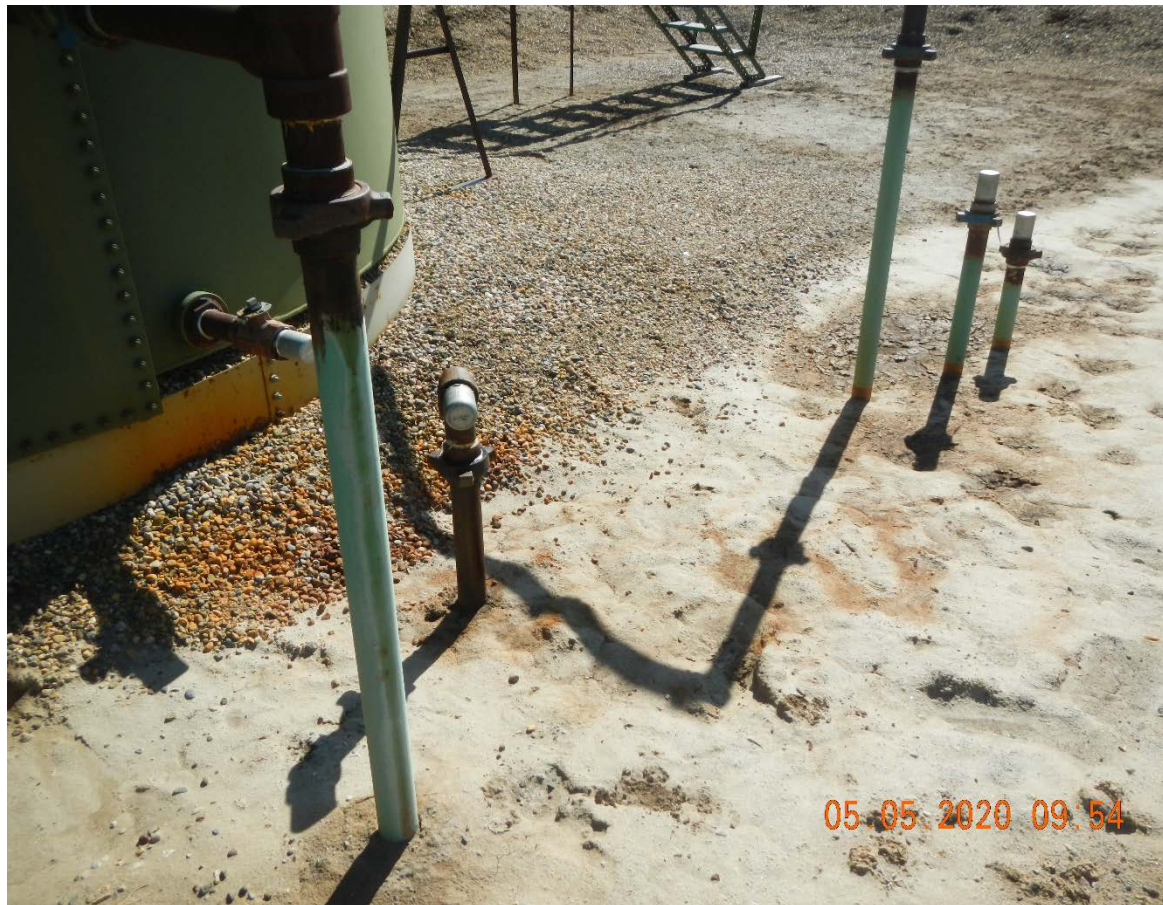
Photo #14 Close up of spill in tank battery, see inspection 10/28/2019.

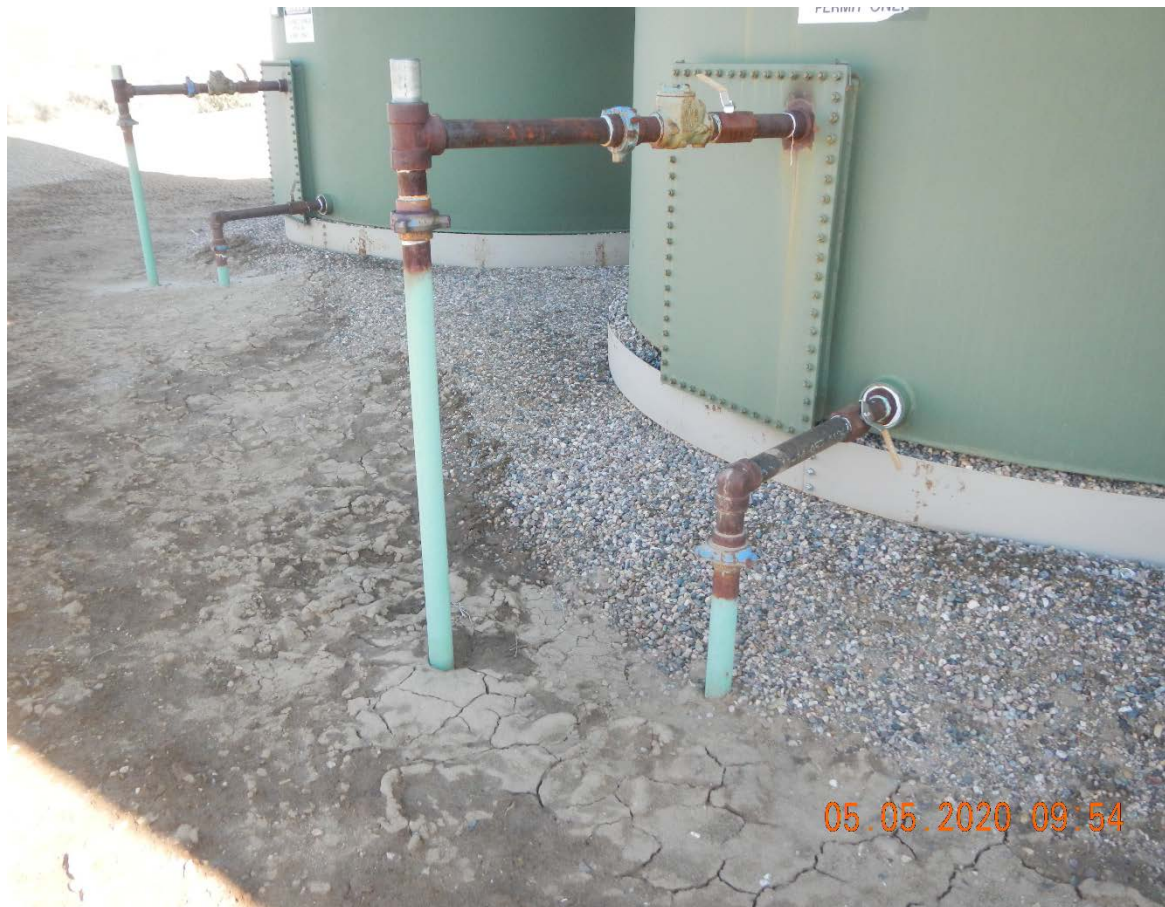
Photo #15 Tank close up.

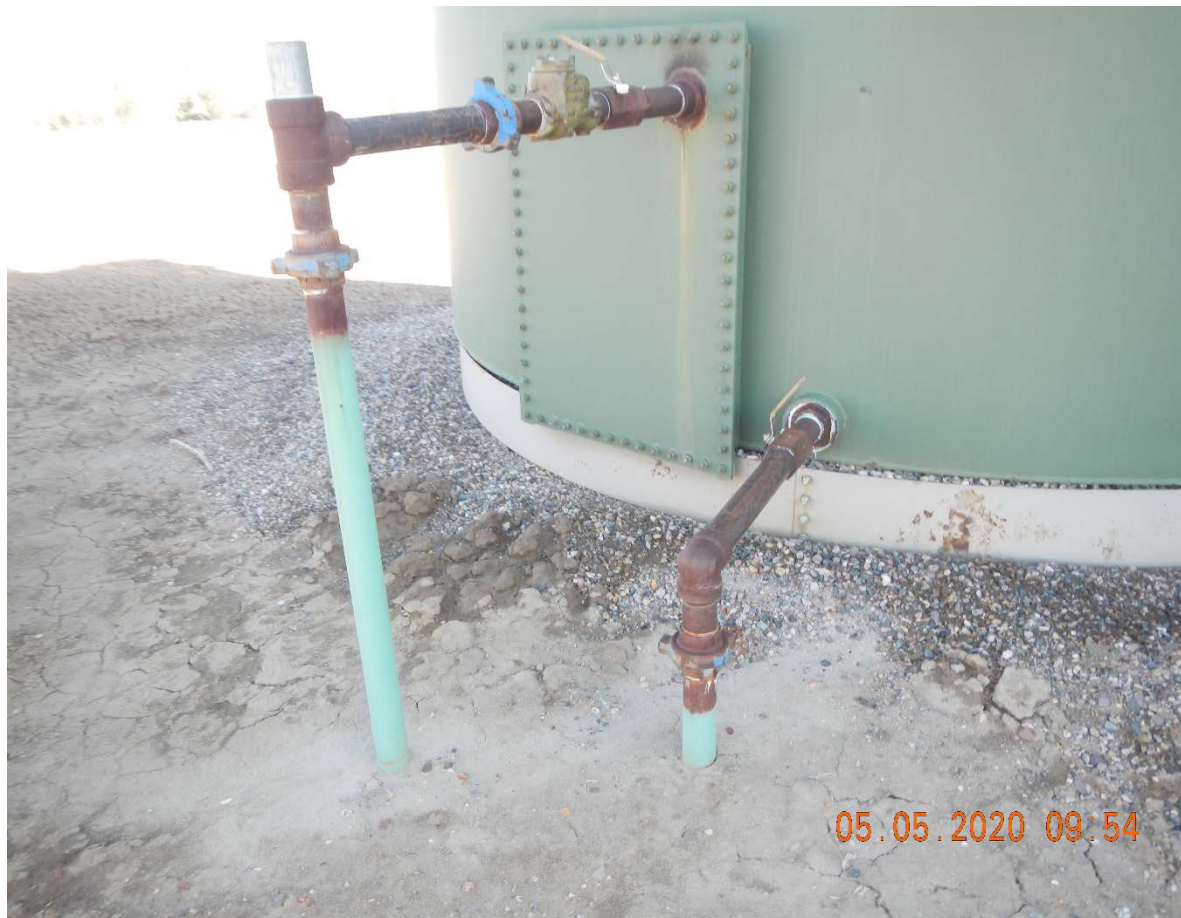
Photo #16 Tank battery Close-up

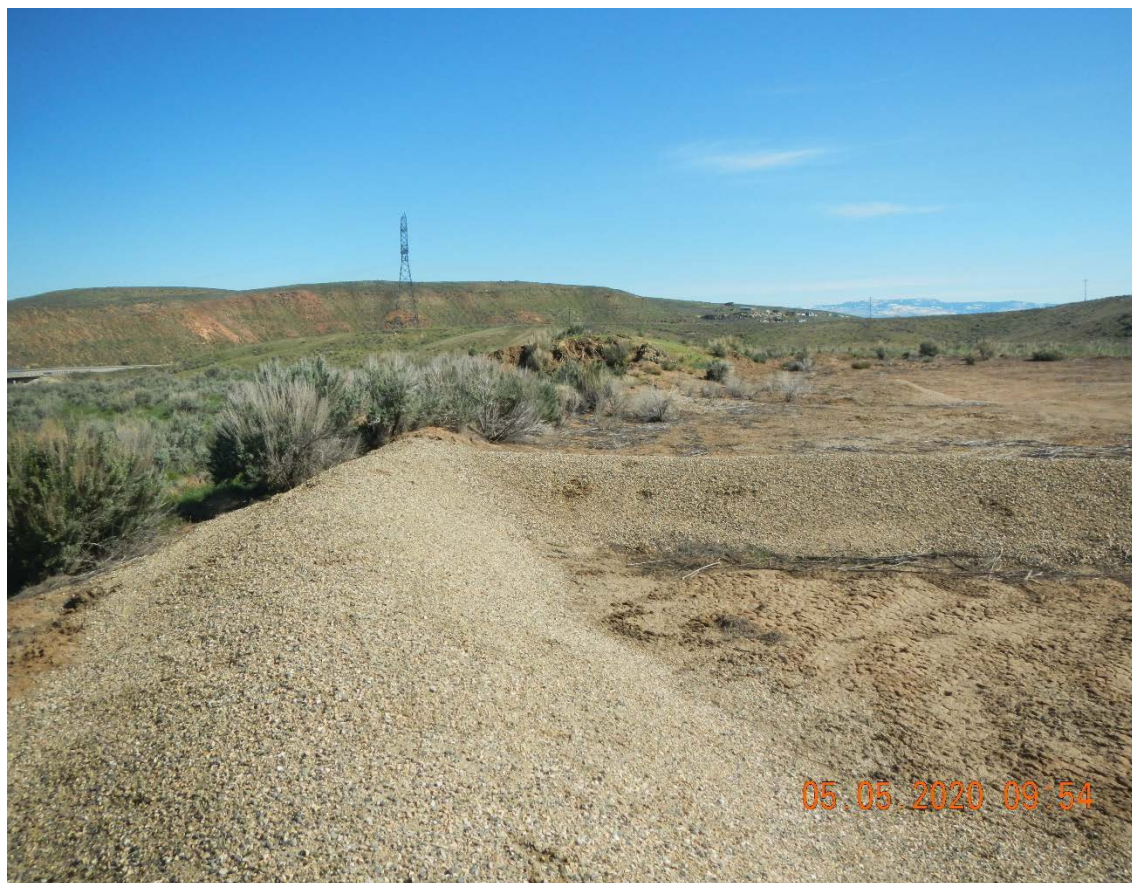
Photo #17 west side of secondary containment. Looking north.

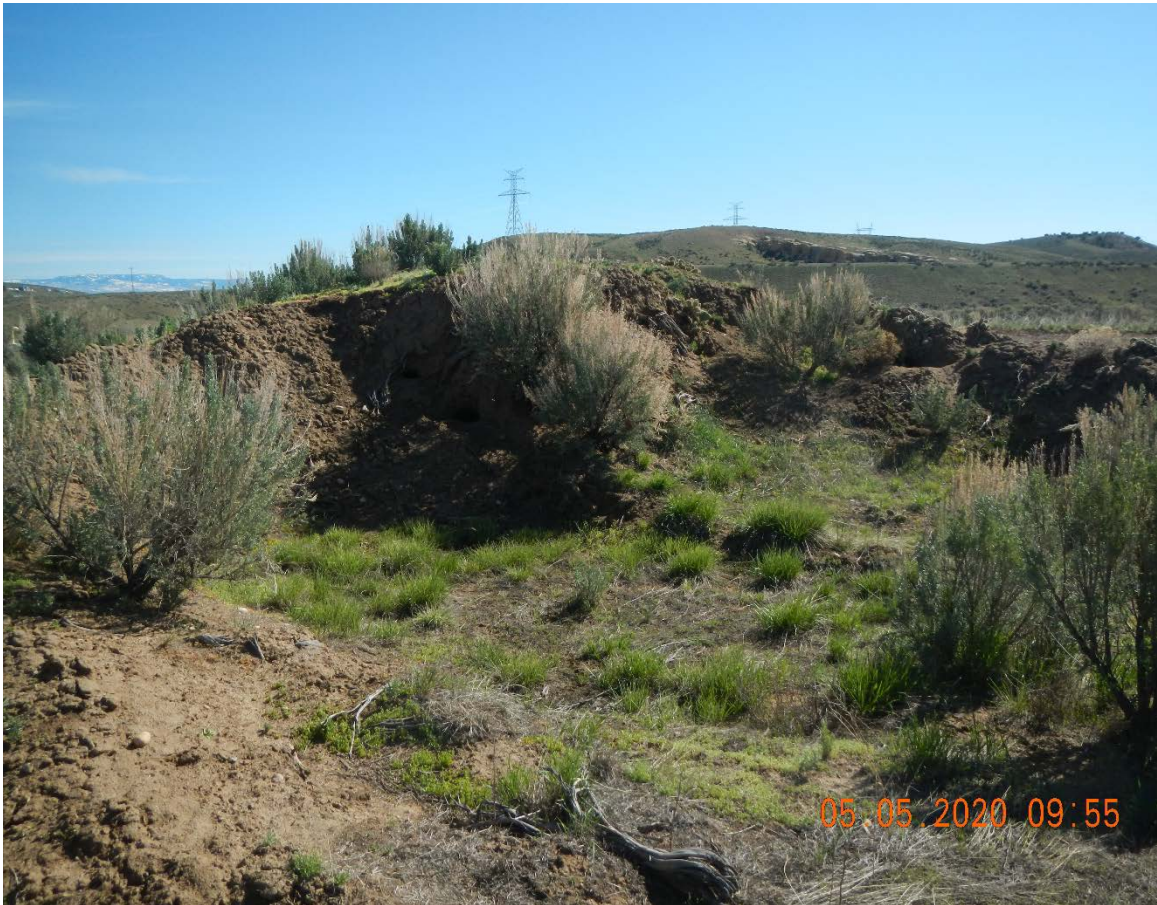
Photo #18 Assumed Stock pile of Topsoil.

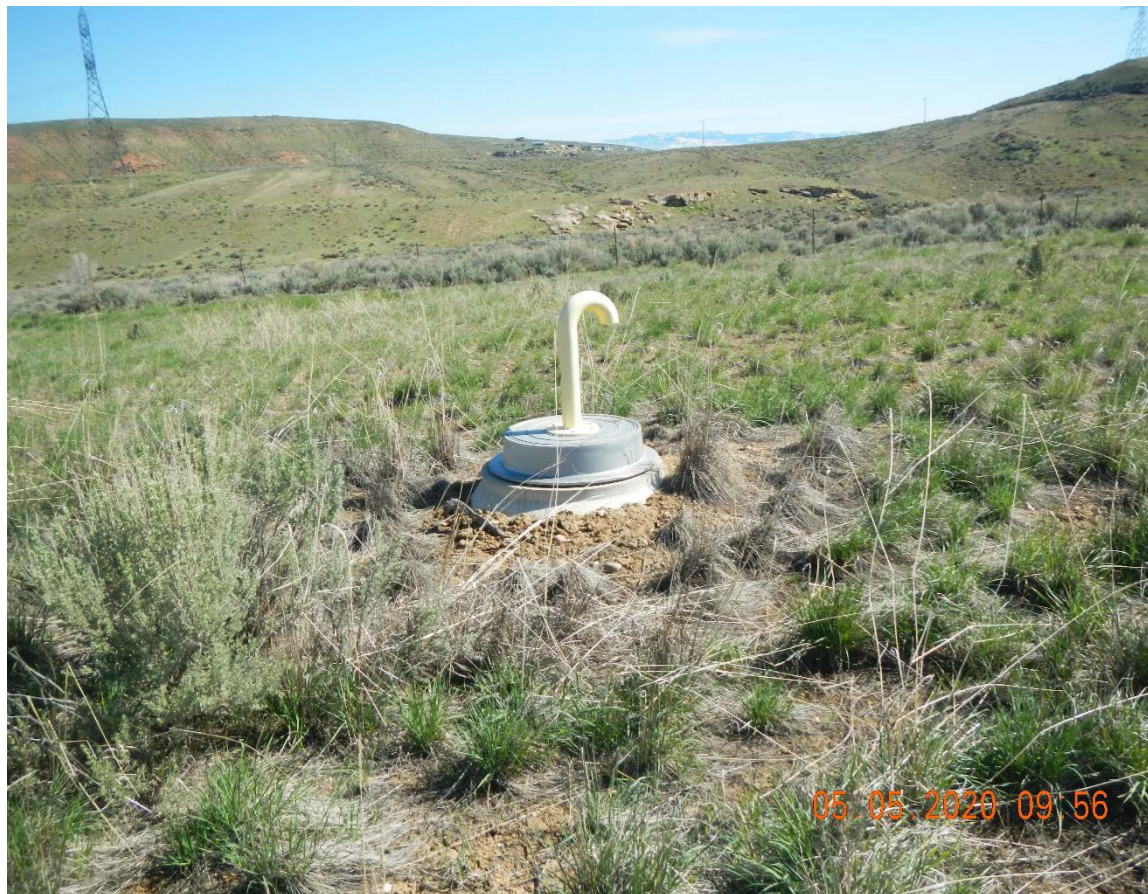
Photo #19 It is believed this is a vent for the powerplant water line from the Yampa River.

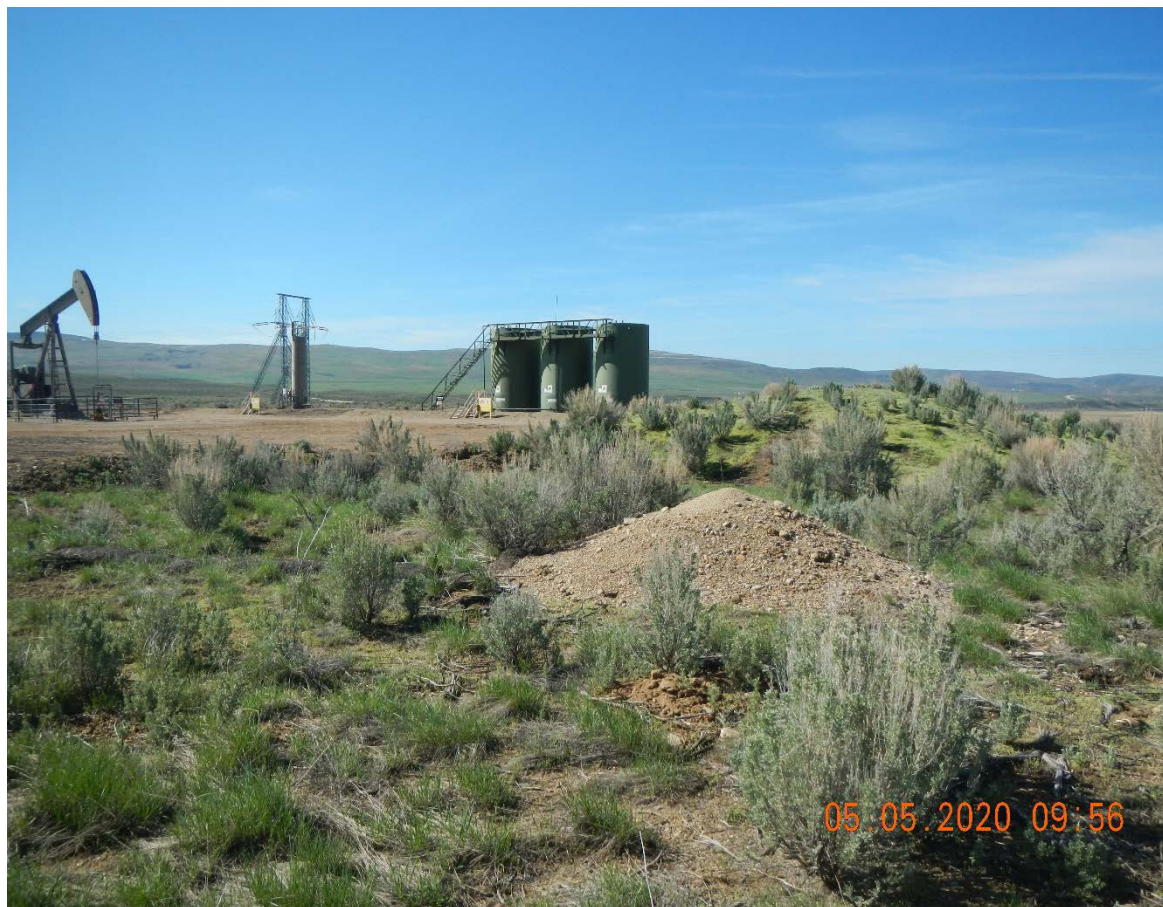
Photo #20 looking at location (looking southwest) from photo #19.

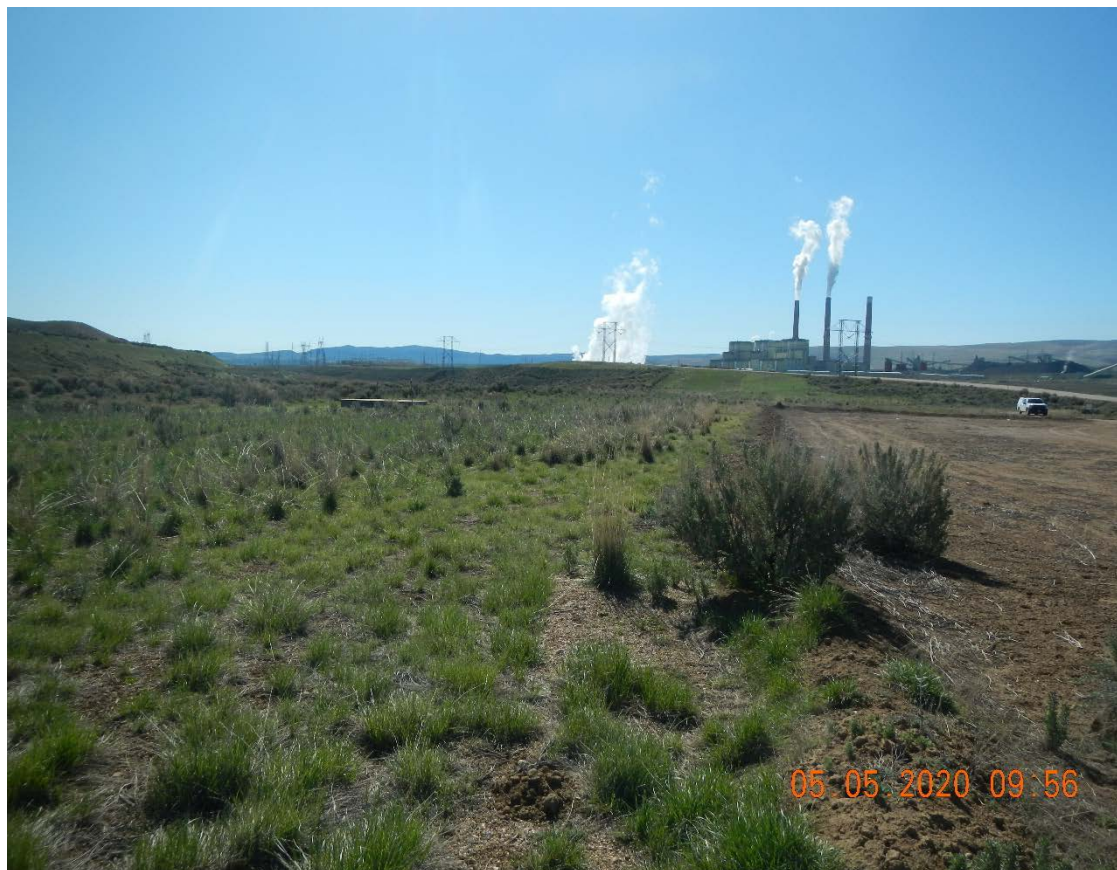
Photo #21 looking south east from north of pad.
