Inspection Photos

Location 430051

ASI 081-07747

Inspection Date: 5/5/2020

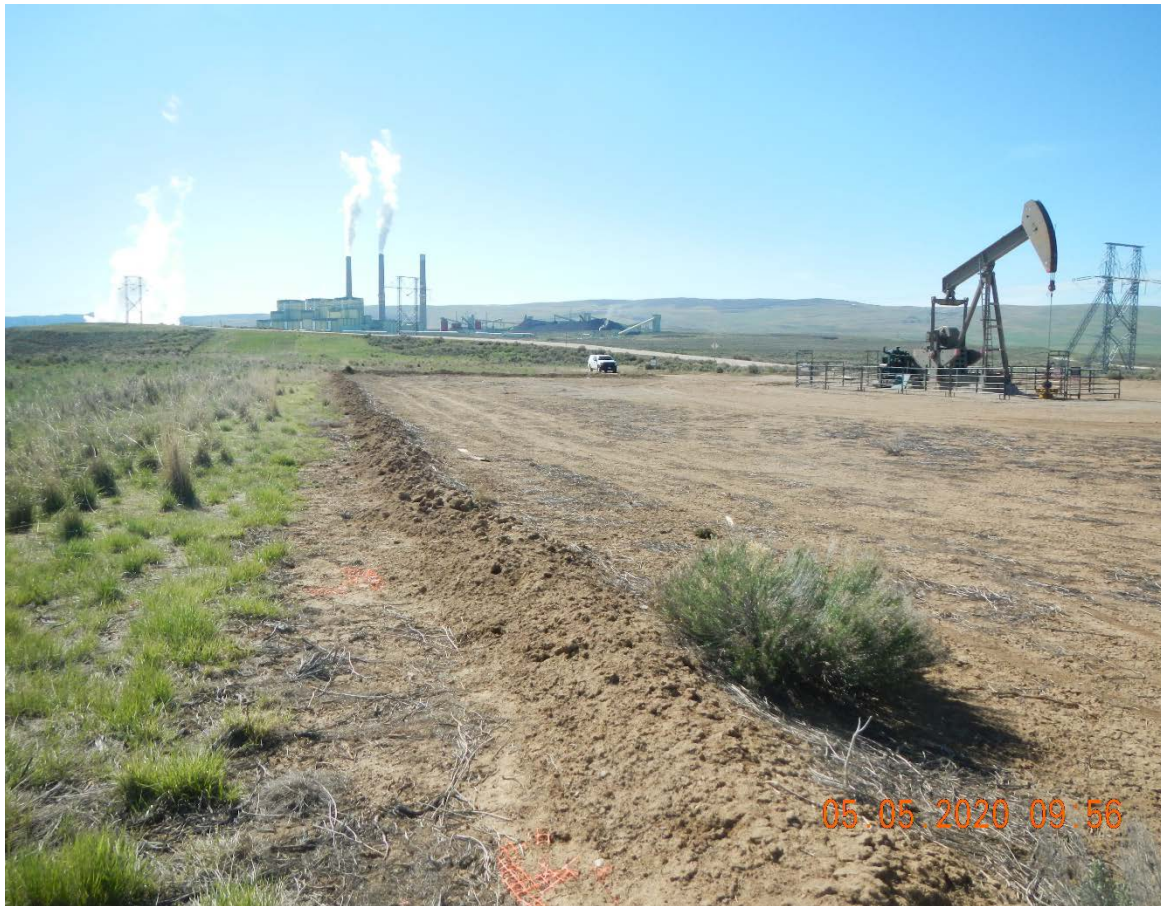
Photo #22 looking south east from north of pad.

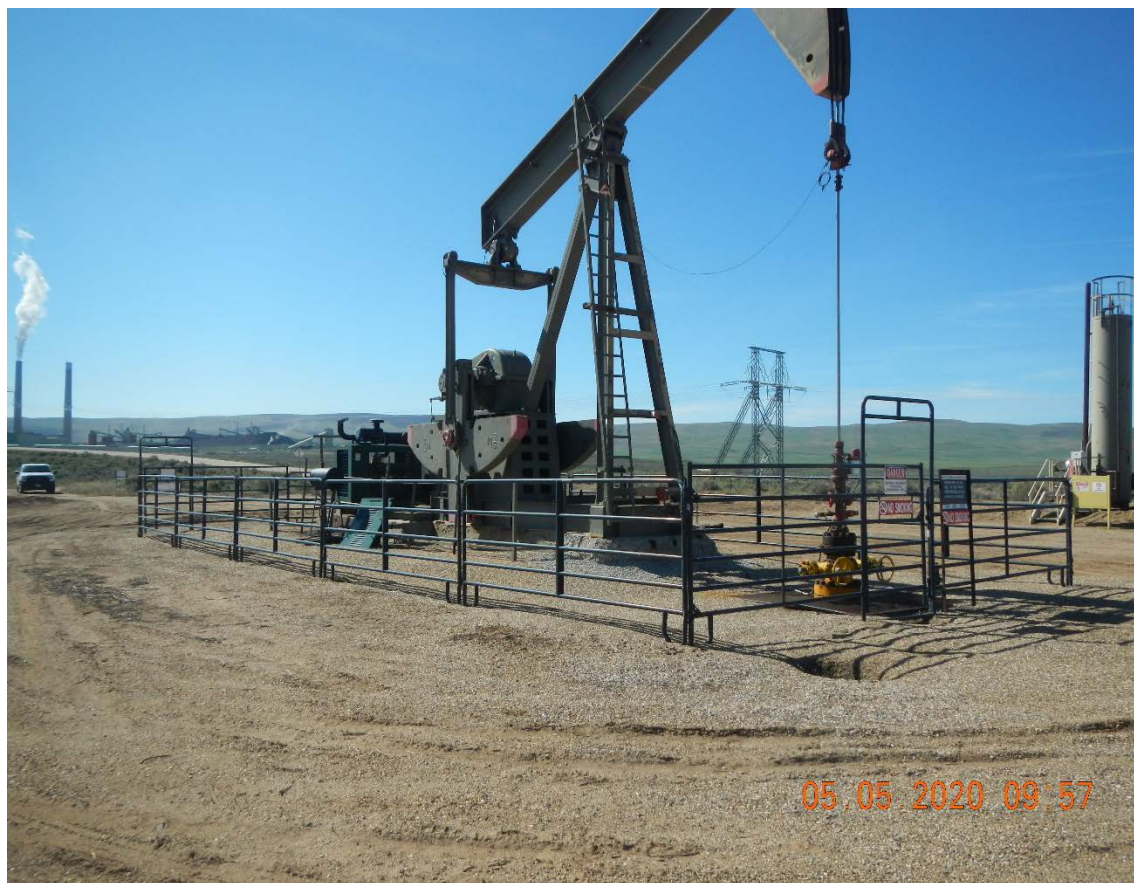
Photo #23 Pumpjack with gas drive motor.

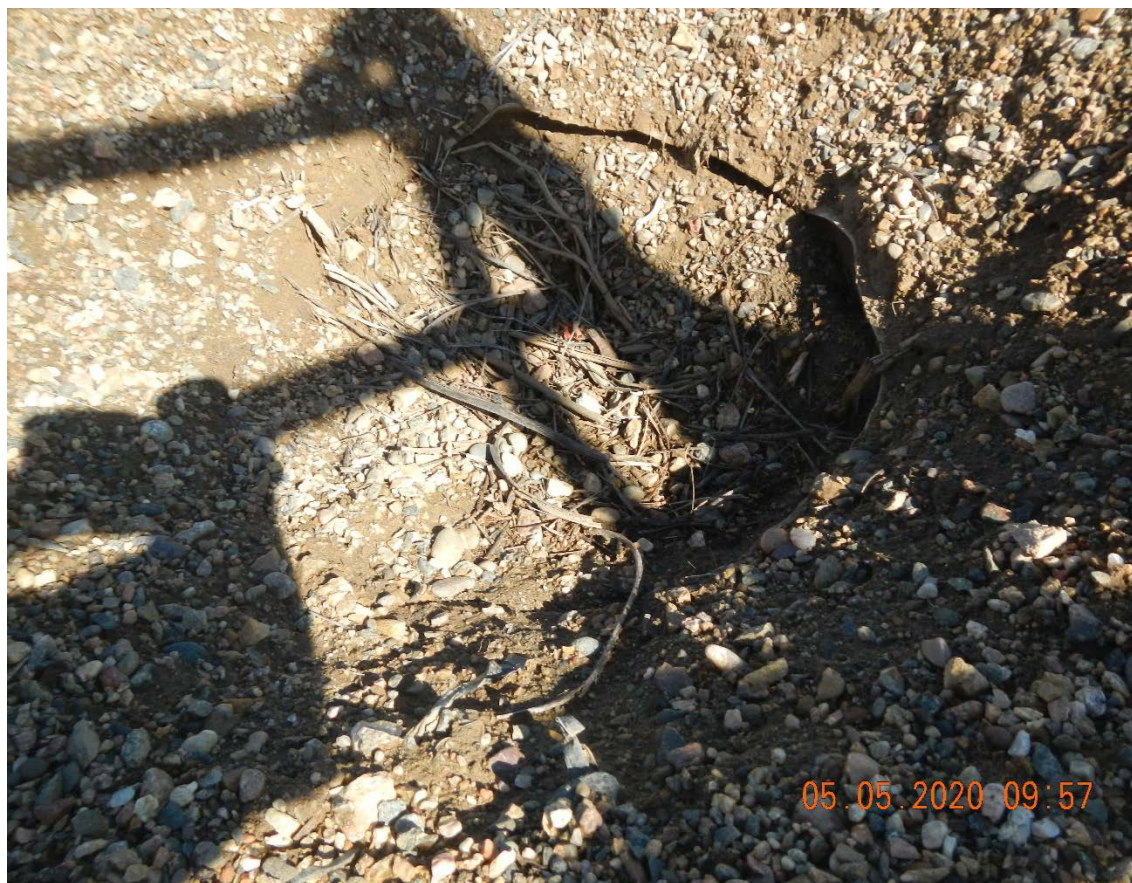
Photo #24 Photo attempted to document filled rat hole, appears 12" culvert material.

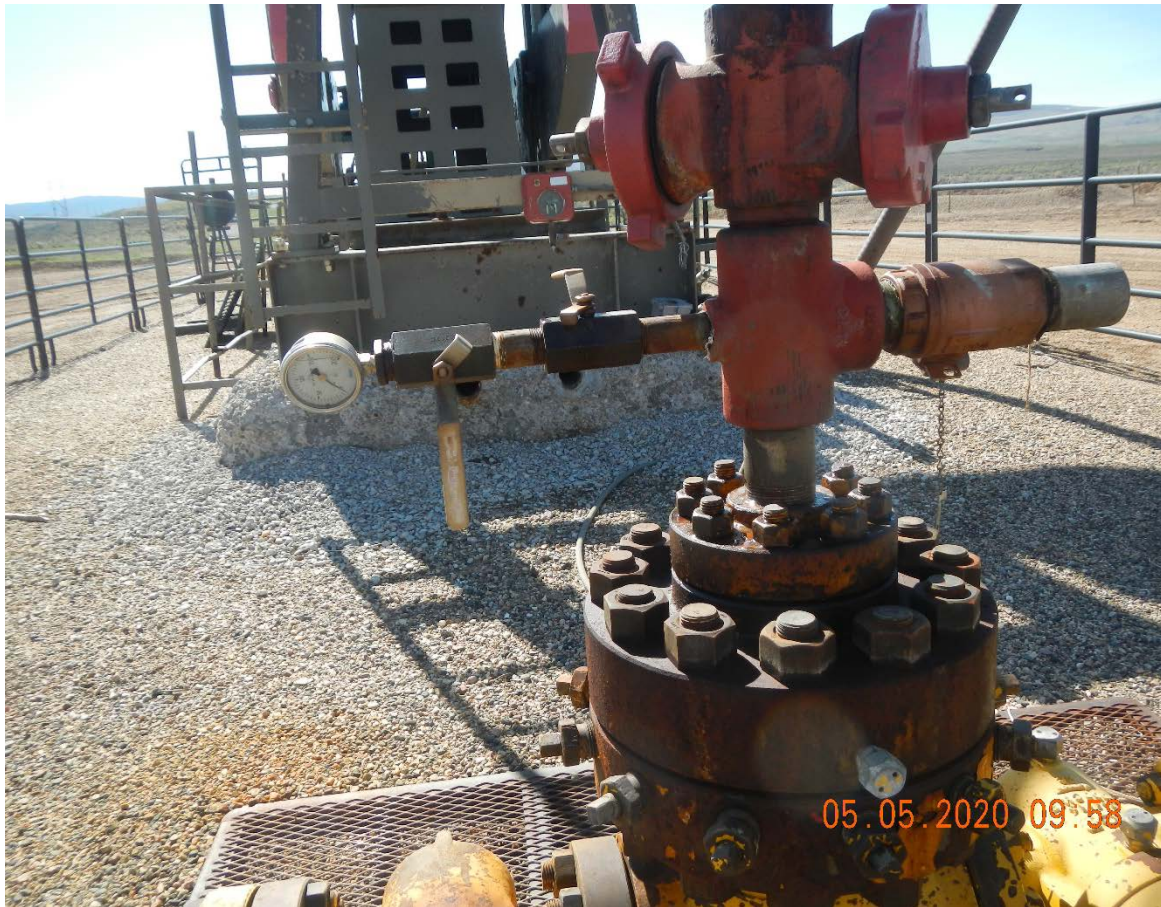
Photo #25 Wellhead. Well was shut in at time of inspection.

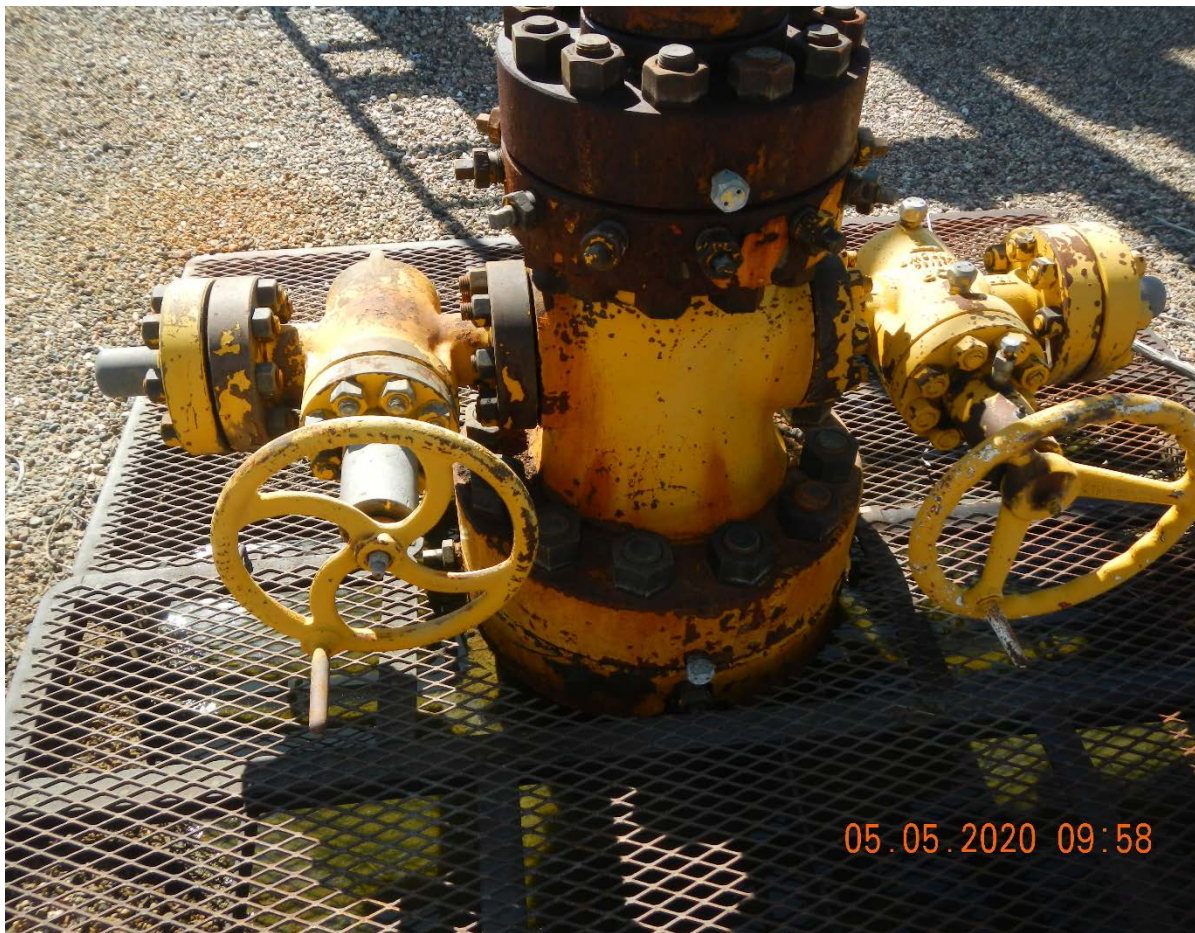
Photo #26 wellhead.

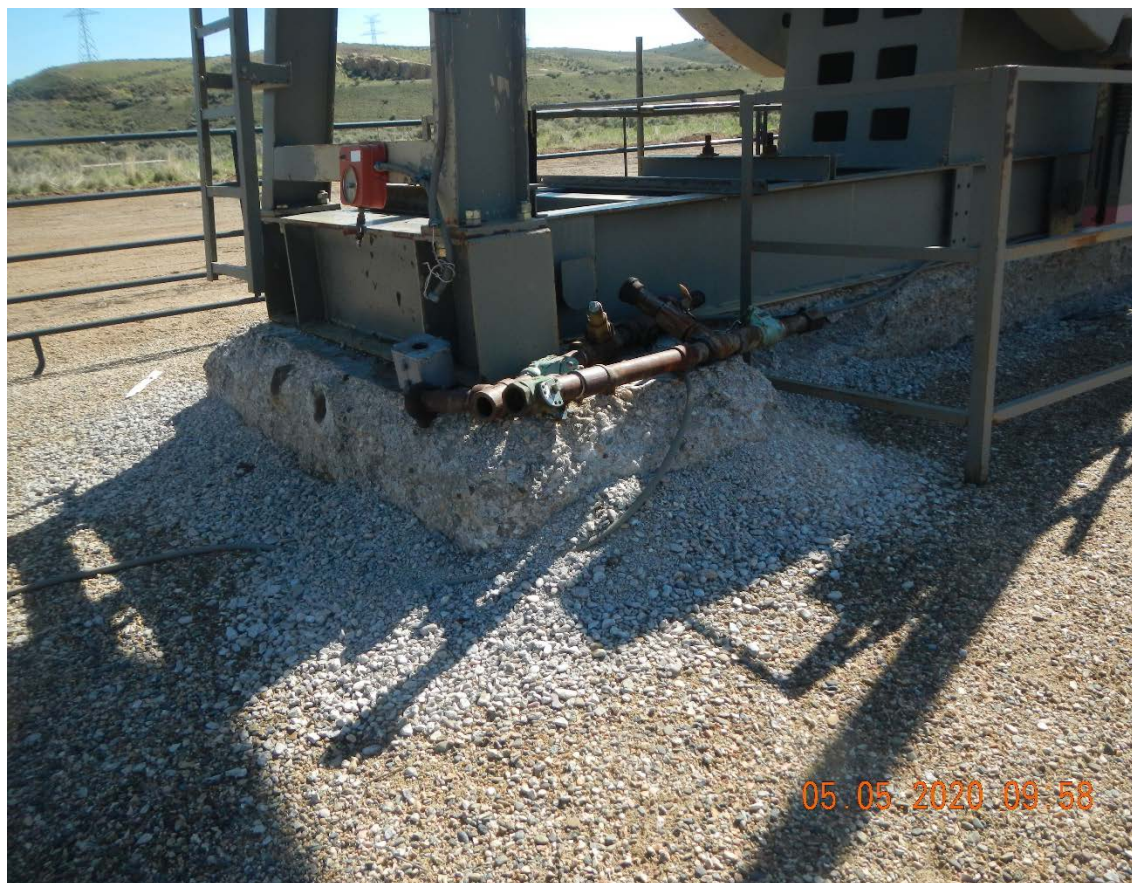
Photo #27 unused equipment.

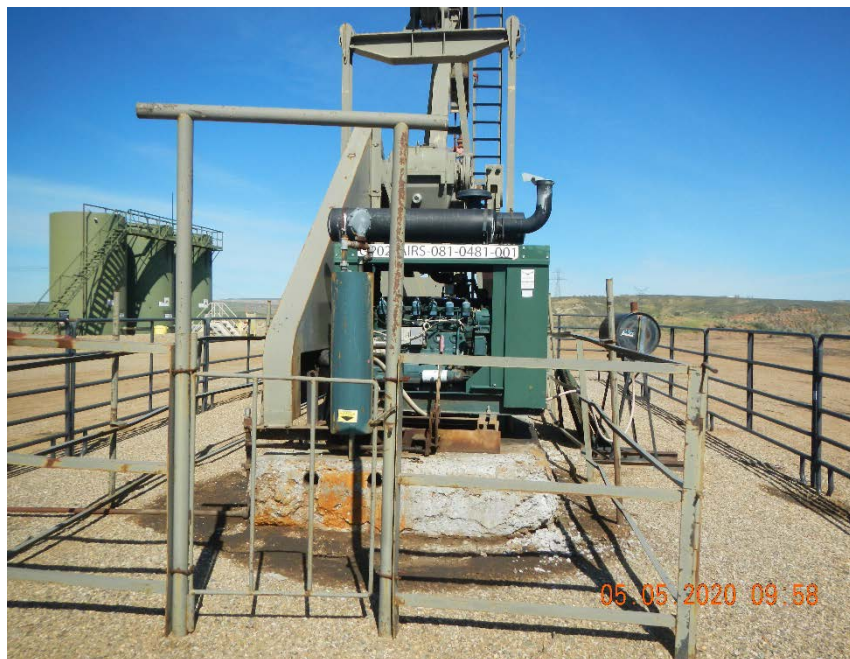
Photo #28 Pumpjack drive motor.
