Inspection Photos  
Operator: Hilcorp Energy  
API#: 067-08231  
Date: 5/5/2020

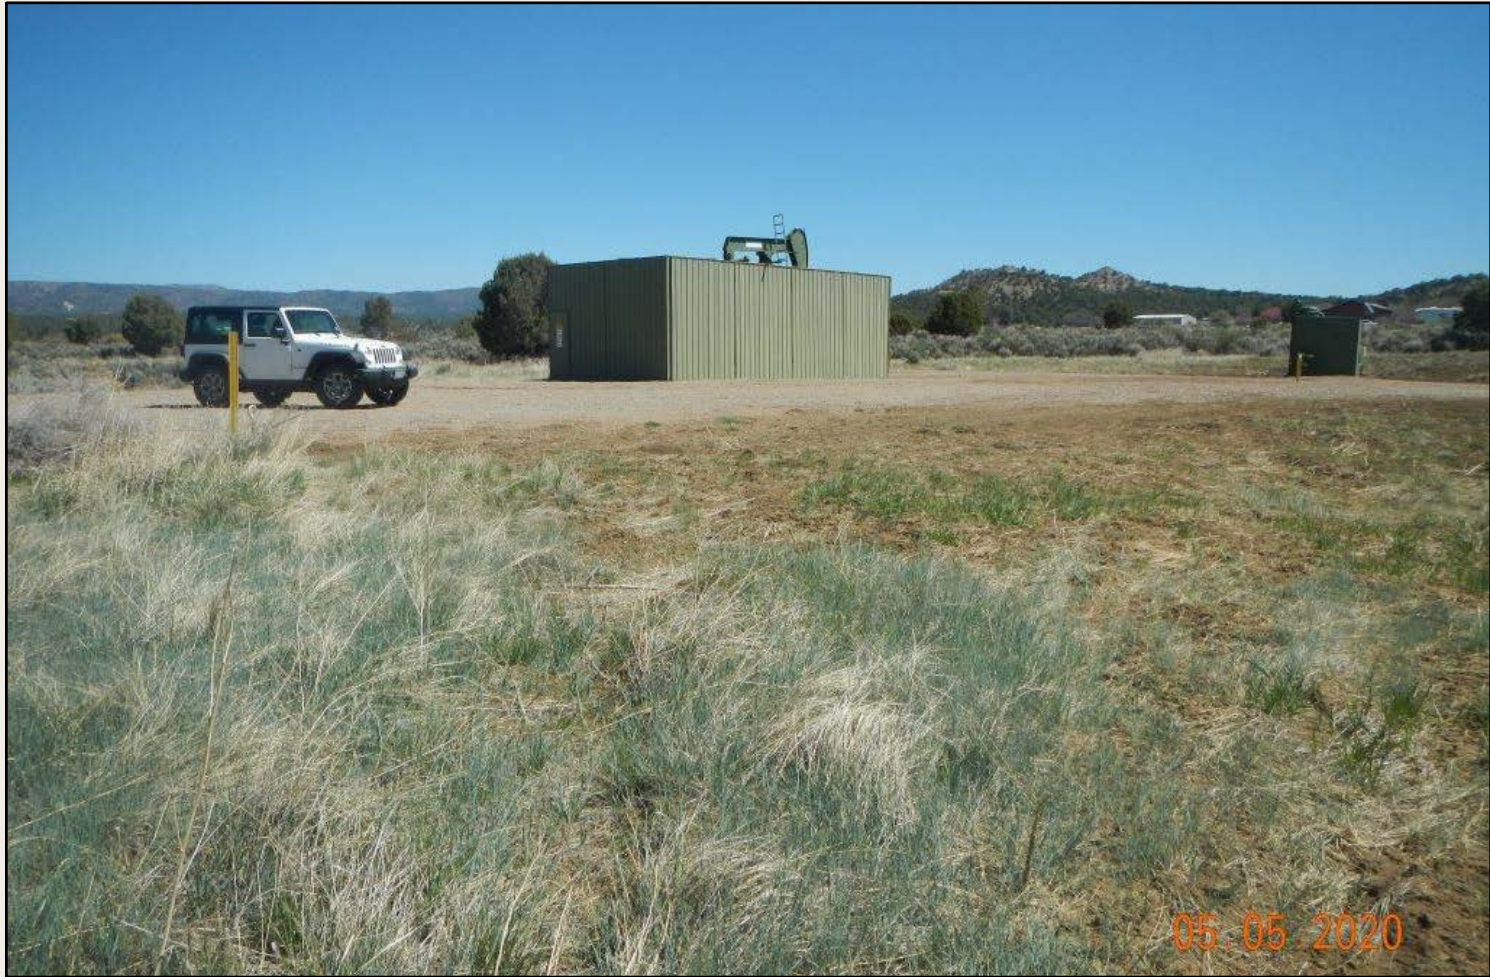
Photo 1. View of the project area from the southwestern corner facing center.

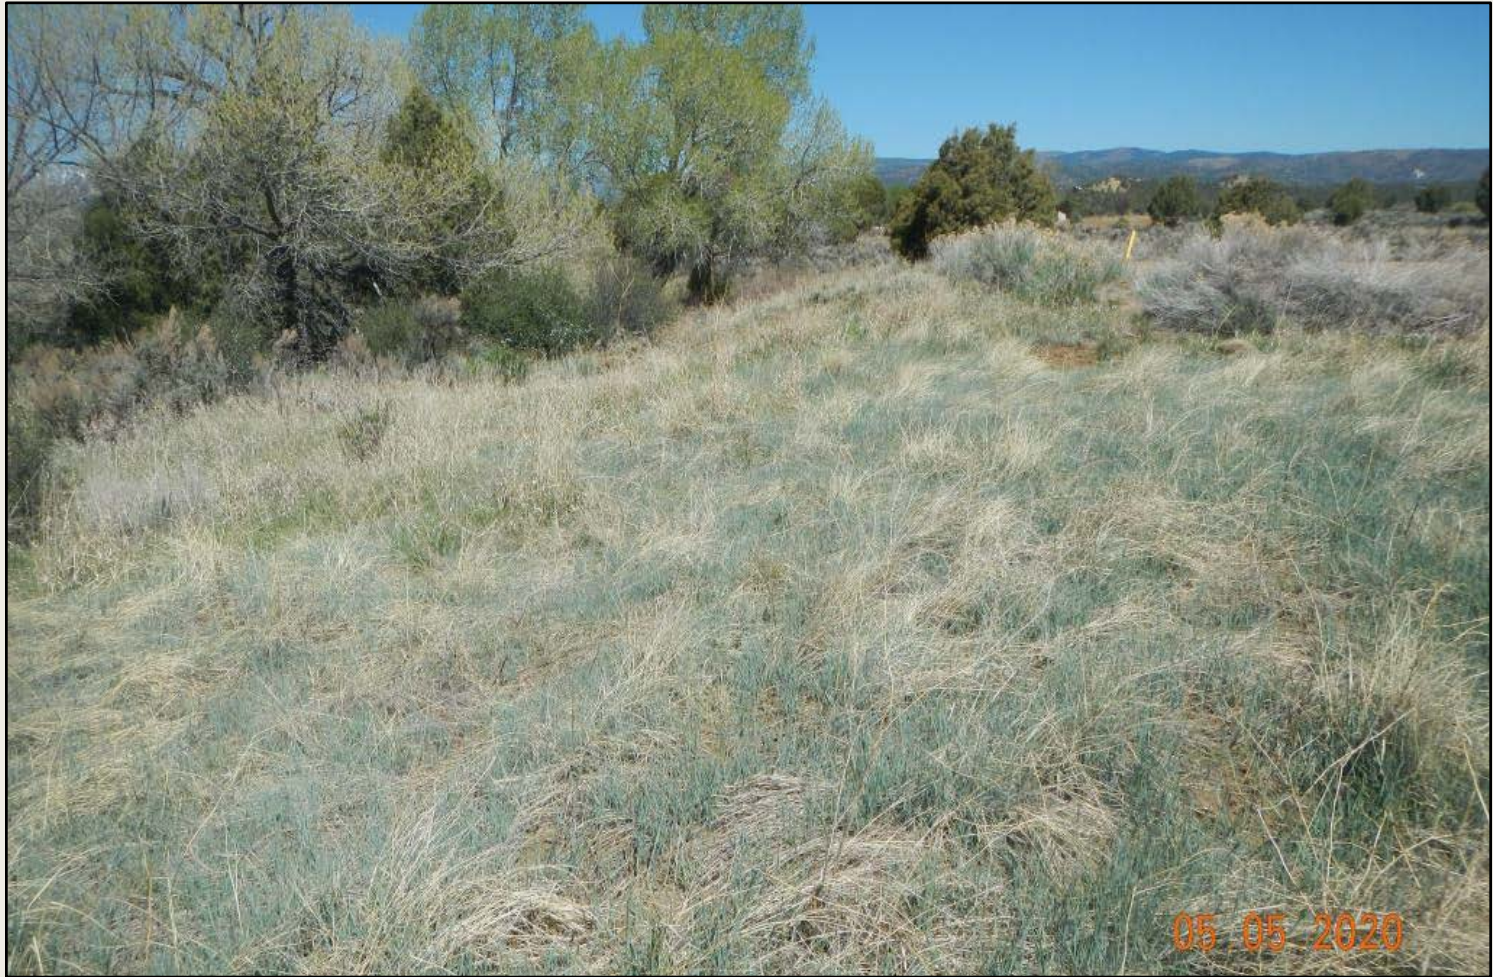
Photo 2. View of the western project area from the southwestern corner facing northward. Revegetation is progressing with western wheatgrass and rubber rabbitbrush.

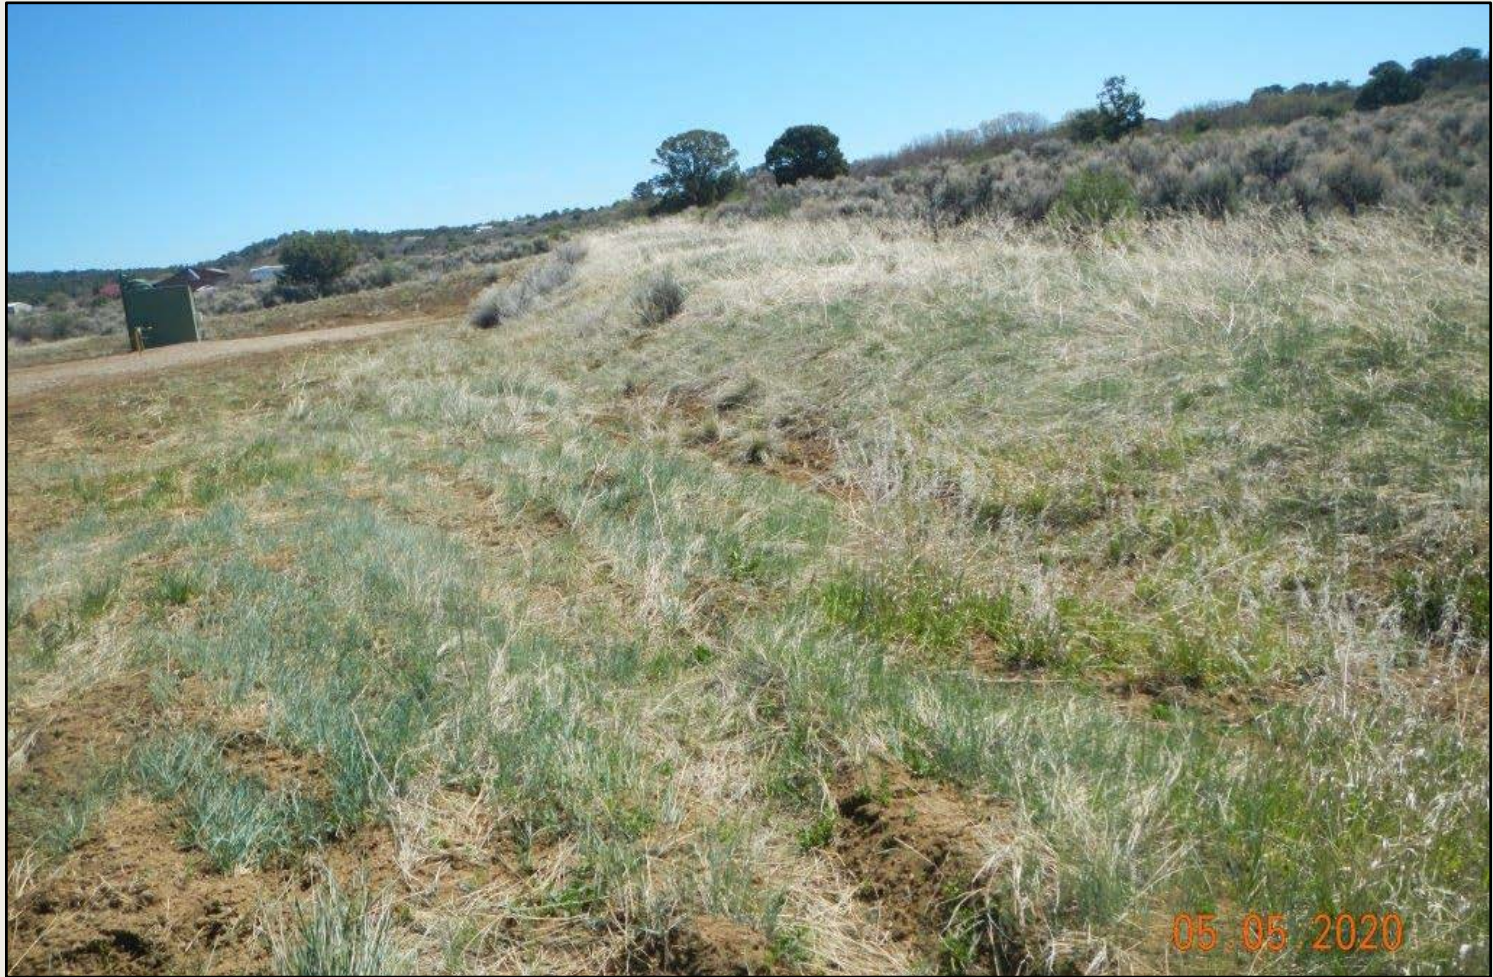
Photo 3. View of the southern project area from the southwestern corner facing eastward.

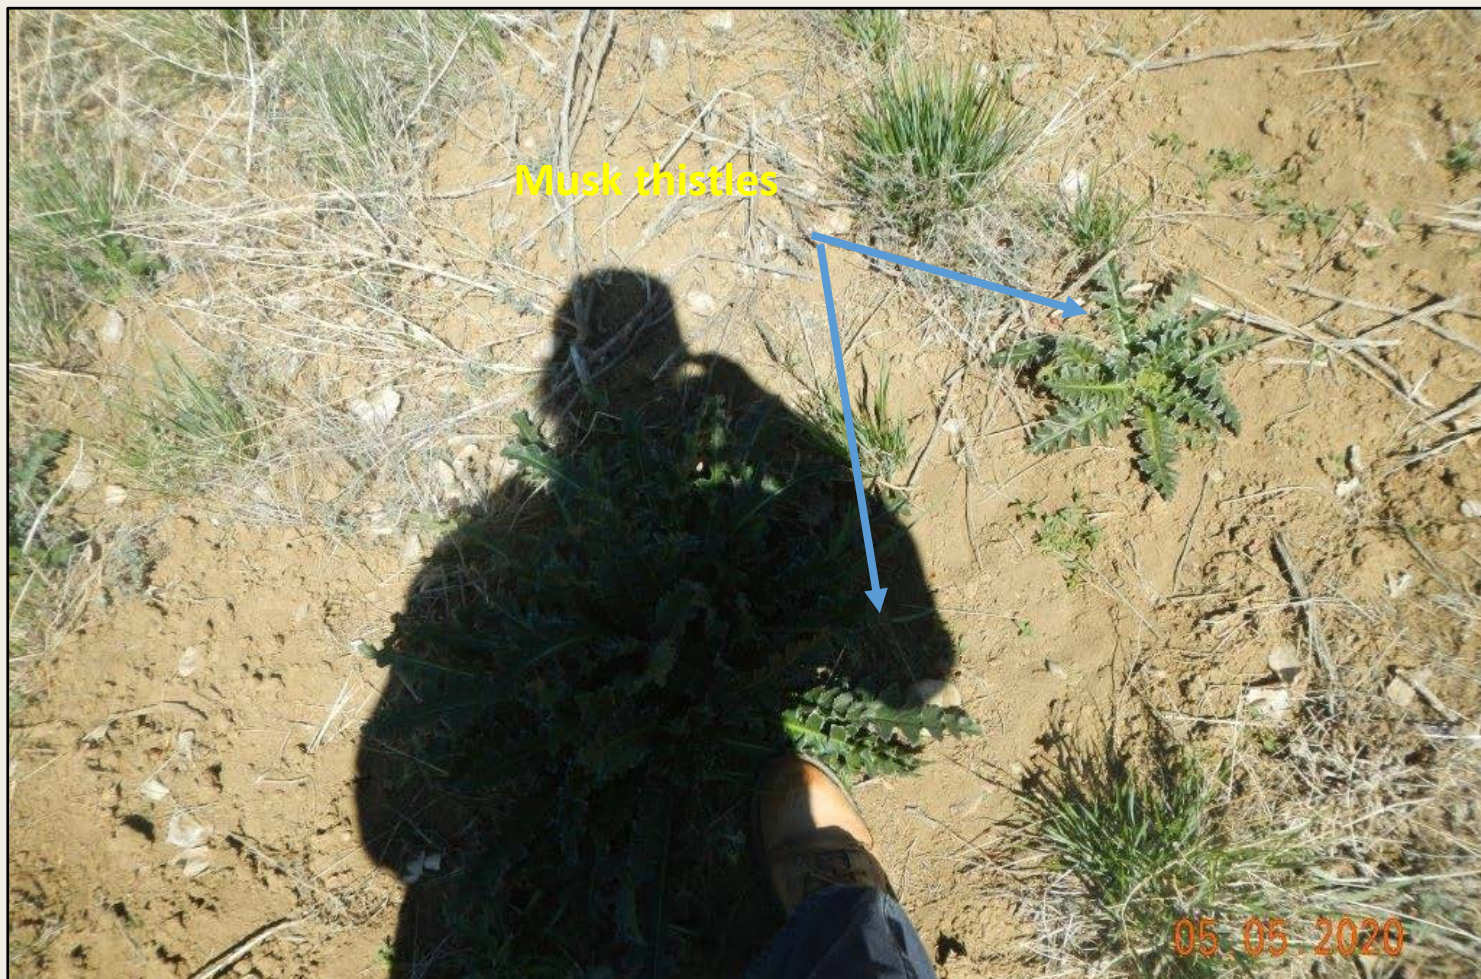
Photo 4. View of musk thistles within the project area.

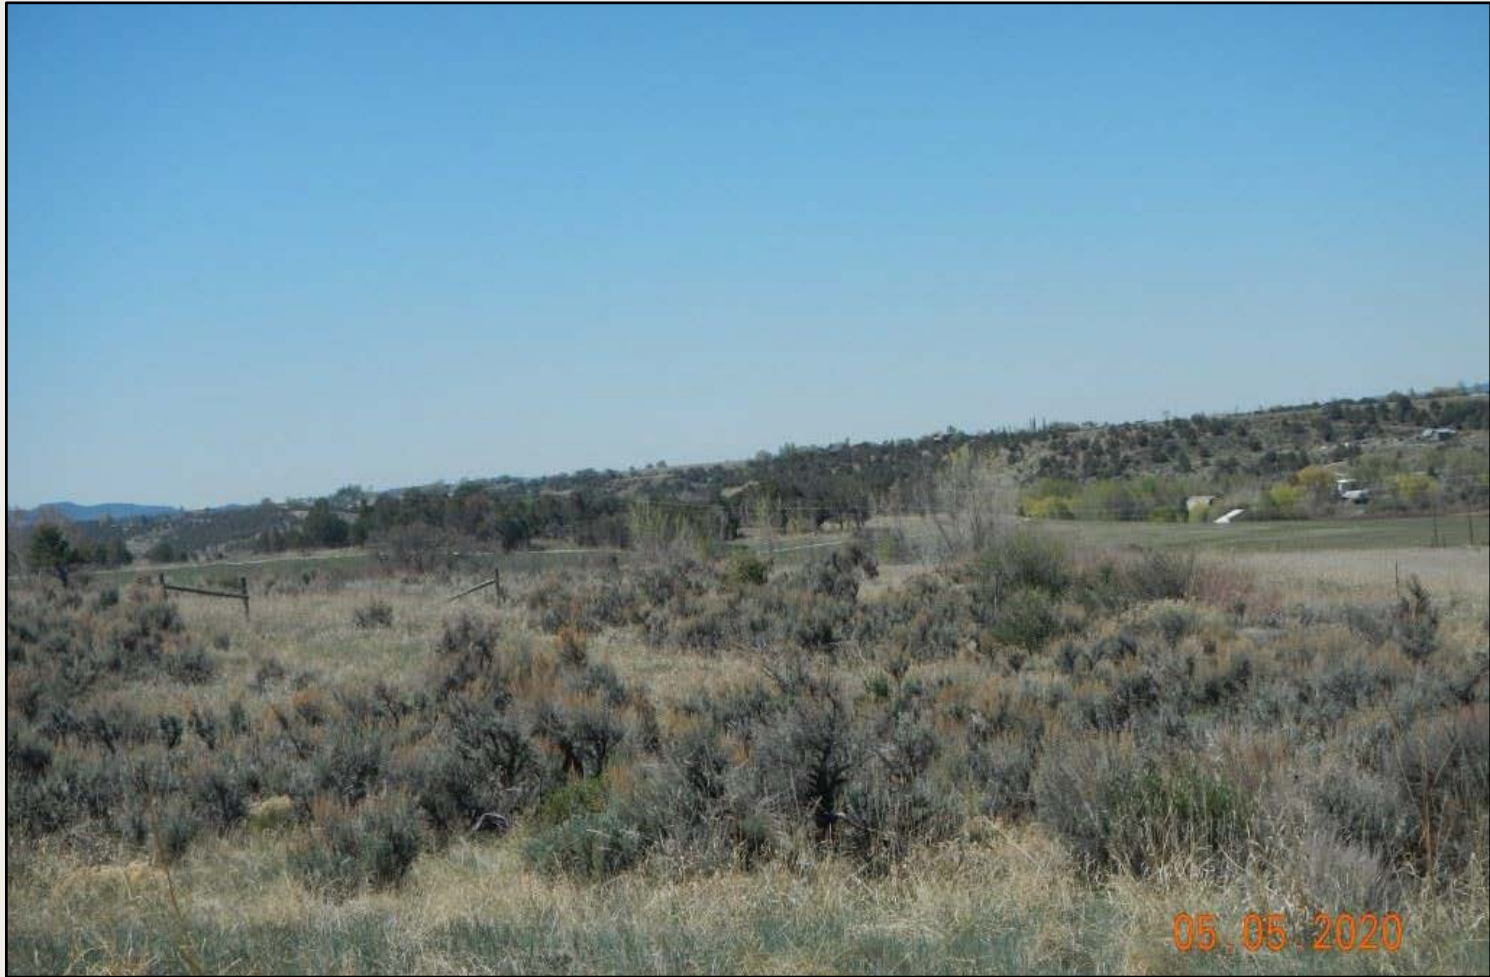
Photo 5. View of reference area comprised of sagebrush shrubland with understory dominated by western wheatgrass, sand dropseed, and blue grama.
