NEW ELK 25-04 API# 05-071-09535 – TIMBER CREEK OPERATING
OGCC OPERATOR NUMBER 10672 - DATE: MAY 06, 2020
CORRECTIVE ACTIONS COMPLETED REGARDING COGCC FIR DOCUMENT # 695102765

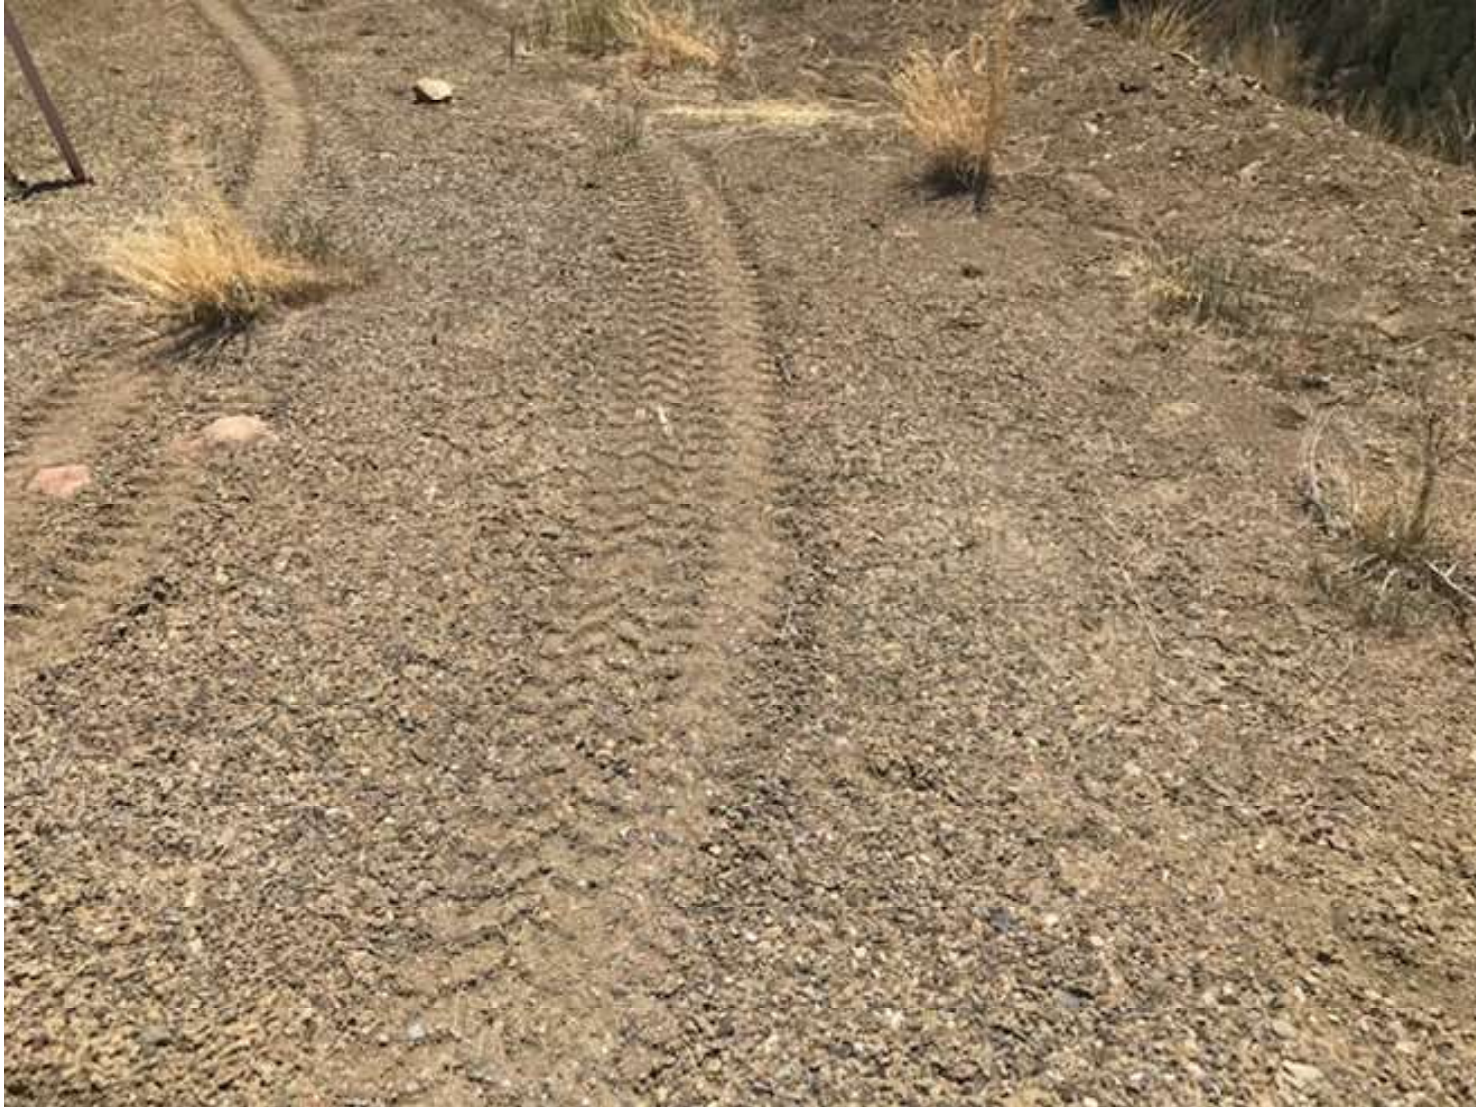
PHOTO 1: THE AUTOMATION POLE LAYING ON THE GROUND WAS REMOVED FROM THE LOCATION.

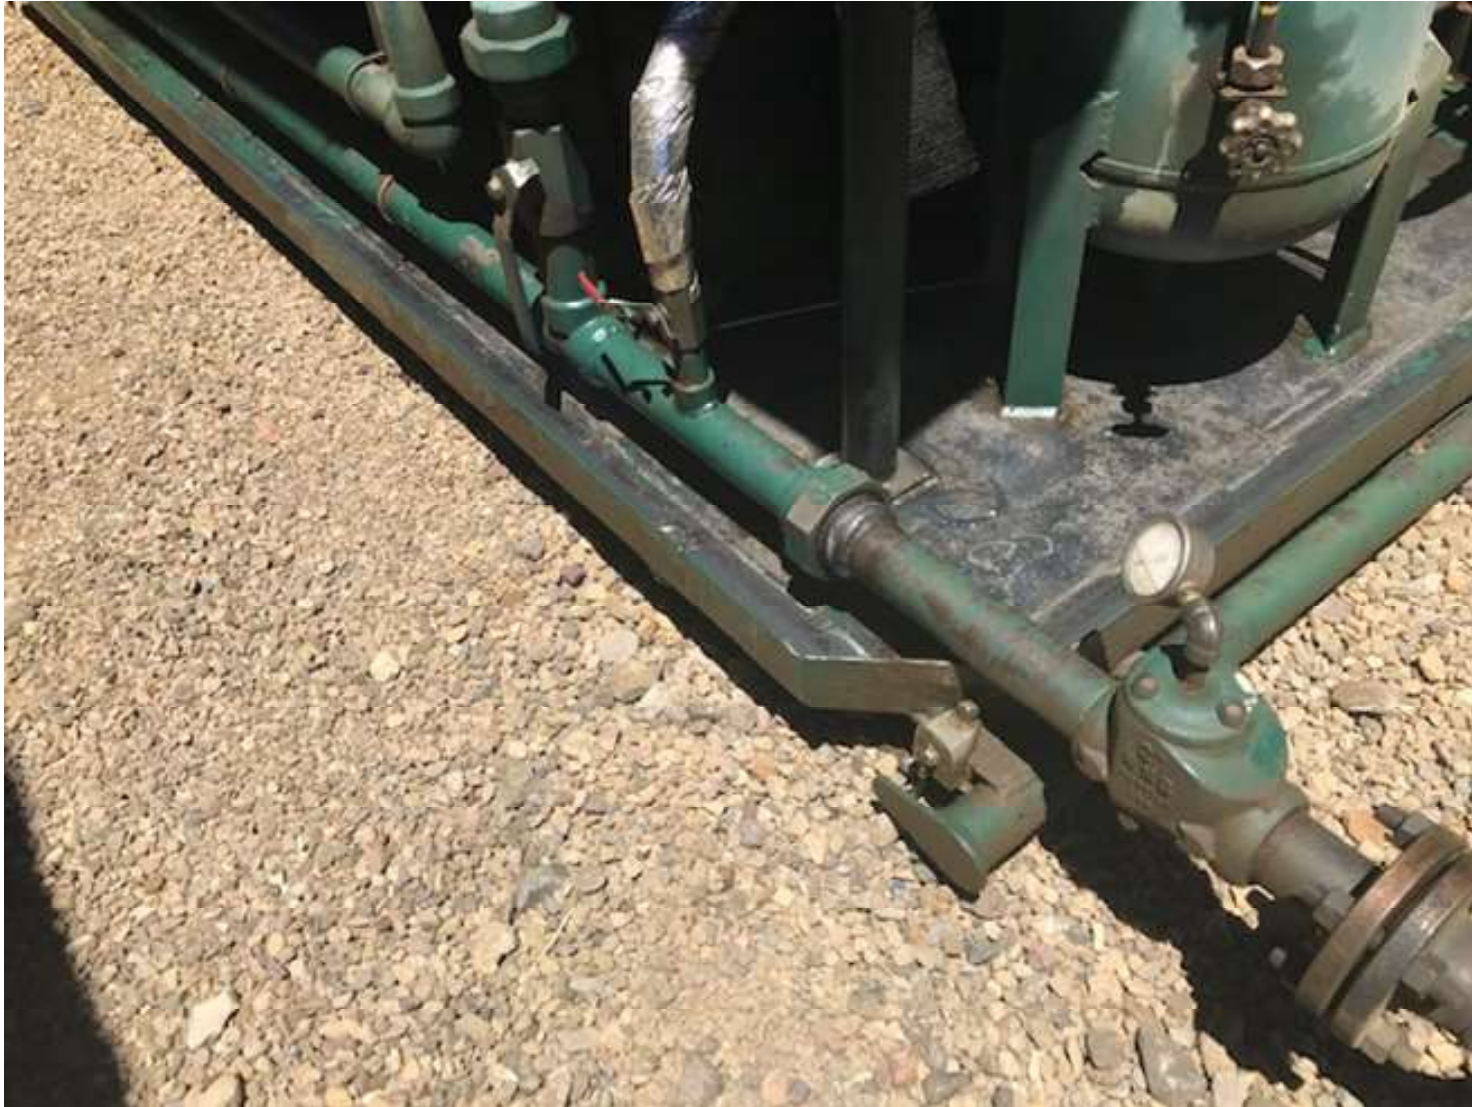
PHOTO 2: THE IMPACTED SOIL/GRAVEL NEAR THE LIQUID RING COMPRESSOR WAS REMOVED FROM LOCATION. MAINTENANCE WAS CONDUCTED ON THE LIQUID RING COMPRESSOR TO STOP THE LEAK.

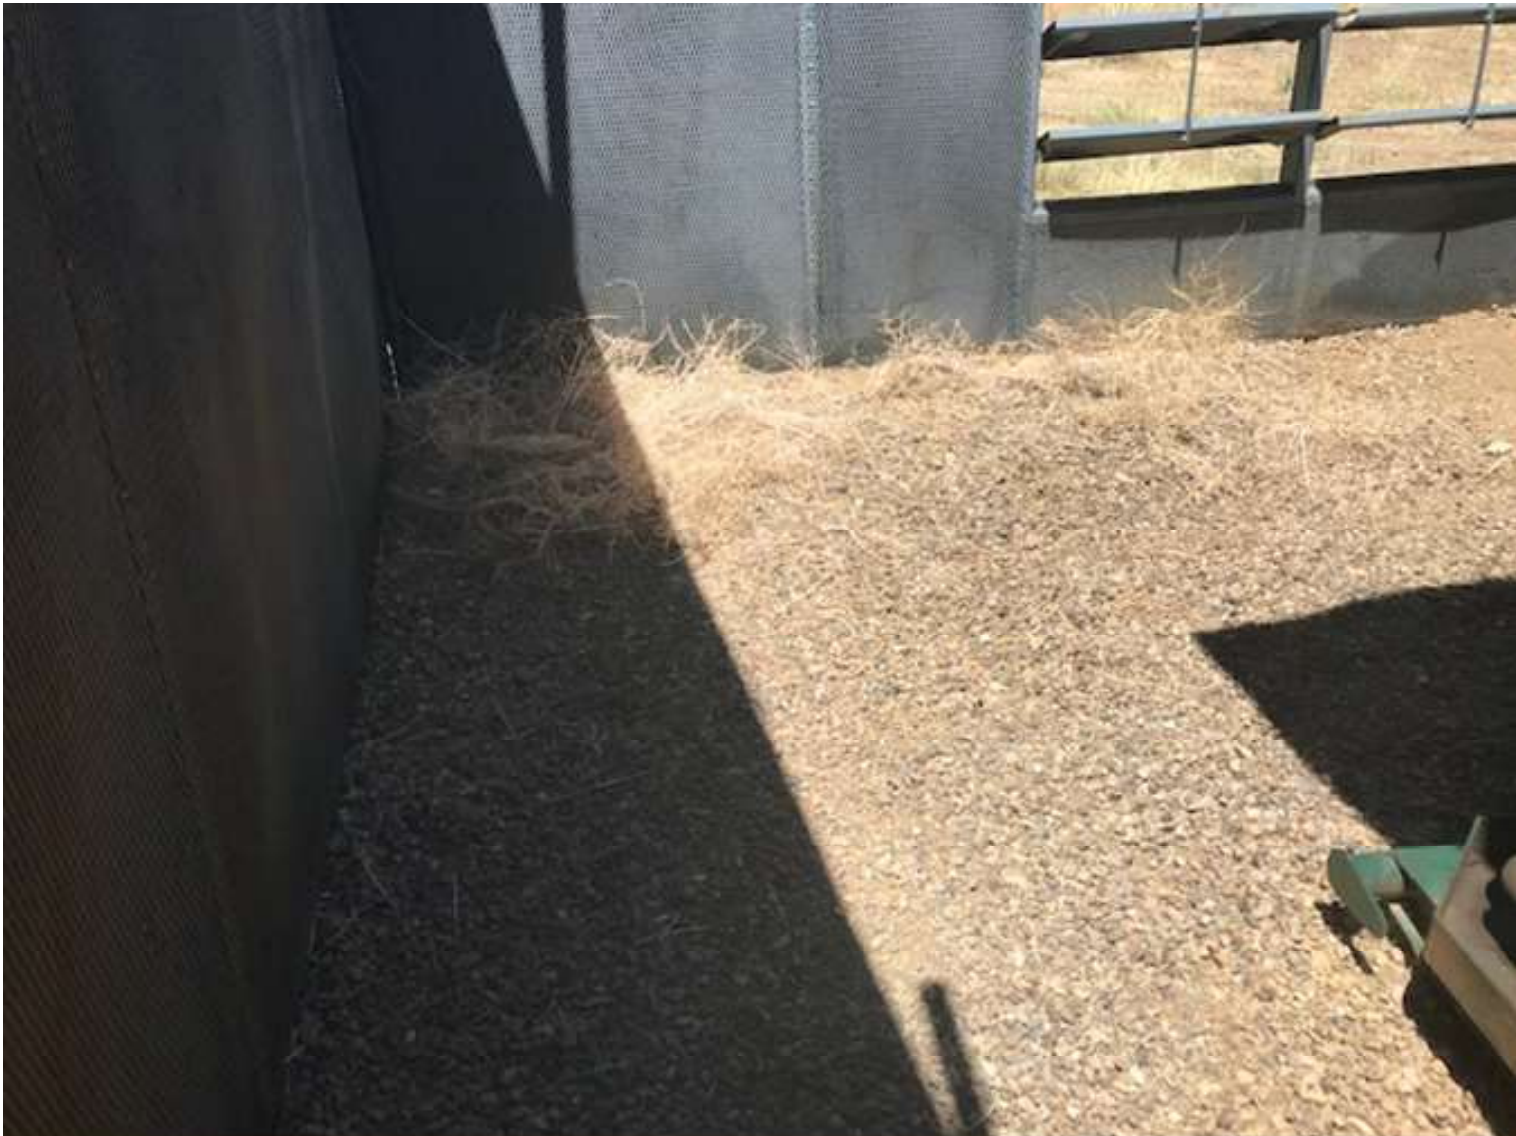
PHOTO 3: THE DISCARDED MATERIAL FOUND INSIDE OF THE SOUND WALLS WERE COLLECTED AND REMOVED FROM THE LOCATION.

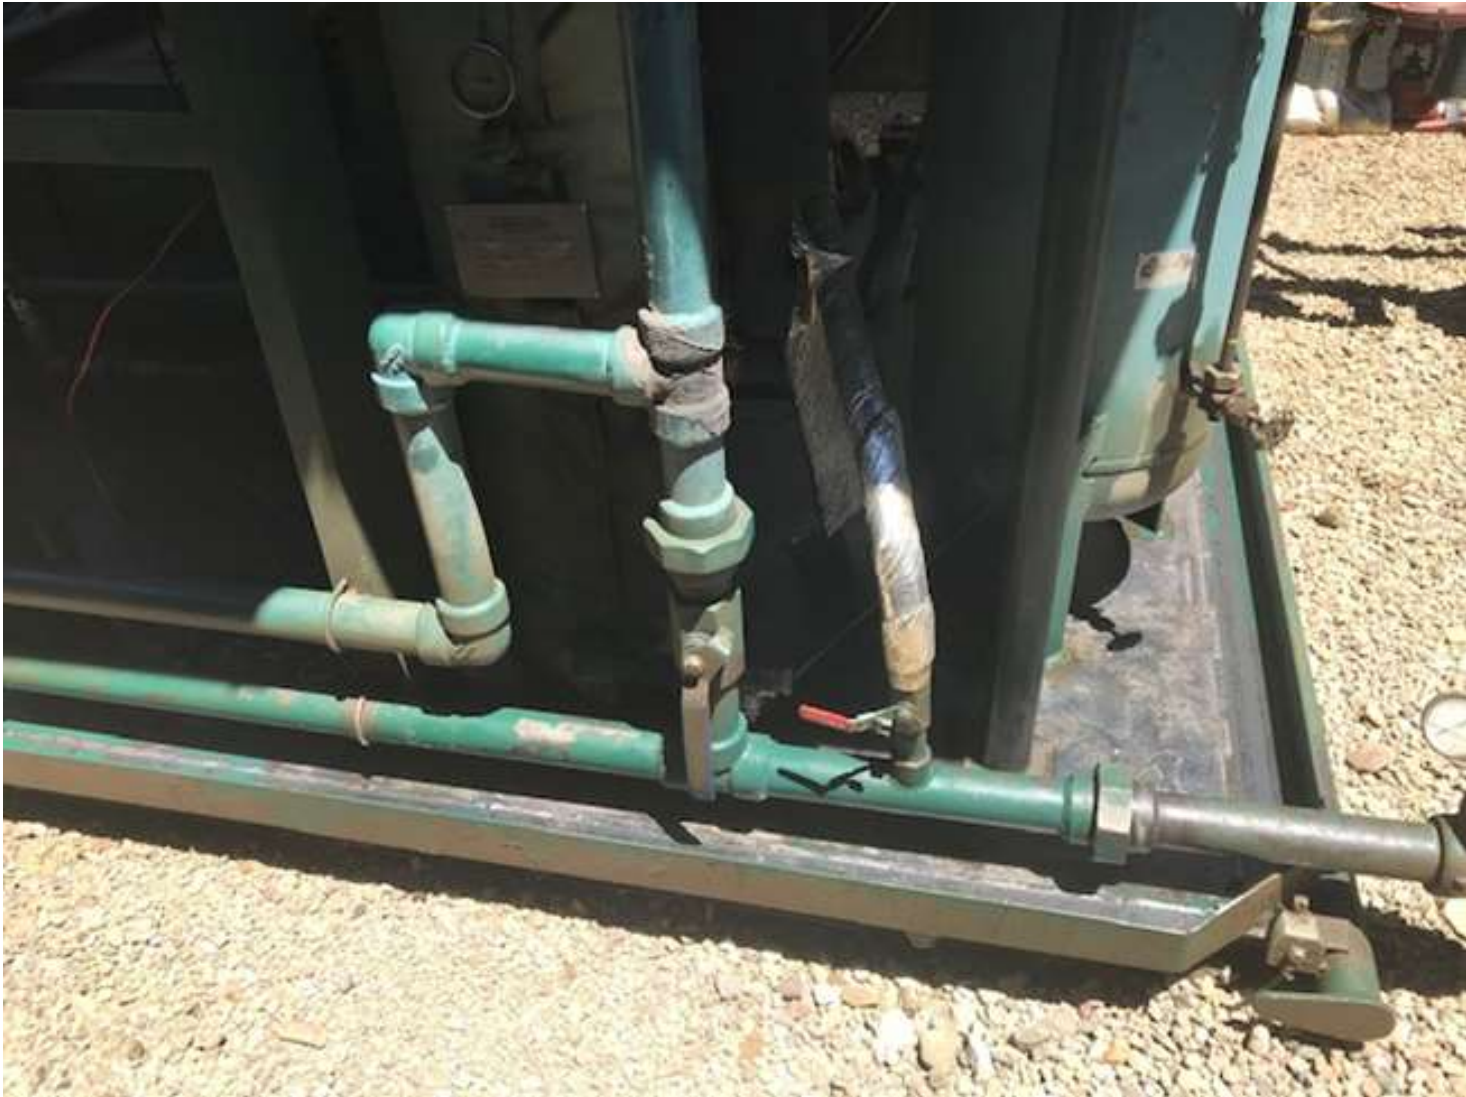
PHOTO 4: THE FLUID ACCUMULATION WAS REMOVED FROM THE CONTAINMENT OF THE LIQUID RING COMPRESSOR AND THE SKID WAS CLEANED.
