Inspection Photos
Operator: BP America
API#: 067-06566
Date: 5/5/2020

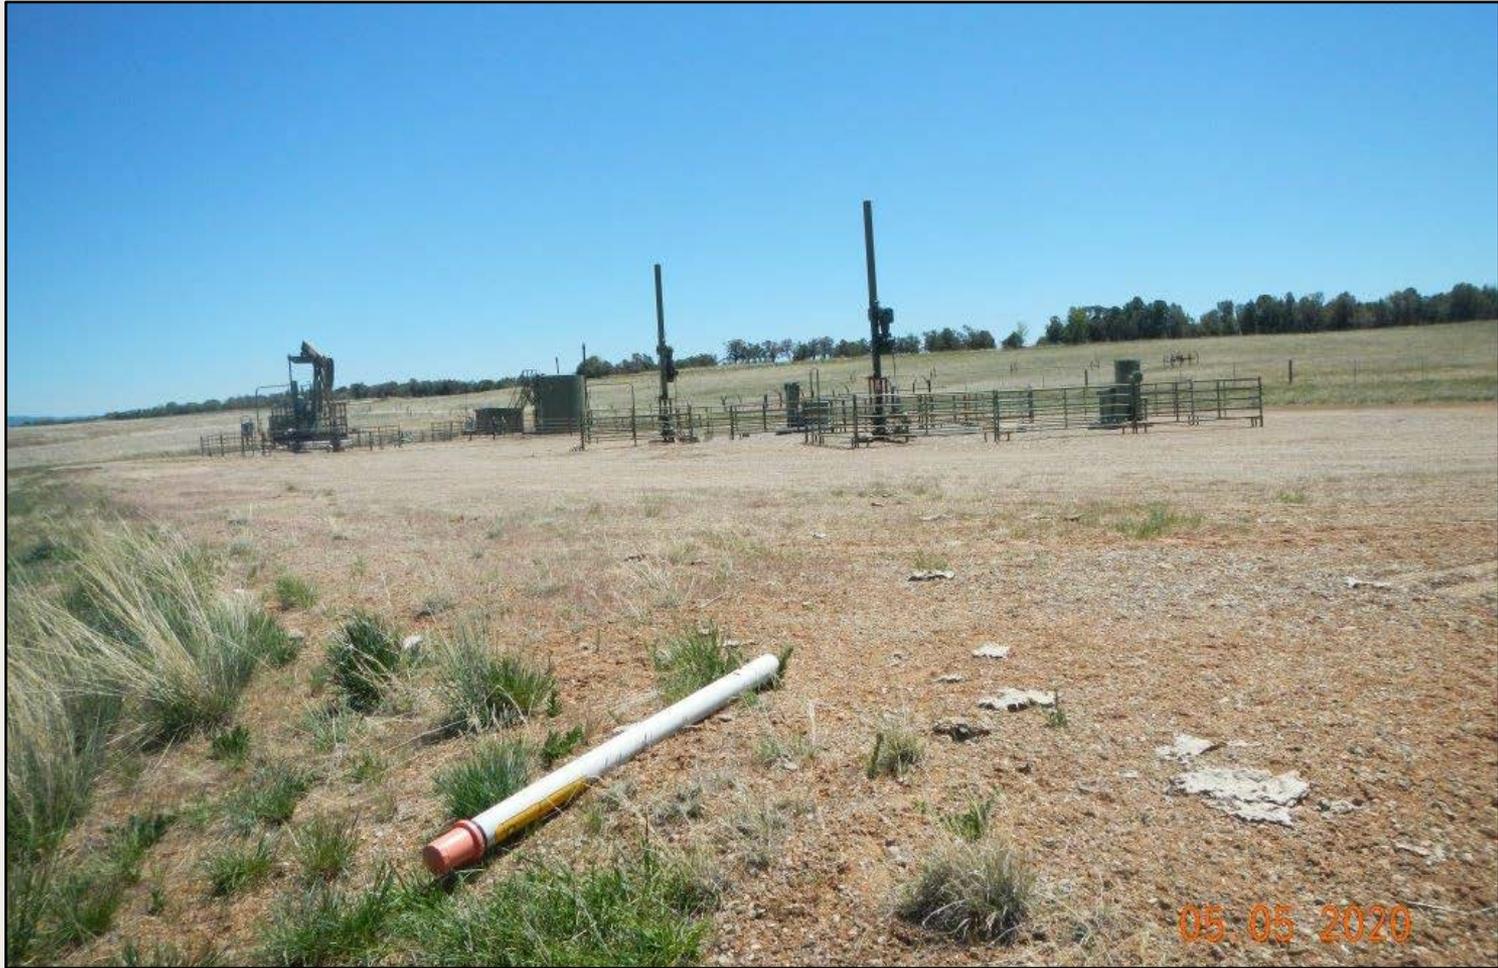
Photo 1. View of the project area from the northwestern corner facing center. Electrical cover is knocked down and needs to be repaired.

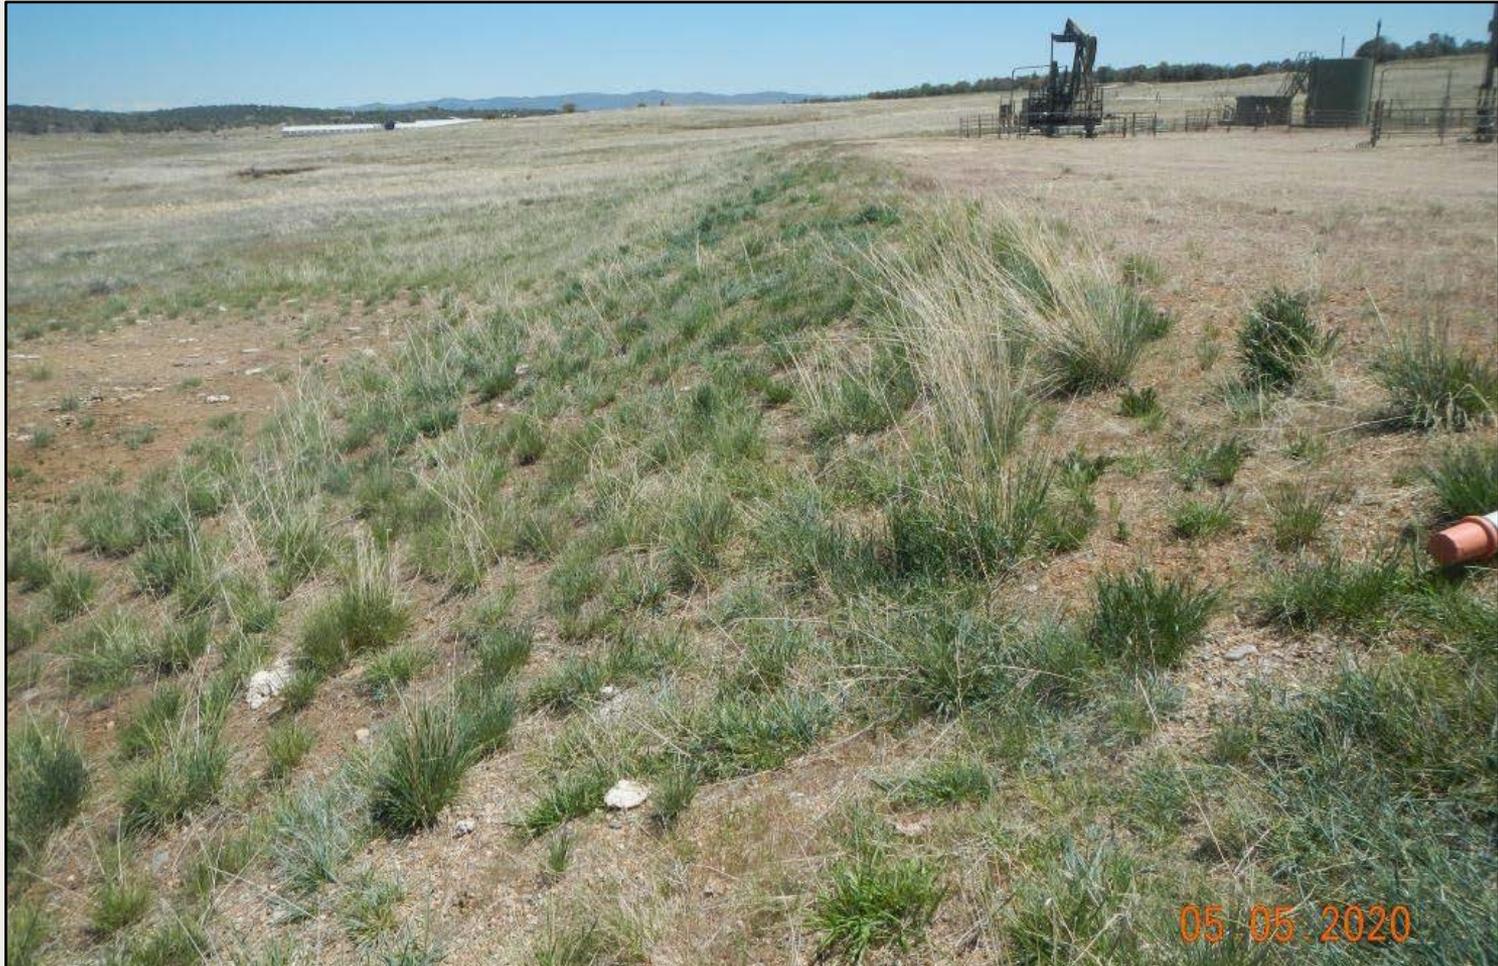
Photo 2. View of the northern fill slope from the northwestern corner facing eastward. Revegetation is progressing with western wheatgrass, crested wheatgrass, and intermediate wheatgrass.

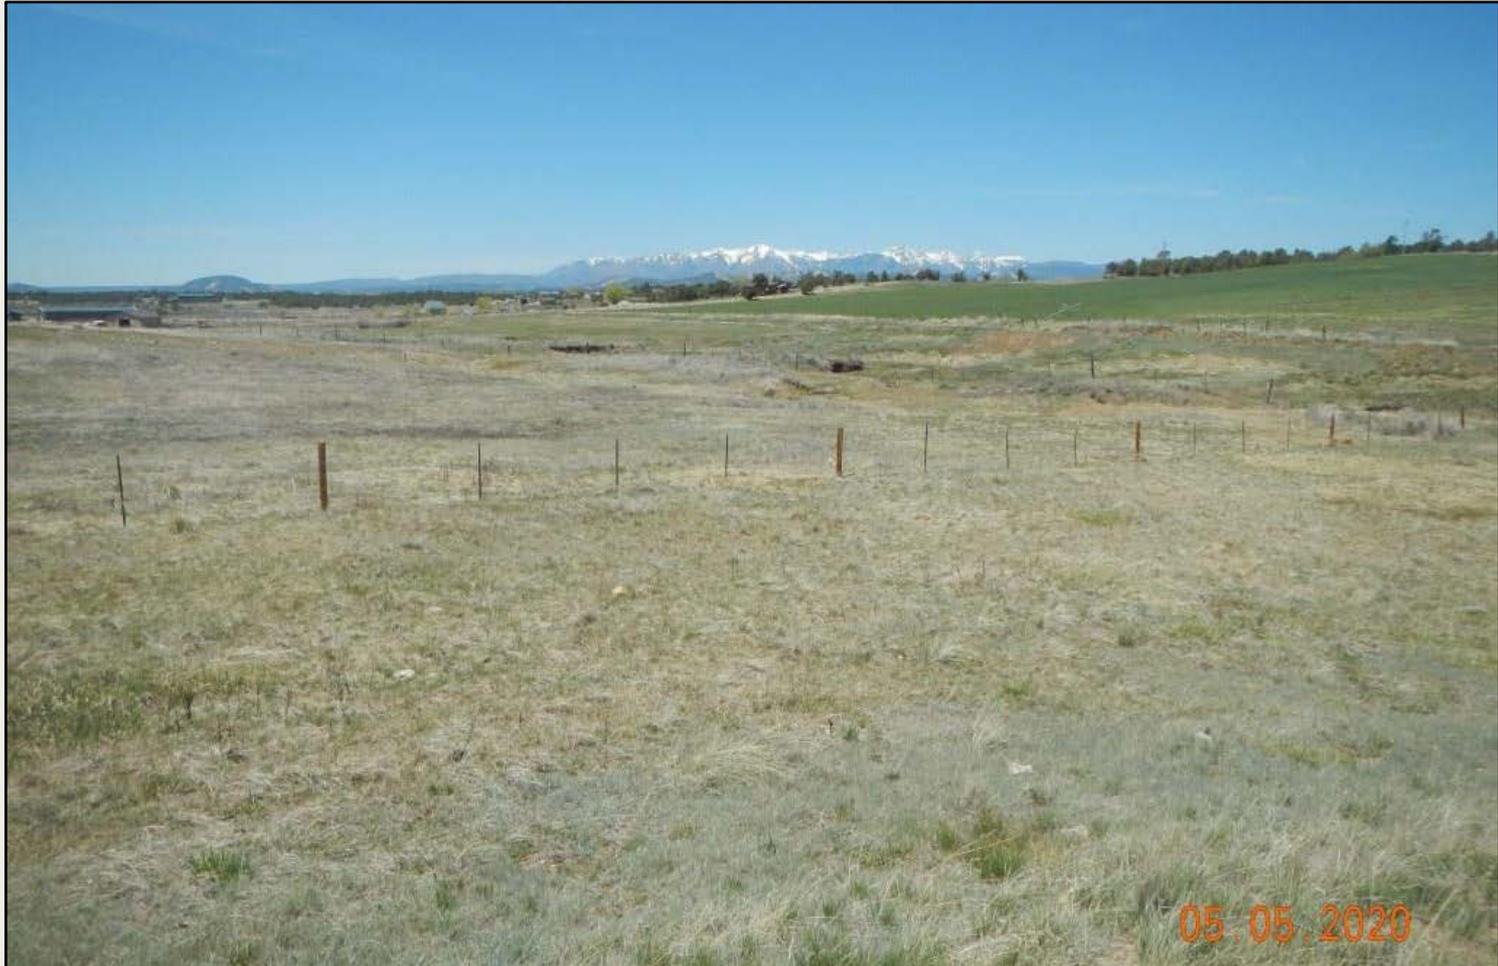
Photo 5. View of reference area comprised of mixed grasses such as smooth brome and western wheatgrass.
