# Inspection Photos

API: 041-06067

Operator: ULTRA RESOURCES INC

Inspection Date: 5/13/2020

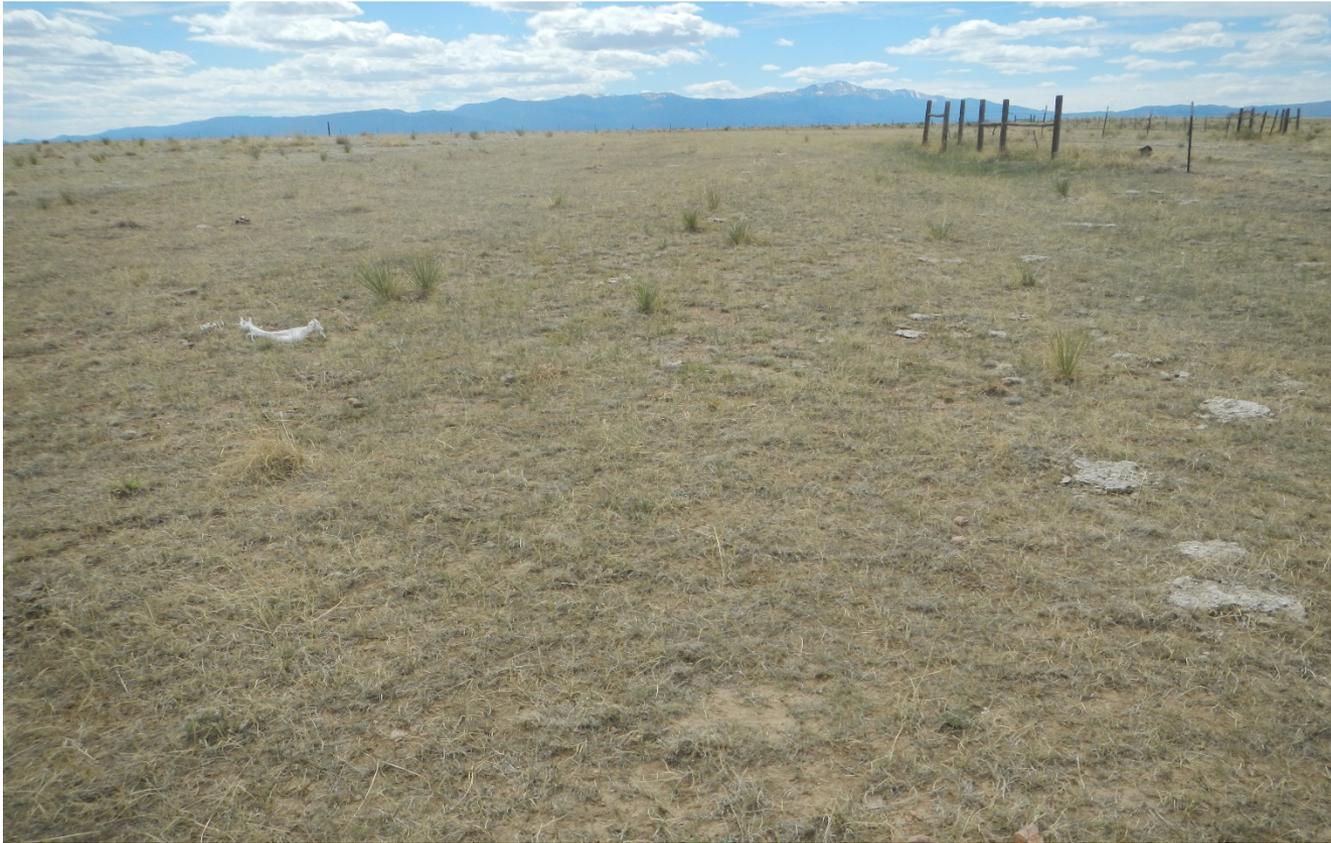
**Photo 1.** Facing west toward the reclaimed access road. The vegetation has uniformly established along the reclaimed road.

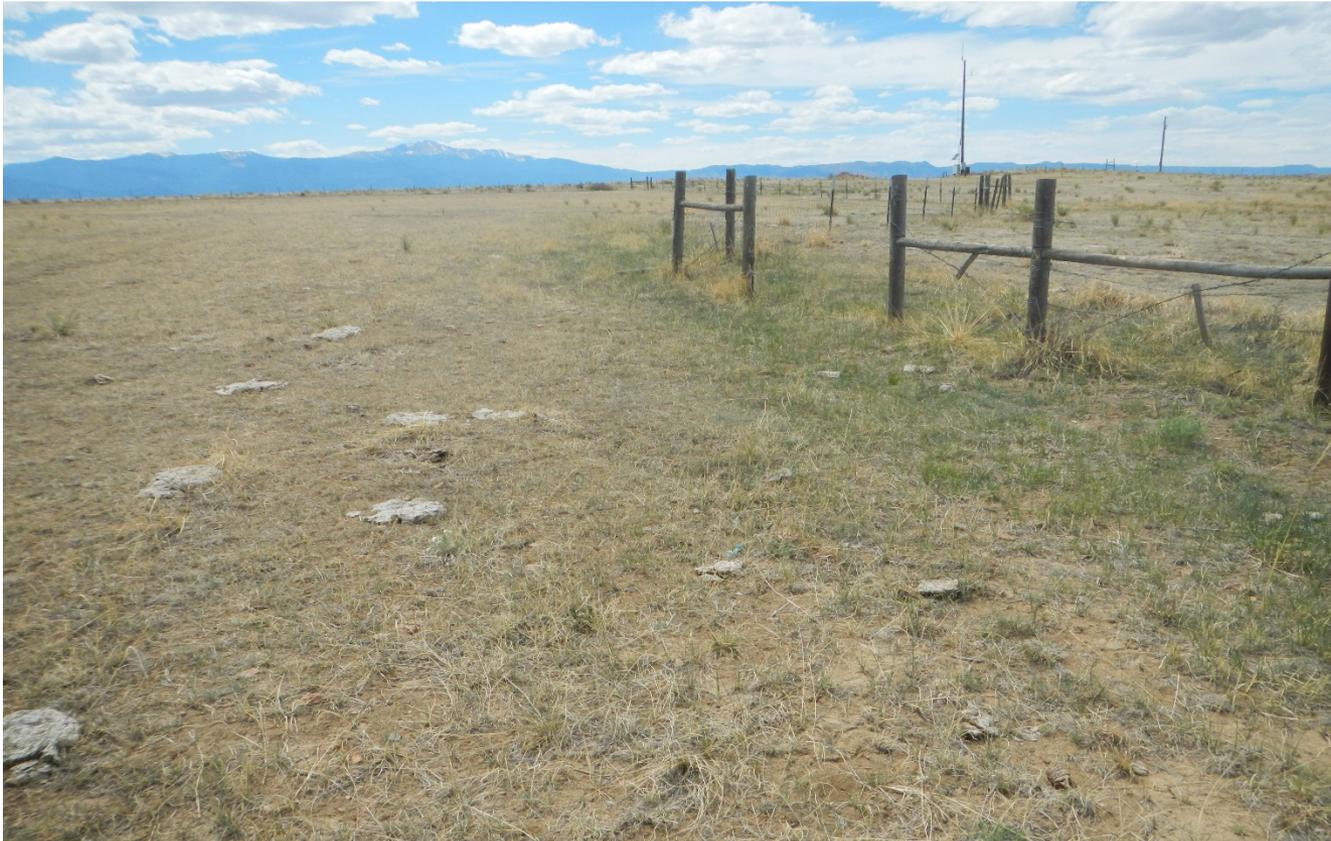
**Photo 2.** The perimeter fence remains around the location and needs to be removed.

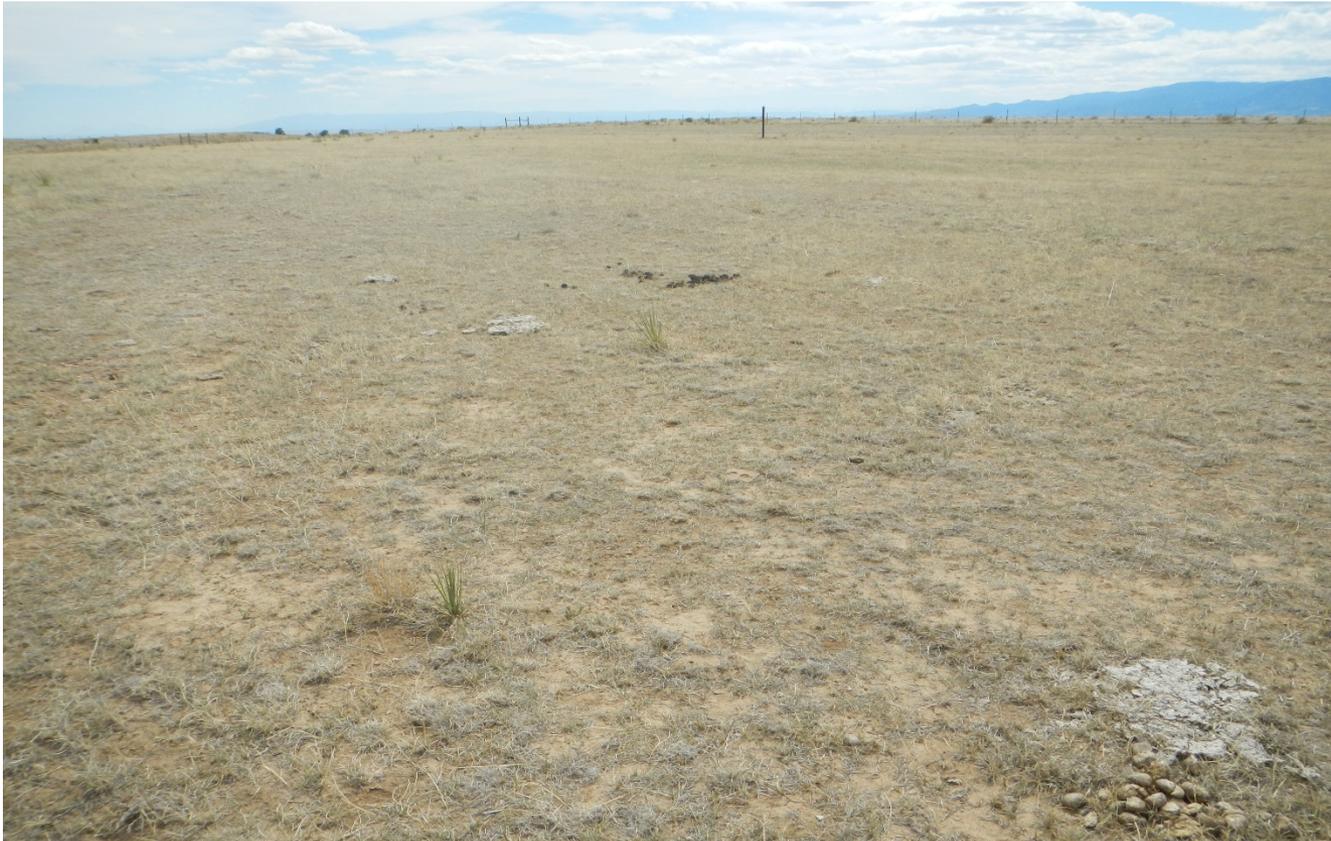
**Photo 3.** Facing southwest toward the location. The vegetation has uniformly established throughout the location.

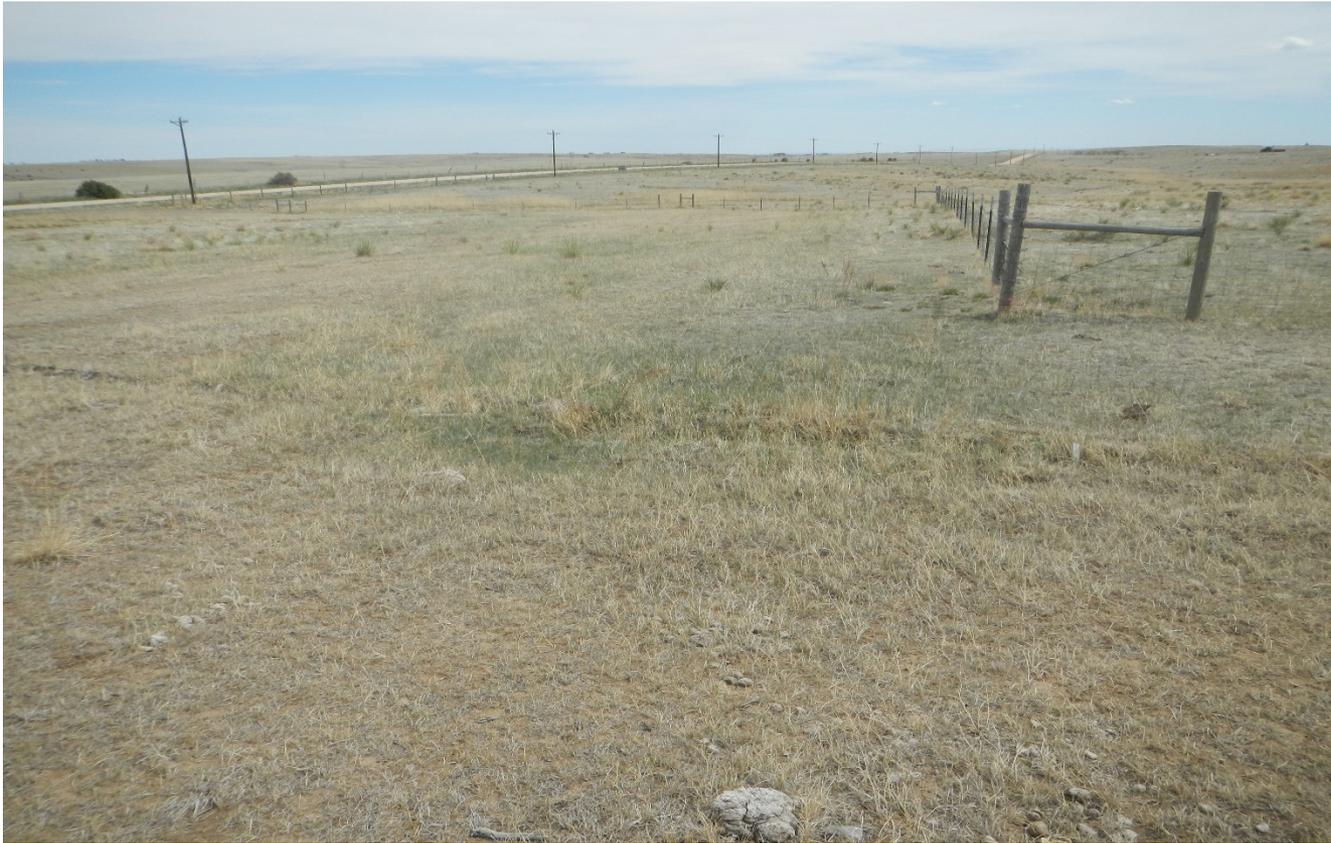
**Photo 4.** Facing south at the location. The perimeter fence remains around the location.

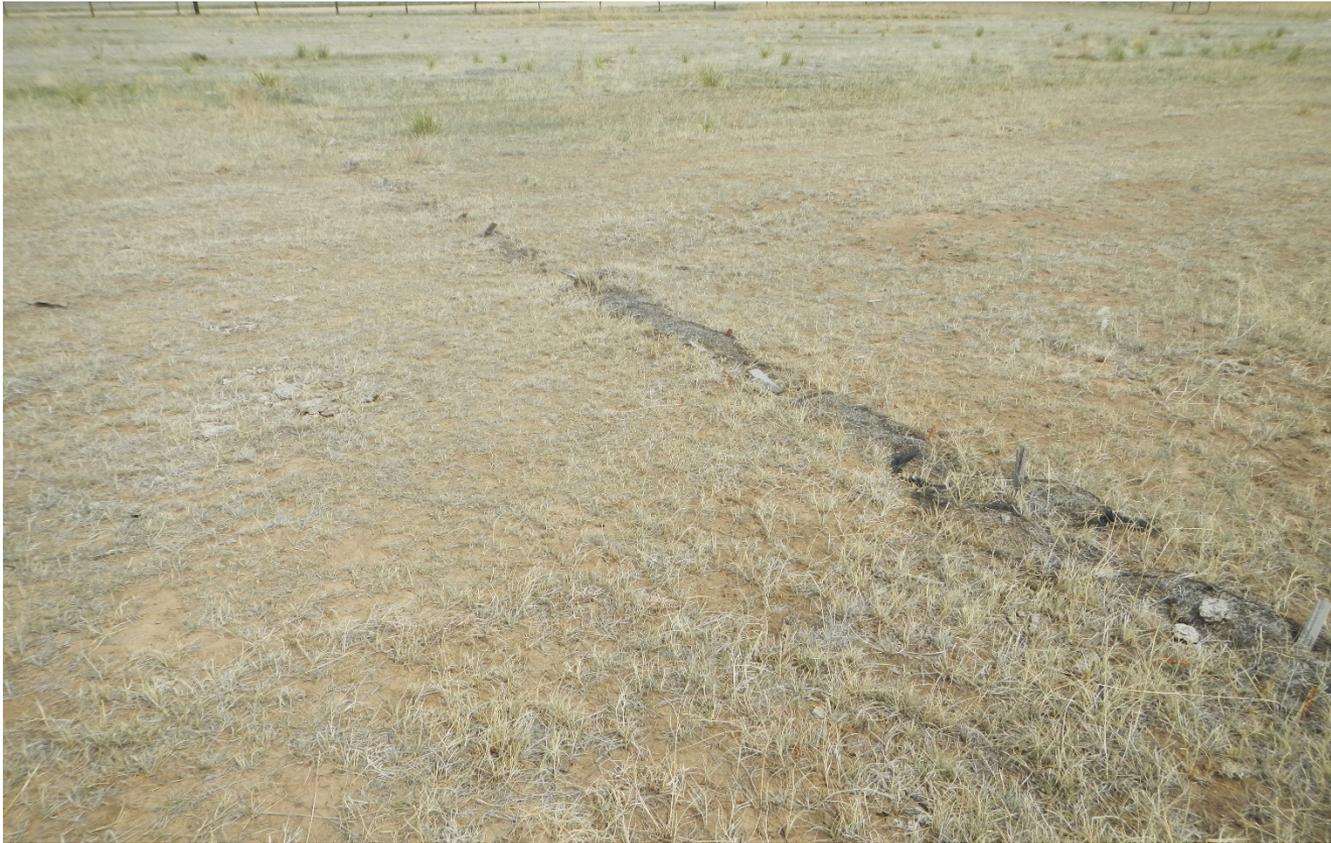
**Photo 5.** The degraded wattles remain at the location. The plastic netting and stakes need to be removed.

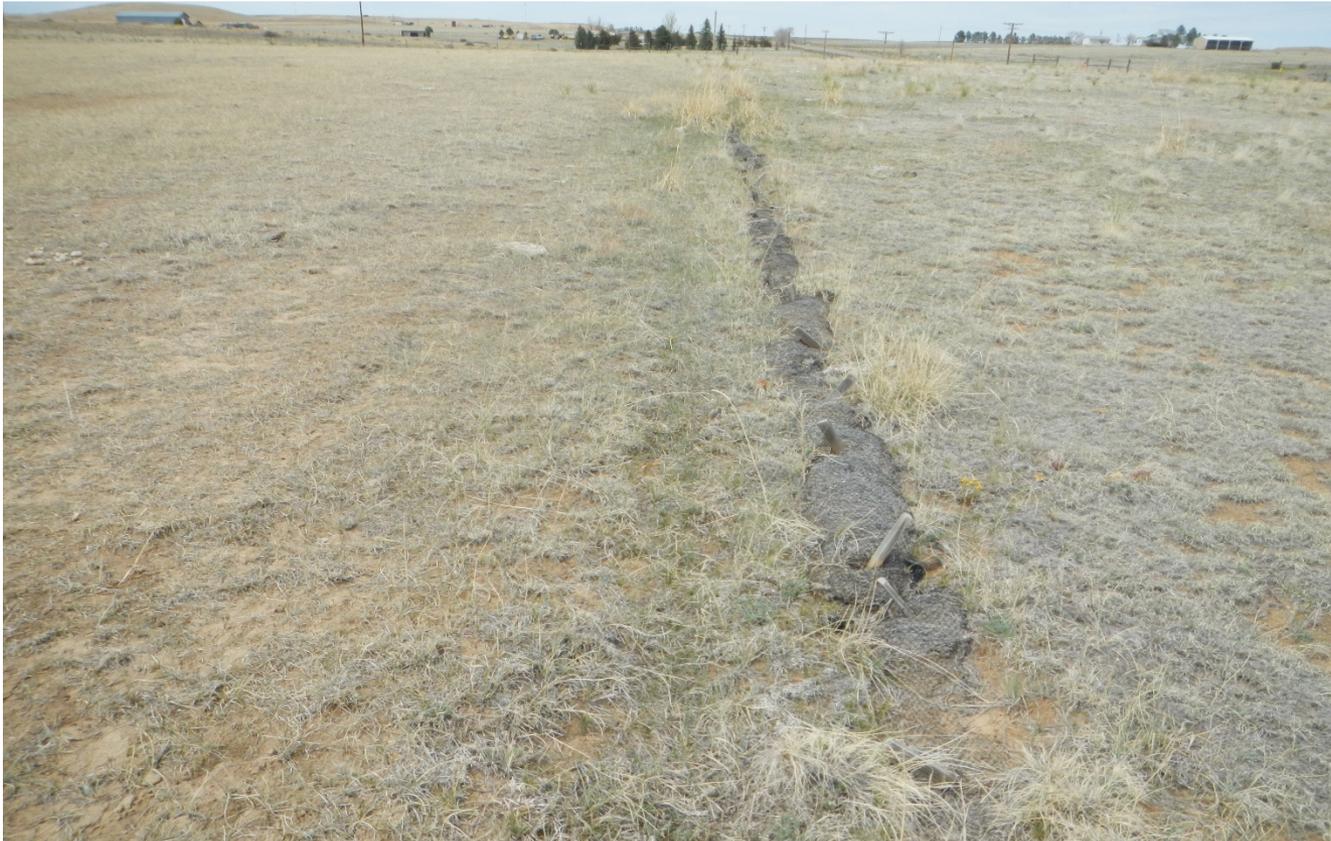
**Photo 6.** The degraded wattles remain at the location. The plastic netting and stakes need to be removed.

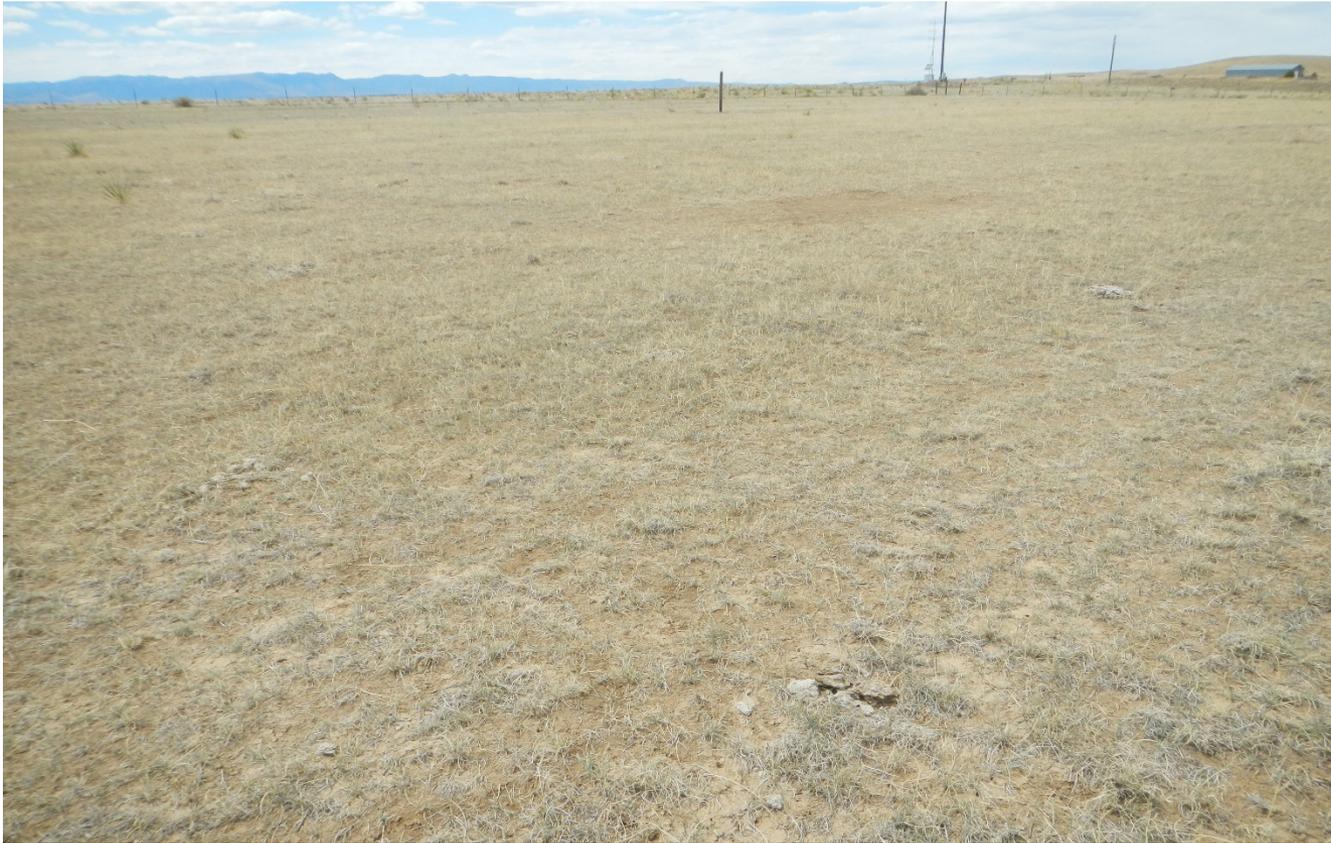
**Photo 7.** Facing northwest toward the location. The vegetation has uniformly established throughout the location.
