COLORADO
Oil & Gas Conservation
Commission
Department of Natural Resources

McSullivan NCT-1 #1

API: 05-103-09258

Inspection: 700401481

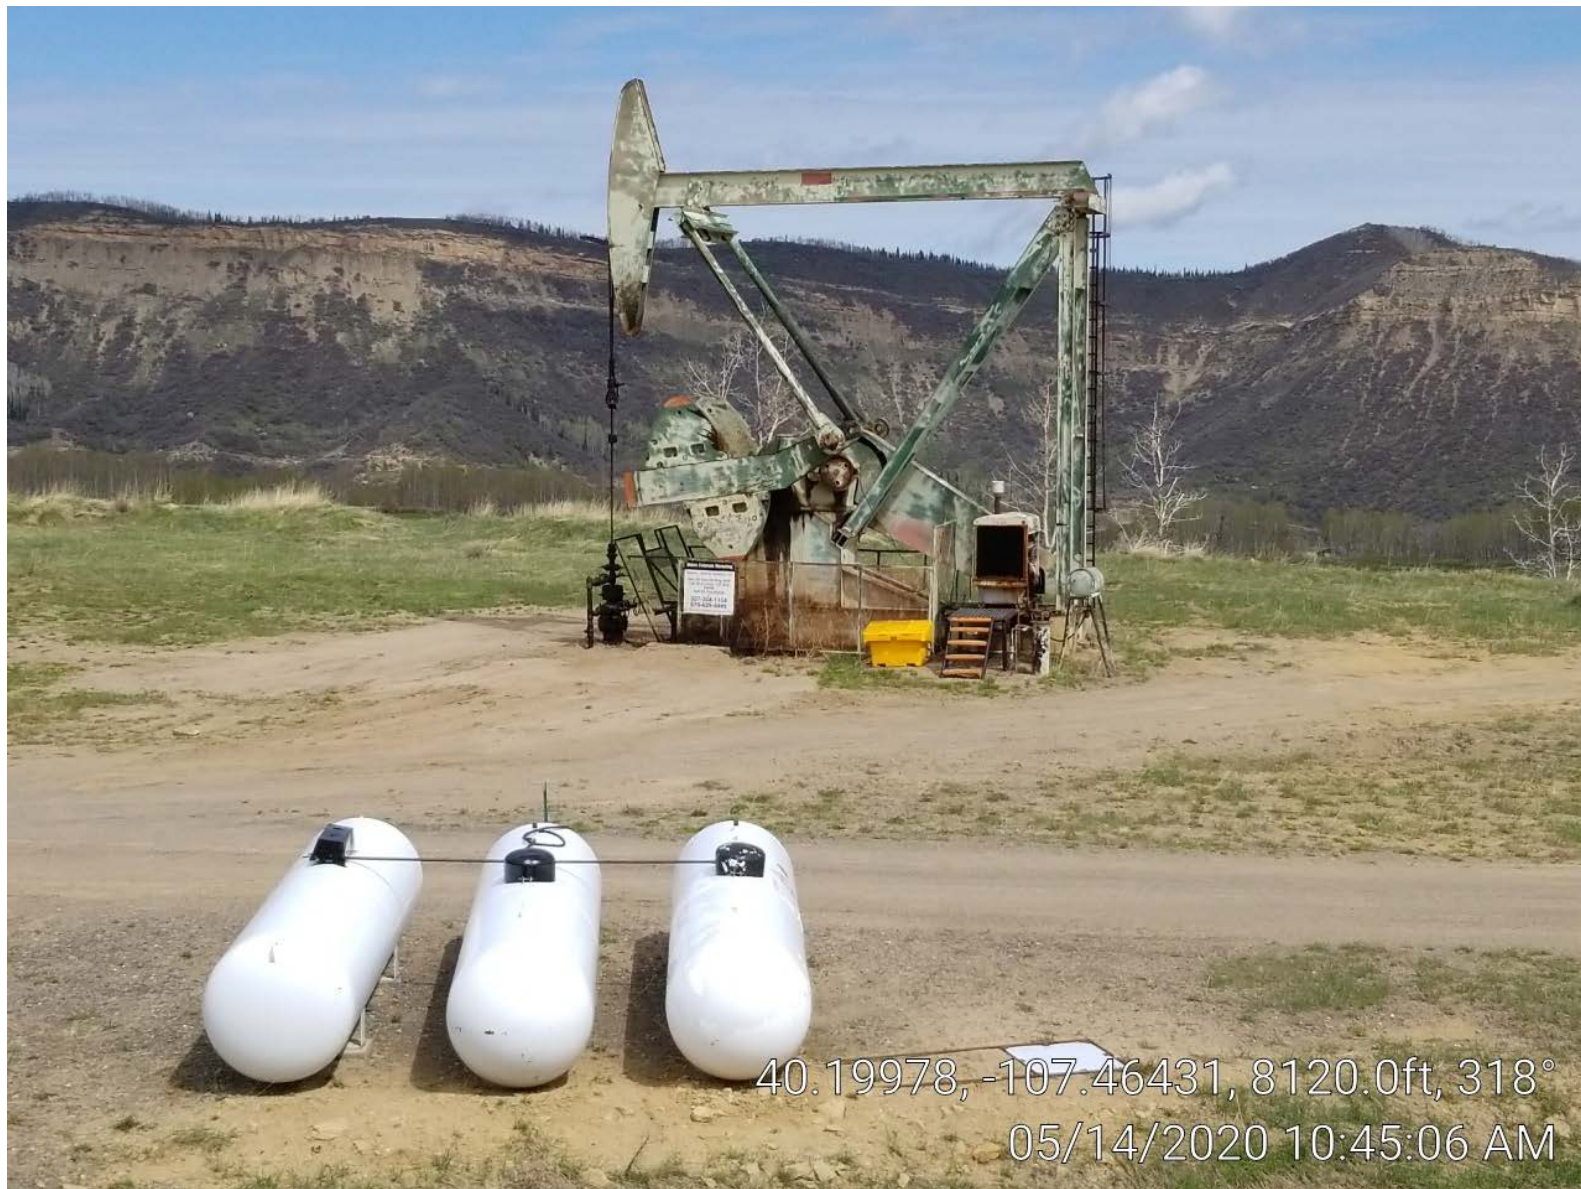
Photo 1. Pump jack & propane tanks.

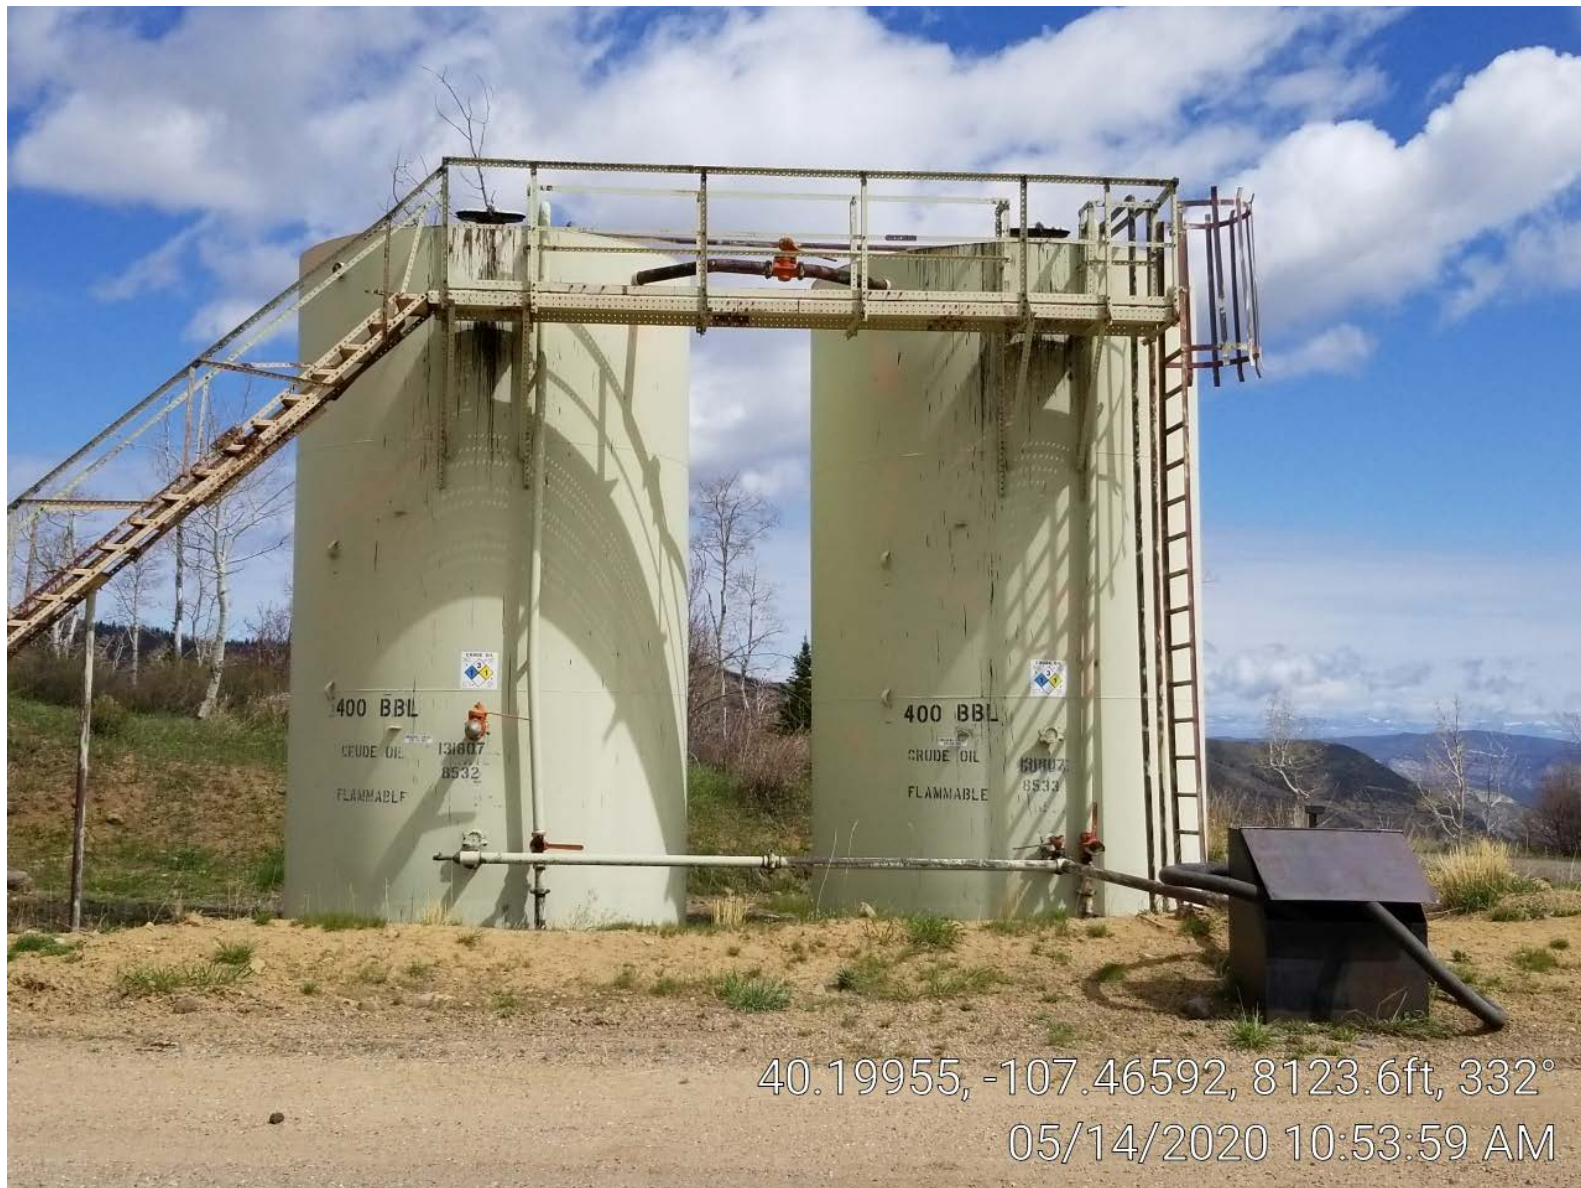
Photo 4. Tanks.

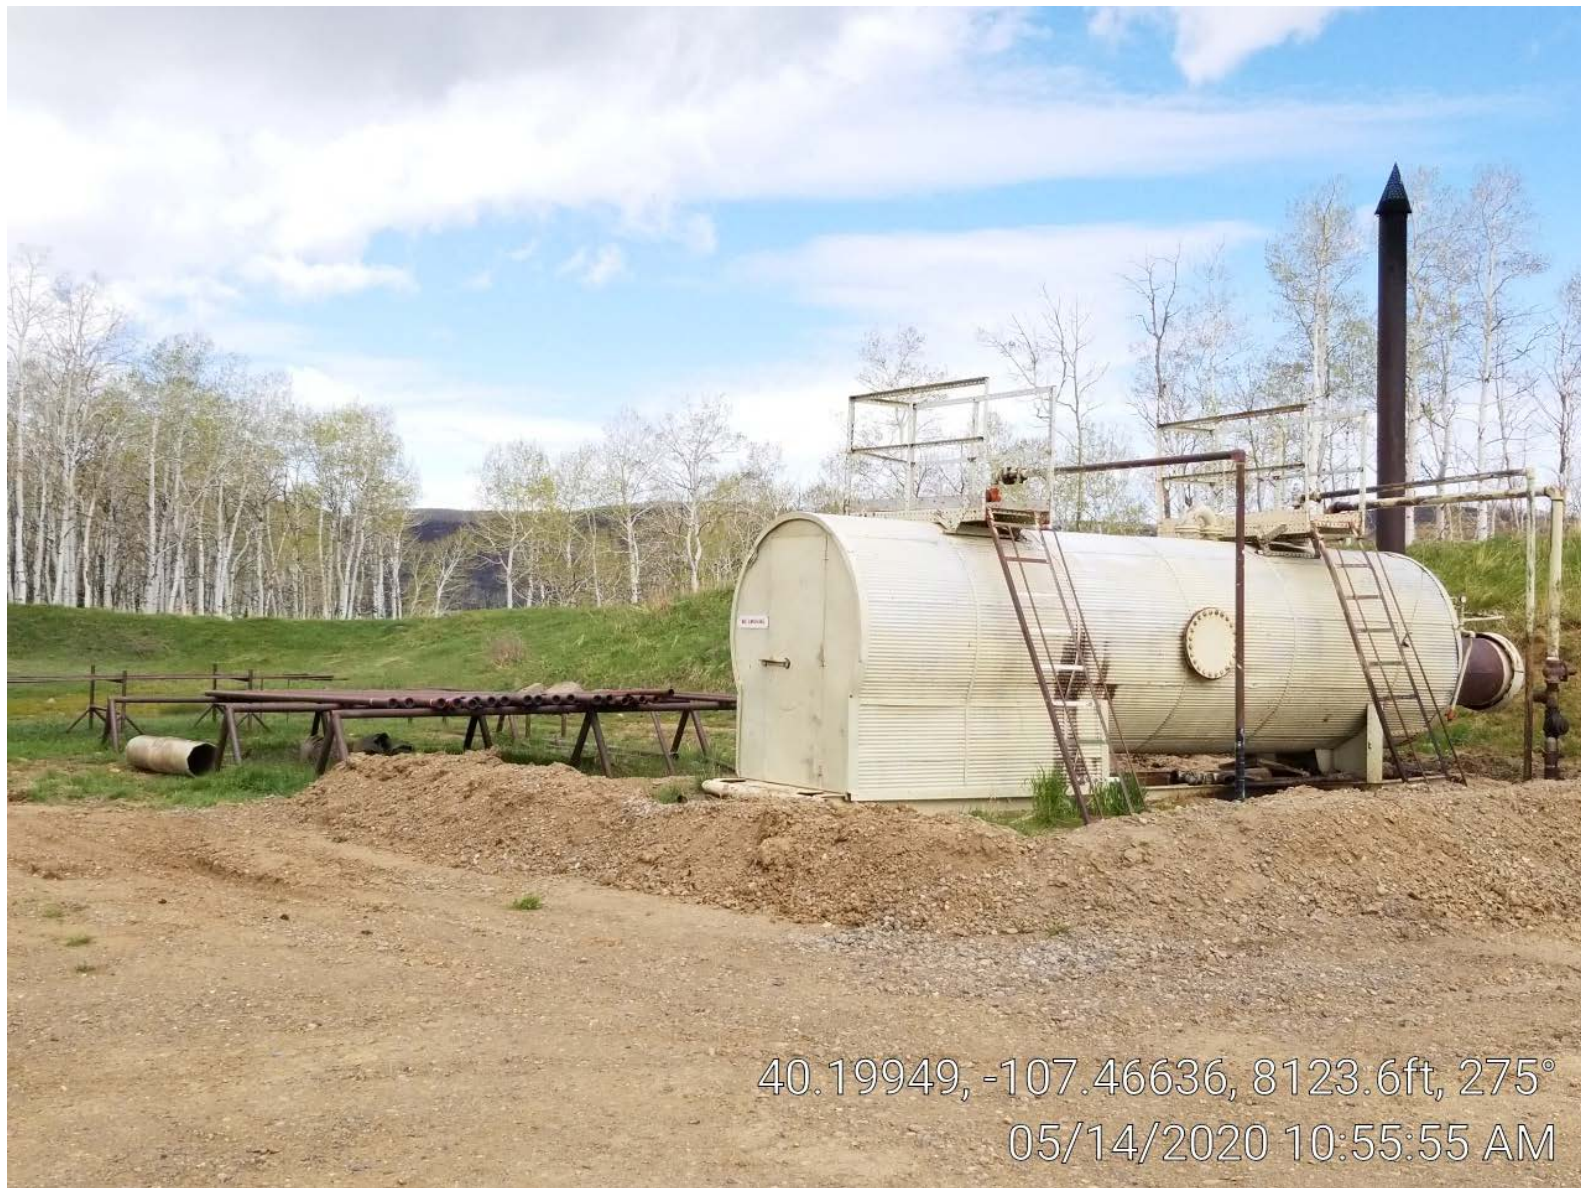
Photo 5. Separator.

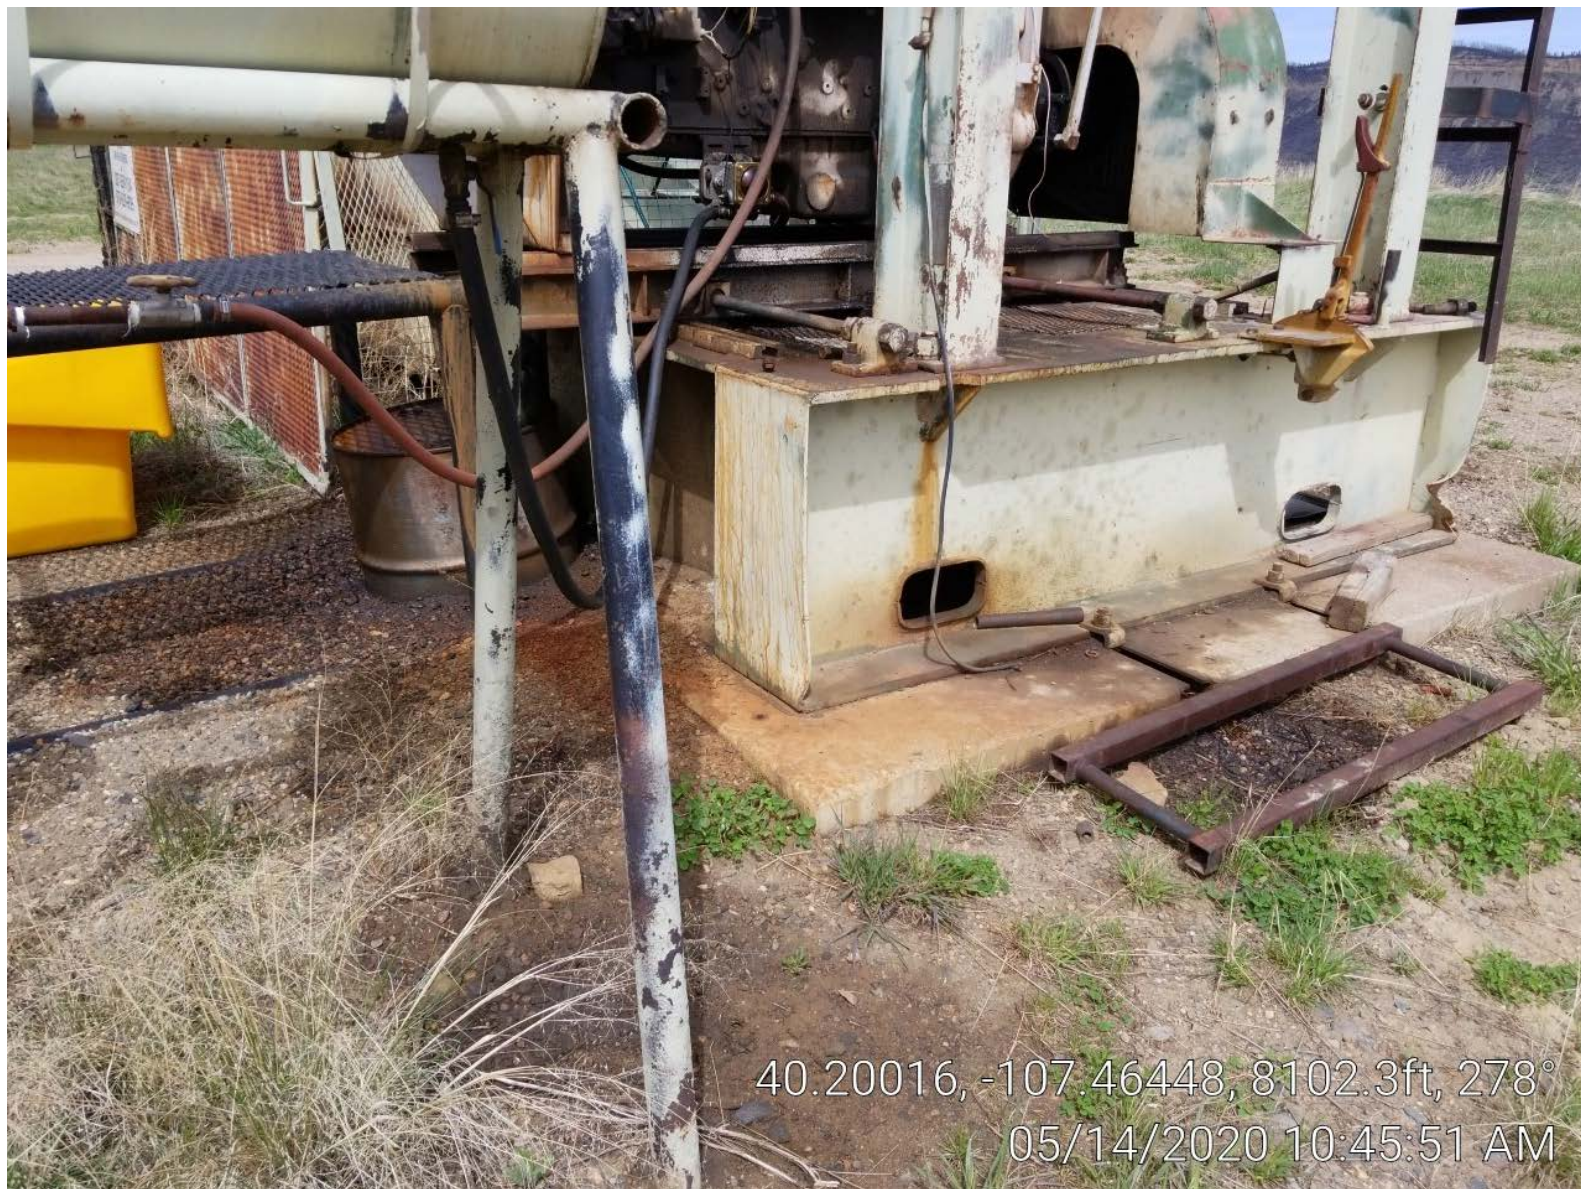
Photo 8. Pump jack at motor end.

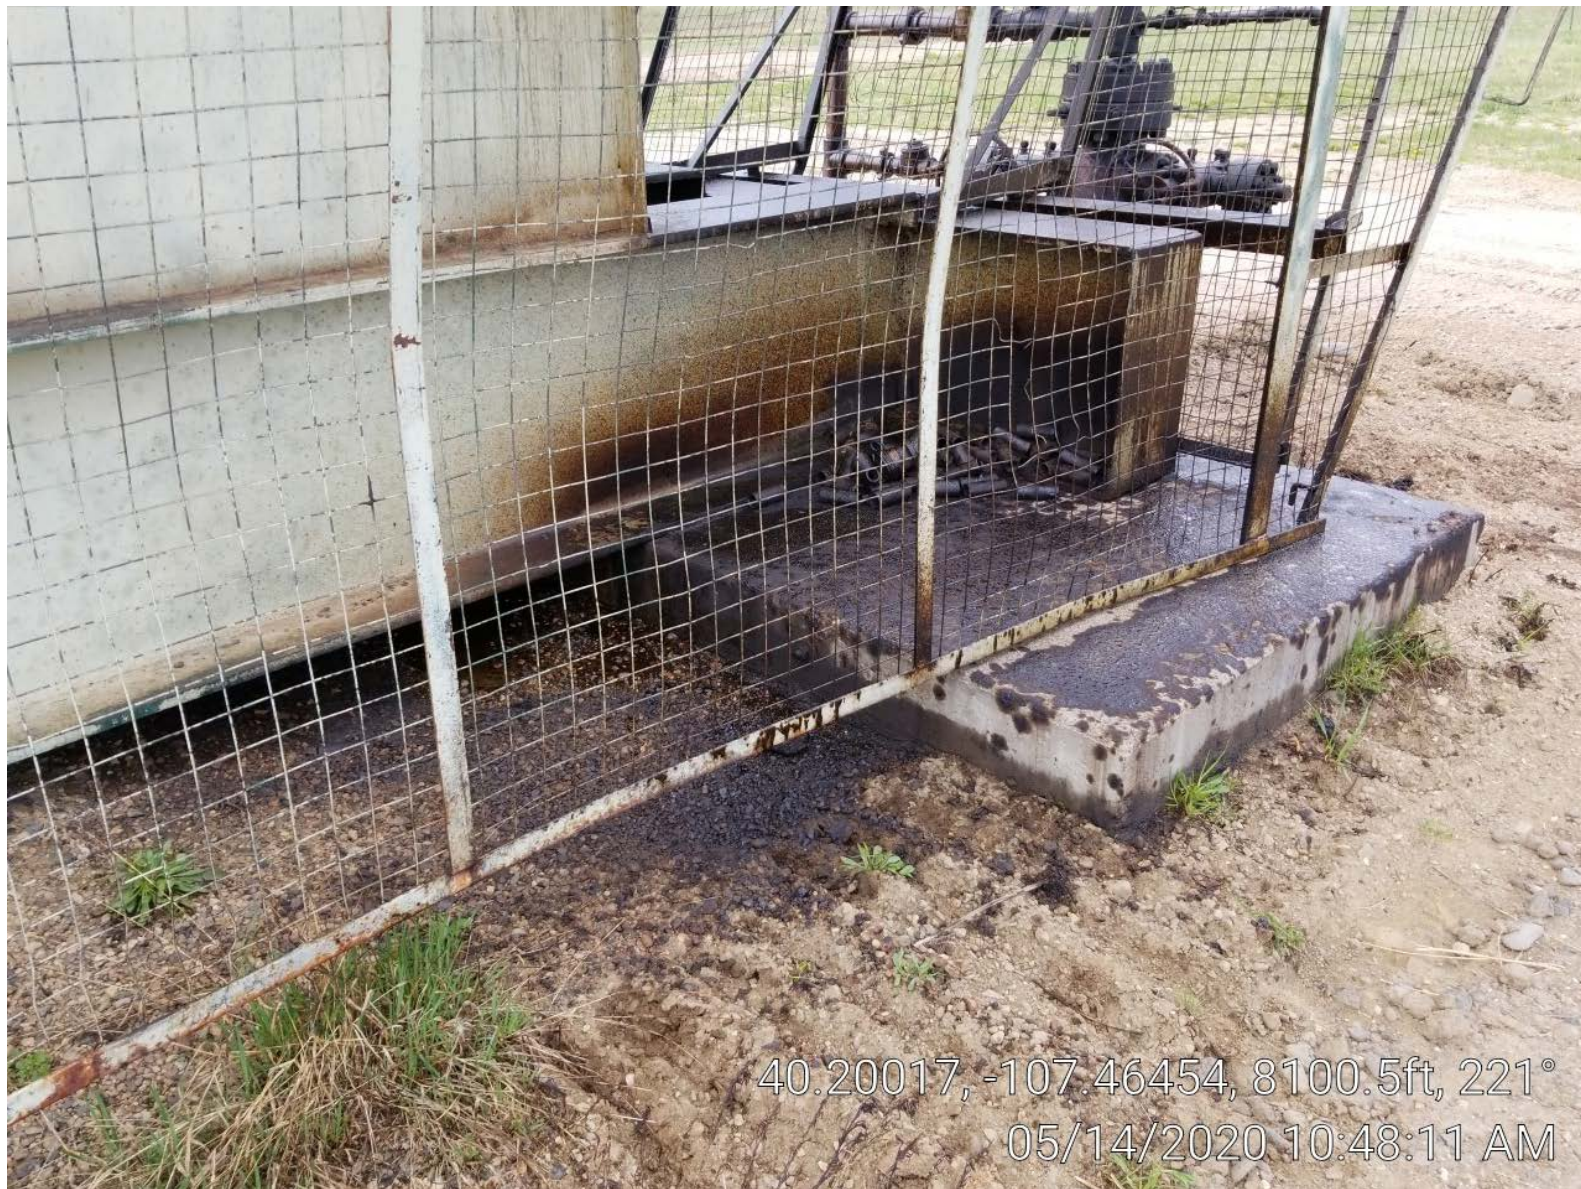
Photo 9. Side of pump jack.

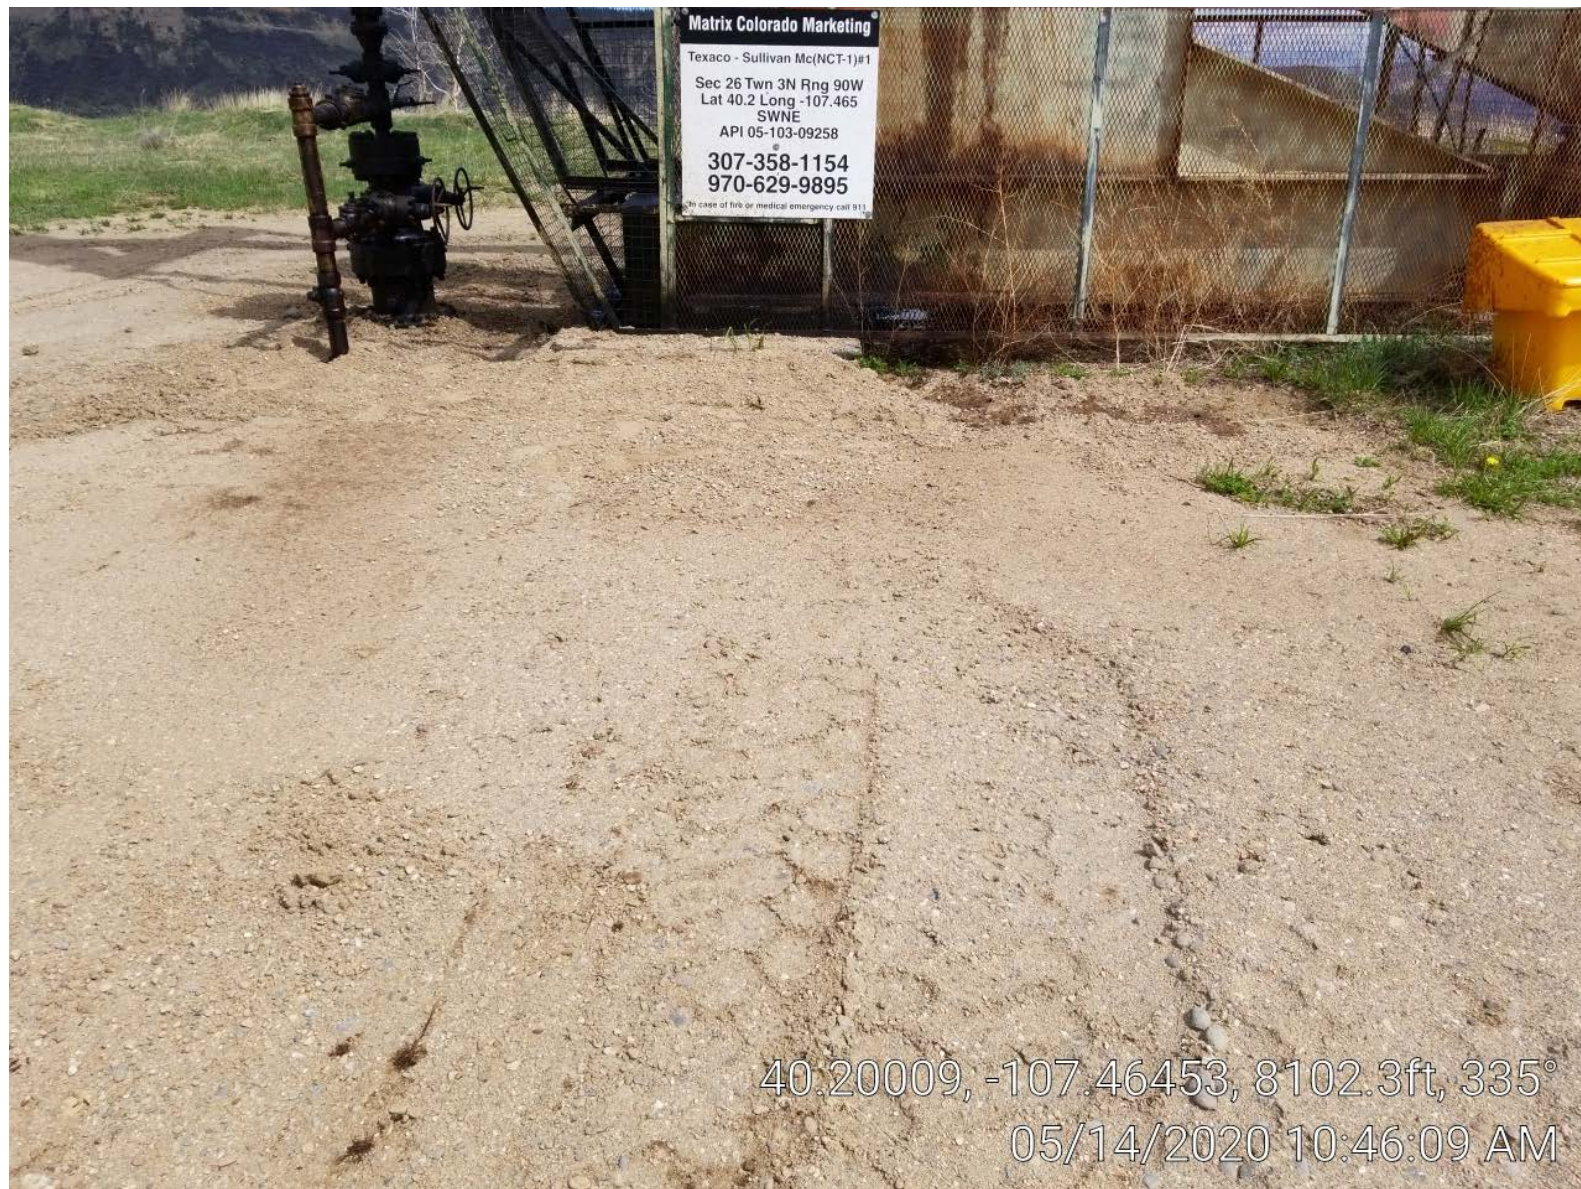
Photo 10. Recent dirt added.

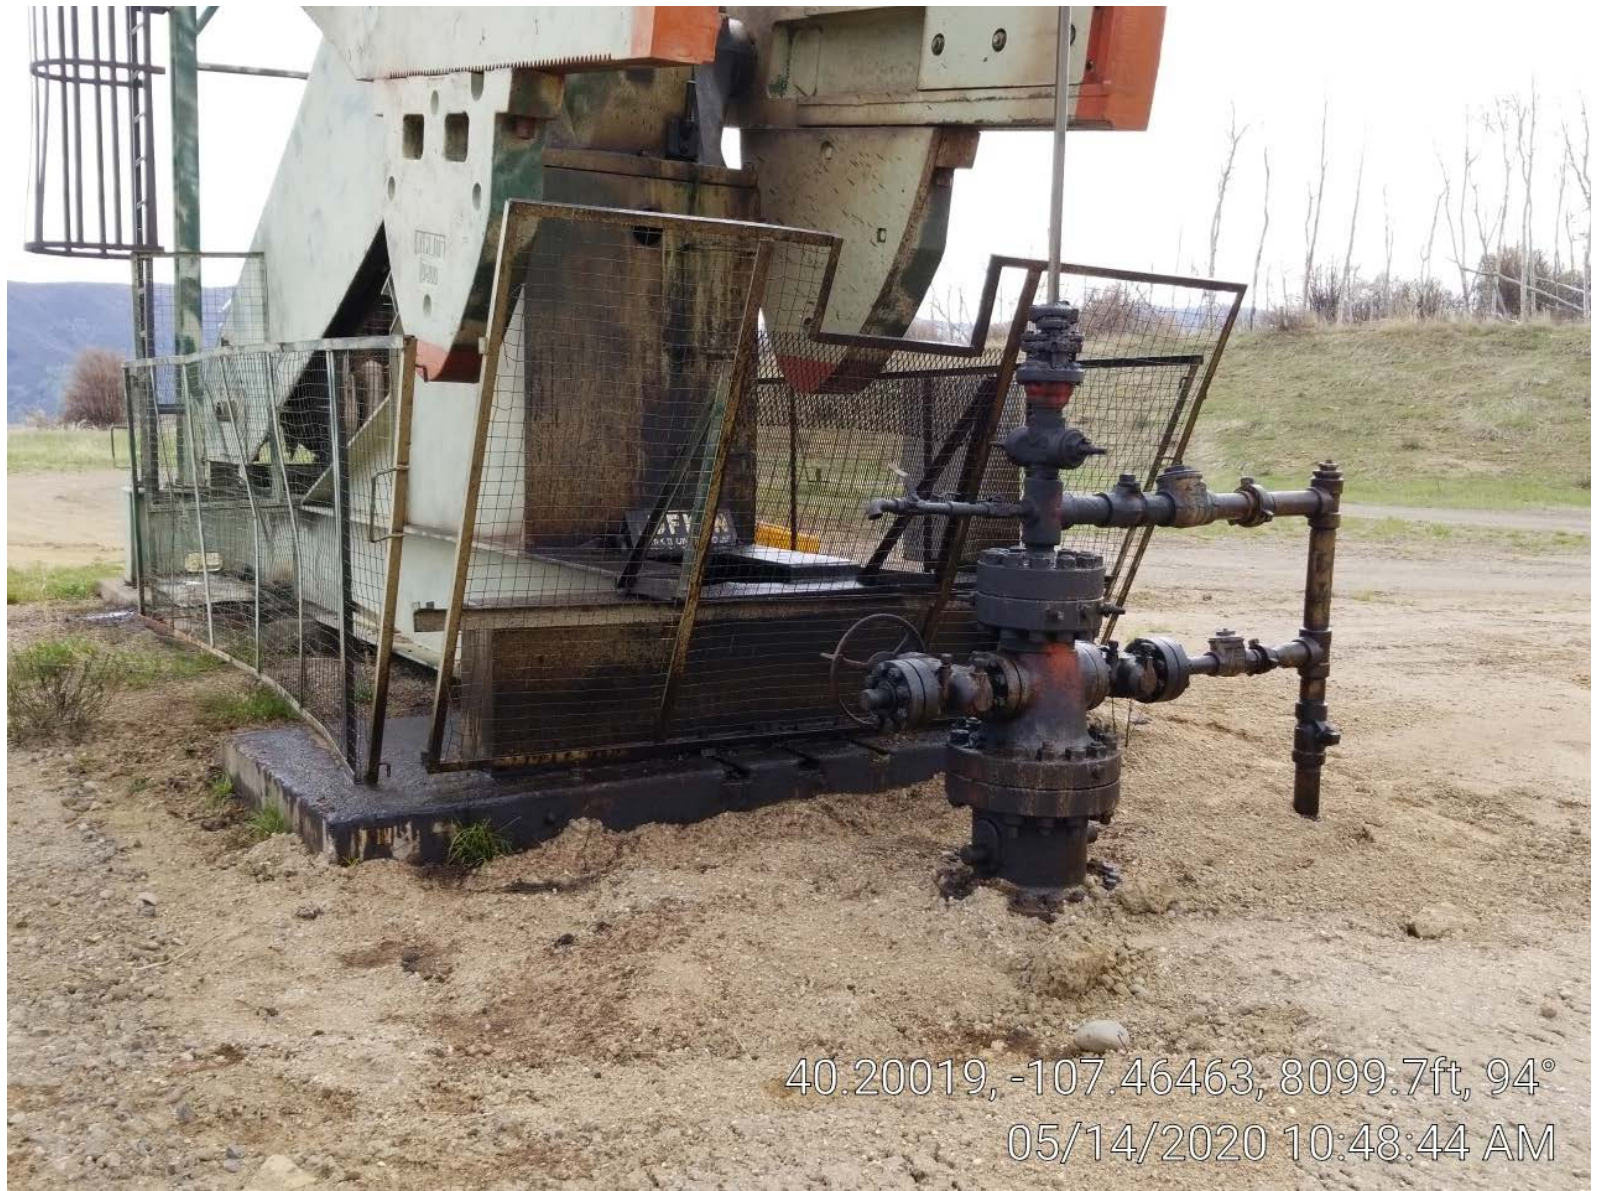
Photo 11. Well head.
