COLORADO
Oil & Gas Conservation
Commission
Department of Natural Resources

Seely Land & Livestock 1 API: 05-103-09250
Inspection: 700401483

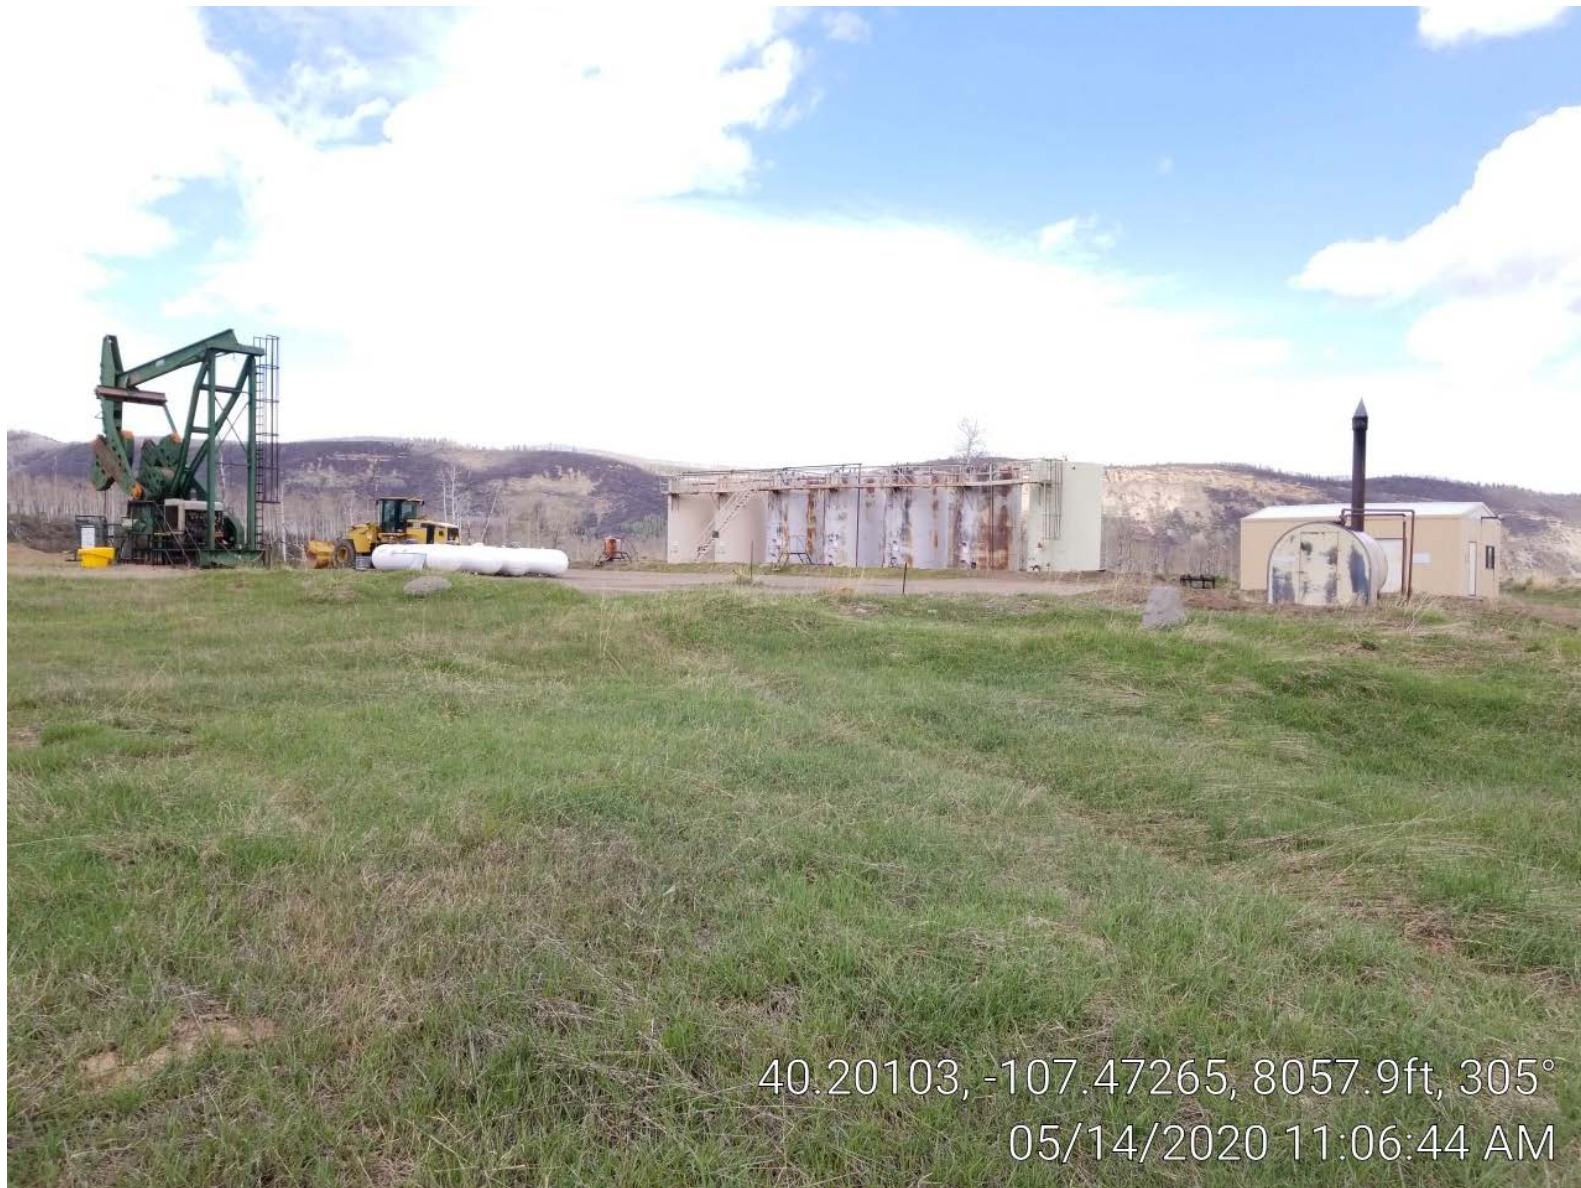
Photo 1. Location.

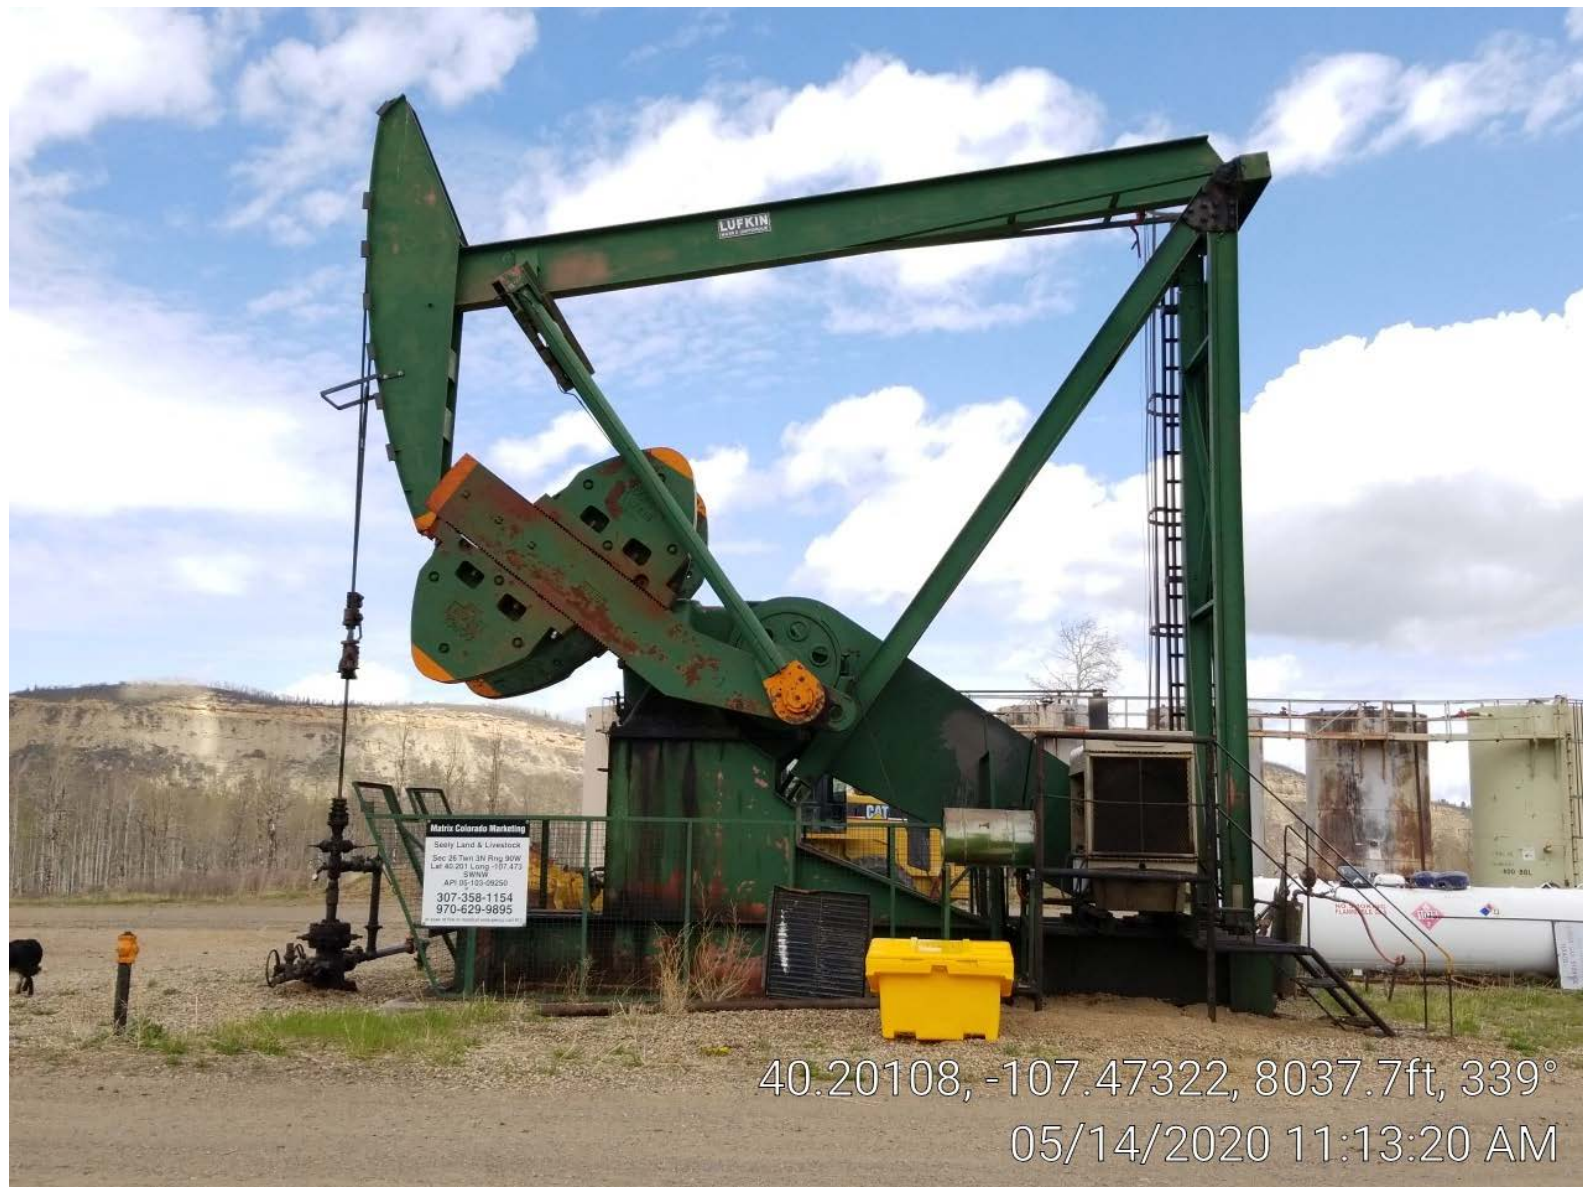
Photo 2. Pump jack.

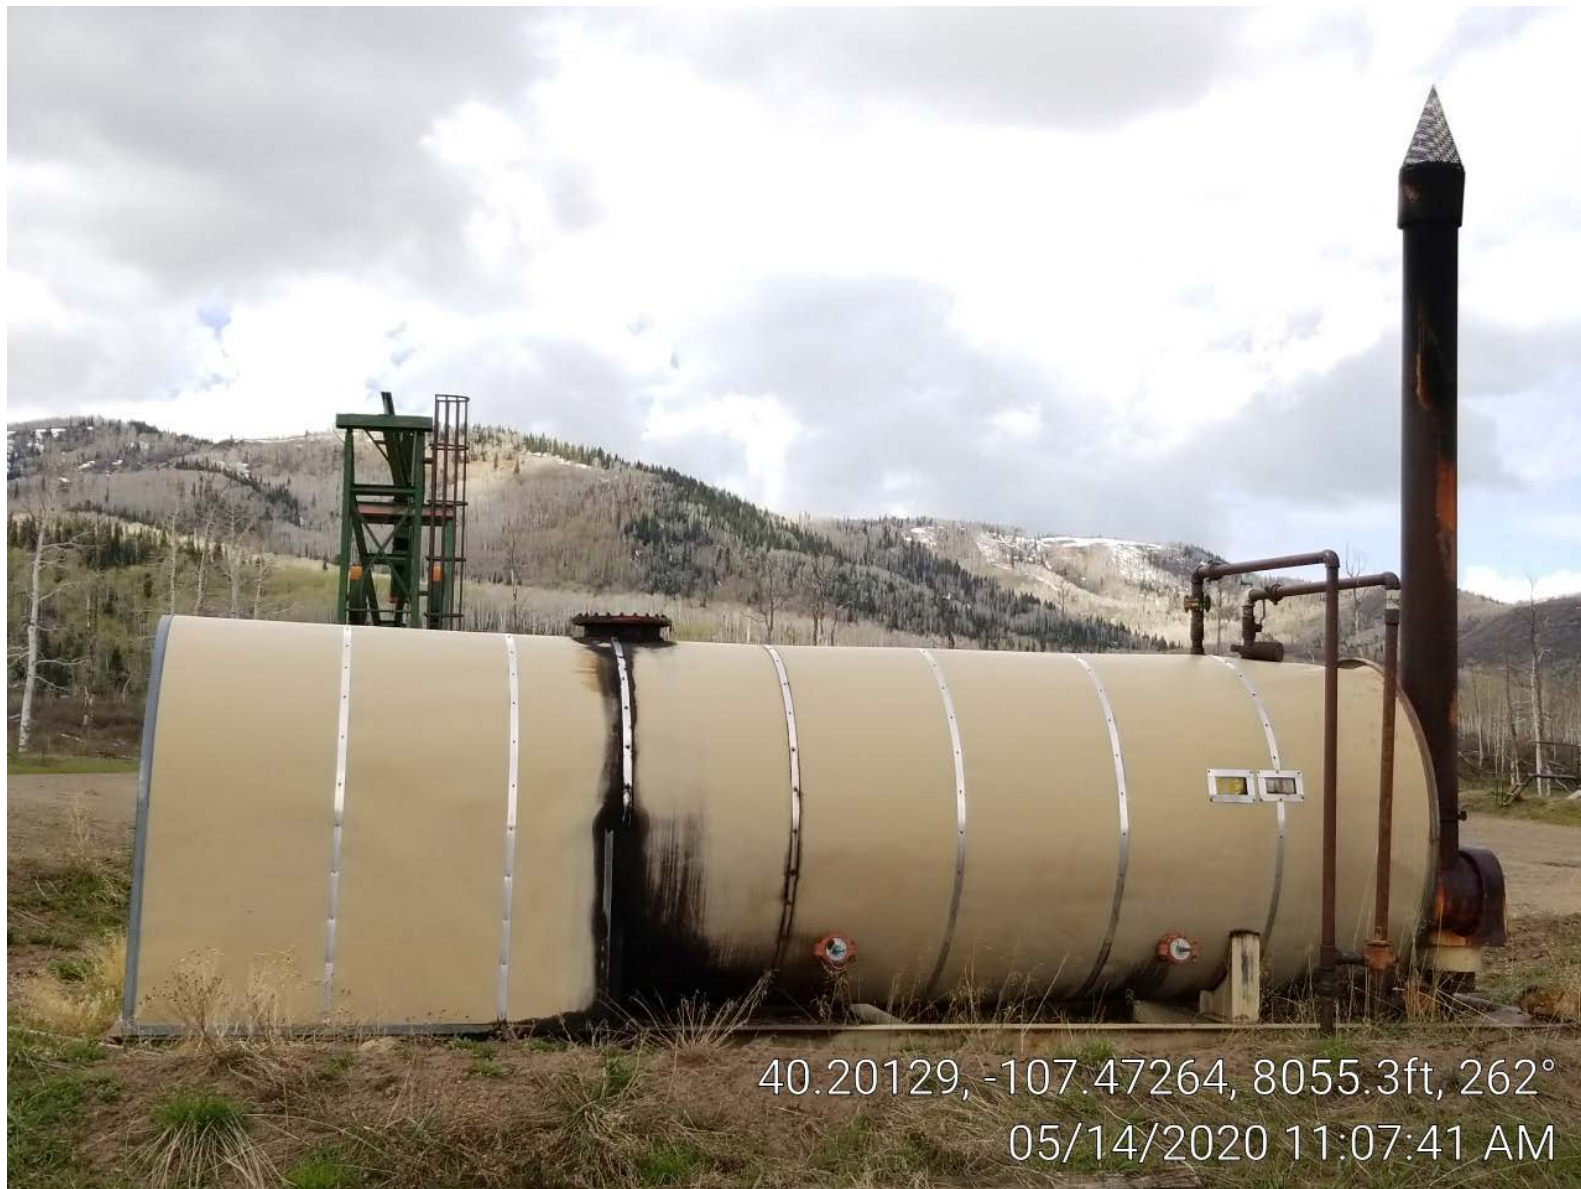
Photo 4. Treater.

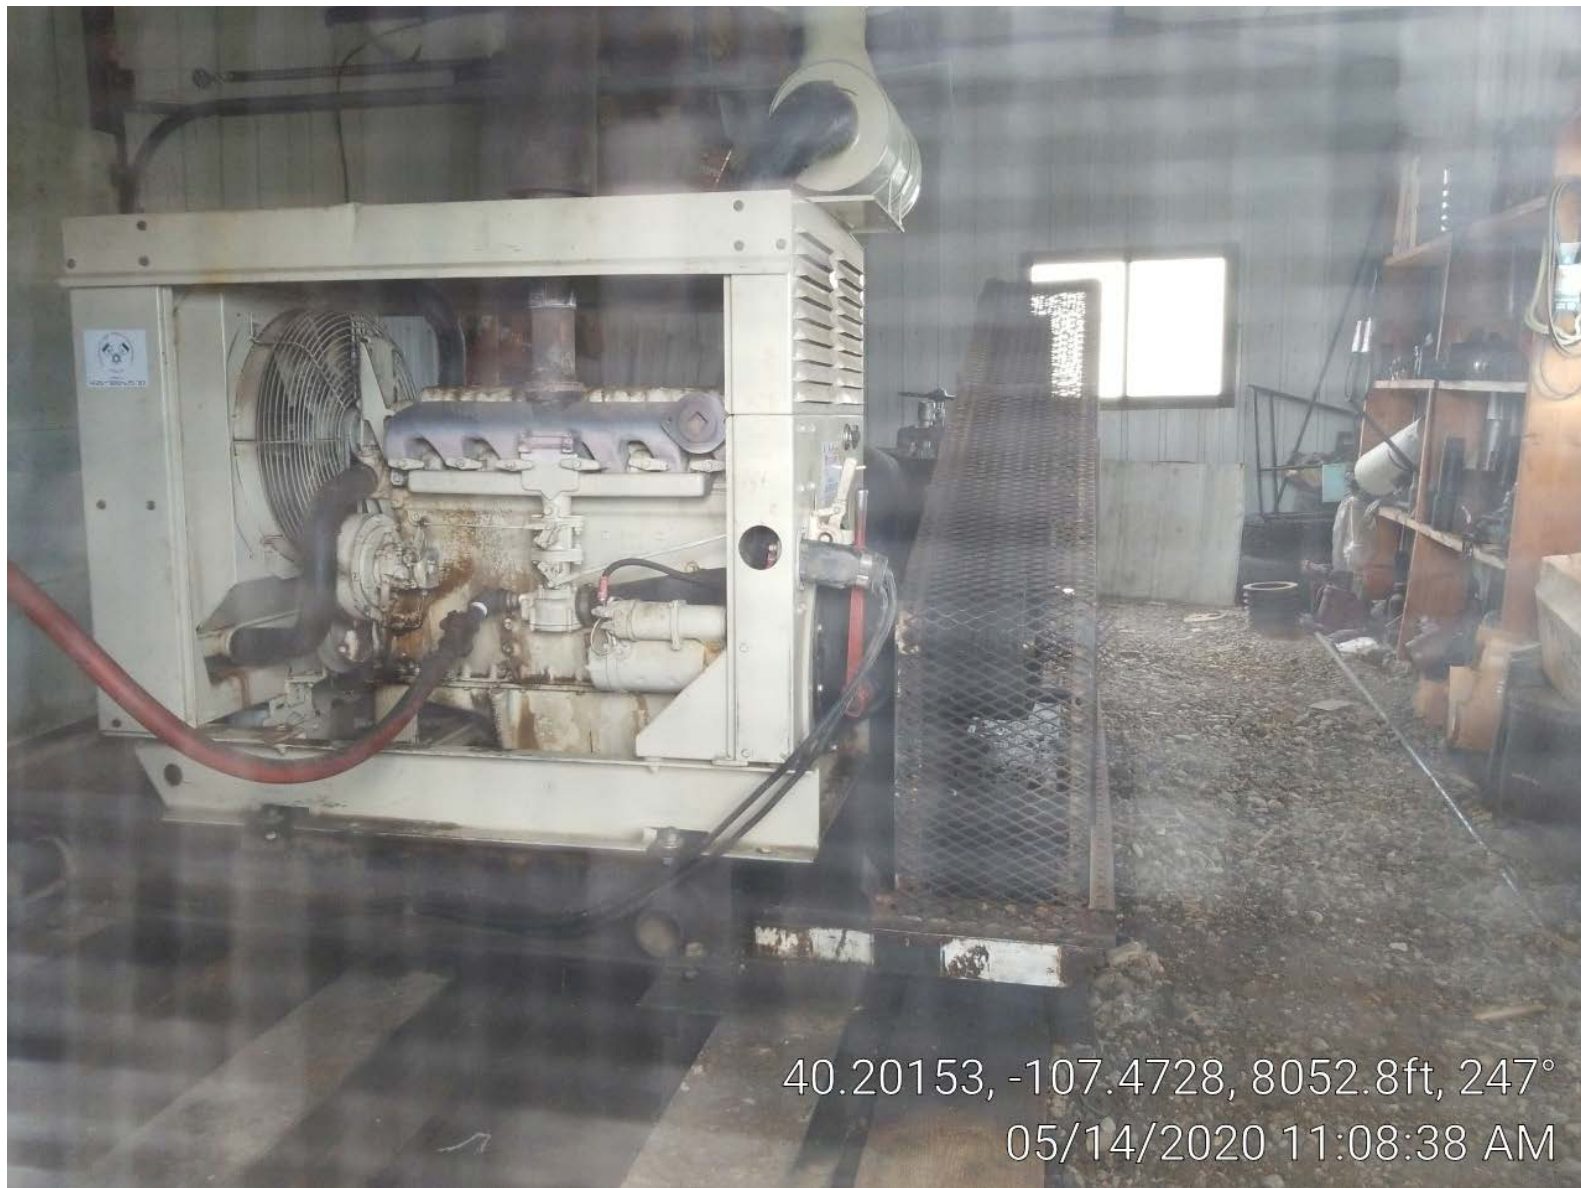
Photo 6. Inside building viewed through window.

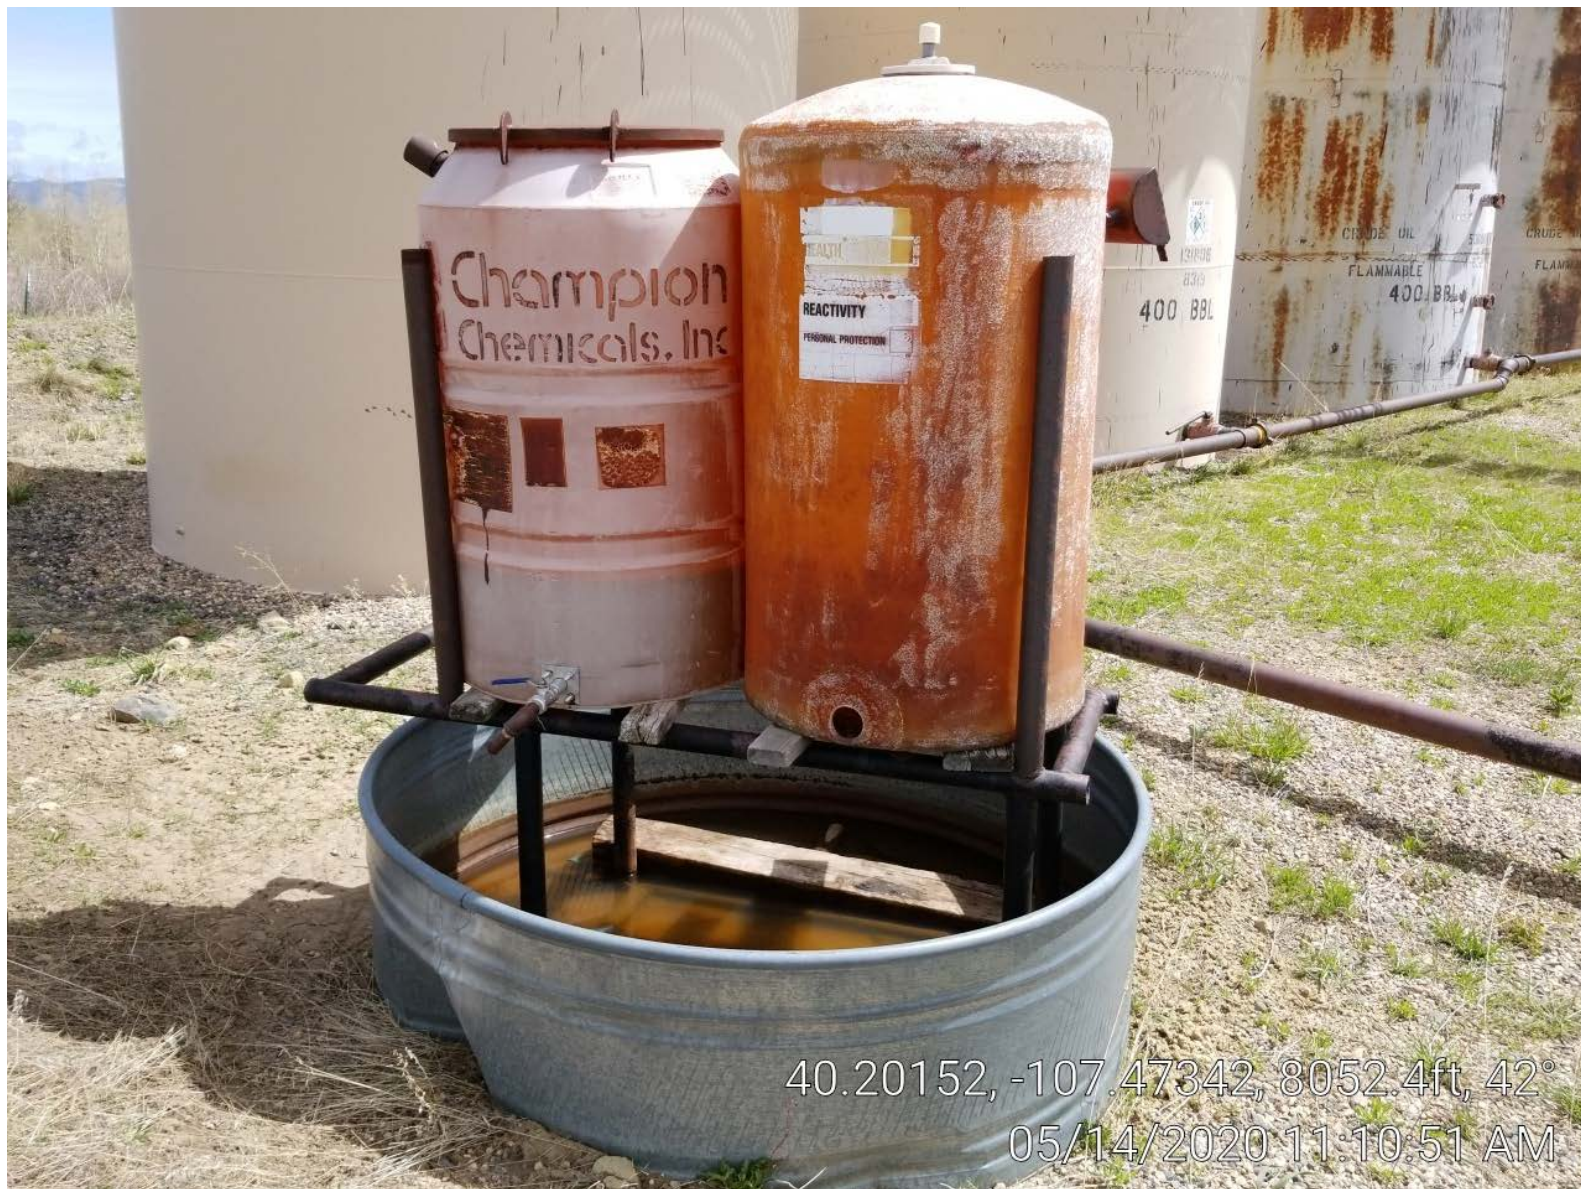
Photo 8. Chemical containers.

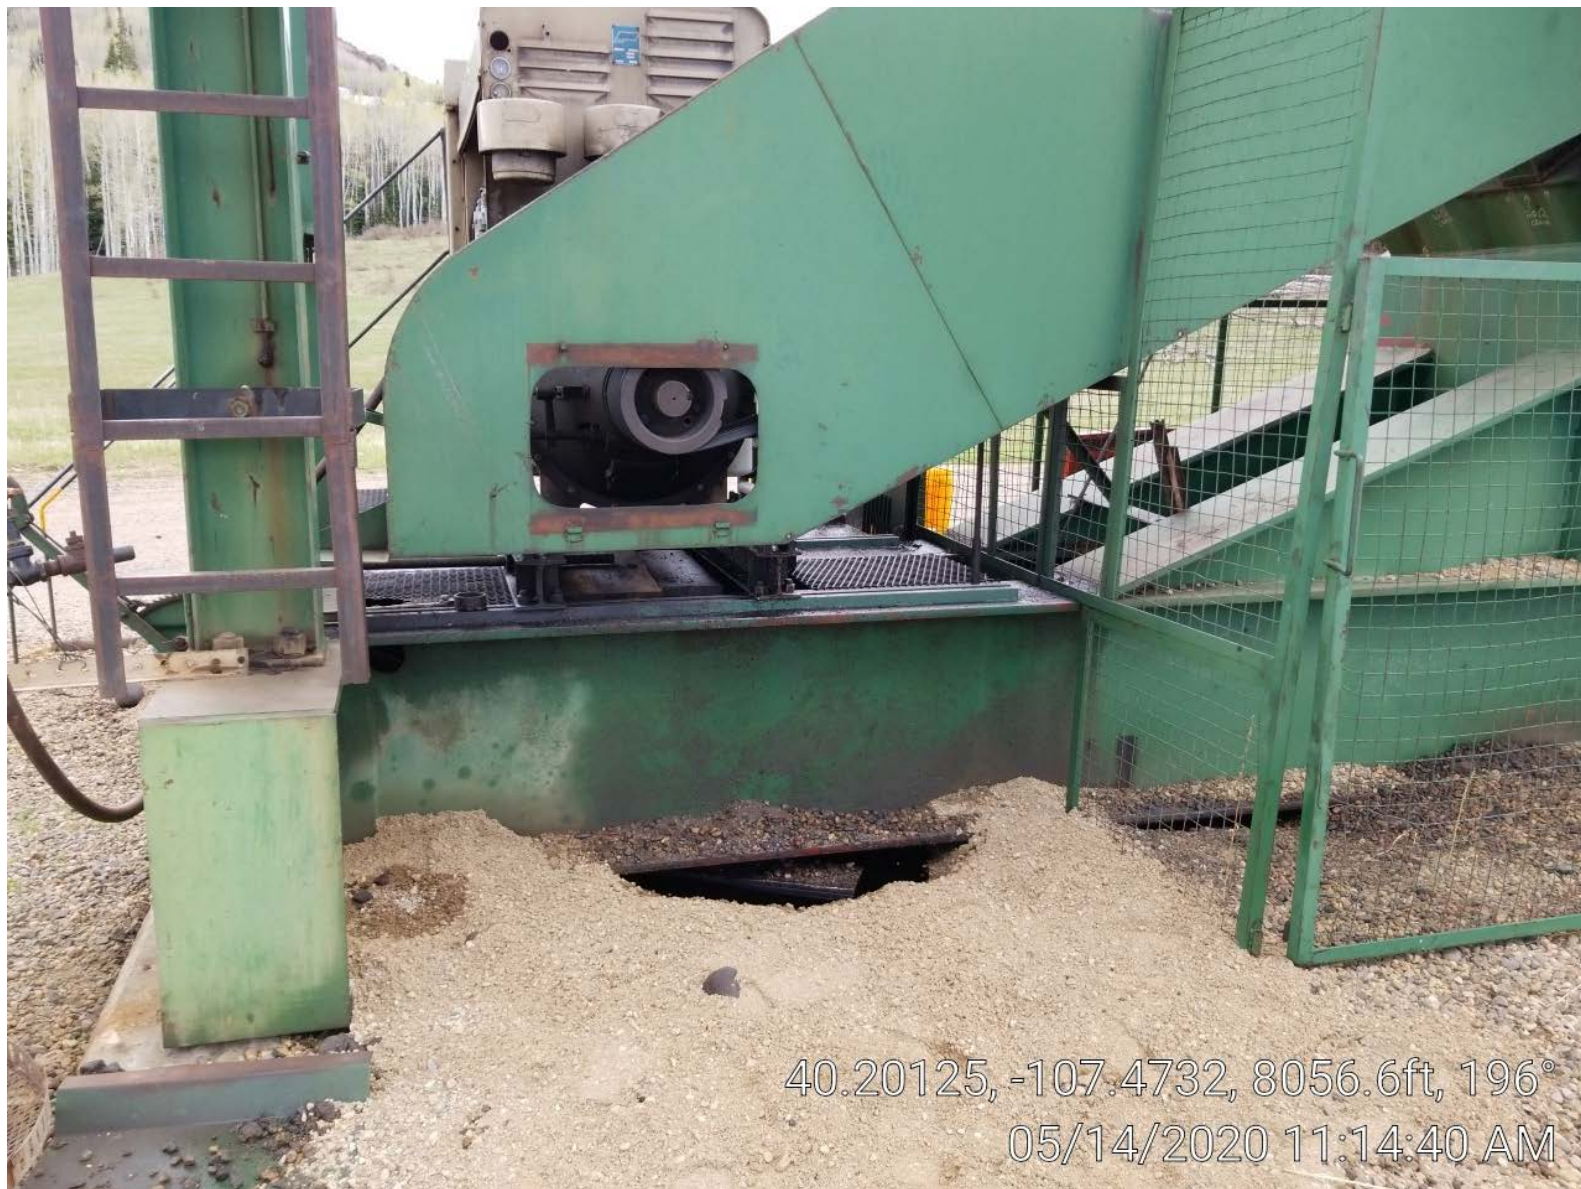
Photo 11. Side of pump jack. Oil on ground partially covered by recent dirt.
