Inspection Photos  
Operator: Petrox  
API#: 007-06269  
Date: 5/15/2020

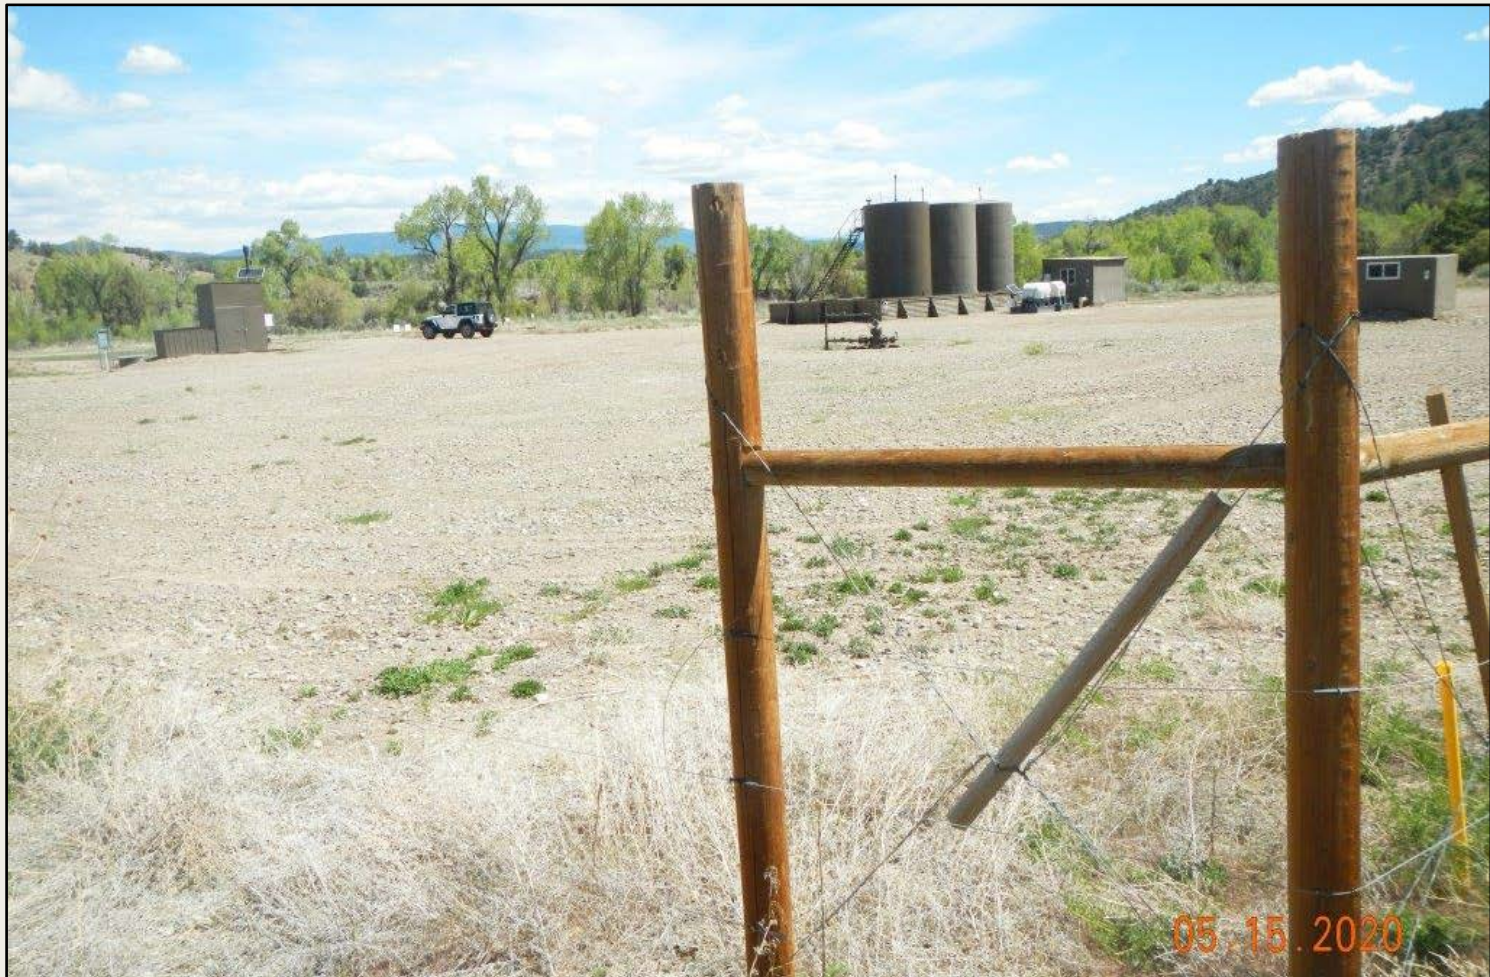
Photo 1. View of the project area from the southwestern corner facing center.

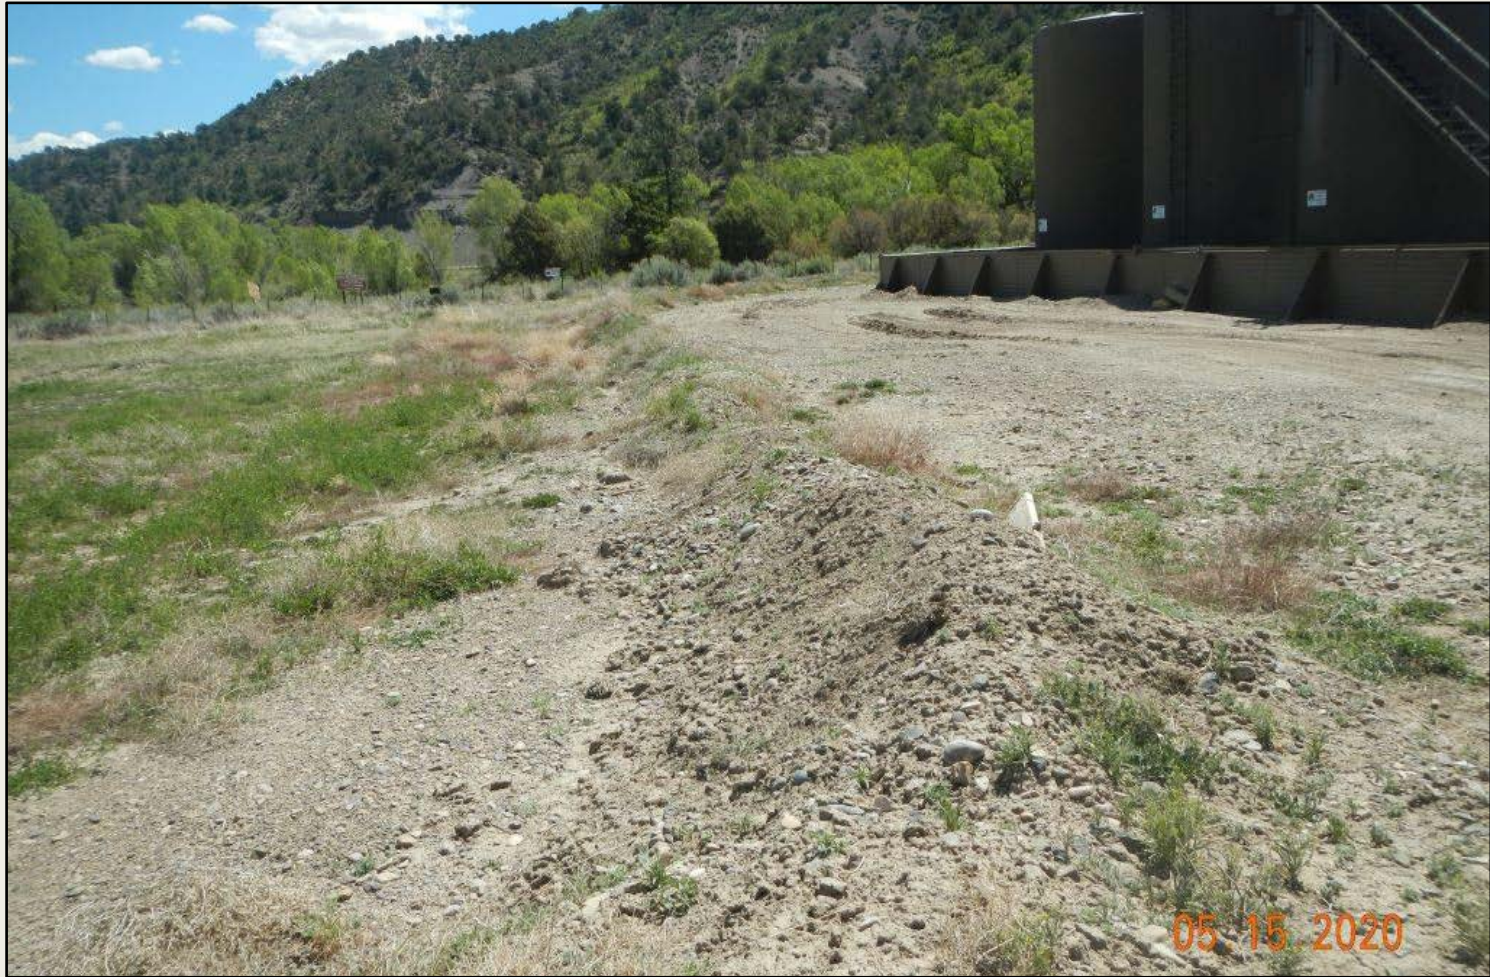
Photo 2. View of the northern project berm with early season weeds becoming established. Needs to be stabilized with desirable perennial vegetation or otherwise stabilized. Short term stormwater controls are needed until stabilized with desirable vegetation.

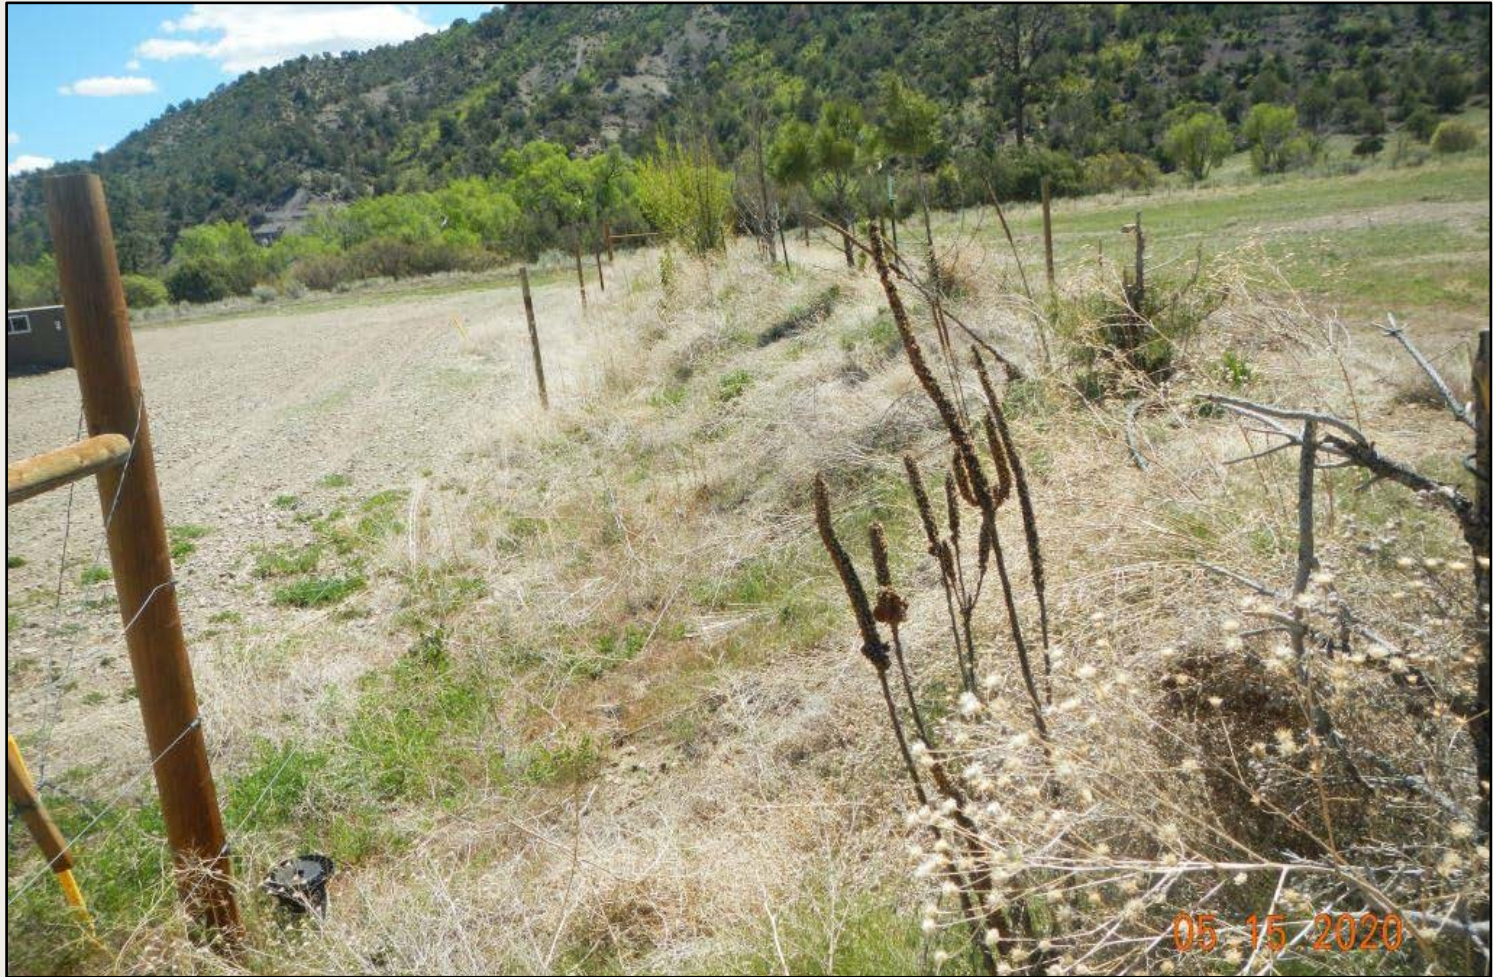
Photo 3. View of the southern project area from the southwestern corner facing eastward. Outer berms are weed infested.

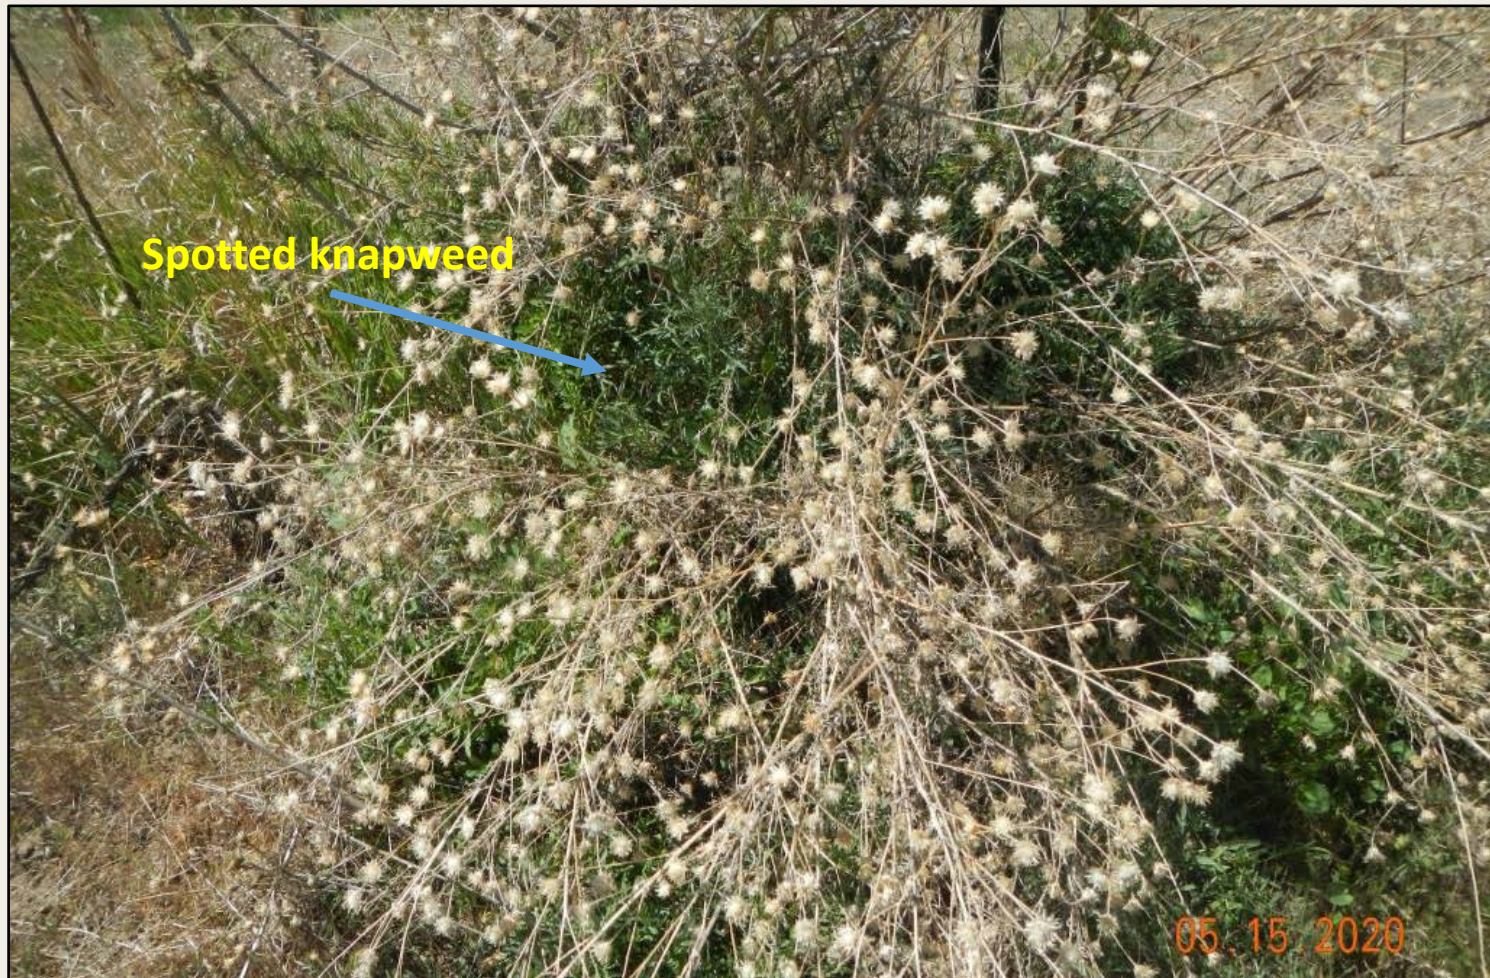
Photo 4. Closeup view of spotted knapweed within the project area with inflorescence from previous growing season.

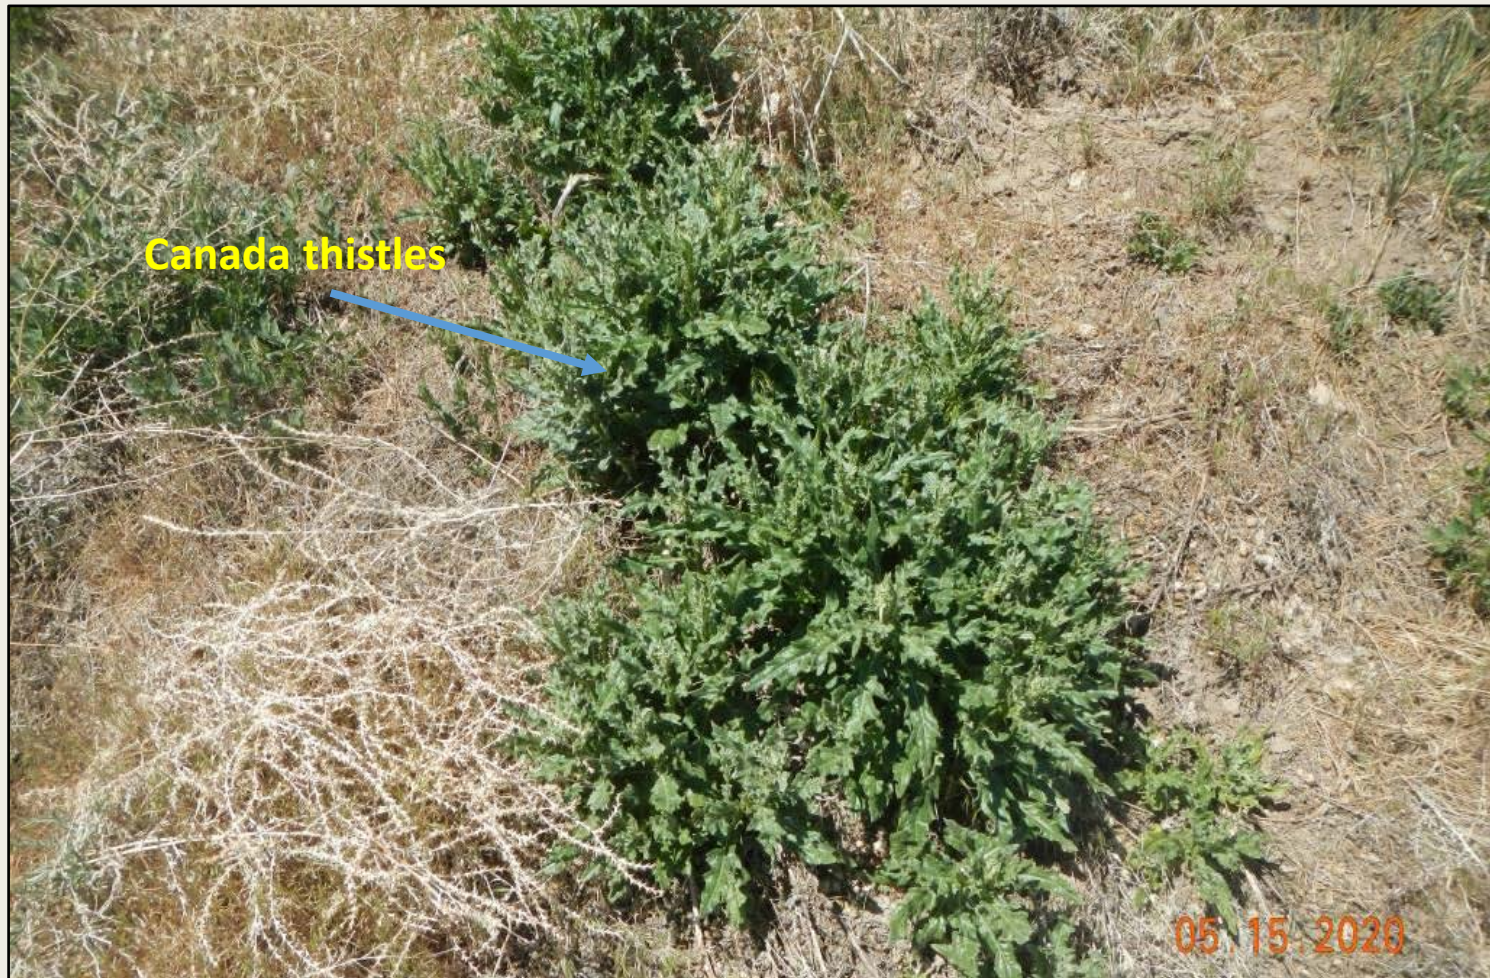
Photo 5. View of dense Canada thistles within the western project area, revegetation berm.

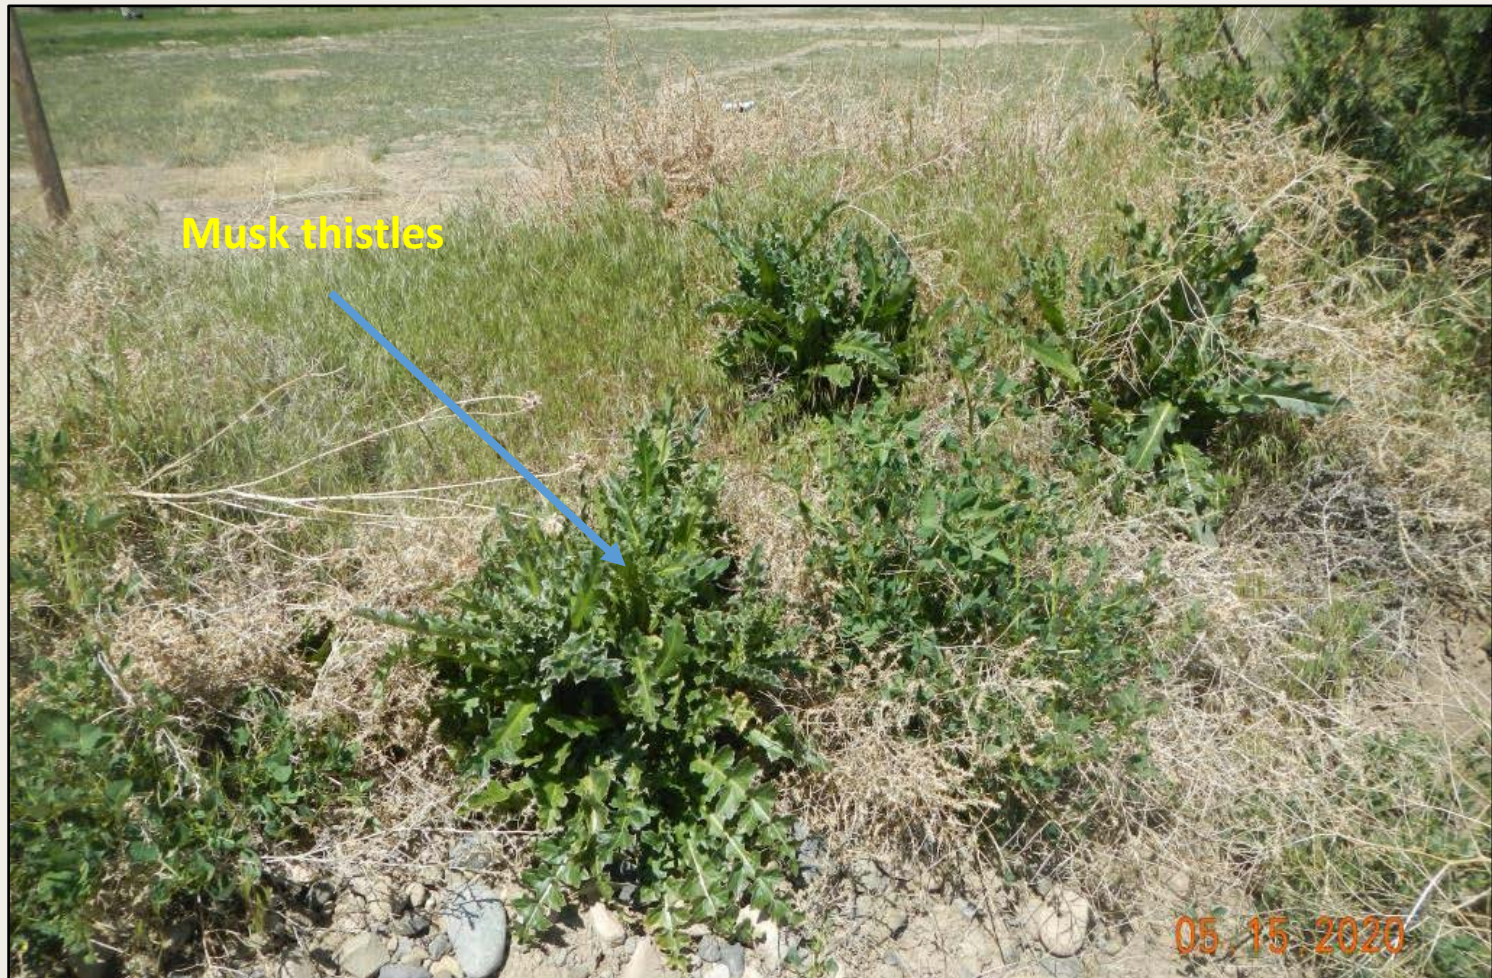
Photo 6. View of dense musk thistles observed within the outer reclamation berm.

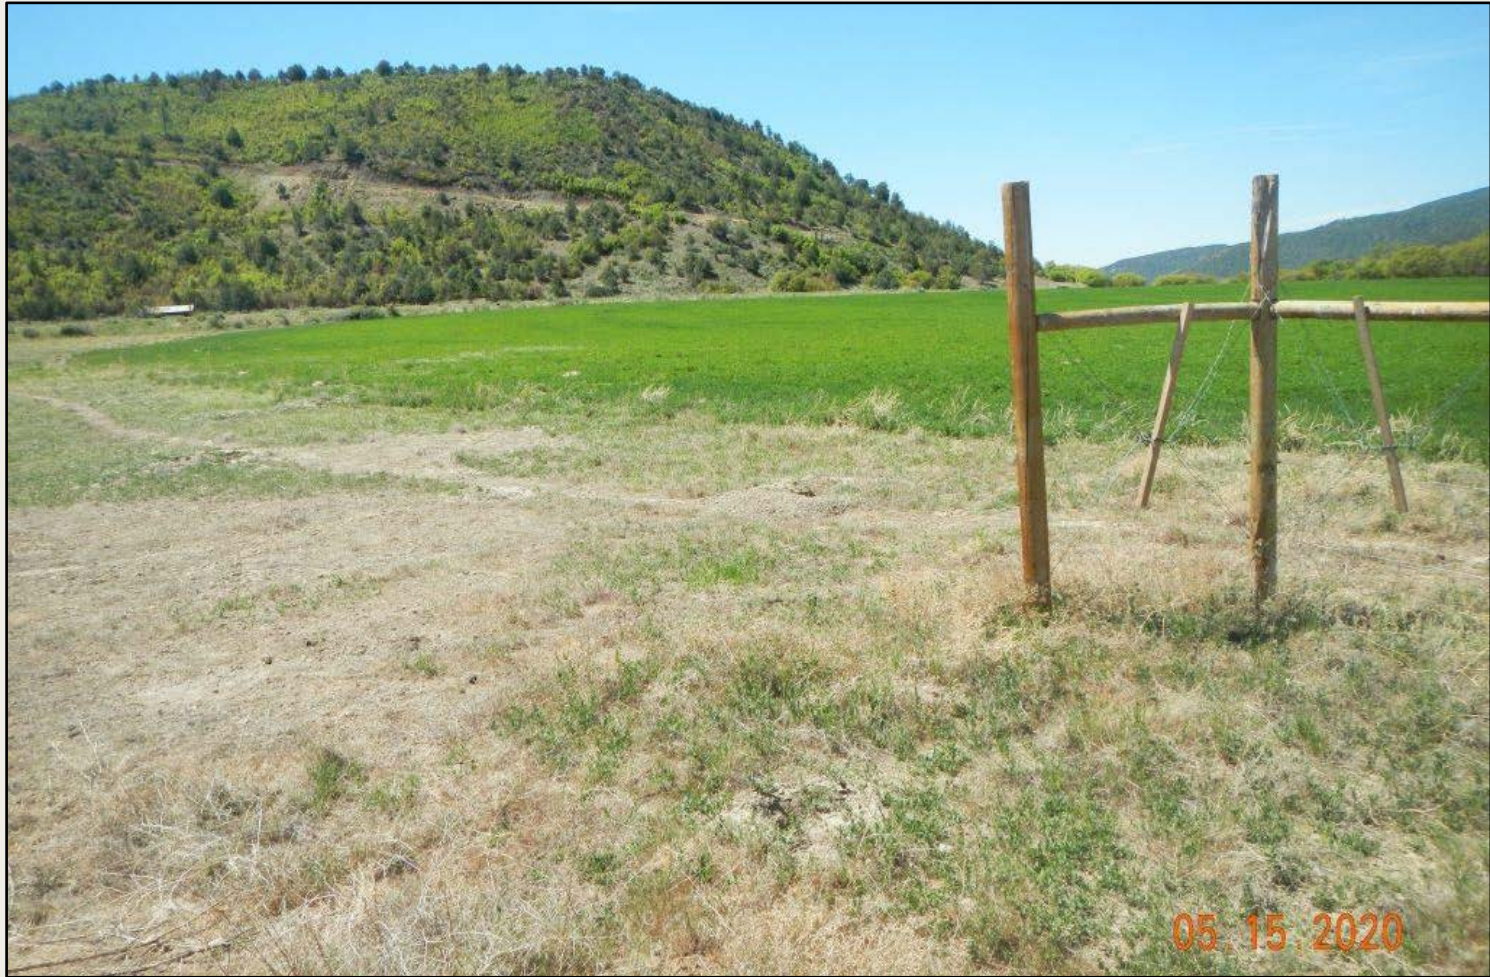
Photo 7. View of reference area vegetation . Location is on the edge of an irrigated grass field, and outside of irrigation alignment.
