Inspection Photos

API: 071-07516

Operator: EVERGREEN NATURAL RESOURCES

Inspection Date: 5/18/2020

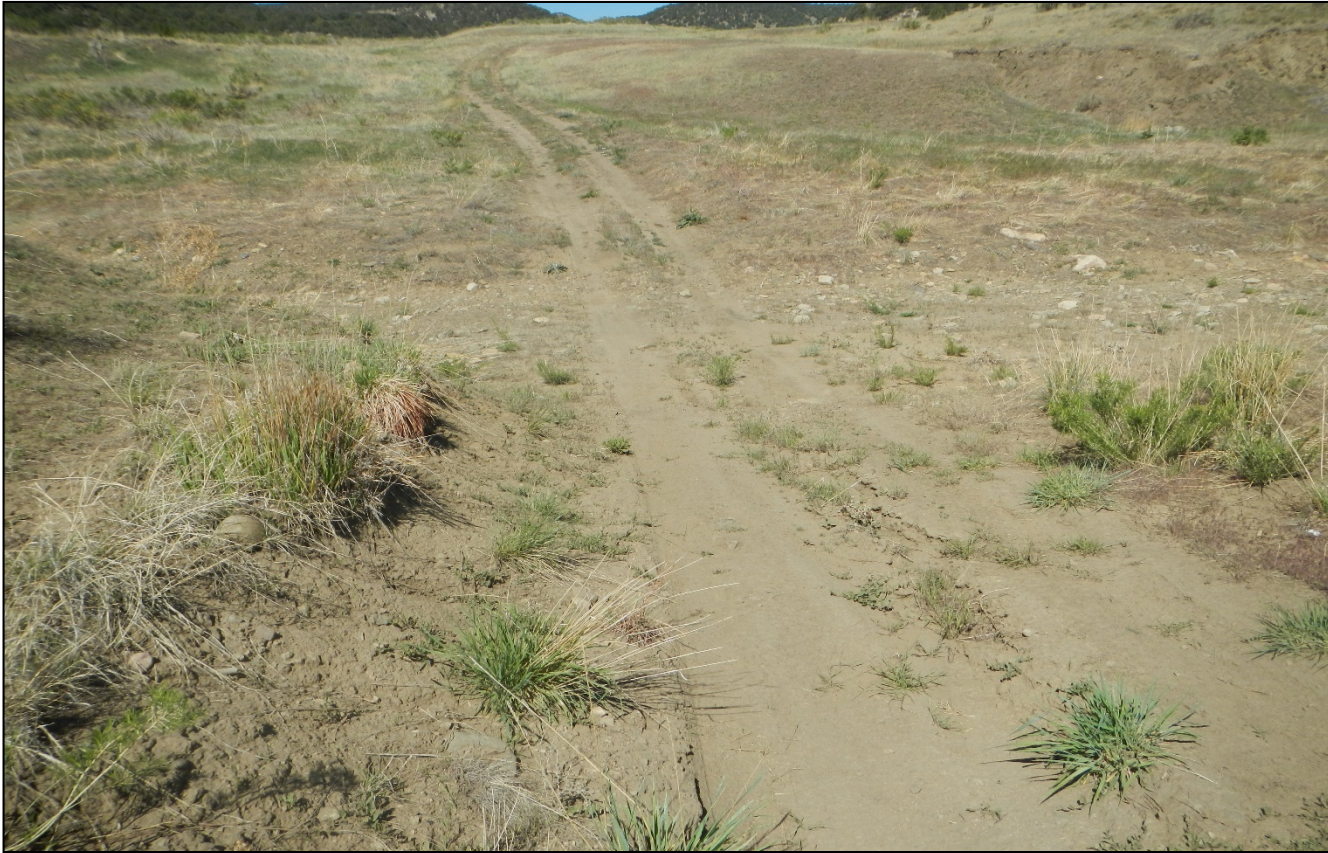
Photo 1. Facing west along the access road crossing the ephemeral drainage.

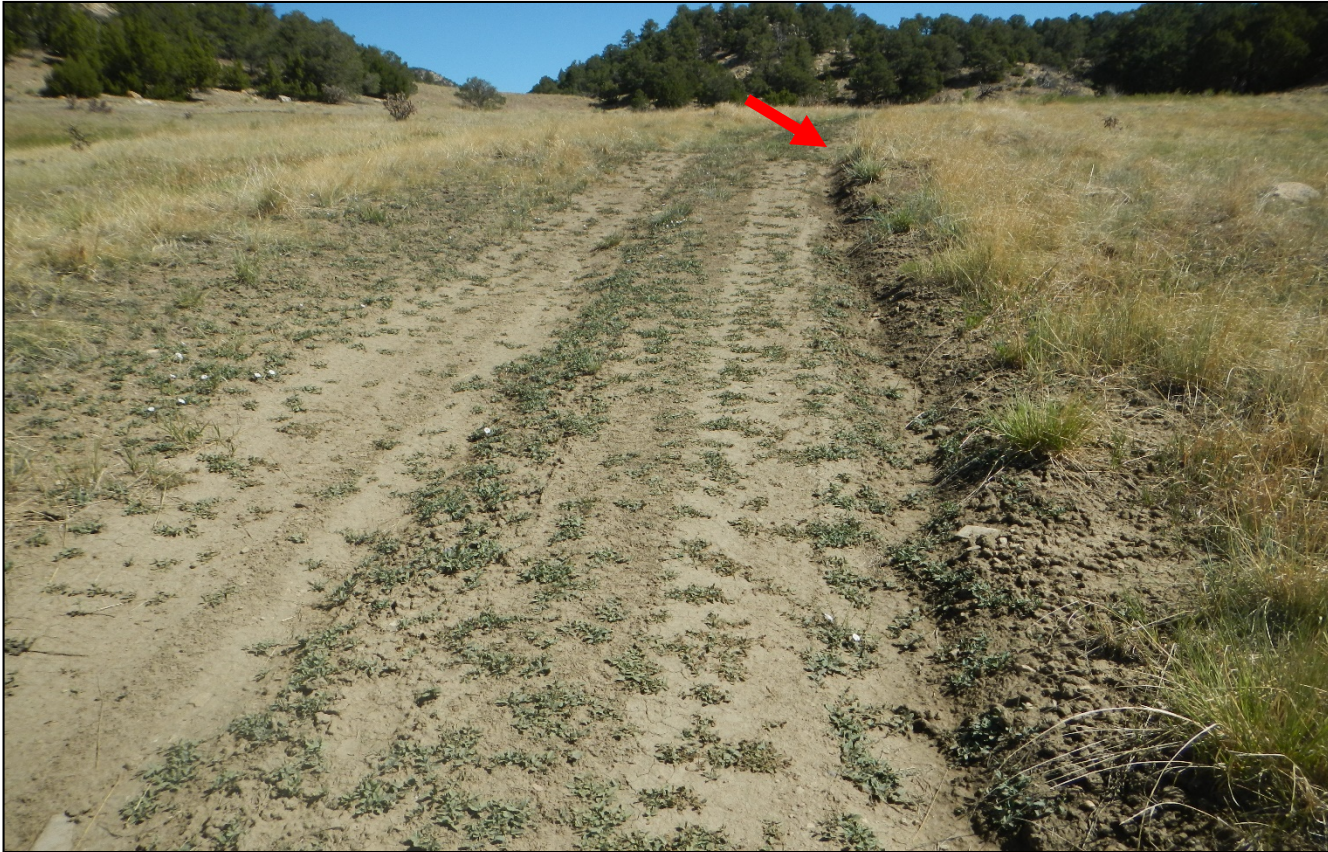
Photo 2. Facing north along the access road. There is an erosion channel that has developed overtopping water bar shown at red arrow.

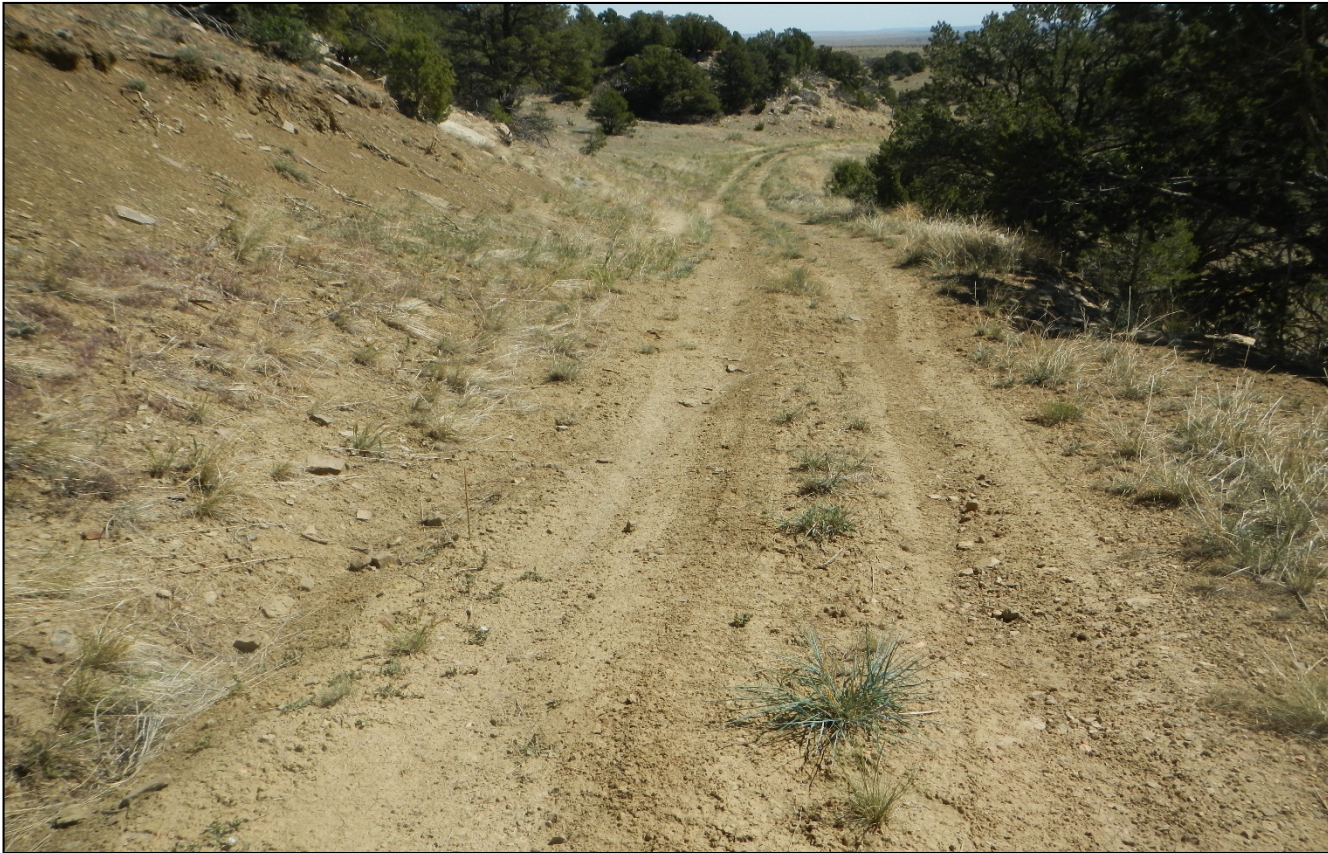
Photo 3. Facing northeast along the access road.

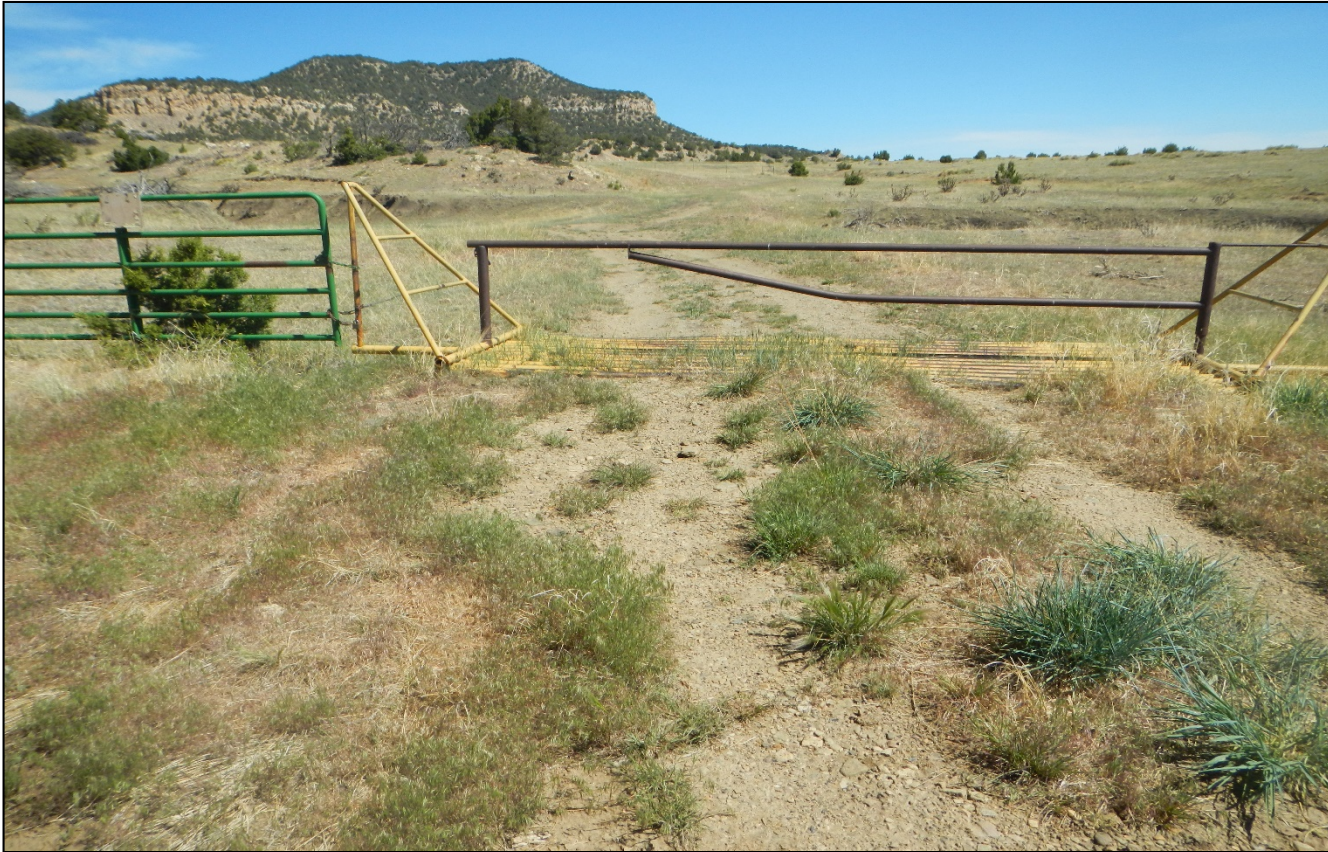
Photo 4. Facing north along the access road. Cattle guard remains in place and is maintained.

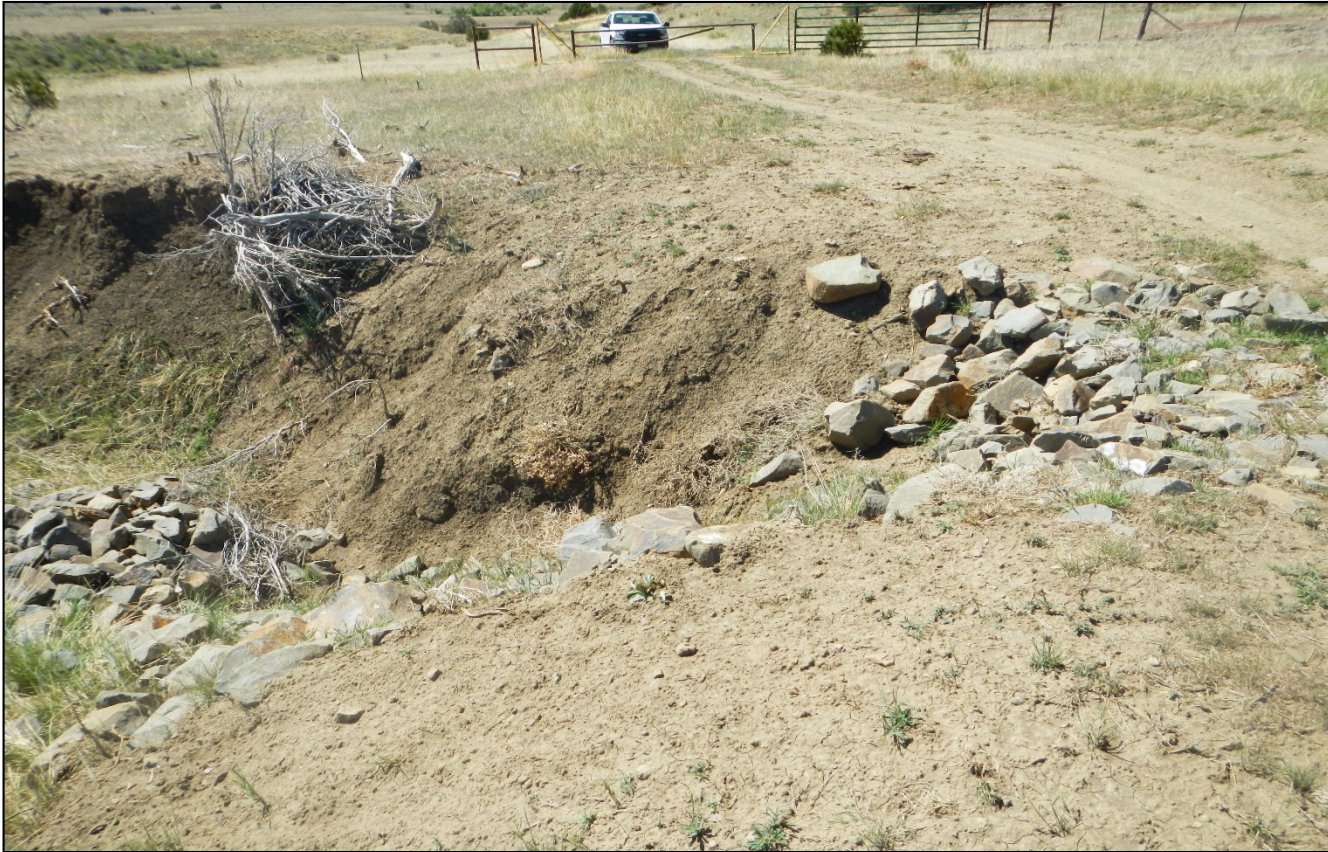
Photo 5. Facing back toward the south near the cattleguard. The road crossing near the drainage will require BMP maintenance. The rock rip rap has been washed out in this area.

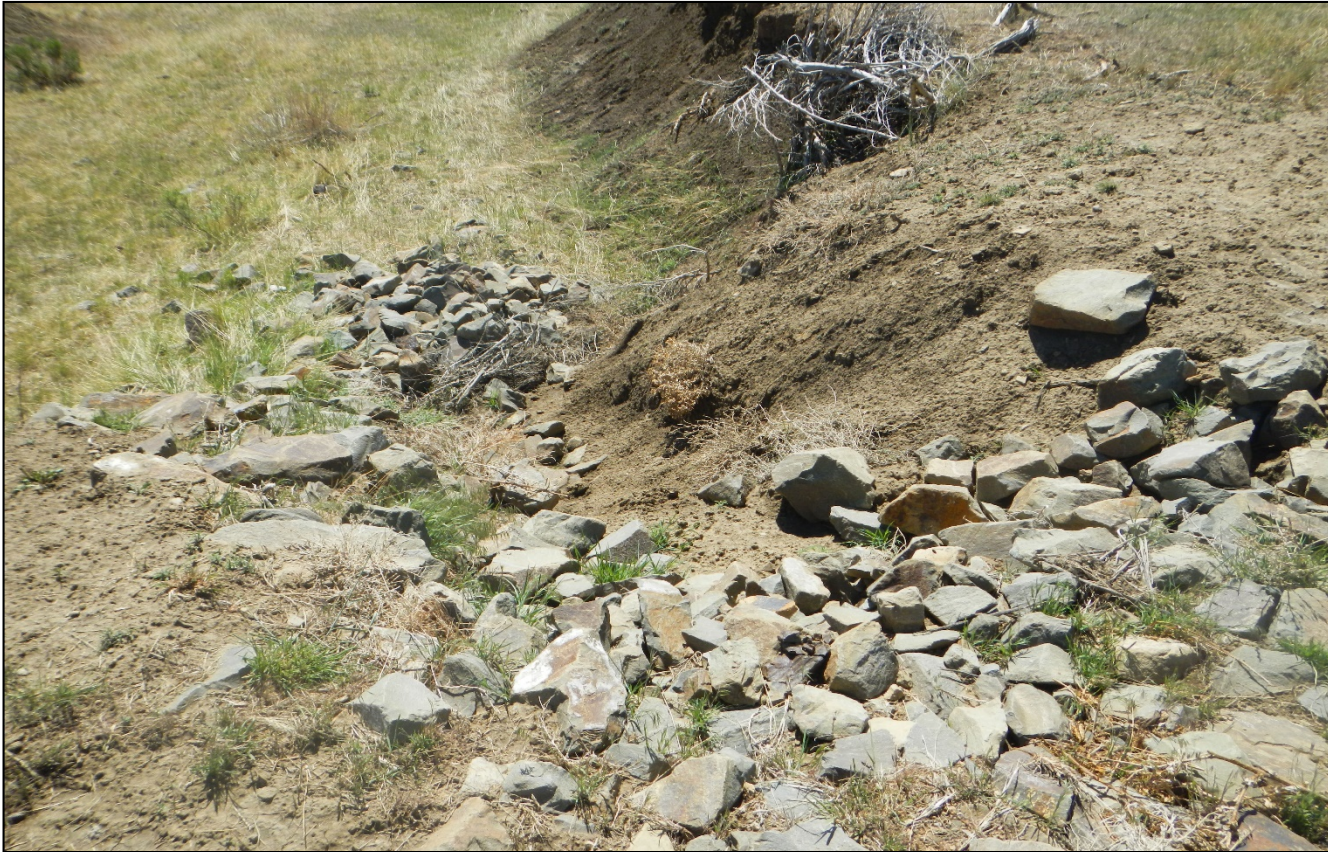
Photo 6. View of rock rip/rap that has been displaced will need to be repaired.

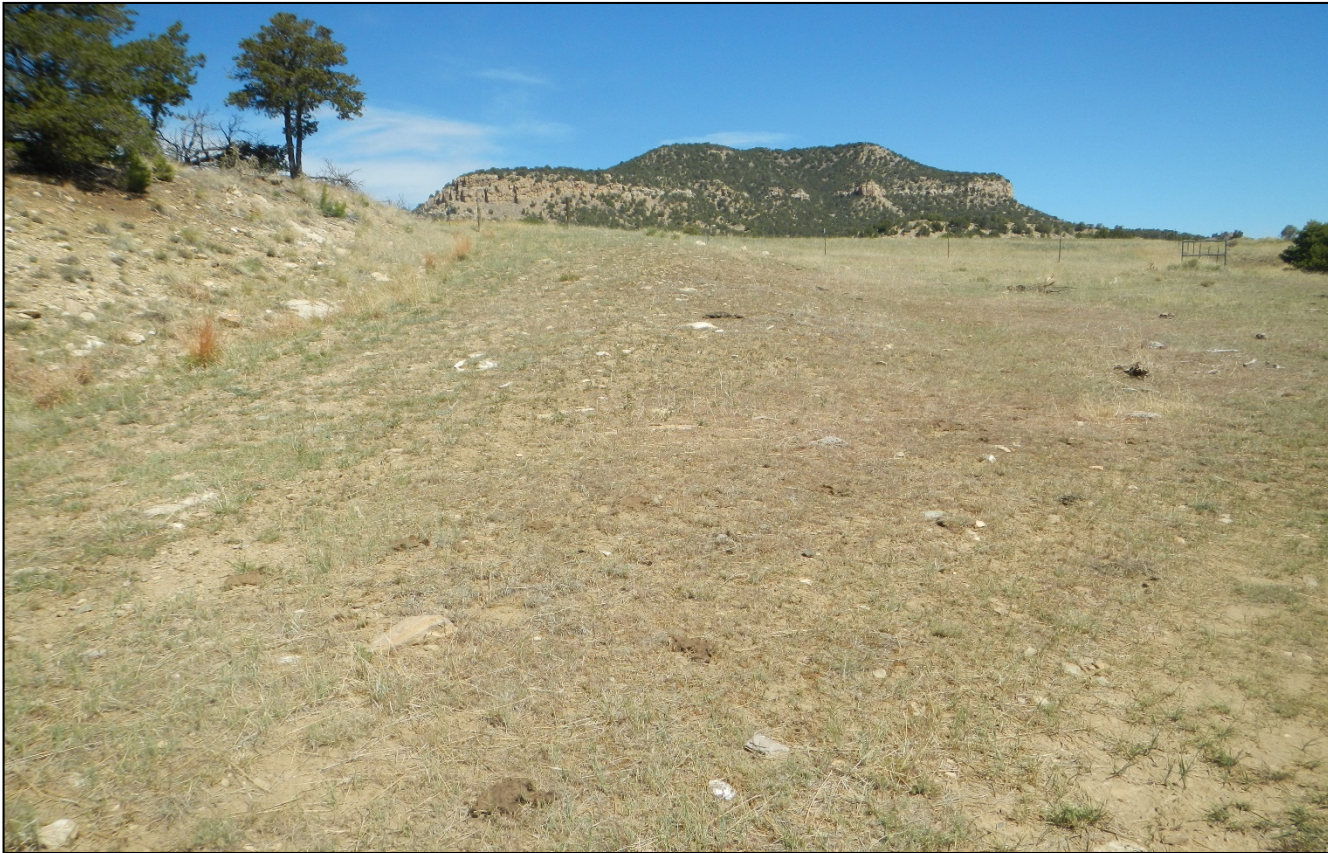
Photo 7. Facing northwest toward reclaimed location.

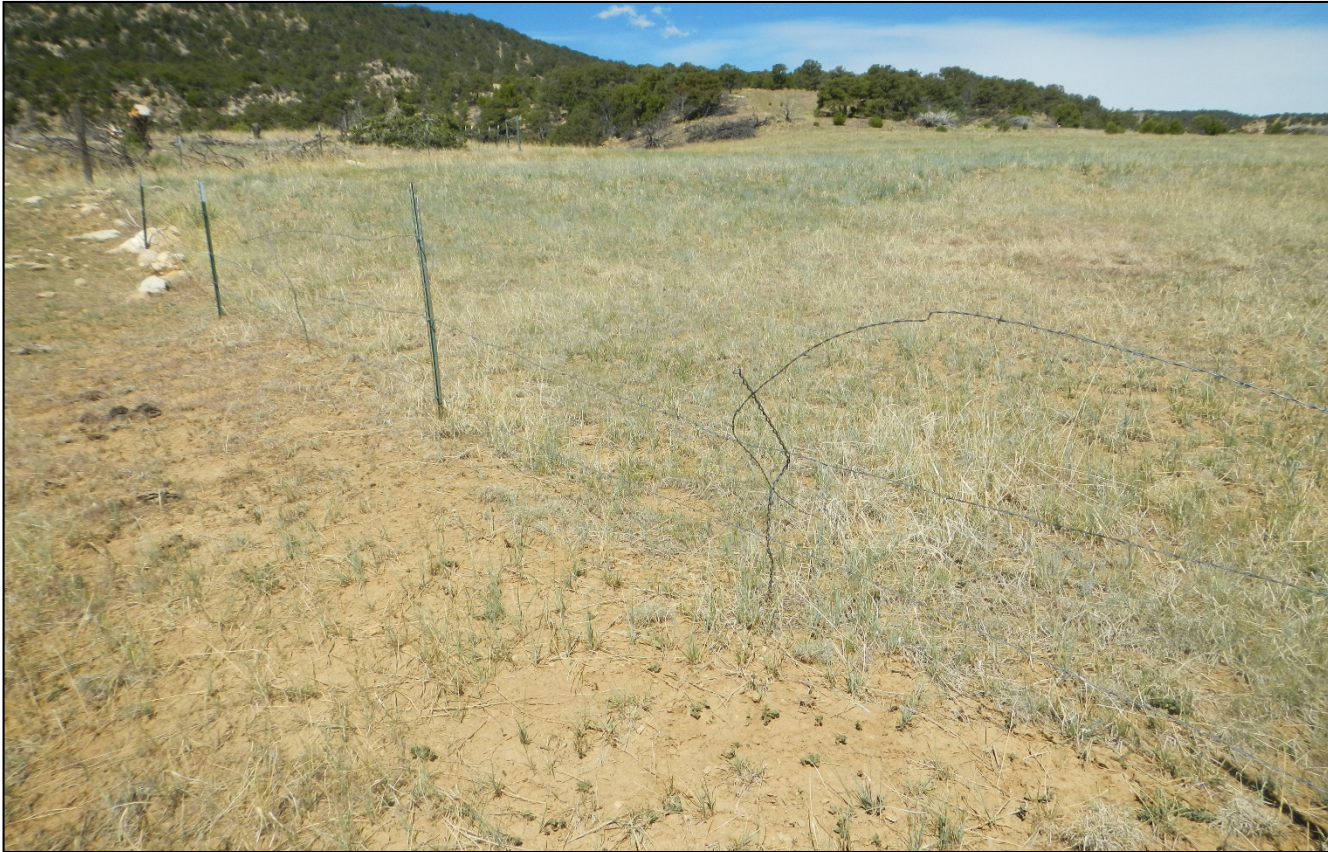
Photo 8. The perimeter fence remains around location and needs maintenance in this area.

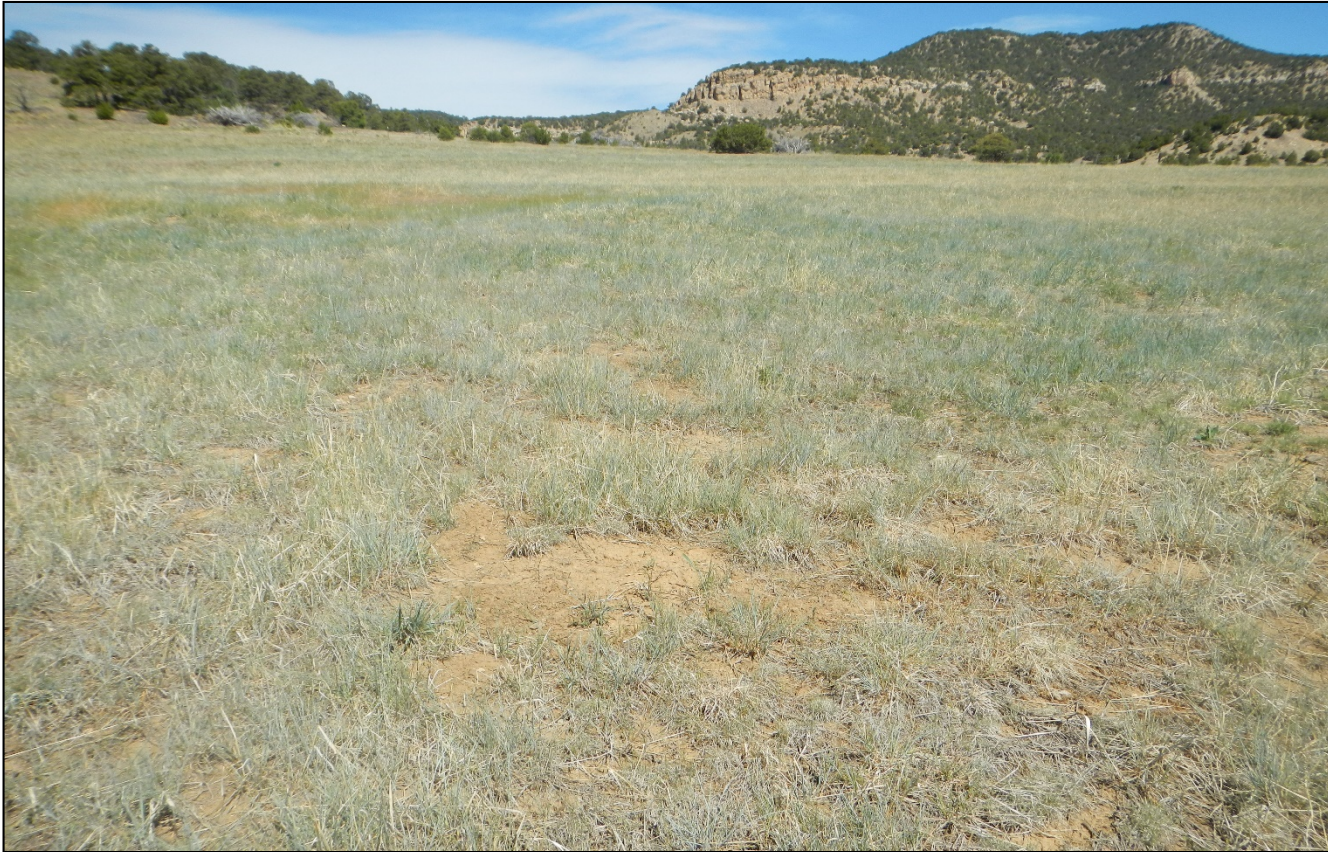
Photo 9. Facing northwest toward the location. The vegetation is uniformly established throughout the location.

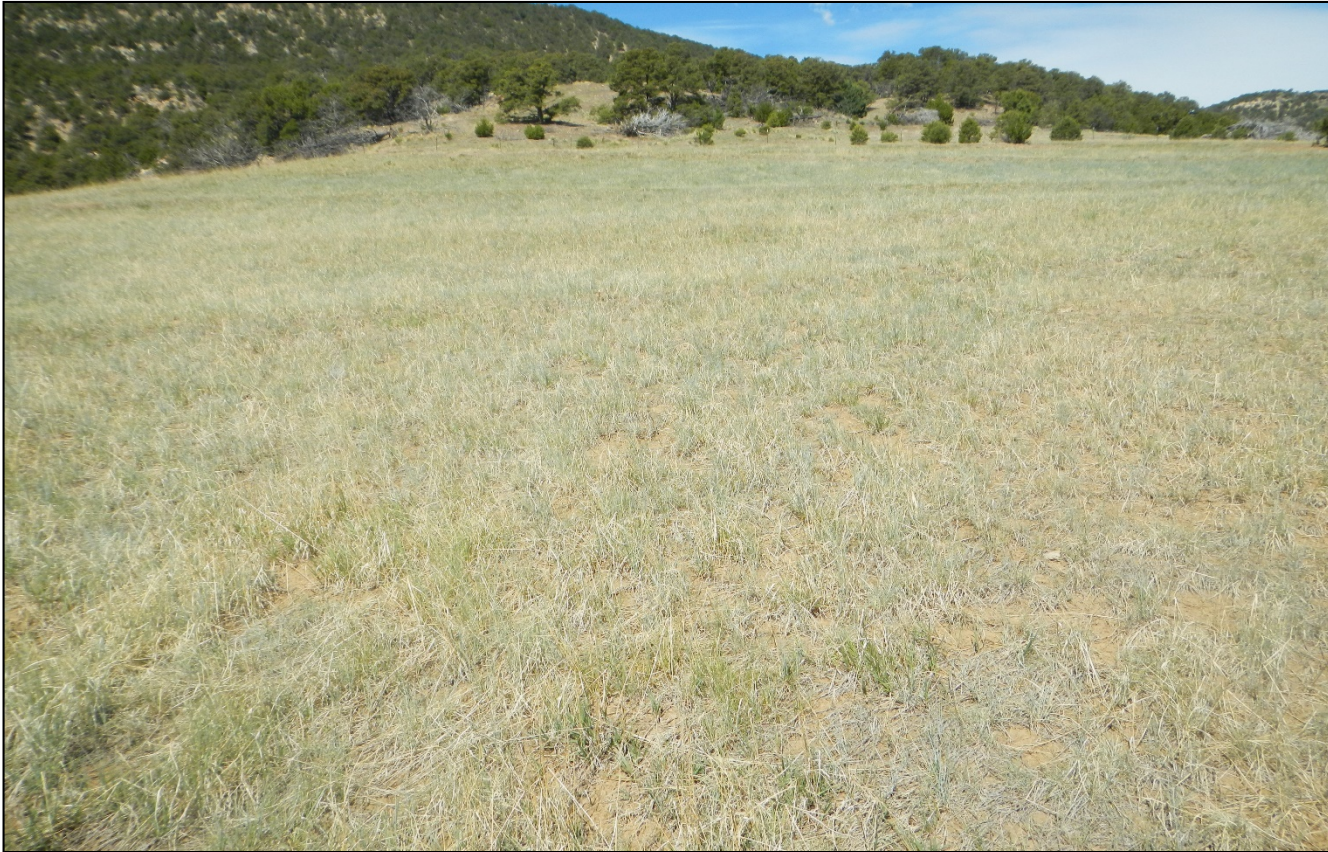
Photo 10. Facing west toward the location. The vegetation is uniformly established throughout the location.

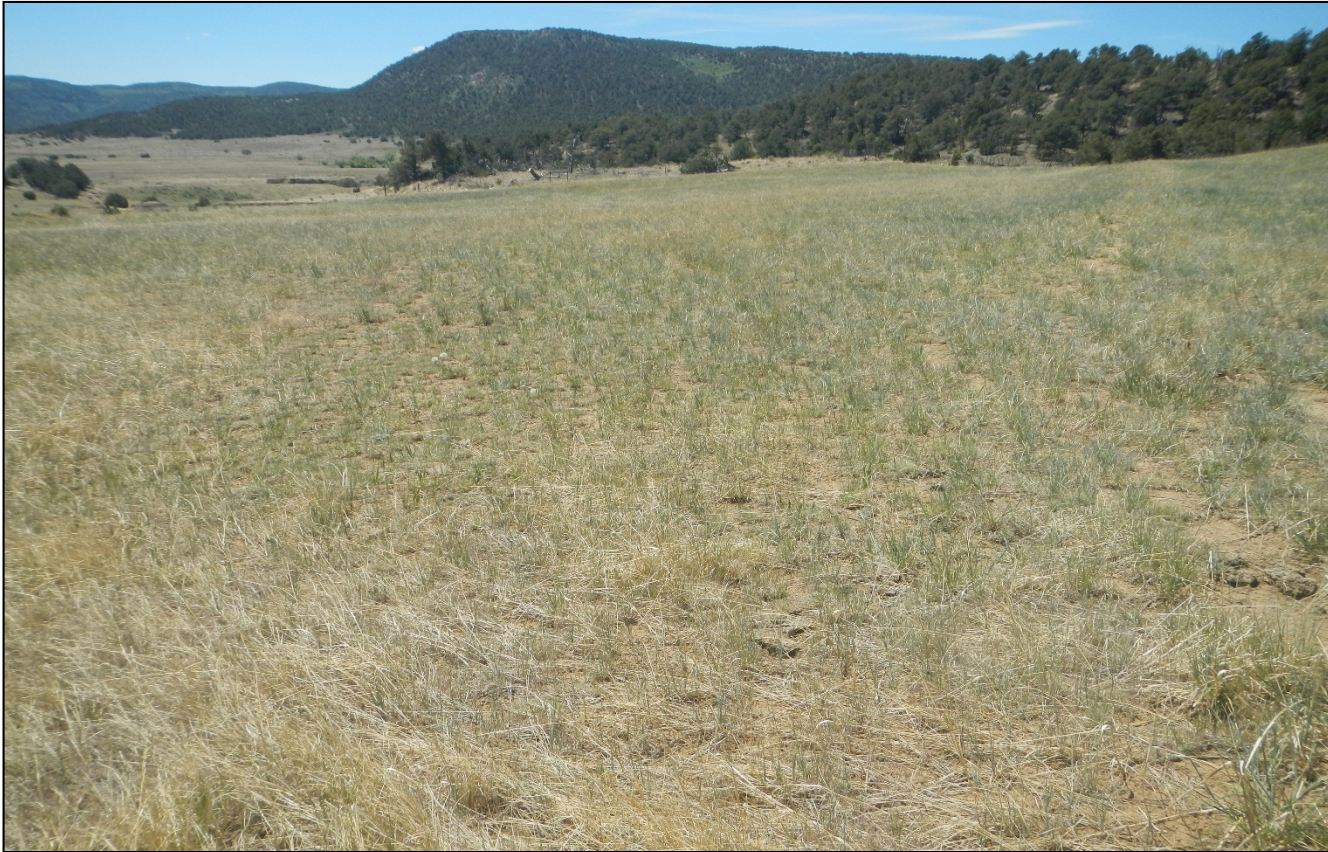
Photo 11. Facing south toward the location. The vegetation is uniformly established throughout the location.
