Inspection Photos
Operator: Southland Royalty
API#: 007-06211
Date: 5/15/2020

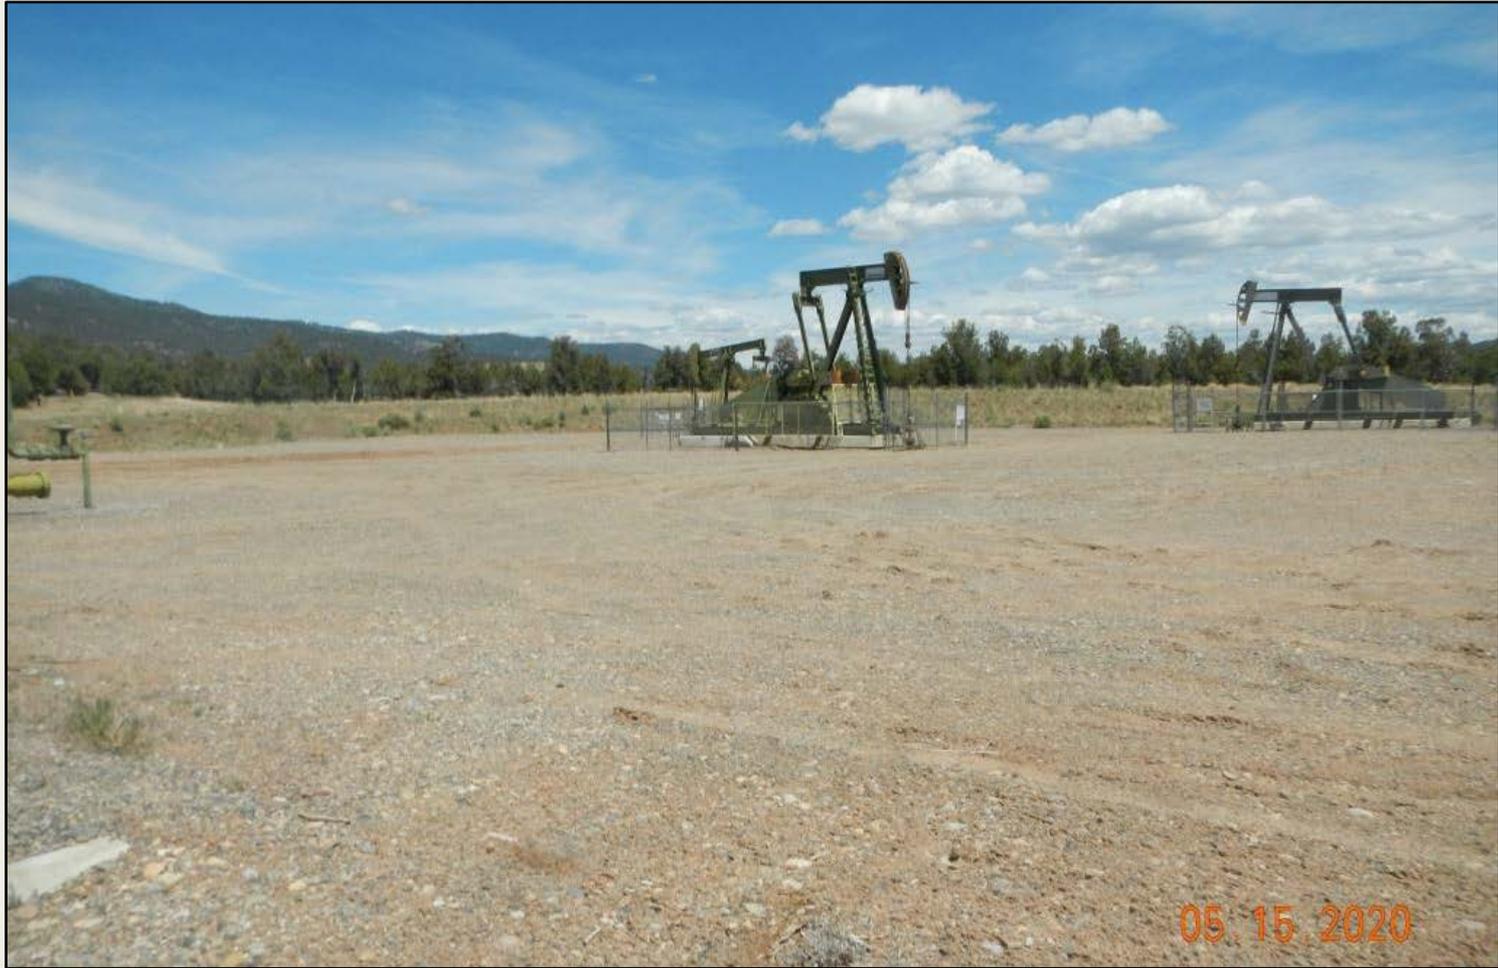
Photo 1. View of the project area from the southwestern corner facing center.

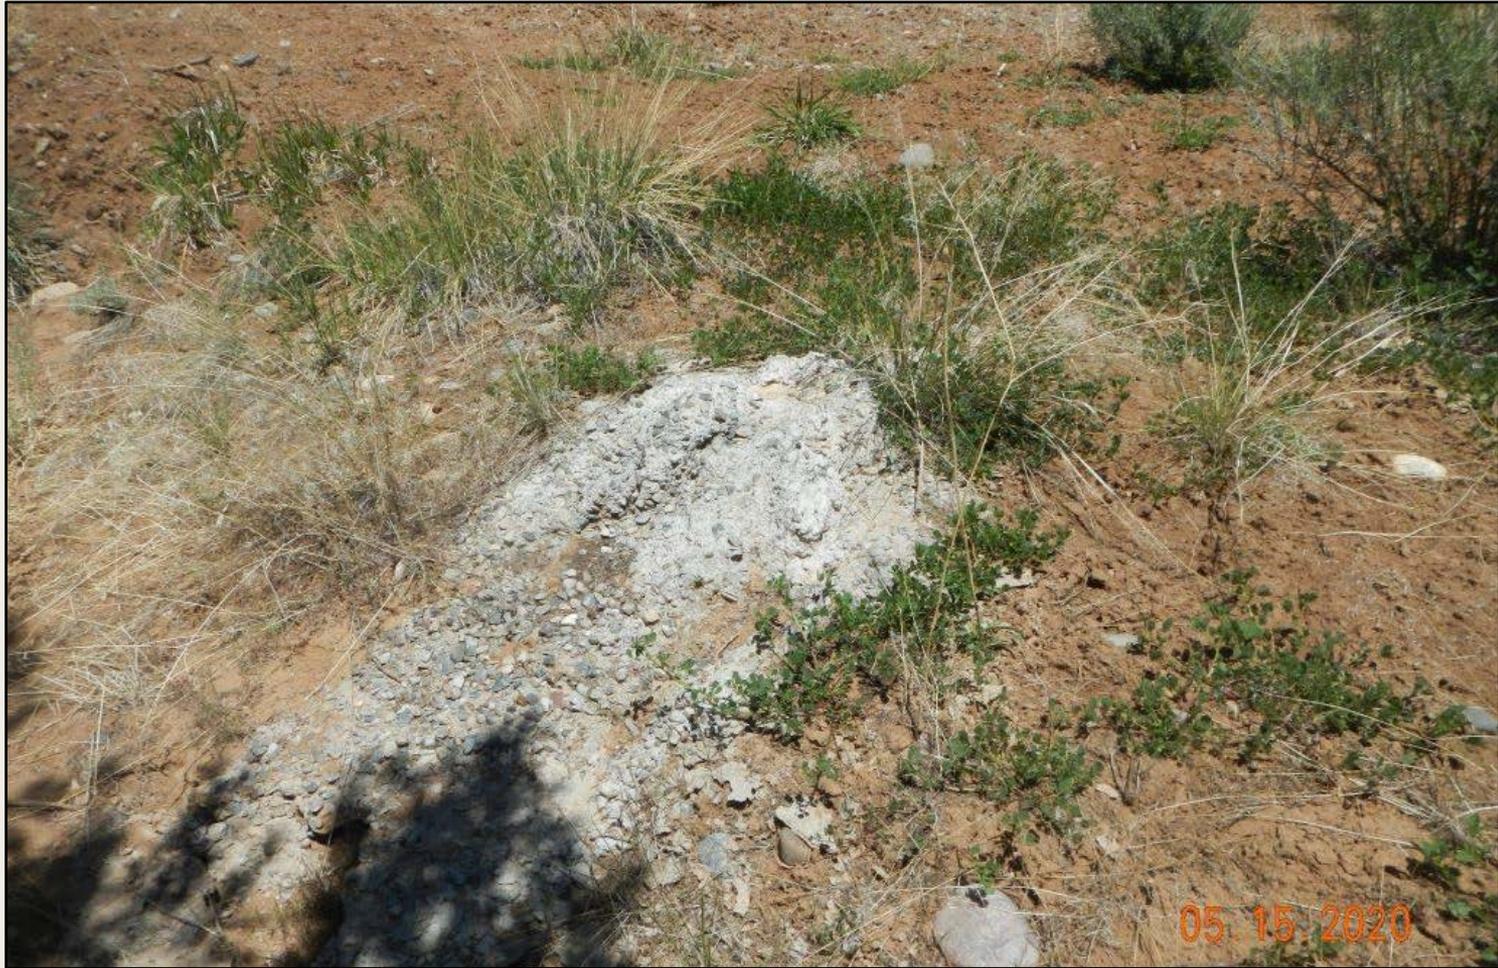
Photo 2. View of cement debris located on the western edge of the project area.

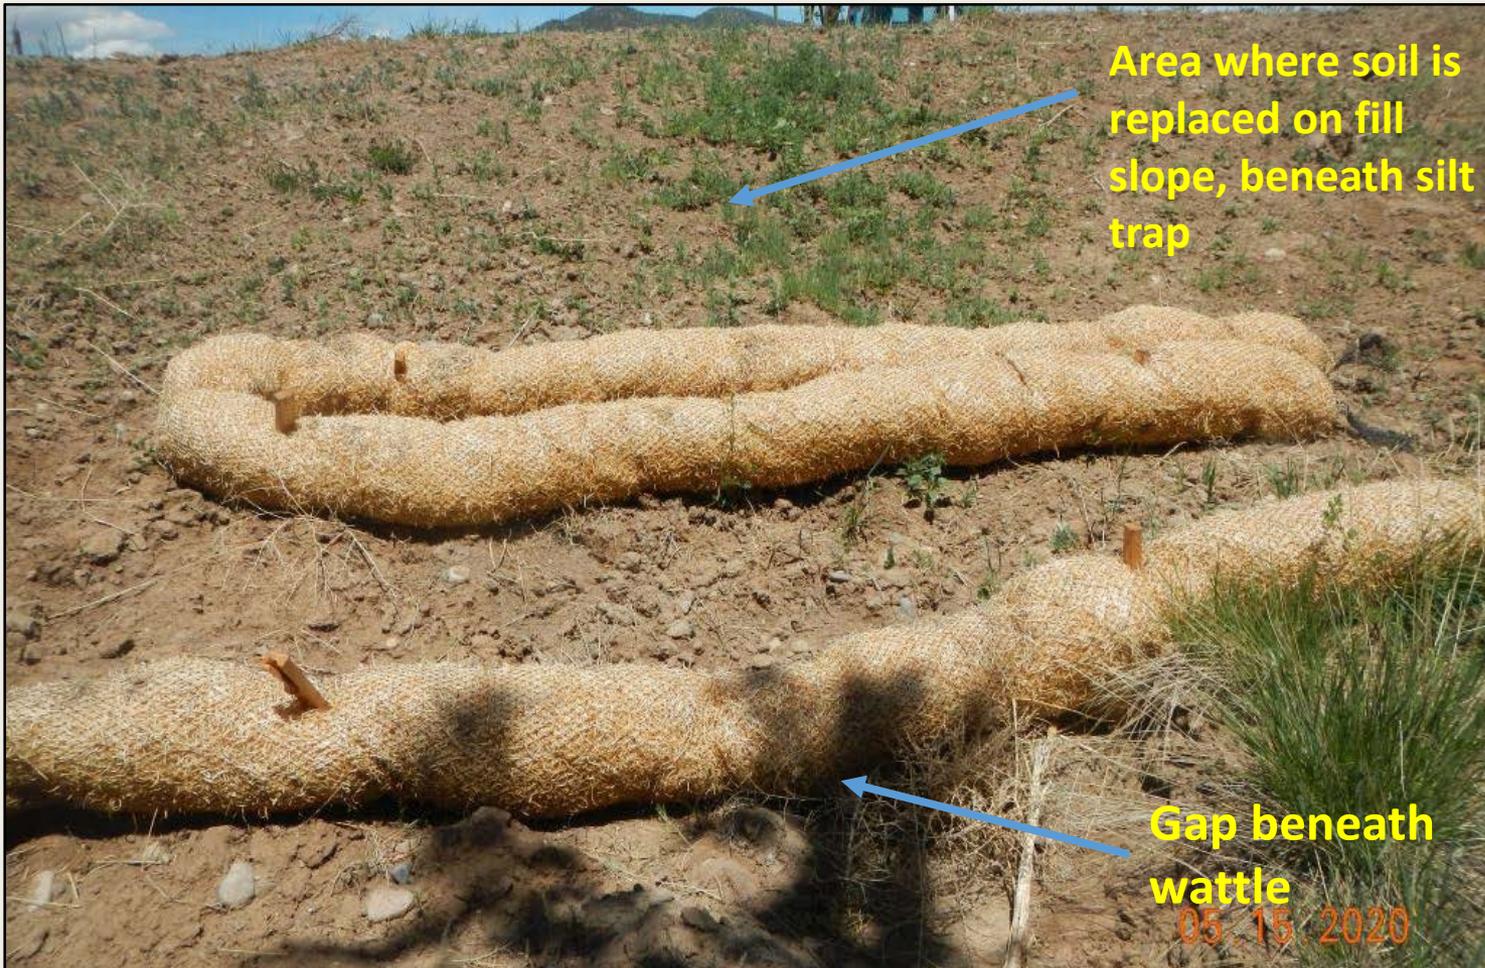
Photo 3. View of area on southern fill slope where sediment trap was breached and is repaired. Area is replaced with soil, and appears to have been seeded. Wattles in place as secondary containment are not installed properly as they are not trenched into soil.

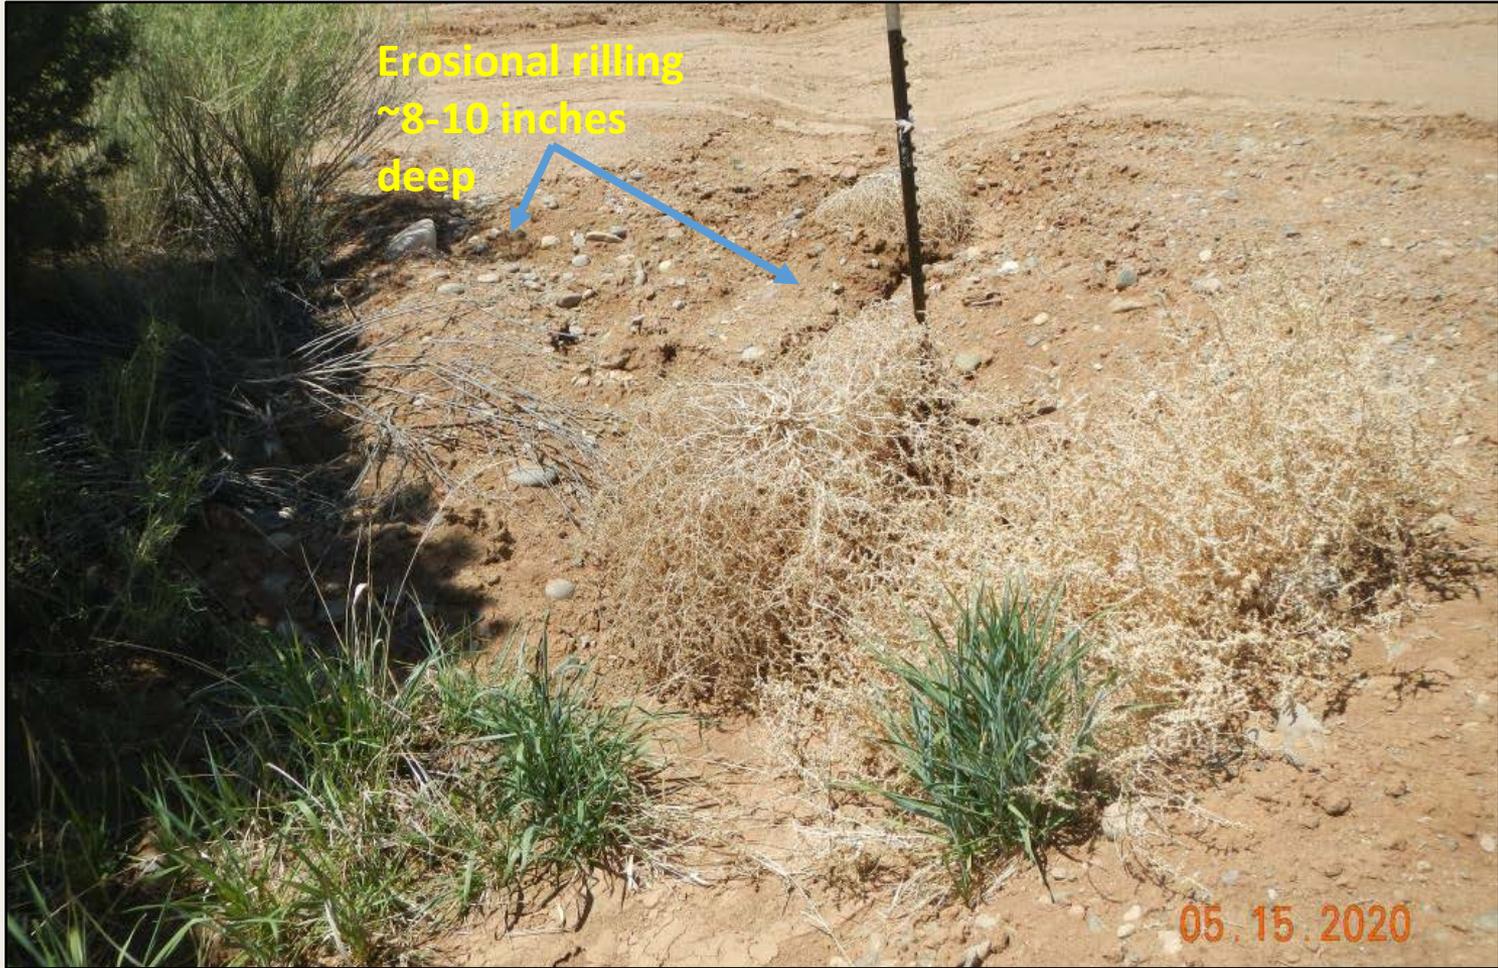
Photo 4. View of area where erosion is occurring where culvert crosses the access road near the well pad entrance. Additional stabilization is needed here.

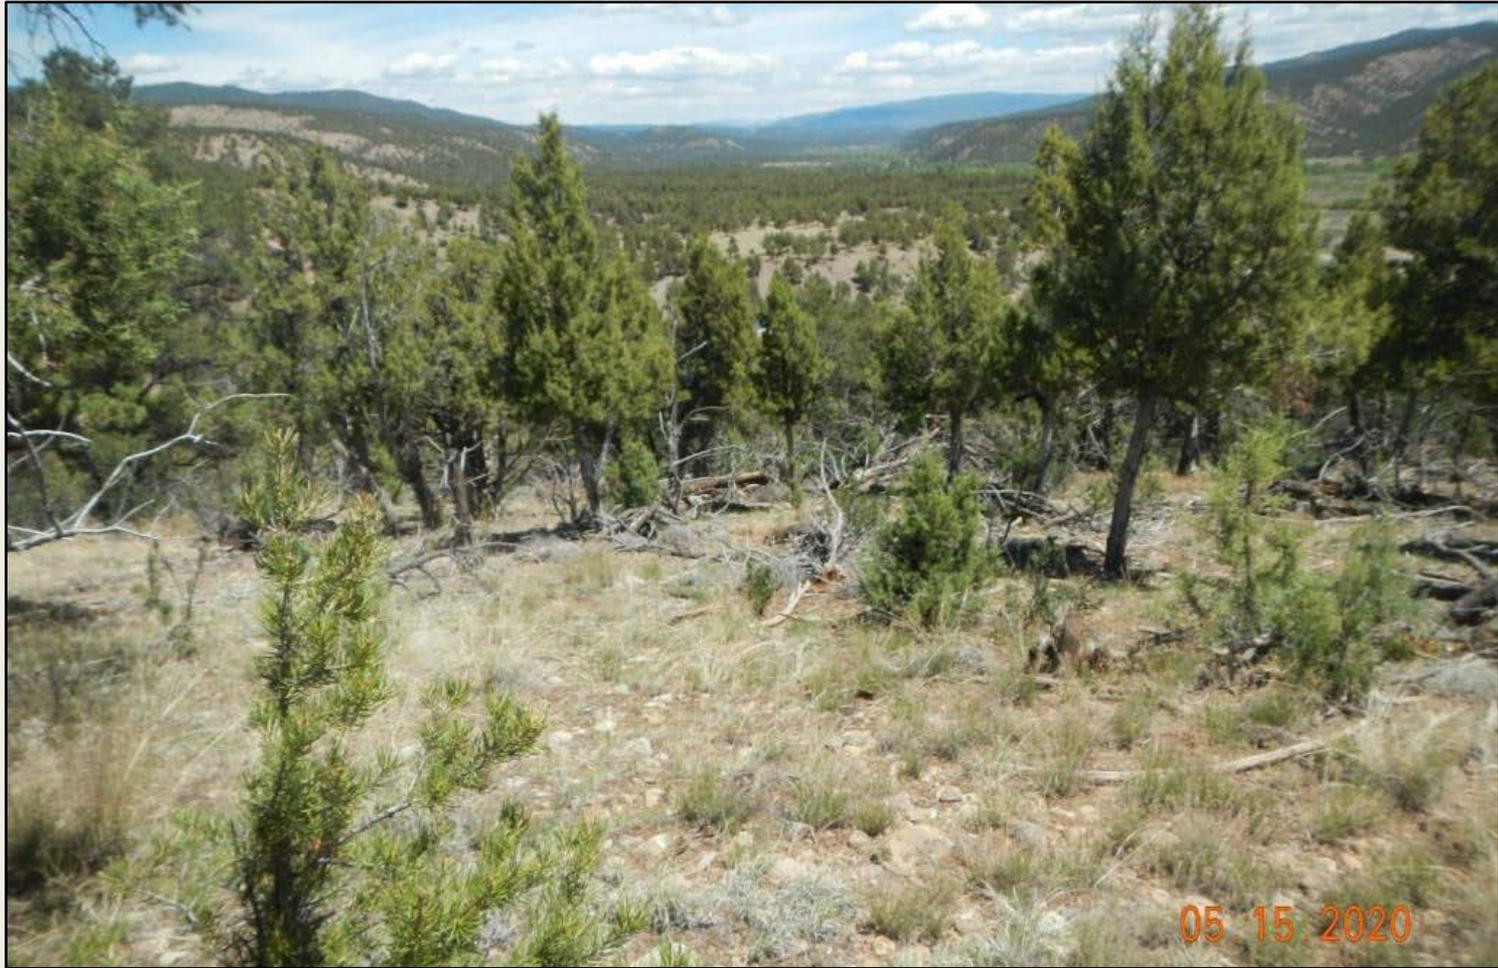
Photo 5. View of reference area vegetation comprised of pinyon juniper woodland with understory of grasses and forbs such as Indian ricegrass, James galleta, and Navajo tea.
