Crestone Peak Resources - COGCC Inspection Photos

Well: Costigan 34-20

API # 123-30058 Date 5/20/2020

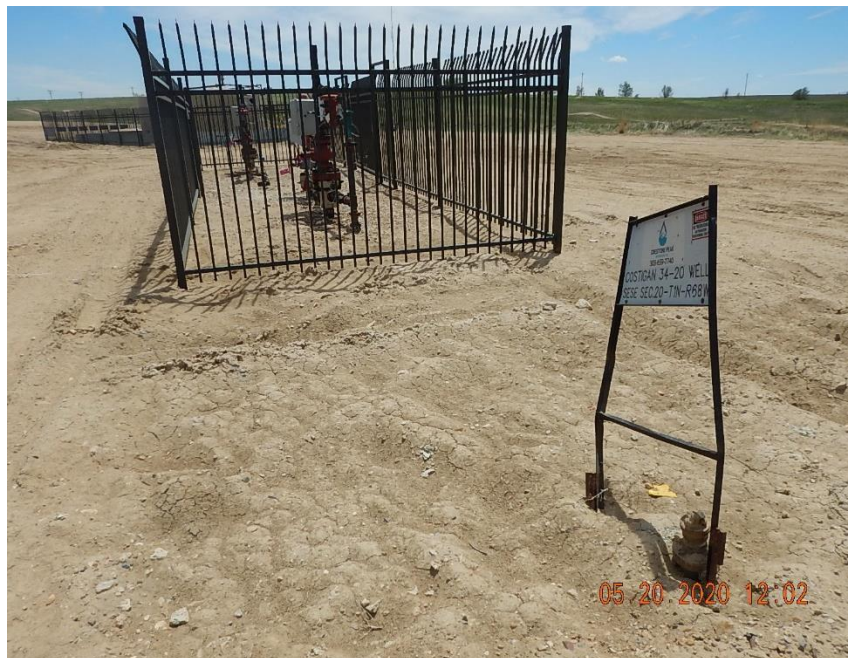
Signage at out of service flowline riser.

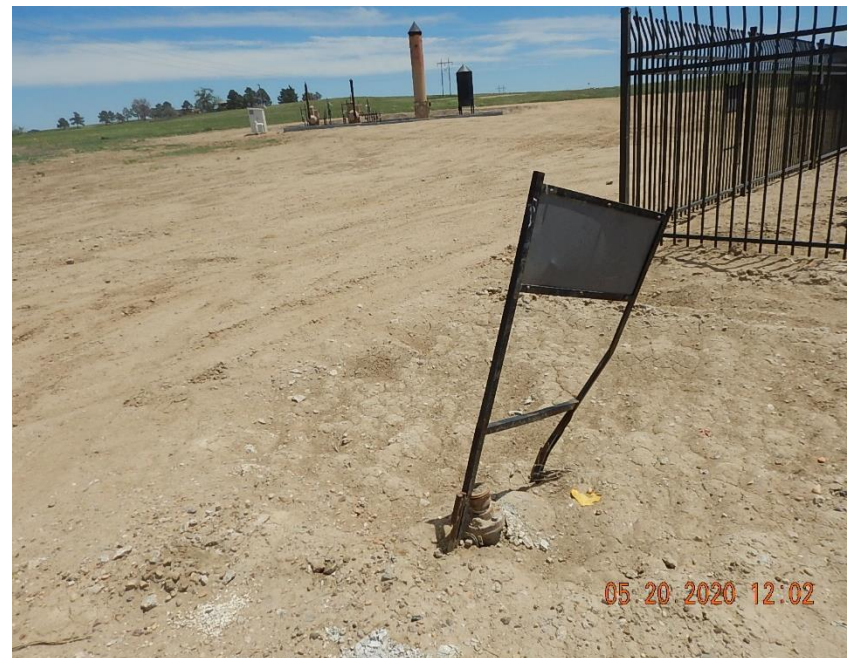
View from Costigan 34-20 PA wellhead flowline riser to facility;
on location flowline/ looking east.

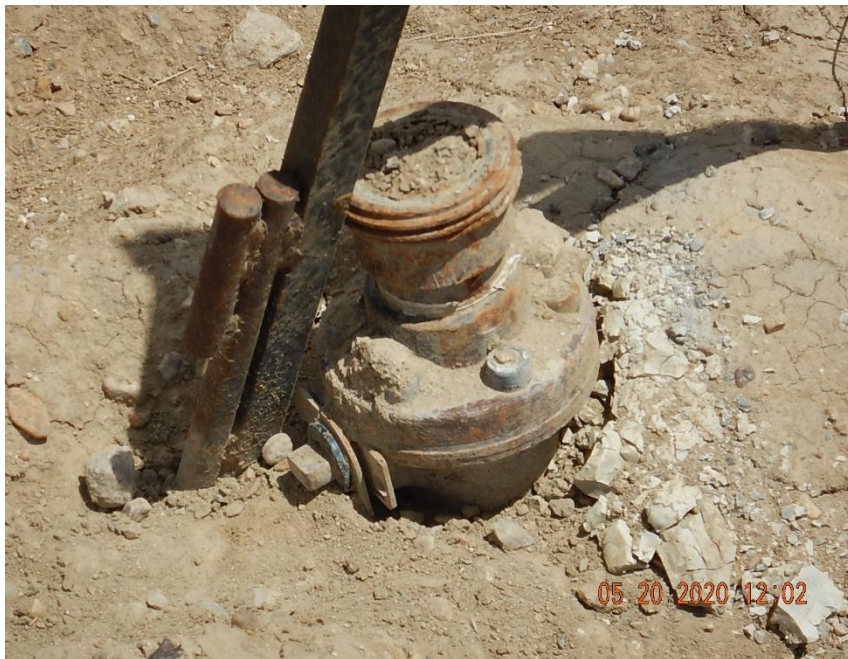
Close up view of inactive flowline riser; Open ended/ Not bull plugged. No OOSLAT in place.

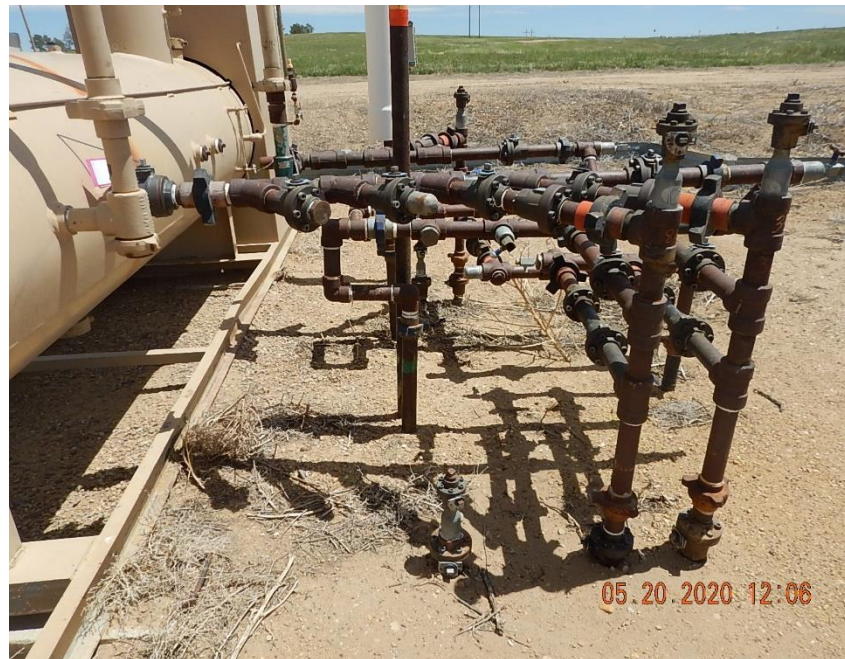
Inactive flowline riser at inlet to heated horizontal separator
No OOSLAT in place

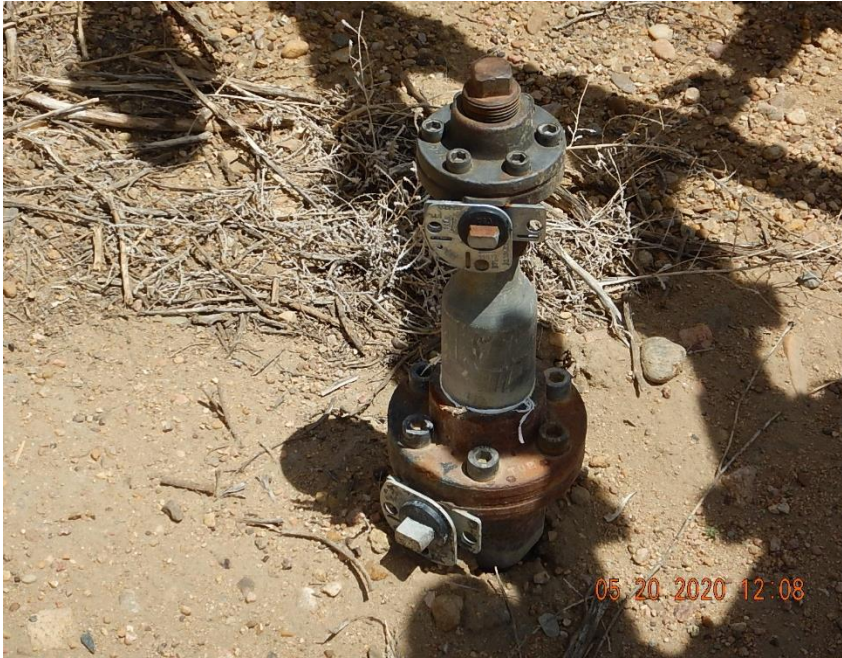
**Close up view of inactive flowline riser at separator
No OOSLAT in place.**

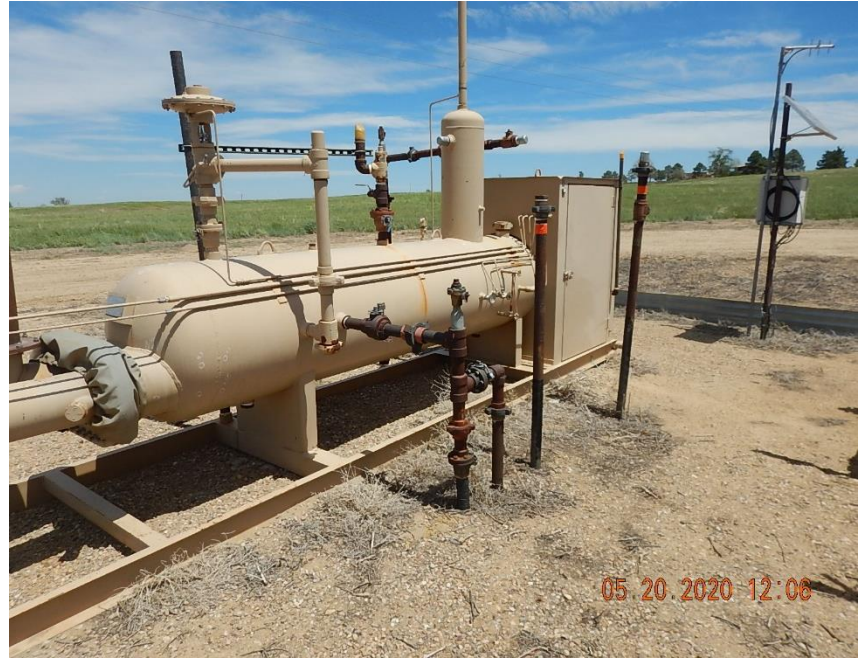
**Out of service flowline risers at horizontal separator;
Unused equipment, No LO/TO (OOSLAT)**
