Inspection Photos
Operator: BP America
API#: 067-08378
Date: 5/20/2020

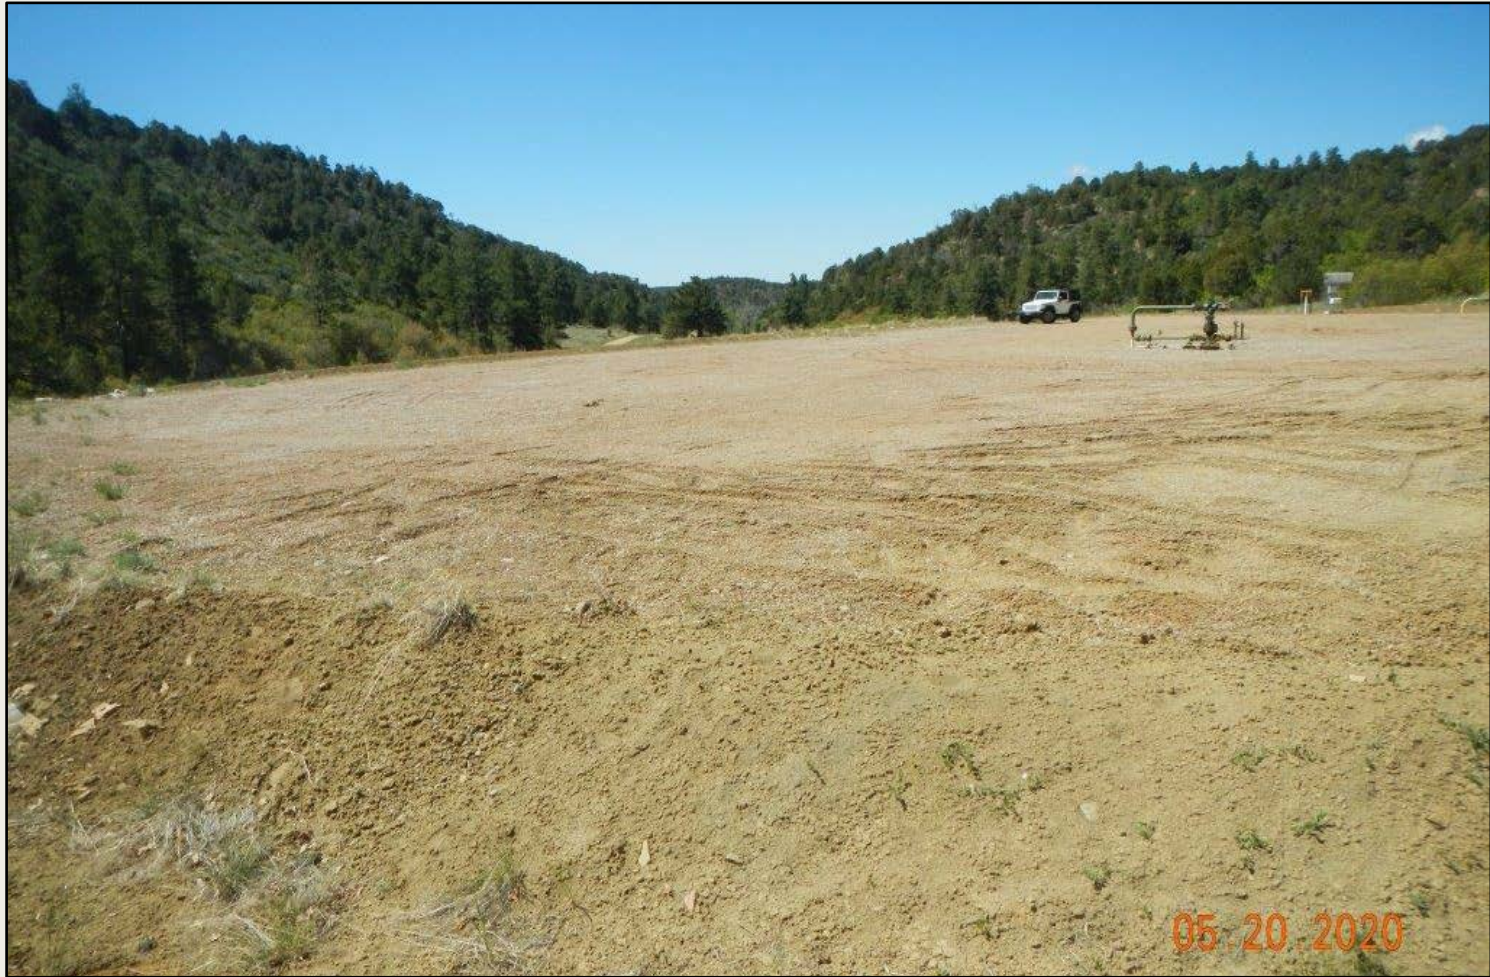
Photo 1. View of the project area from the northeastern corner facing center.

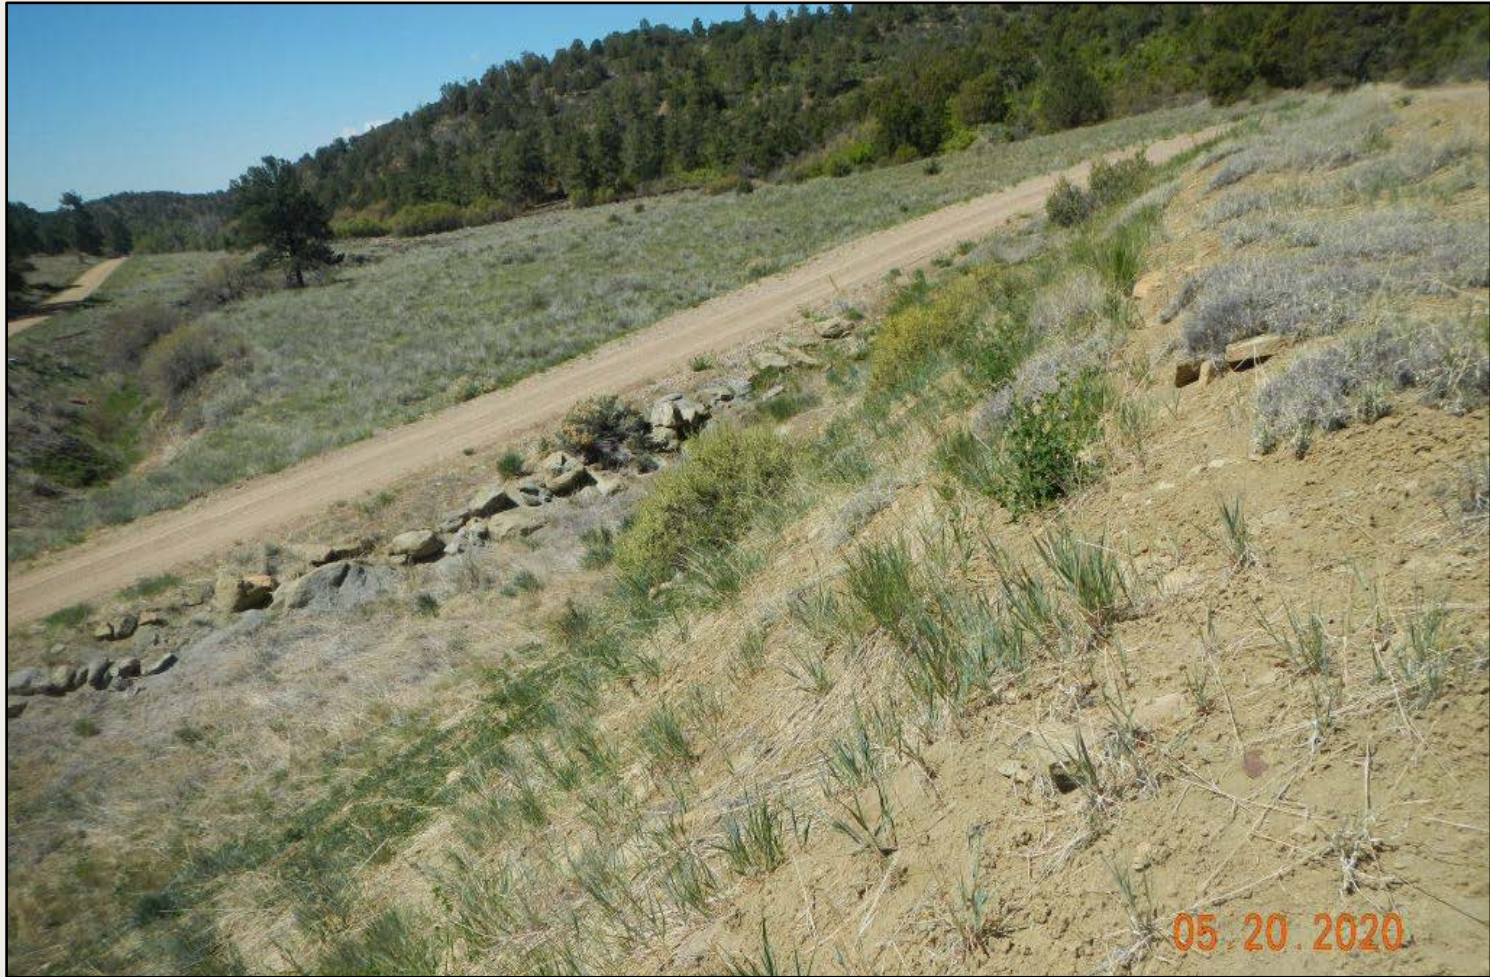
Photo 2. View of the southern fill slope from the southeastern corner facing westward. Revegetation is progressing with grasses such as western wheatgrass, sand dropseed, and smooth brome.

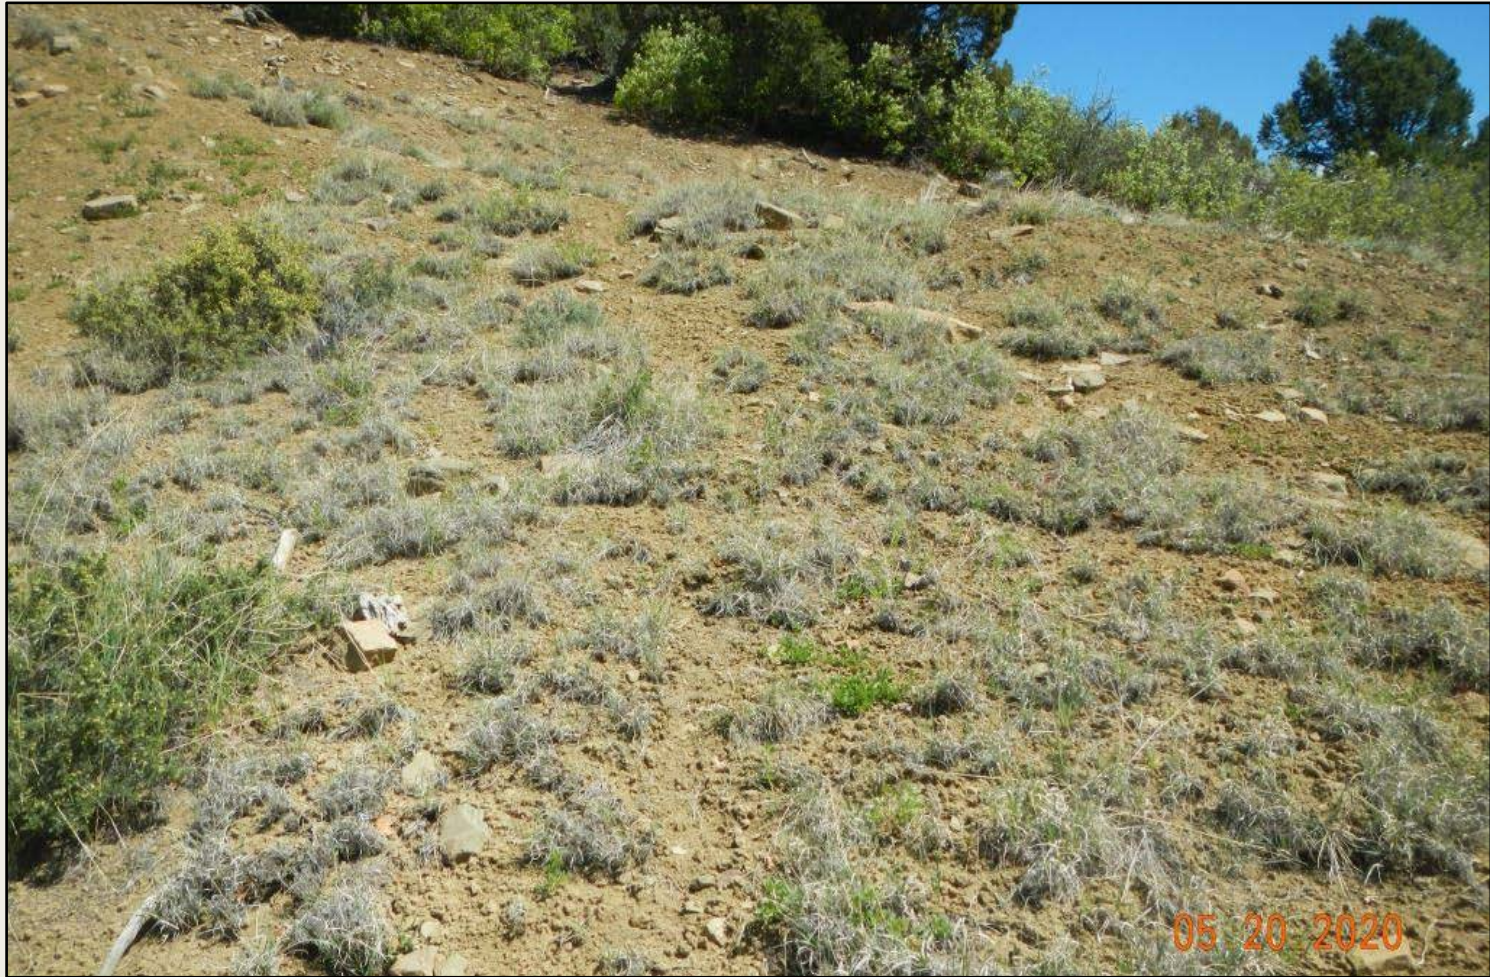
Photo 3. View of the northeastern cut-slope. Revegetation is progressing here with blue gramma and *Heterotheca villosa*.

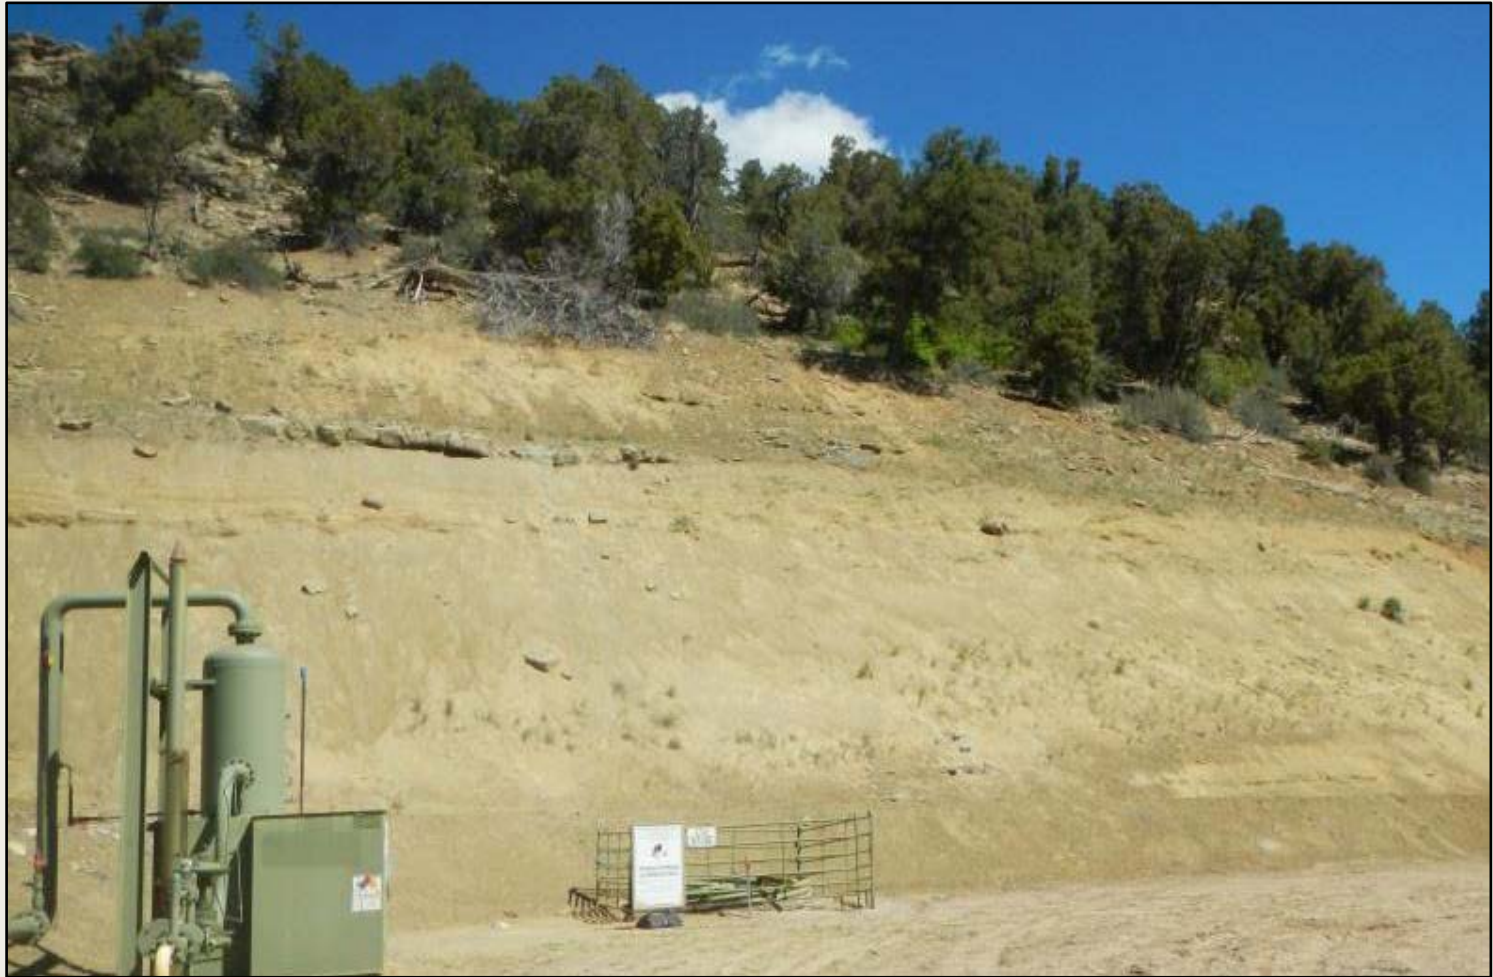
Photo 4. View of the northern cut-slope. Vegetation is not increasing significantly. Bare soils need stabilization.

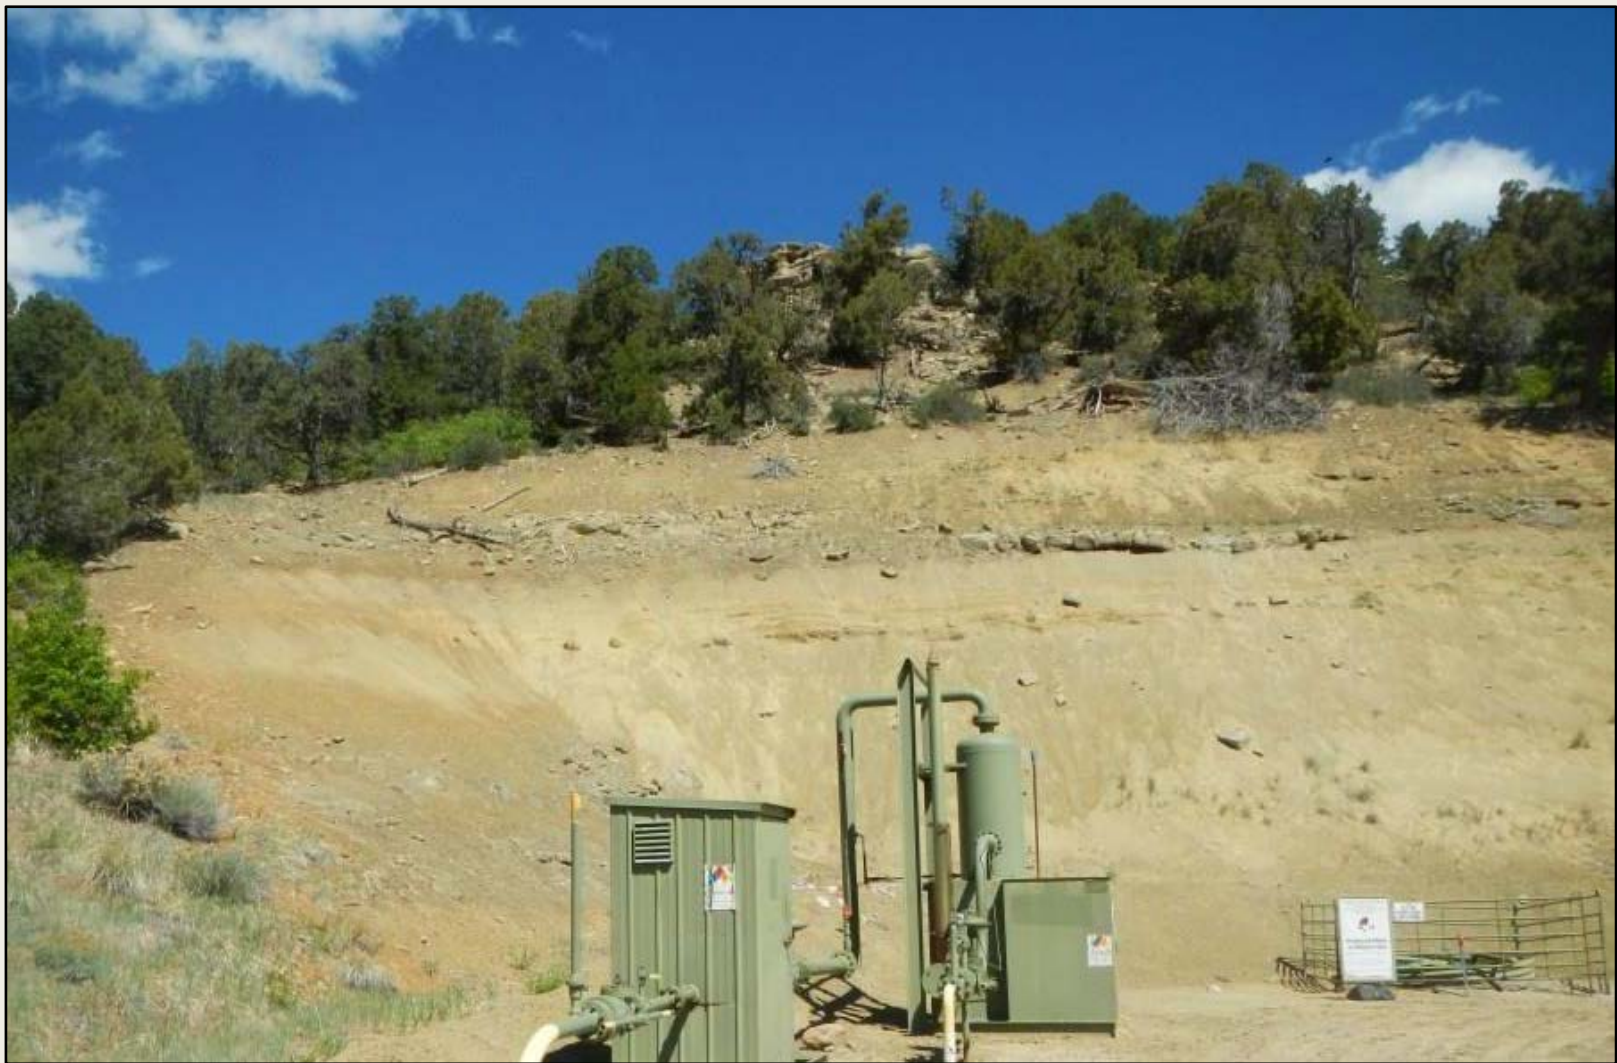
Photo 5. View of the northwestern cut-slope. Bare soils need stabilization.

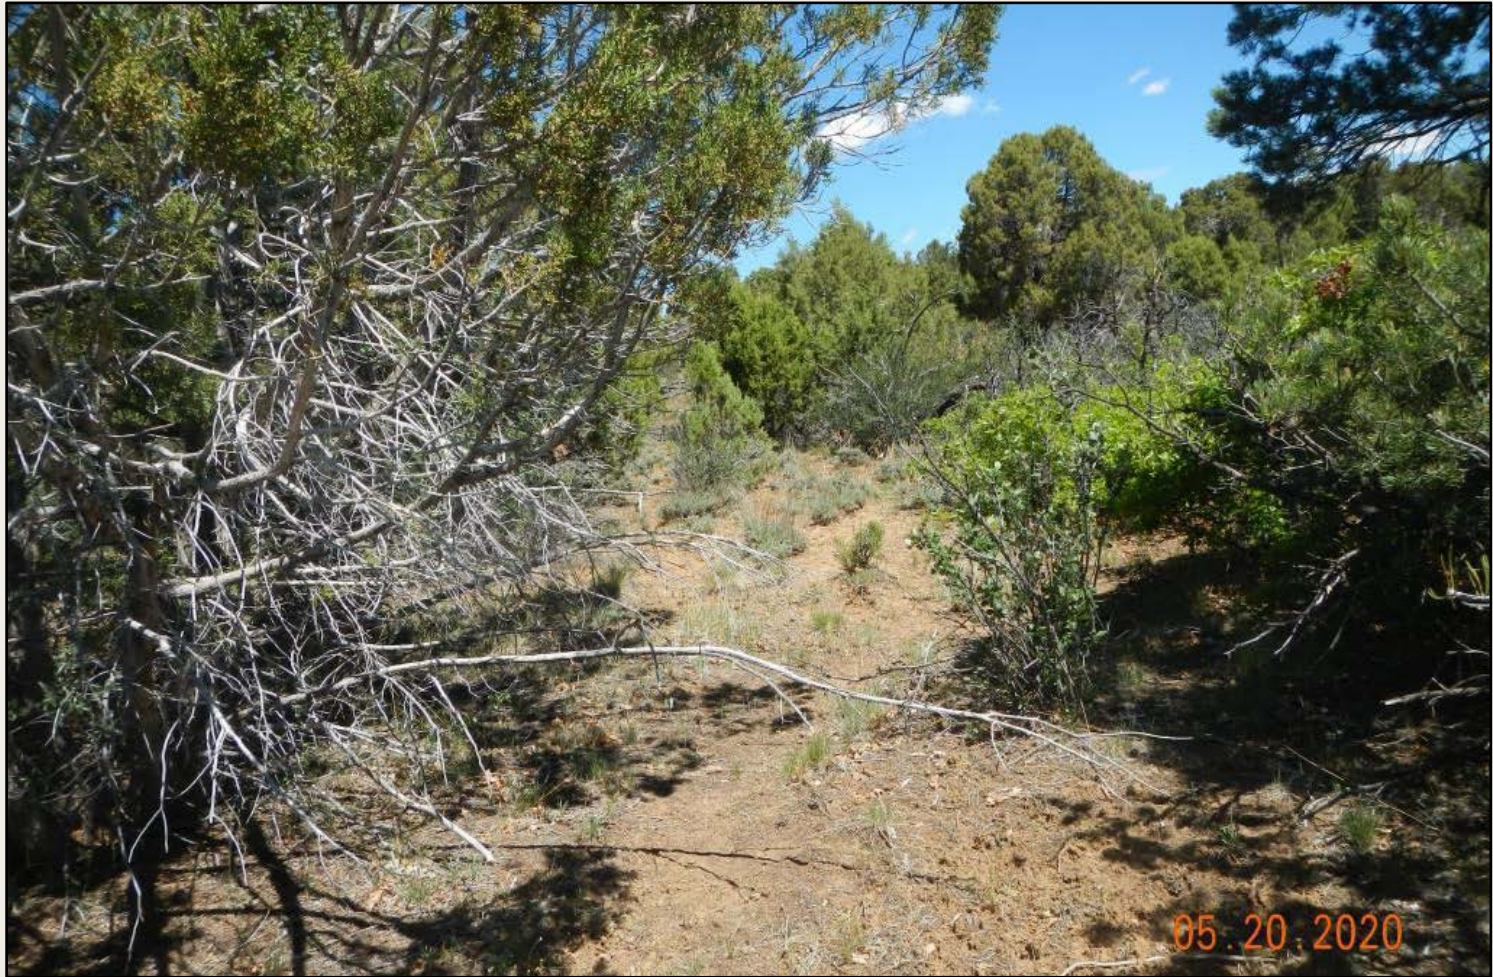
Photo 6. View of reference area vegetation comprised of pinyon juniper woodland with understory of gambel oak, black sage, muttongrass, and penstemon.
